## Wellhead Closure Checklist 2

| Site Name | REI H 9-32D,33D |
| Remediation Project # | 28512 |

| Client | Oxy |

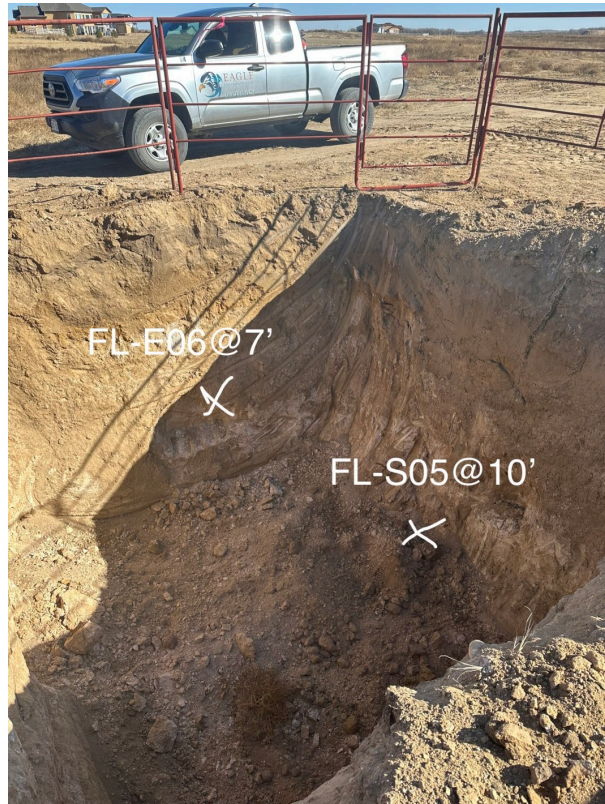
R2 - P1

| # | Sample Date | Sample Time | Soil Sample ID | PID Readings | Visual | Olfactory | Equipment Name |
|---|---|---|---|---|---|---|---|
| R2 | 11/10/2023 | 01:04 PM | FL-E06@7' | 1.3 | N.S | N.O | Flowline |

Facing southeast

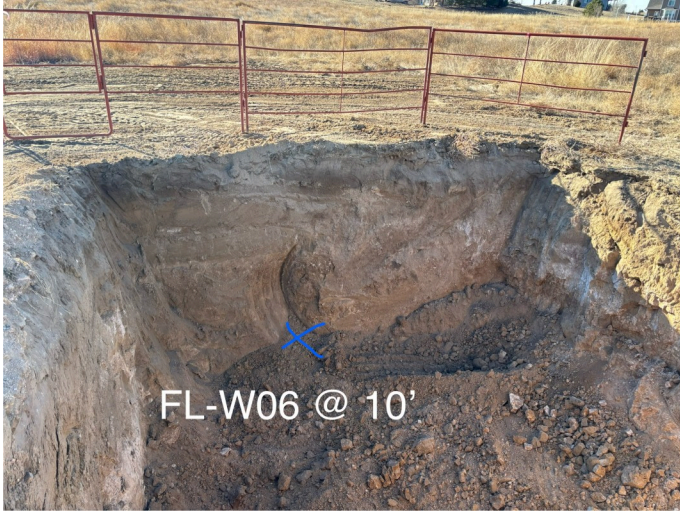
R5 - P1

| # | Sample Date | Sample Time | Soil Sample ID | PID Readings | Visual | Olfactory | Equipment Name |
|---|---|---|---|---|---|---|---|
| R5 | 01/03/2024 | 1:25 PM | FL-W06 @ 10' | 2.2 | N.S | N.O | Flowline |

Looking west

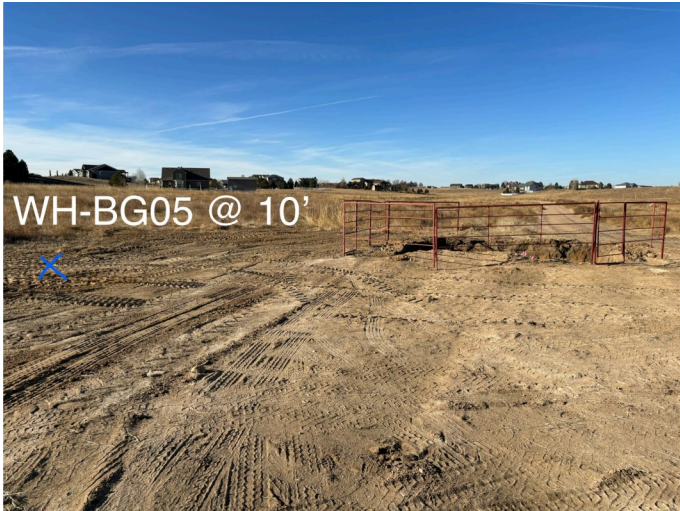
R7 - P1

| # | Sample Date | Sample Time | Soil Sample ID | PID Readings | Visual | Olfactory | Equipment Name |
|---|---|---|---|---|---|---|---|
| R7 | 01/03/2024 | 01:55 PM | WH-BG05 @ 10' | 0.4 | N.S | N.O | Wellhead Background |

Looking north

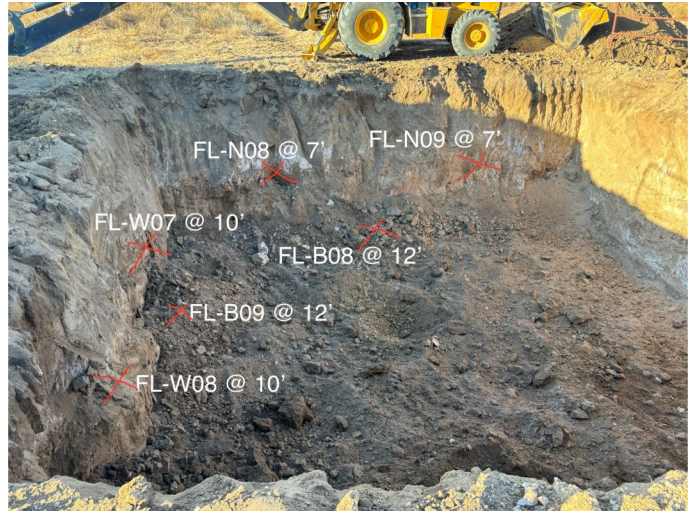
R8 - P1

| # | Sample Date | Sample Time | Soil Sample ID | PID Readings | Visual | Olfactory | Equipment Name |
|---|---|---|---|---|---|---|---|
| R8 | 01/23/2024 | 03:05 PM | FL-N08 @ 7' | 0.7 | N.S | N.O | Flowline |

Looking north

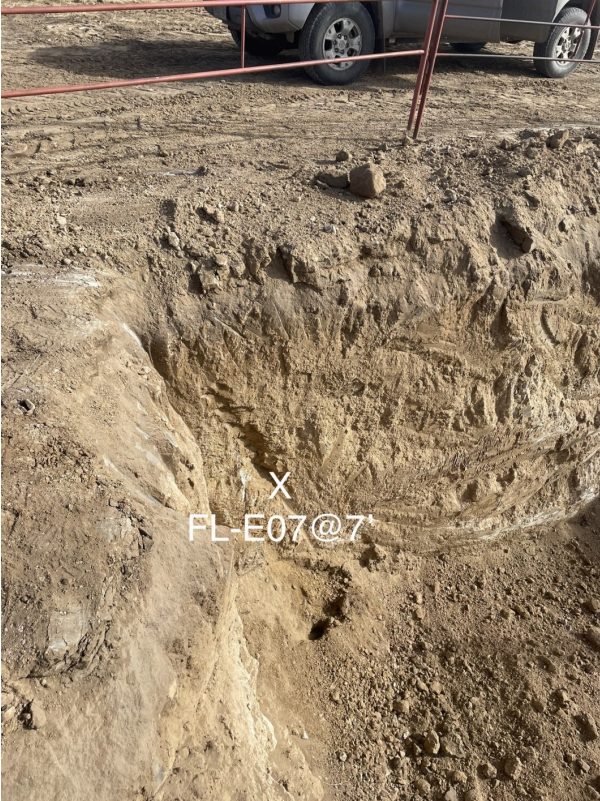
R14 - P1

| # | Sample Date | Sample Time | Soil Sample ID | PID Readings | Visual | Olfactory | Equipment Name |
|---|---|---|---|---|---|---|---|
| R14 | 01/24/2024 | 11:50 AM | FL-E07@7' | 3.1 | N.S | N.O | Flowline |

Facing East

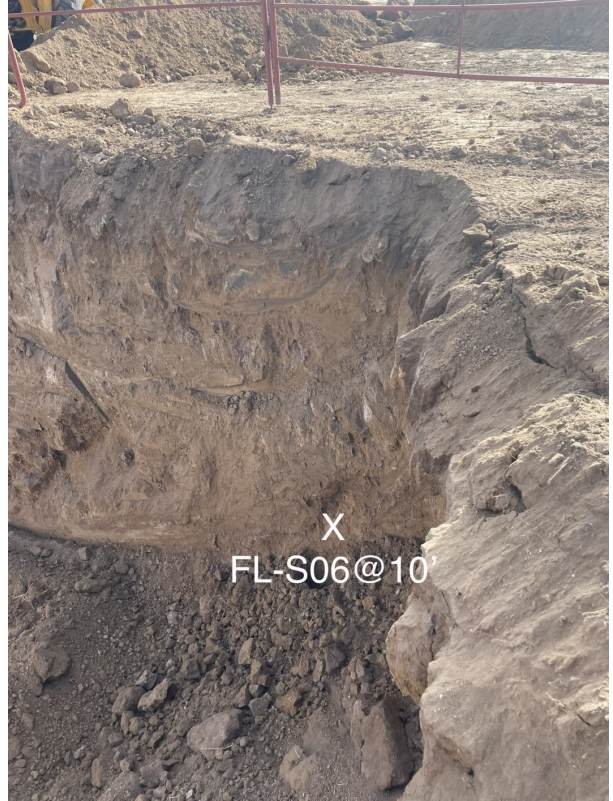
R15 - P1

| # | Sample Date | Sample Time | Soil Sample ID | PID Readings | Visual | Olfactory | Equipment Name |
|---|---|---|---|---|---|---|---|
| R15 | 01/24/2024 | 12:00 PM | FL-S06@10' | 3.9 | N.S | N.O | Flowline |

Facing South

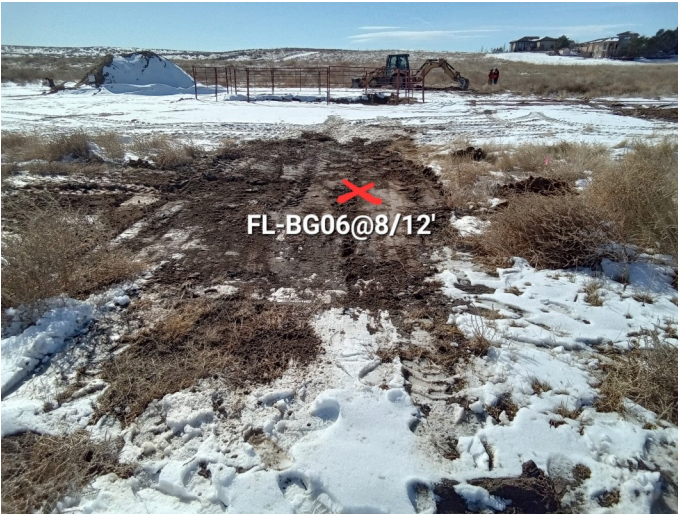
R16 - P1

| # | Sample Date | Sample Time | Soil Sample ID | PID Readings | Visual | Olfactory | Equipment Name |
|---|---|---|---|---|---|---|---|
| R16 | 02/12/2024 | 01:30 PM | FL-BG06@8' | 0.7 | N.S | N.O | Wellhead Background |

Looking west

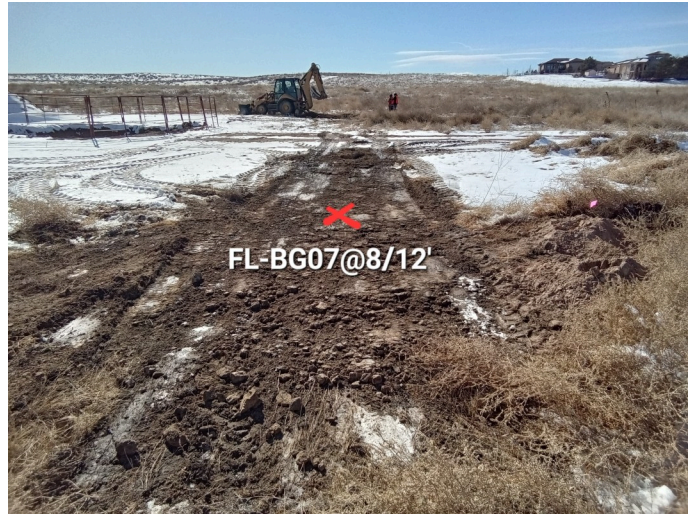
R18 - P1

| # | Sample Date | Sample Time | Soil Sample ID | PID Readings | Visual | Olfactory | Equipment Name |
|---|---|---|---|---|---|---|---|
| R18 | 02/12/2024 | 01:34 PM | FL-BG07@8' | 0.4 | N.S | N.O | Wellhead Background |

Looking southwest

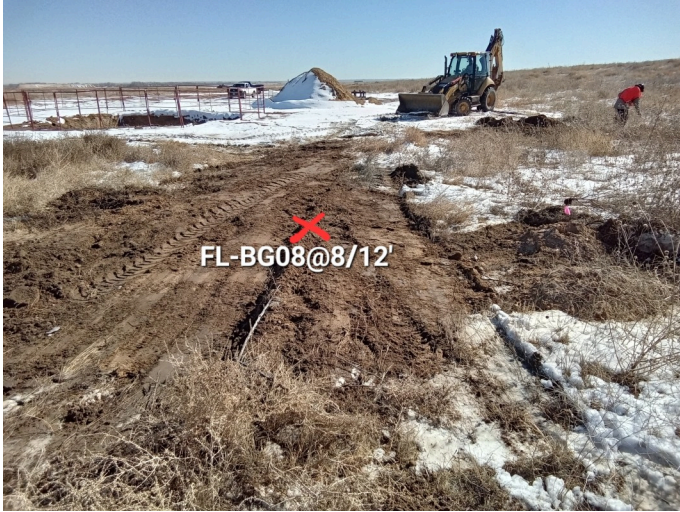
R20 - P1

| # | Sample Date | Sample Time | Soil Sample ID | PID Readings | Visual | Olfactory | Equipment Name |
|---|---|---|---|---|---|---|---|
| R20 | 02/12/2024 | 01:38 PM | FL-BG08@8' | 0.2 | N.S | N.O | Wellhead Background |

Looking southeast

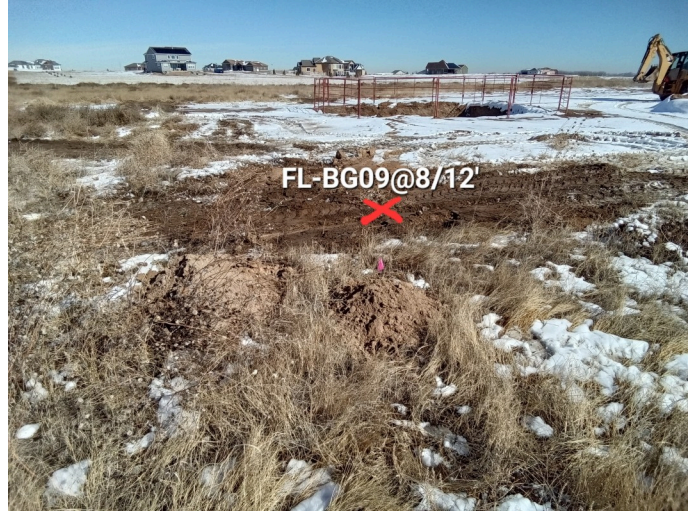
R22 - P1

| # | Sample Date | Sample Time | Soil Sample ID | PID Readings | Visual | Olfactory | Equipment Name |
|---|---|---|---|---|---|---|---|
| R22 | 02/12/2024 | 01:42 PM | FL-BG09@8' | 0.4 | N.S | N.O | Wellhead Background |

Looking east

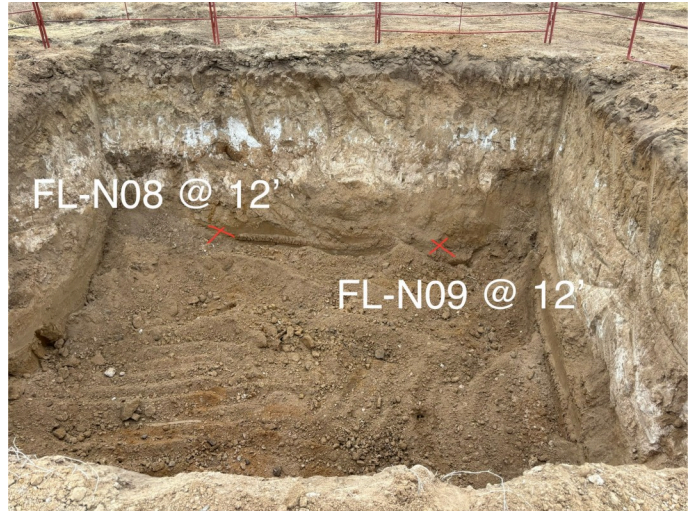
R26 - P1

| # | Sample Date | Sample Time | Soil Sample ID | PID Readings | Visual | Olfactory | Equipment Name |
|---|---|---|---|---|---|---|---|
| R26 | 03/08/2024 | 12:25 PM | FL-N08 @ 12' | 0.0 | N.S | N.O | Flowline |

Facing north

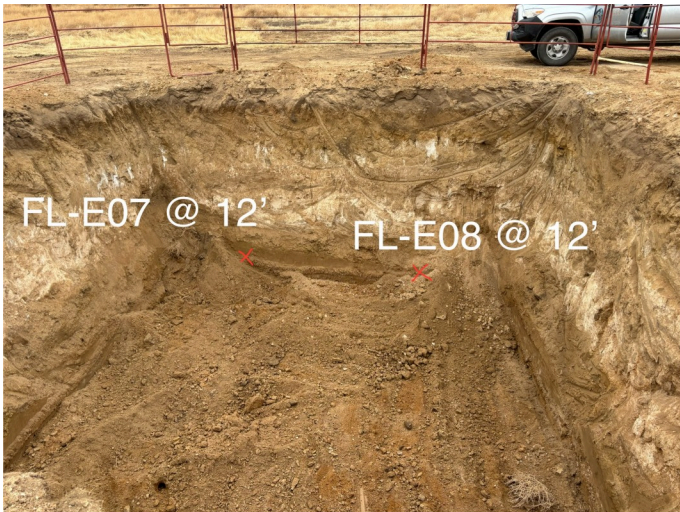
R28 - P1

| # | Sample Date | Sample Time | Soil Sample ID | PID Readings | Visual | Olfactory | Equipment Name |
|---|---|---|---|---|---|---|---|
| R28 | 03/08/2024 | 12:40 PM | FL-E07 @ 12' | 0.8 | N.S | N.O | Flowline |

Facing east

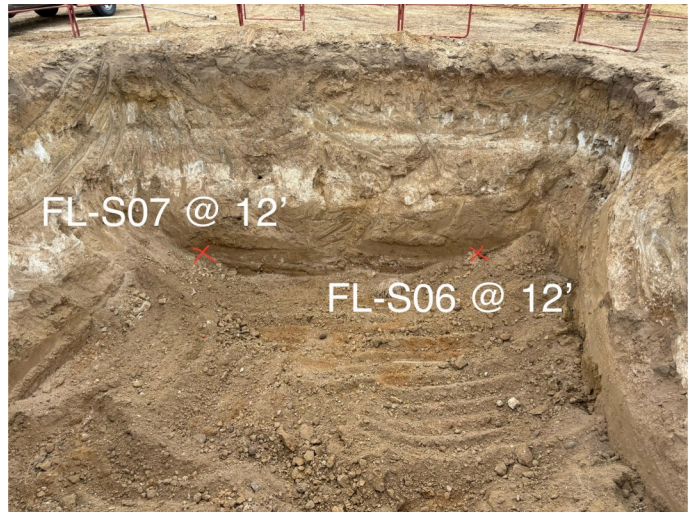
R30 - P1

| # | Sample Date | Sample Time | Soil Sample ID | PID Readings | Visual | Olfactory | Equipment Name |
|---|---|---|---|---|---|---|---|
| R30 | 03/08/2024 | 01:00 PM | FL-S06 @ 12' | 0.8 | N.S | N.O | Flowline |

Facing south
