Pintail Lateral Reclamation Plan, Remediation Project 28892 Weld County, Colorado

Taproot Rockies Midstream, LLC

SWCA Environmental Consultants

**PINTAIL LATERAL RECLAMATION PLAN,
REMEDICATION PROJECT 28892
WELD COUNTY, COLORADO**

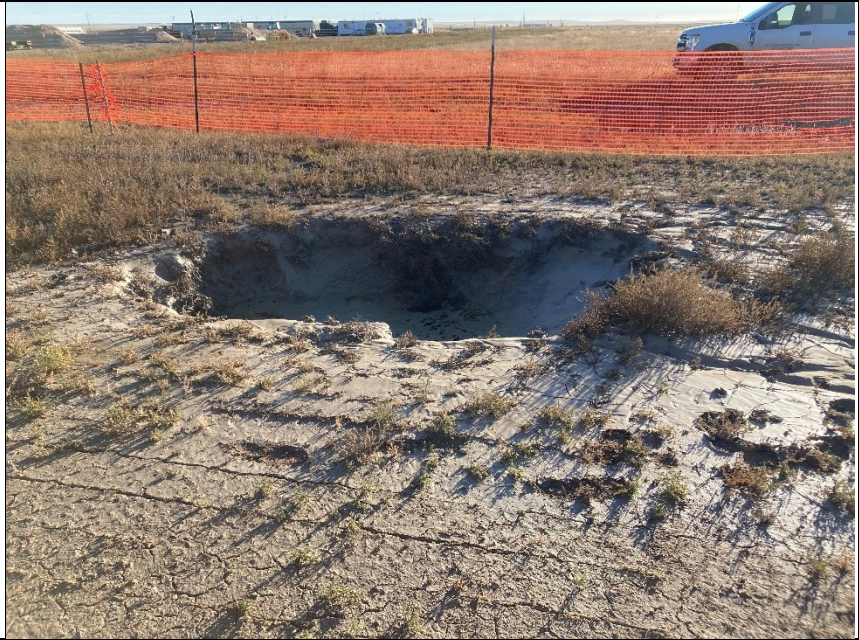
Photo: 2

Release location looking southwest.

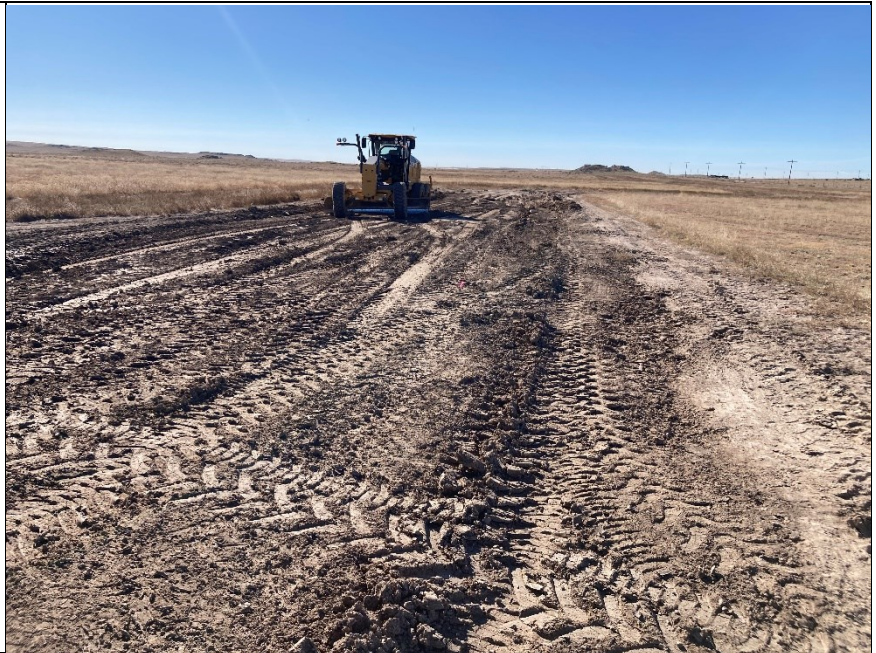
Photo: 8

Surface scraping of impacted area.

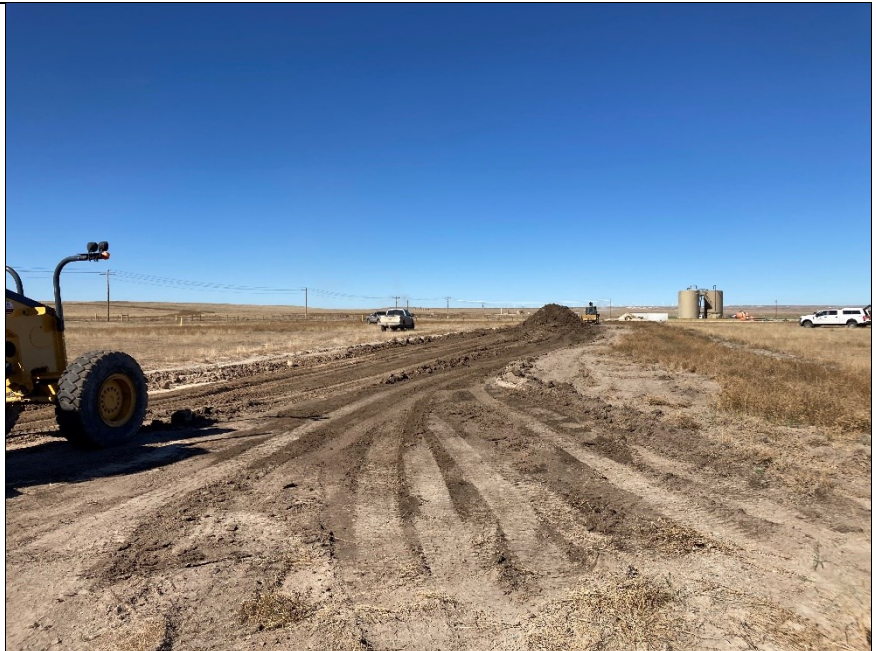
Photo: 9

Looking south at the primary and secondary excavation areas on 11/18

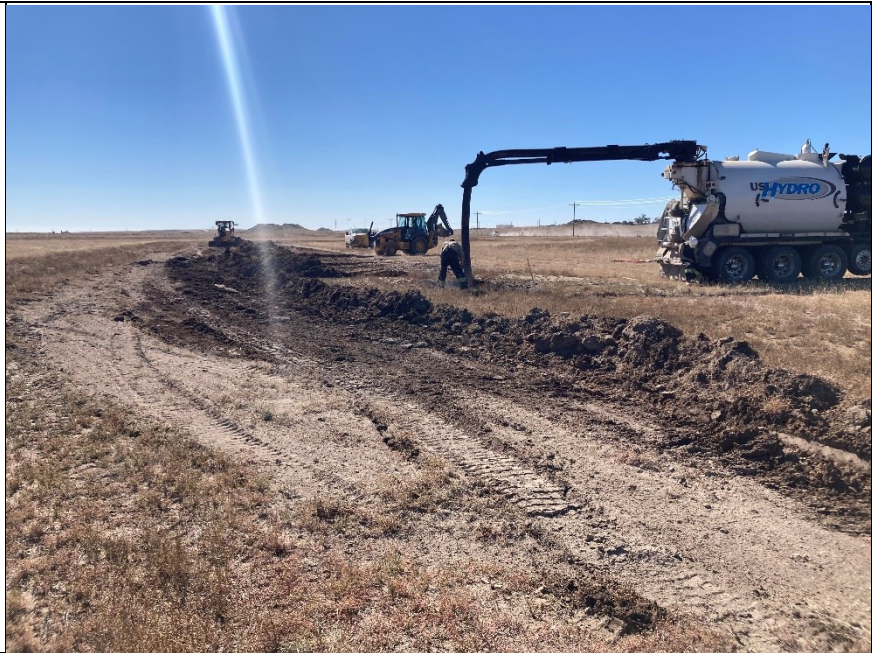
Photo: 10

Primary excavation area after exposing failed pipeline. Day 2 of hydroexcavation 10/19/22.

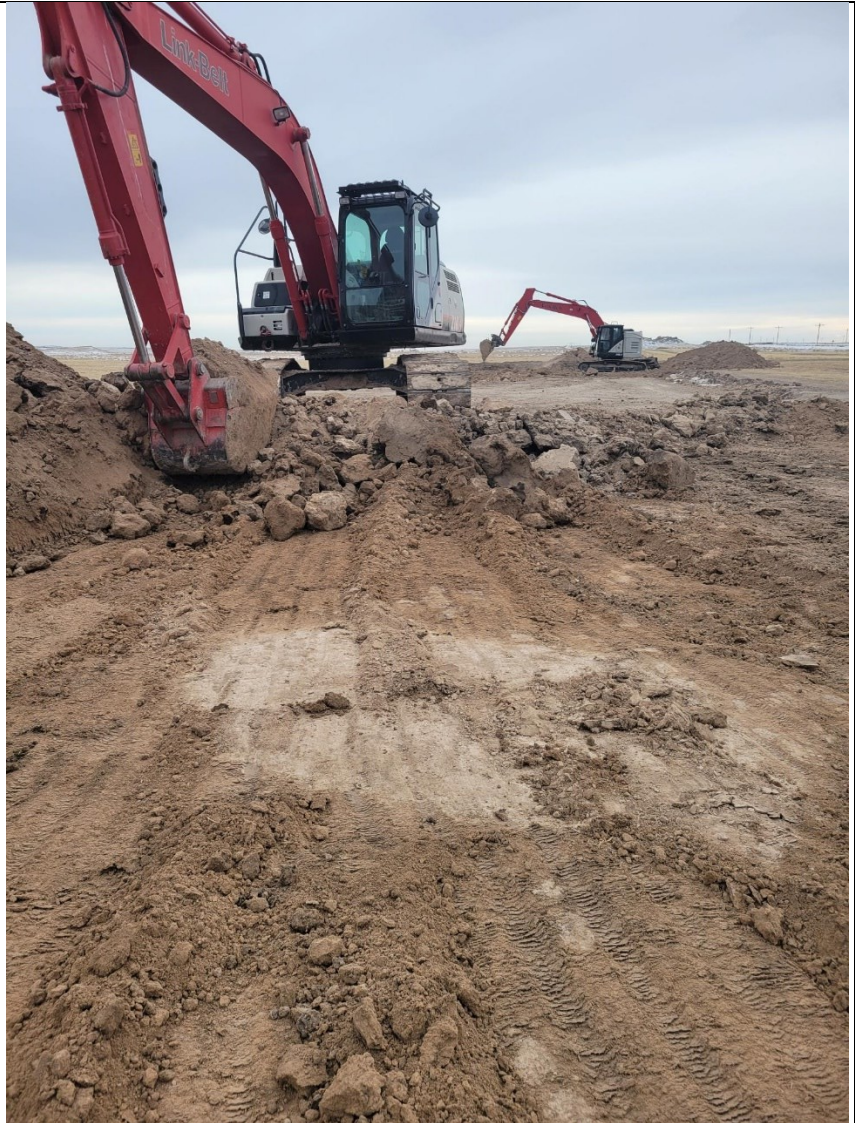
Photo: 15**Description:**

Final Site Conditions following excavation of 1,150 tons of soil on 12/20 and 12/21.
