Interim Reclamation and Stormwater Inspection

Operator: PDC Energy Inc - 69175

Location ID: 470630

Inspection Photos
Location Name: Ella-64N66W 5SWNW
Location ID: 470630

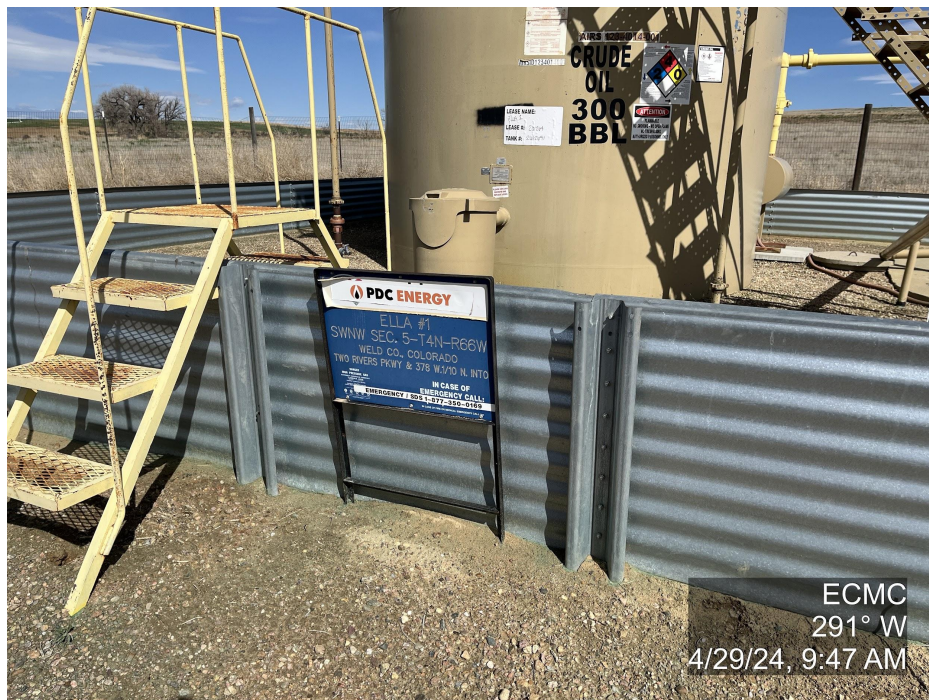
Photo 1. The photo was taken at the tank battery location facing West. The photo illustrates the operator sign at the tank battery.

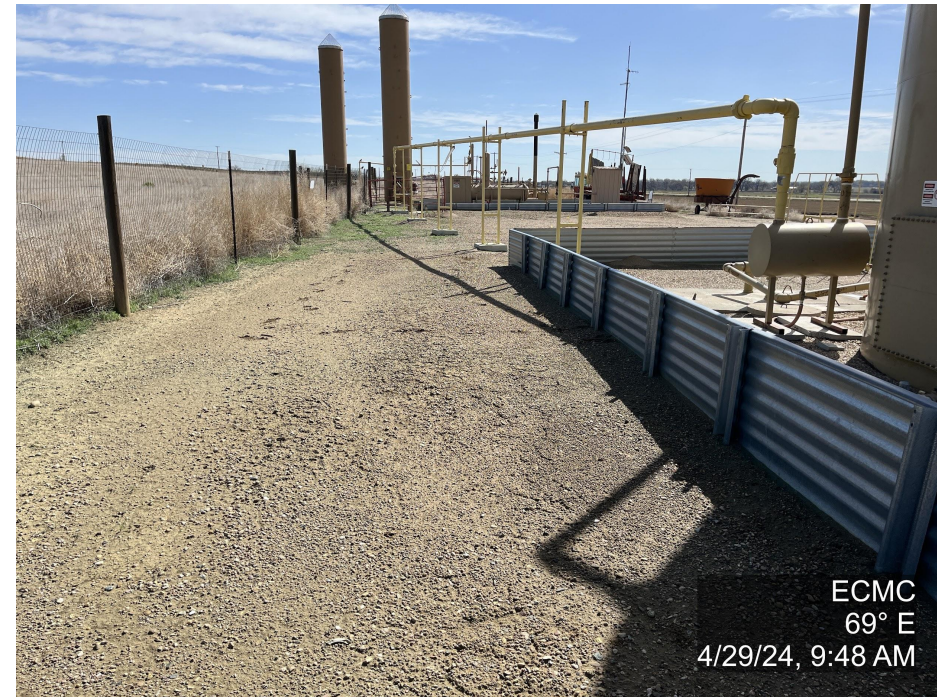
Photo 2. The photo was taken at the tank battery location facing East. The photo illustrates the tank battery equipment and edge of the production pad.

Note - The green vegetation along the interior of the fencing appears to be Kochia.

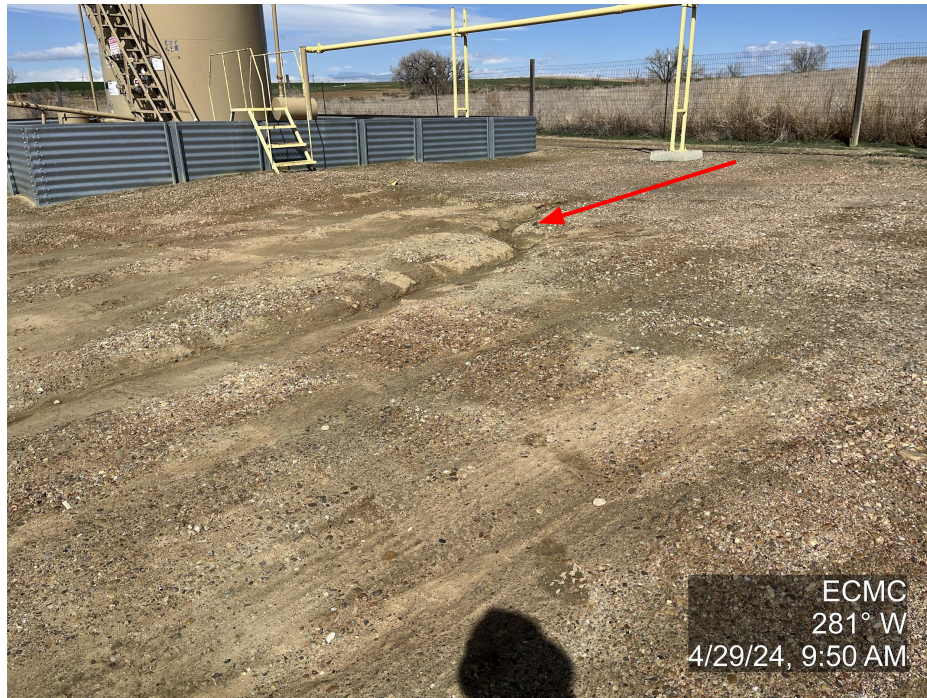
Photo 3. The photo was taken at the tank battery location facing West. The photo illustrates an example of multiple erosional rills along the production pad.

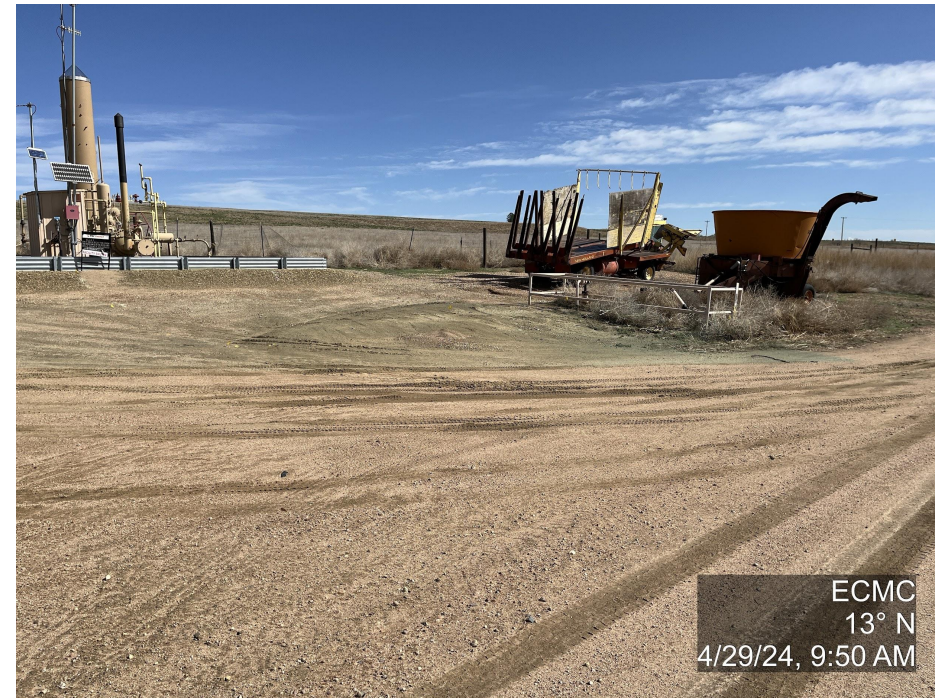
Photo 4. The photo was taken at the tank battery facility facing North. The photo illustrates unused equipment being stored on the production pad.

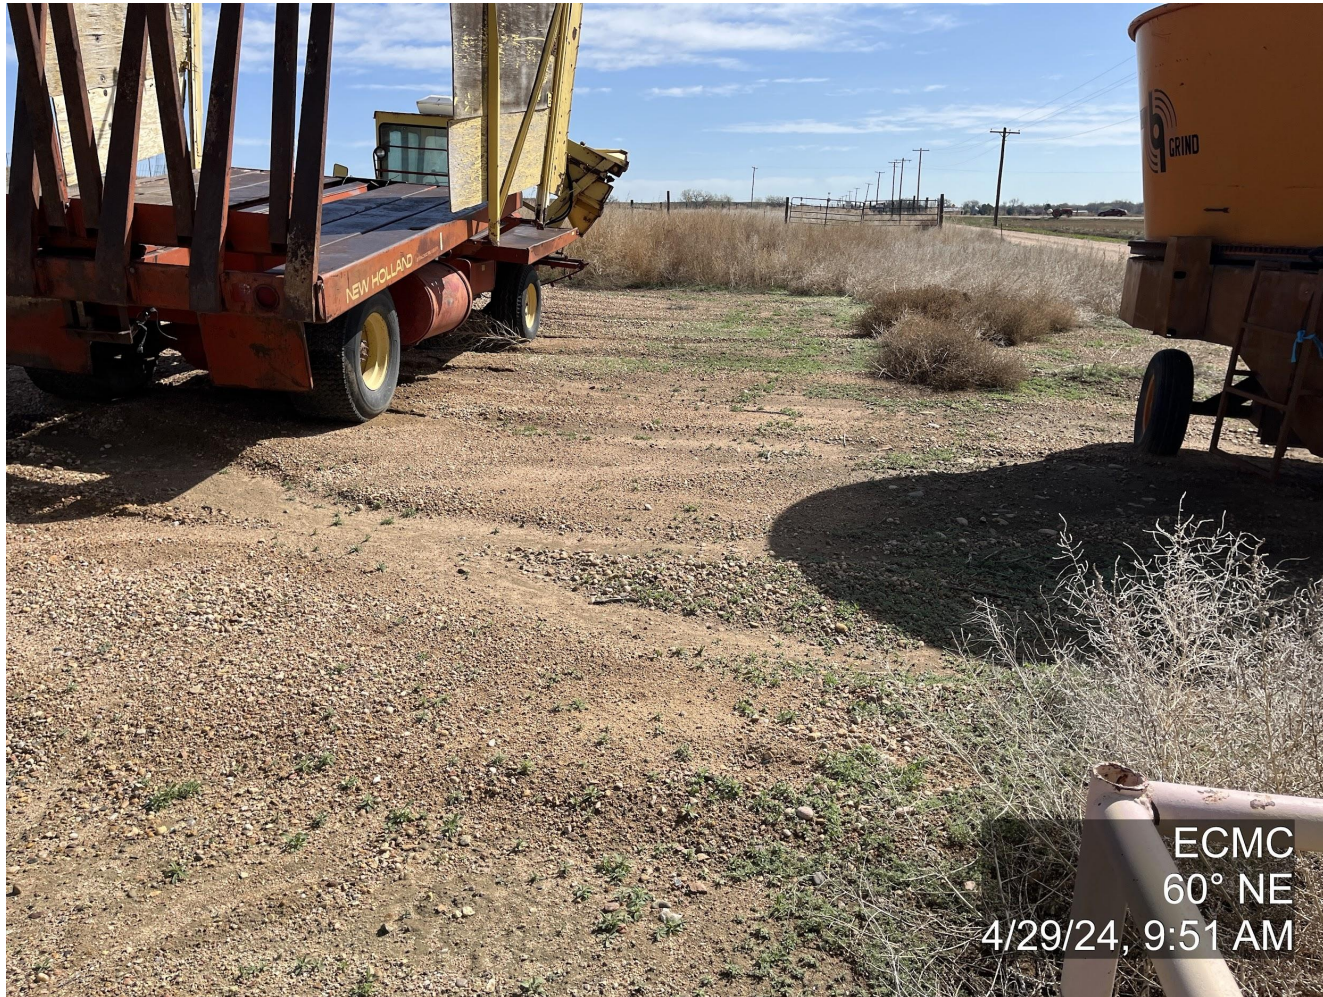
Photo 5. The photo was taken at the tank battery facility facing Northeast. The photo illustrates an unused area of the production pad that remains as well as former production area that has been overgrown with Russian thistle and Kochia.

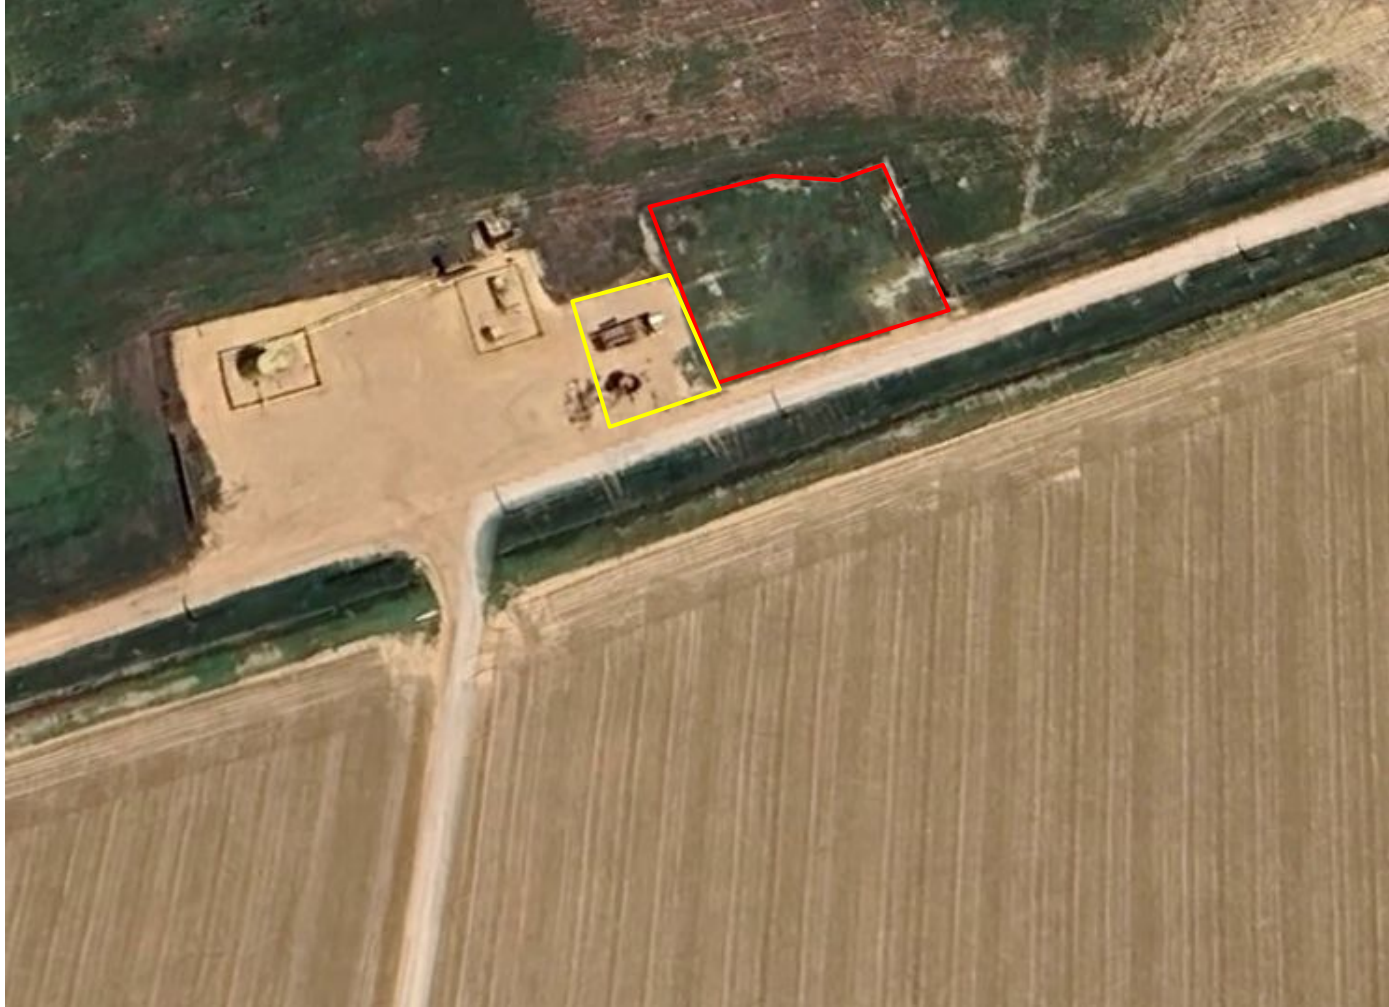
Photo 6. The image is of the tank battery facility using Google Earth imagery. The red box indicates the area formerly used on the tank battery facility that is dominated by Russian thistle and Kochia and should continue to be managed as part of the interim reclamation area. The yellow box indicates the area of the production pad that is storing unused equipment.
