Interim Reclamation and Stormwater Inspection

Operator: PDC Energy Inc - 69175

Location ID: 447371

Location Name: Johnson 17-1, Knutson K17-25

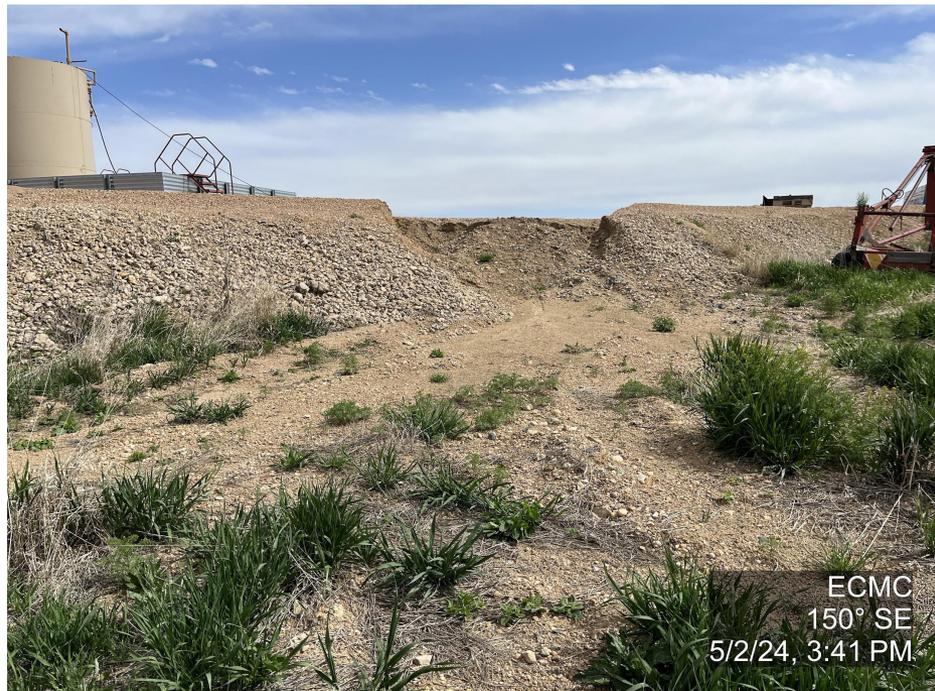
Photo 2. The photo was taken at the tank battery location facing Southeast. The photo illustrates gully erosion on the West side of the production pad.

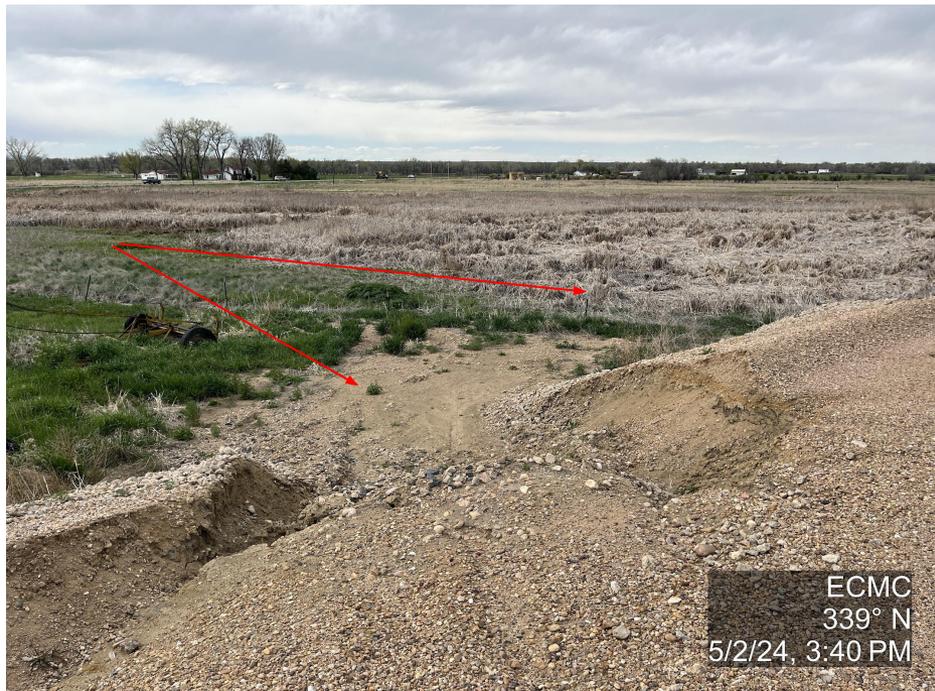
Photo 3. The photo was taken at the tank battery location facing North. The photo illustrates the gully erosion and sedimentation off the location.

Note - Freshwater emergent wetlands extend to the boundary of the location disturbance.

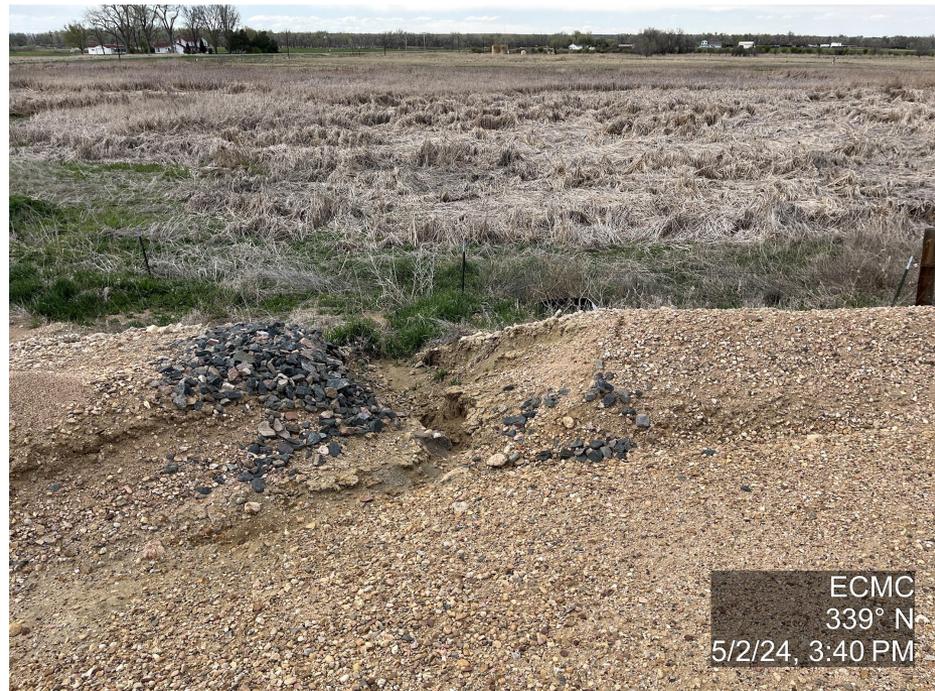
Photo 4. The photo was taken at the tank battery location facing North. The photo illustrates erosion on the East side of the production pad.

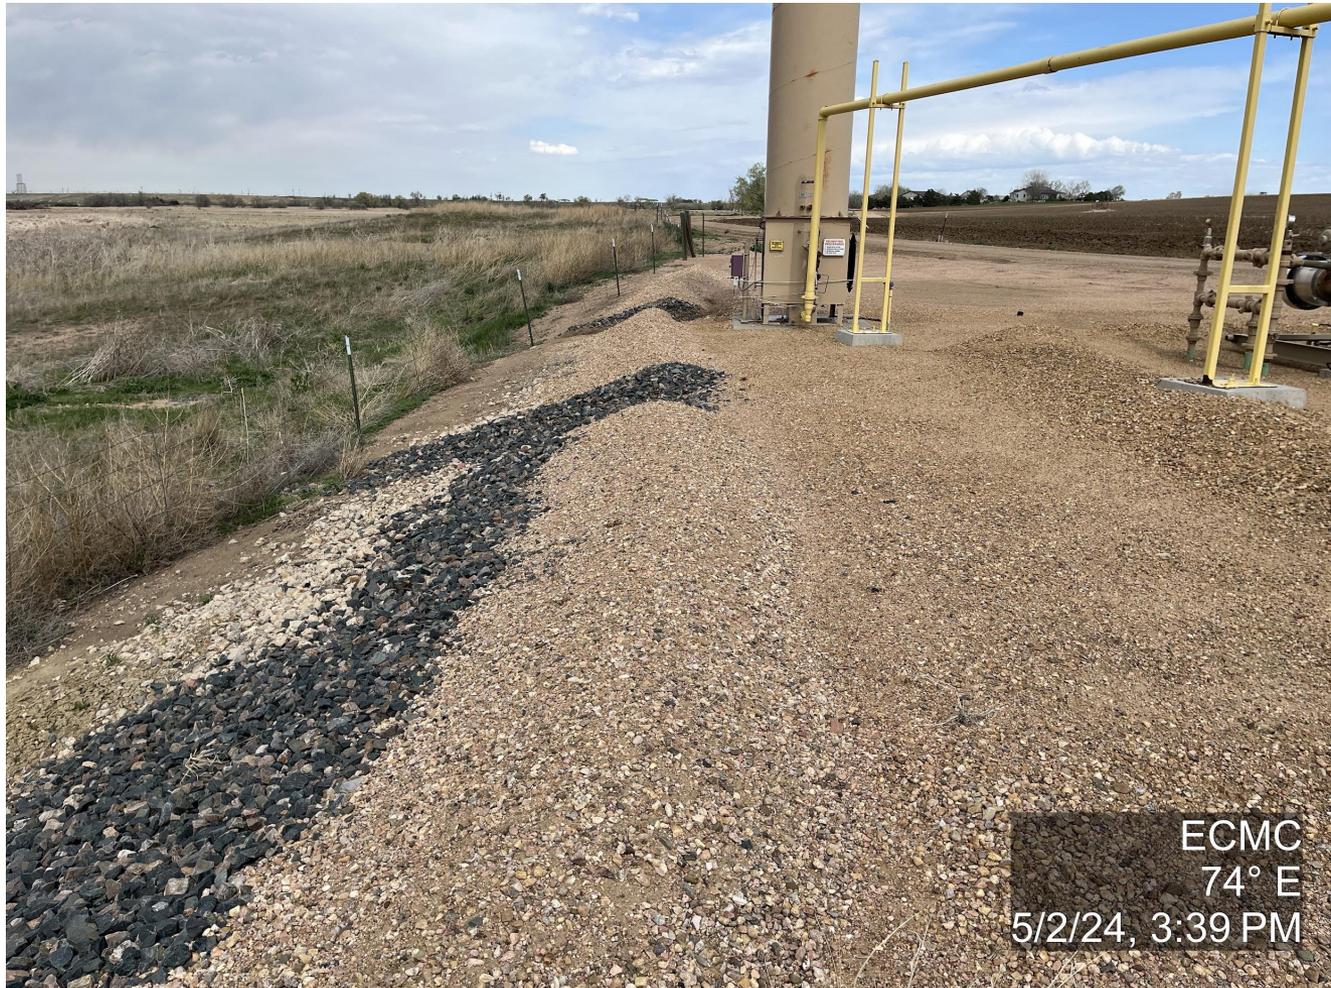
Photo 5. The photo was taken at the tank battery location facing East. The photo illustrates the production pad boundary with interim areas.
