Operator: BONANZA CREEK ENERGY OPERATING COMPANY LLC

Location Name: North Platte T-27 Pad

Loc ID: 441915

Inspection: 708200986

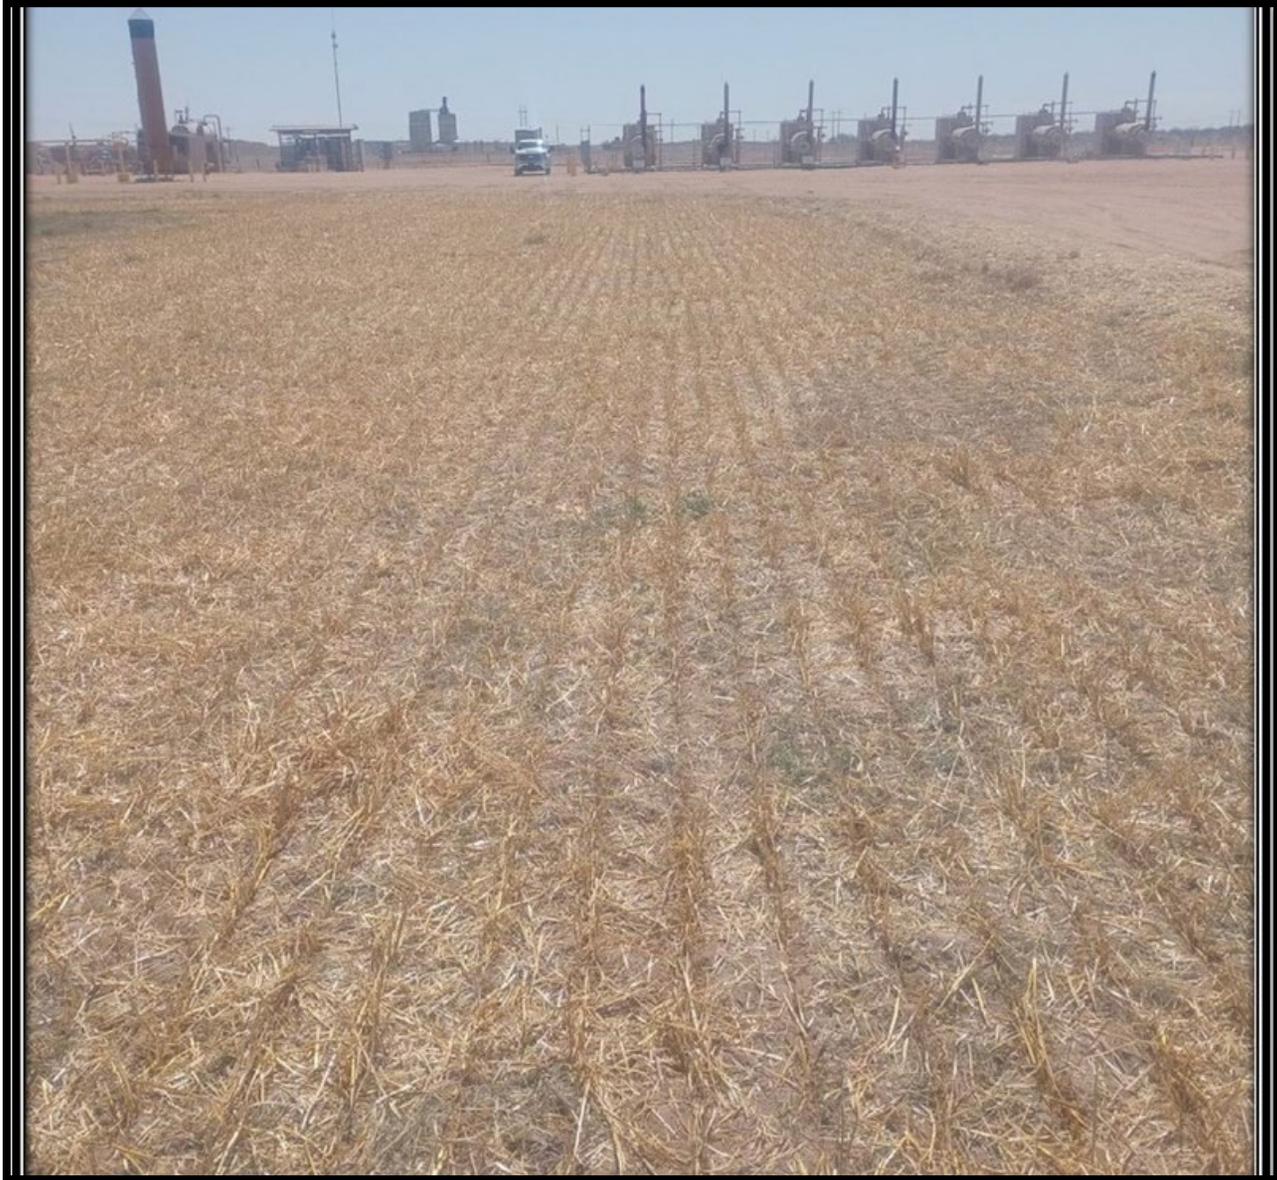
Exhibit A

CA: This location does not comply with Rule 1003. During this inspection, it was observed that interim areas are not progressing towards Rule 1003 standards and regulations with evidence of undesirable vegetation (Russian thistle and kochia) and areas of non-uniform vegetation cover resulting in exposed soils. Additional reclamation activities are required in order to comply with Rule 1003. Refer to attached inspection photos. Perform reclamation in accordance to Rule 1003. Establish vegetation with total perennial, non-invasive uniform plant cover of at least eighty (80) percent of reference area levels. Use a seed mixture requested by the surface owner, or a mixture prescribed by the local county NRCS. Ensure erosion controls are implemented to stabilize the seeded soil and continue to monitor and manage this site until the location meets Rule 1003 standards.

CA Resolution: Operator has reported that the location has been mowed, re-seeded, and crimped with straw mulch to encourage desired vegetation growth and to comply with Rule 1003.
