Final Reclamation and Stormwater Inspection

Operator: PDC ENERGY INC - 69175

Location ID: 332931

Inspection Photos
Location Name: Yaklich PM F 11-3
Location ID: 332931

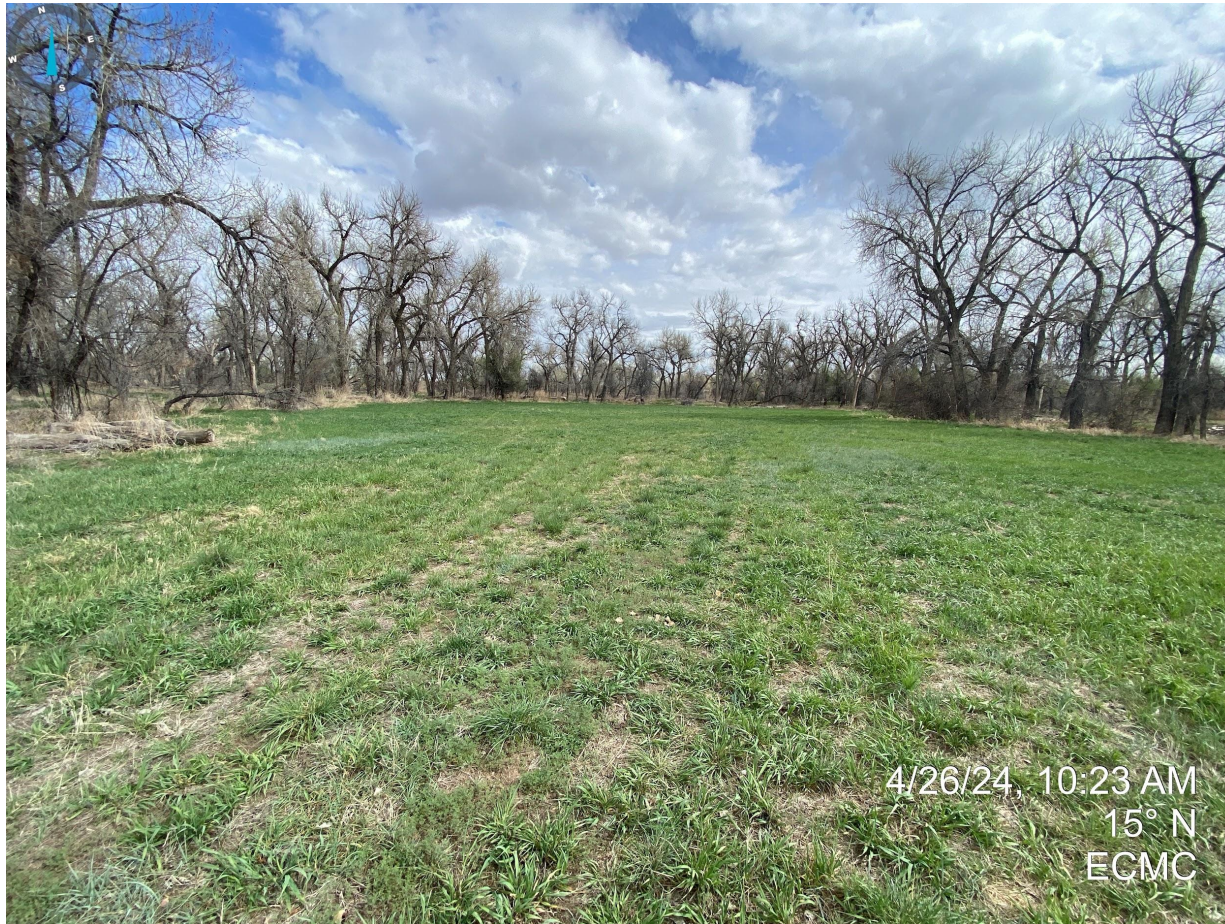
Photo 1. Facing north at the former well location. It appears that reclamation activities have been performed and the location is progressing towards Rule 1004 standards and regulations.

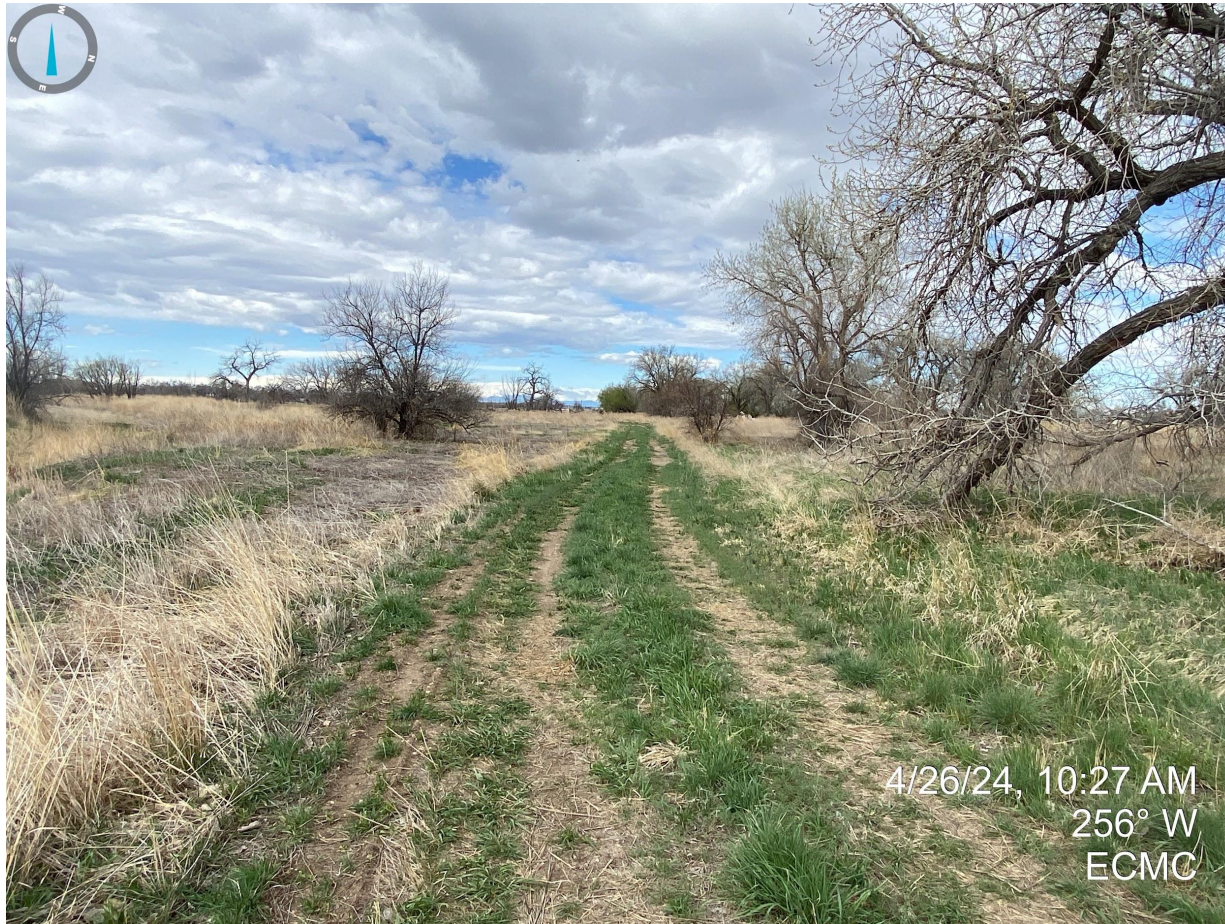
Photo 5. Facing west along the access road. Portions of the access road did not exist prior to oil and gas development. Refer to Photos 7 & 8 for additional information.

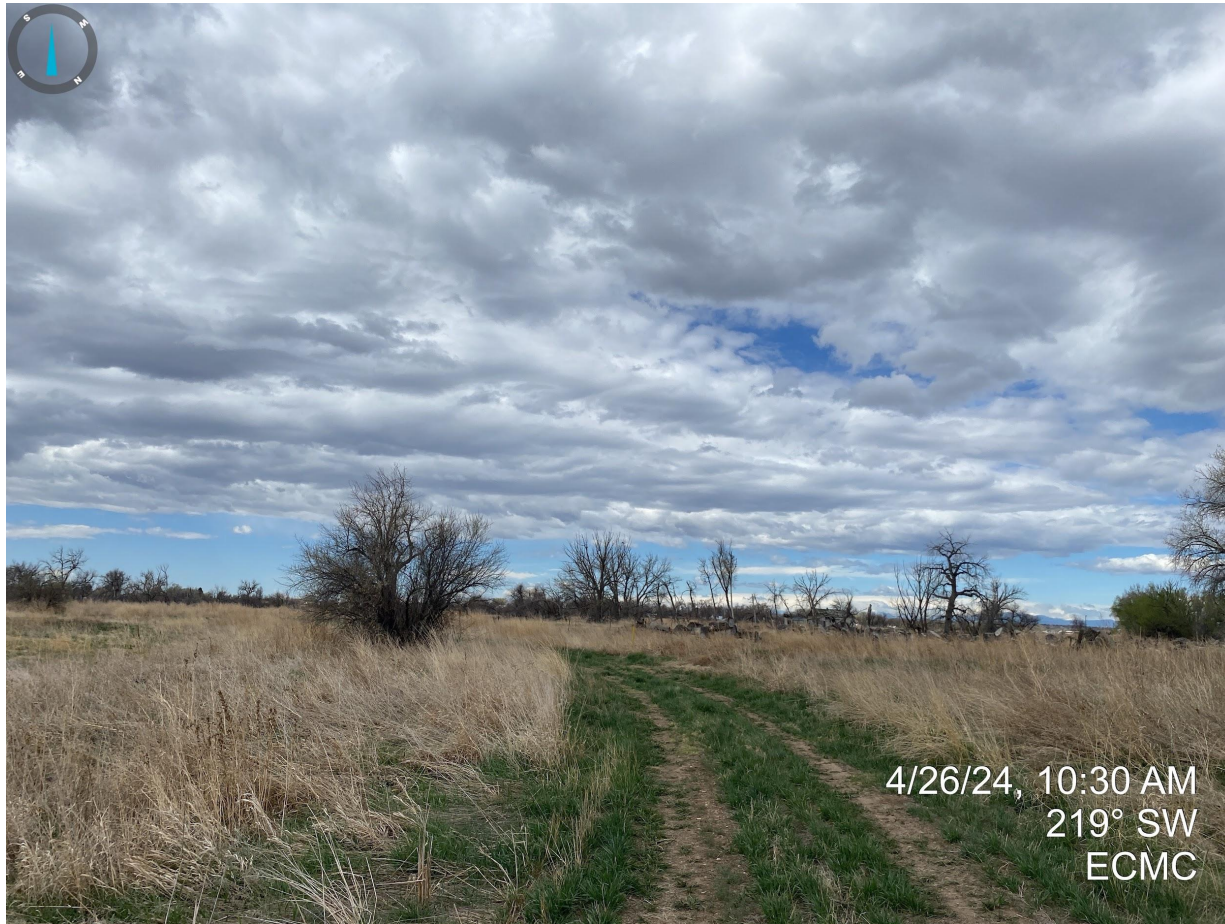
Photo 6. Facing southwest along the access road. Portions of the access road did not exist prior to oil and gas development. Refer to Photos 7 & 8 for additional information.

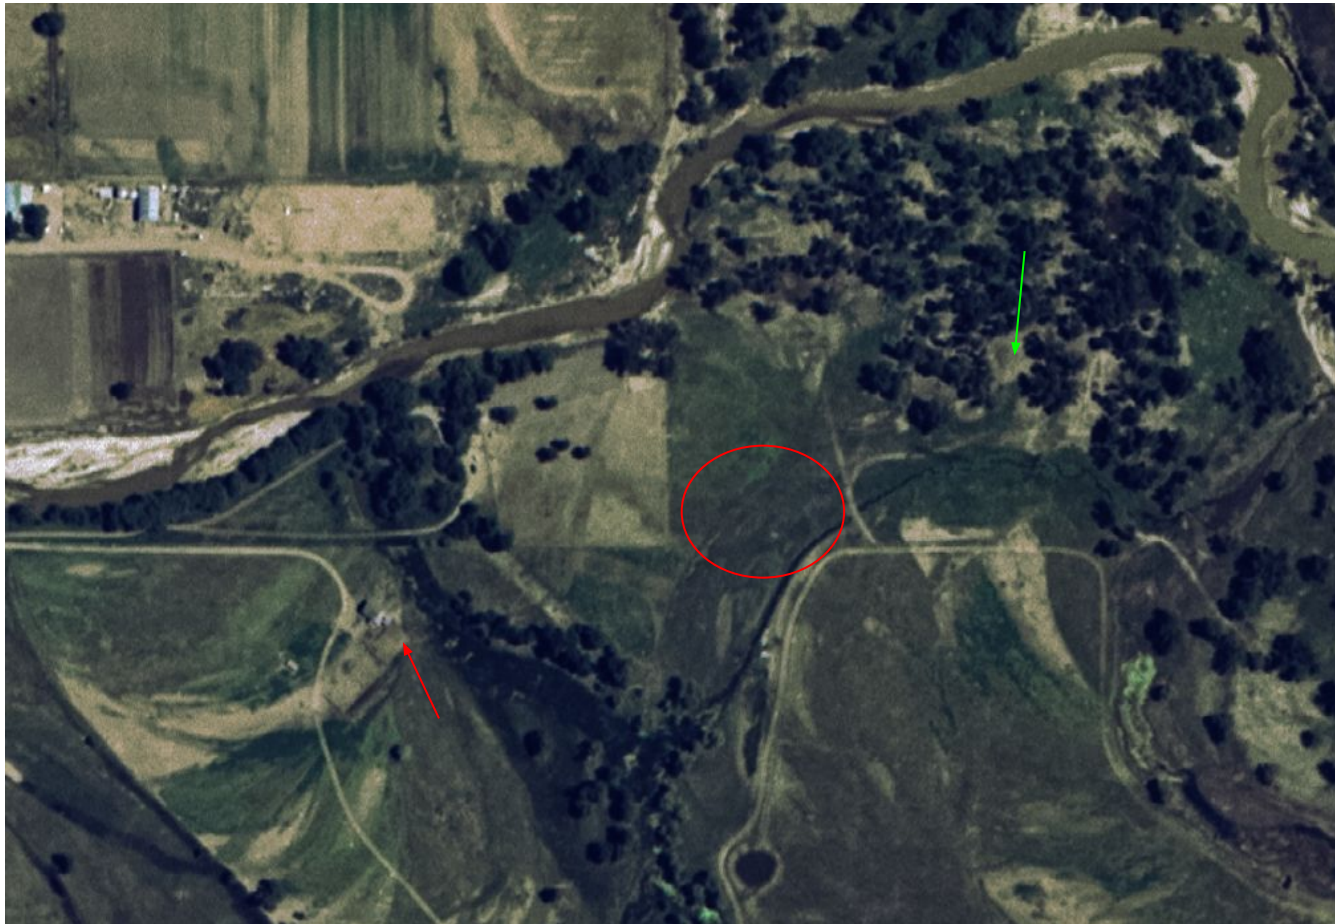
Photo 7. Historical imagery from 07/05/1978 illustrates that portions of the access road (outlined in red) did not exist prior to oil and gas development. Red arrow indicates a reference point for Photo 7 and Photo 8. Green arrow illustrates approximate location of Well API 123-14097 (not drilled at the time of this photo) for reference.

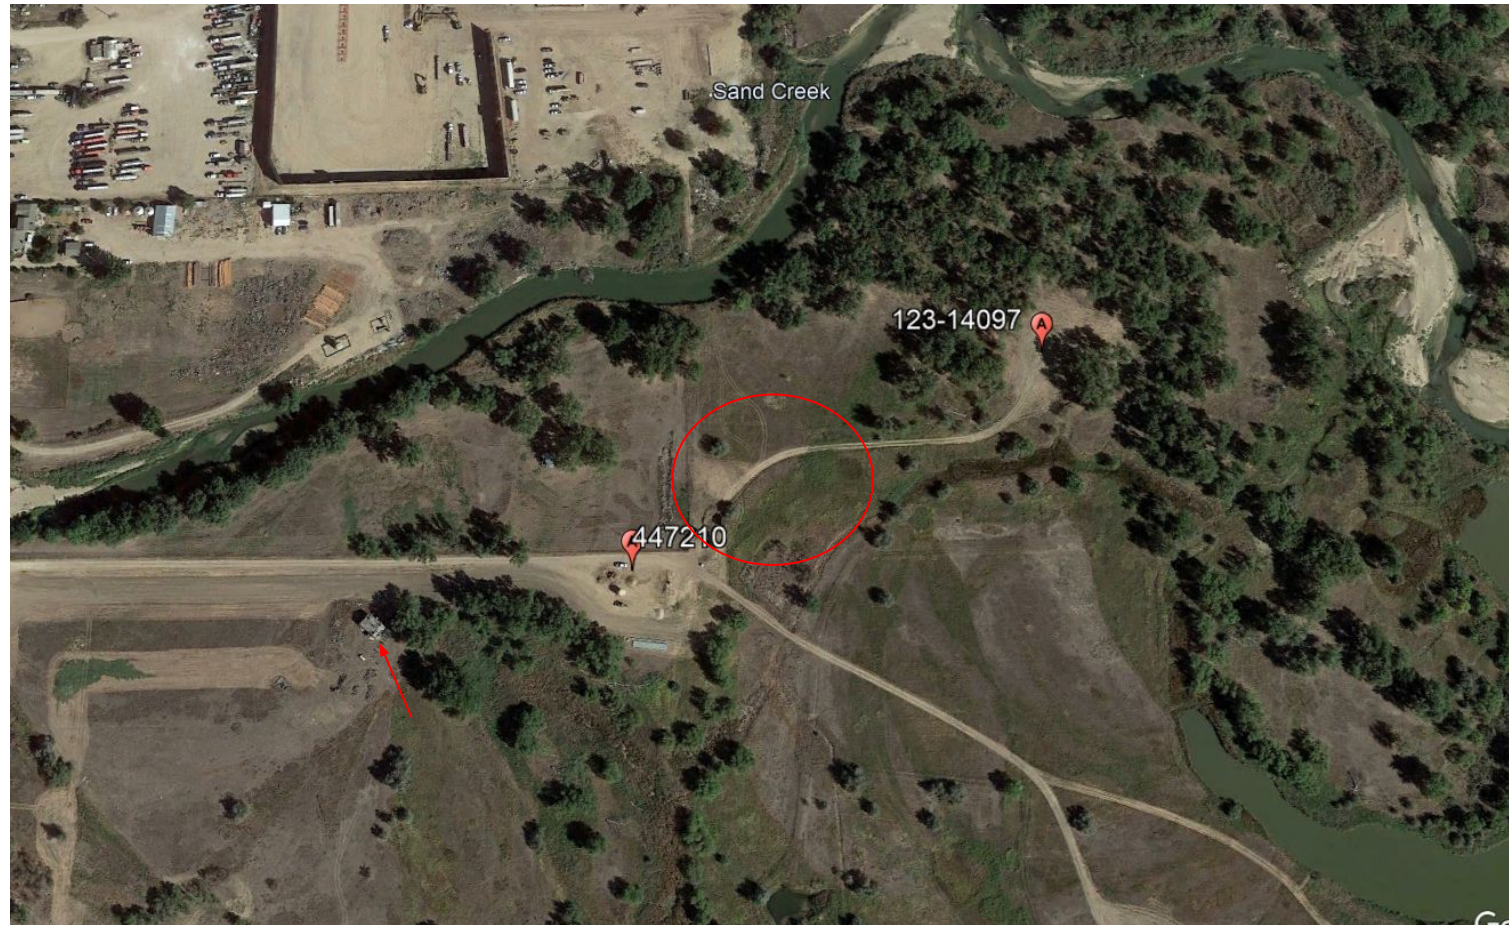
Photo 8. Google Earth aerial imagery taken circa 09/2018 illustrating the highlighted portion of the access road that did not exist prior to oil and gas development.

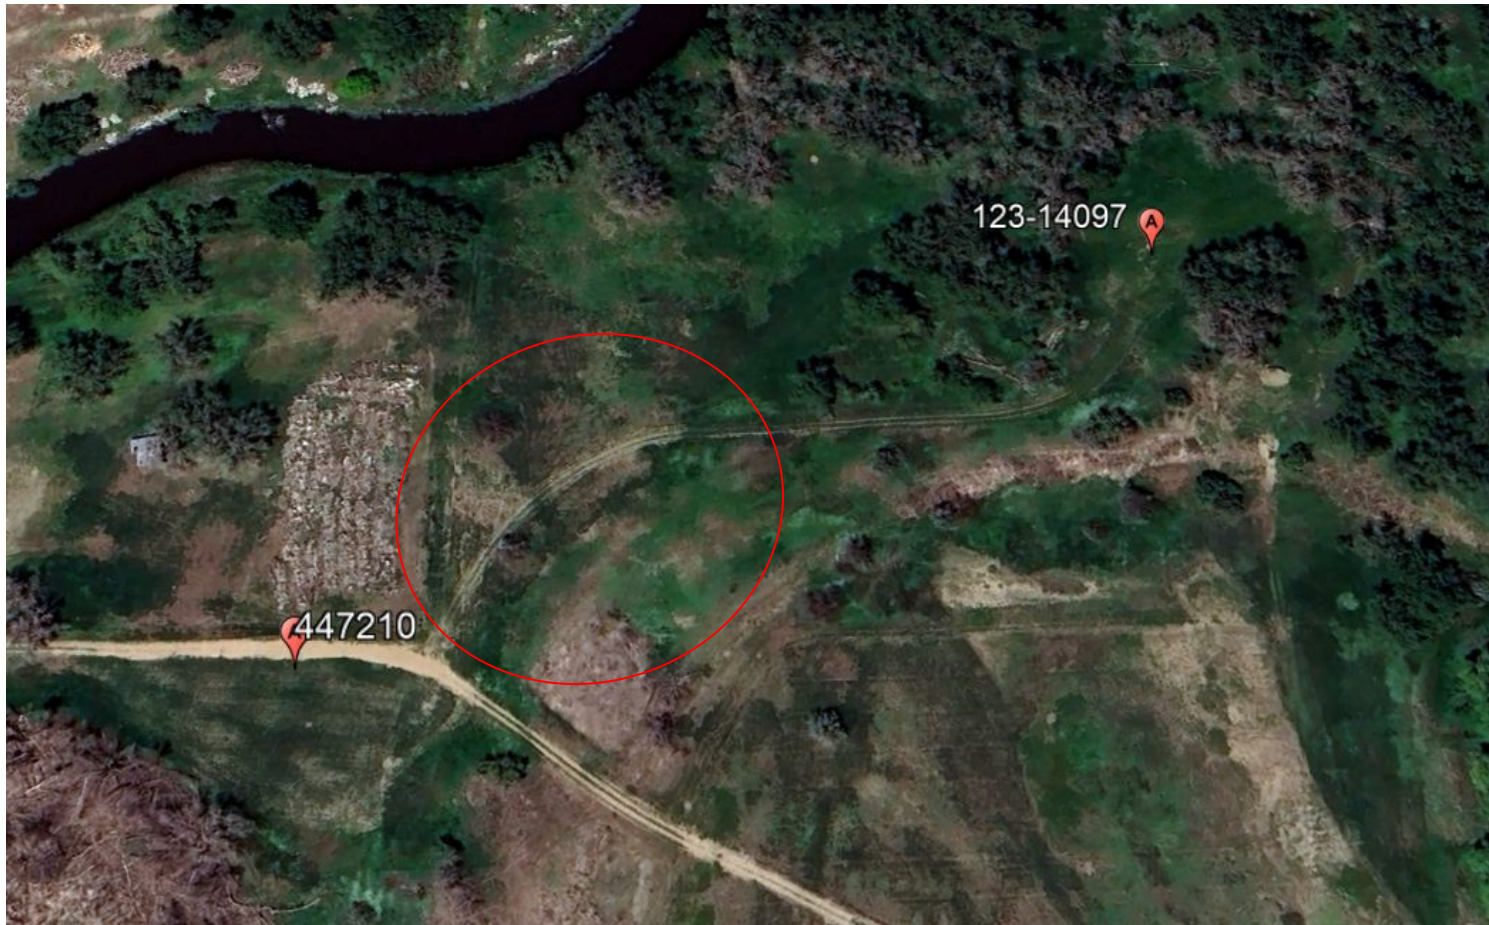
Photo 9. Google Earth aerial imagery taken circa 05/2023 illustrating the highlighted portion of the access road that did not exist prior to oil and gas development.
