Final Reclamation and Stormwater Inspection

Operator: PDC ENERGY INC - 69175

Location ID: 447210

Inspection Photos
Location Name: Yaklich PM F 11-03, 6
Location ID: 447210

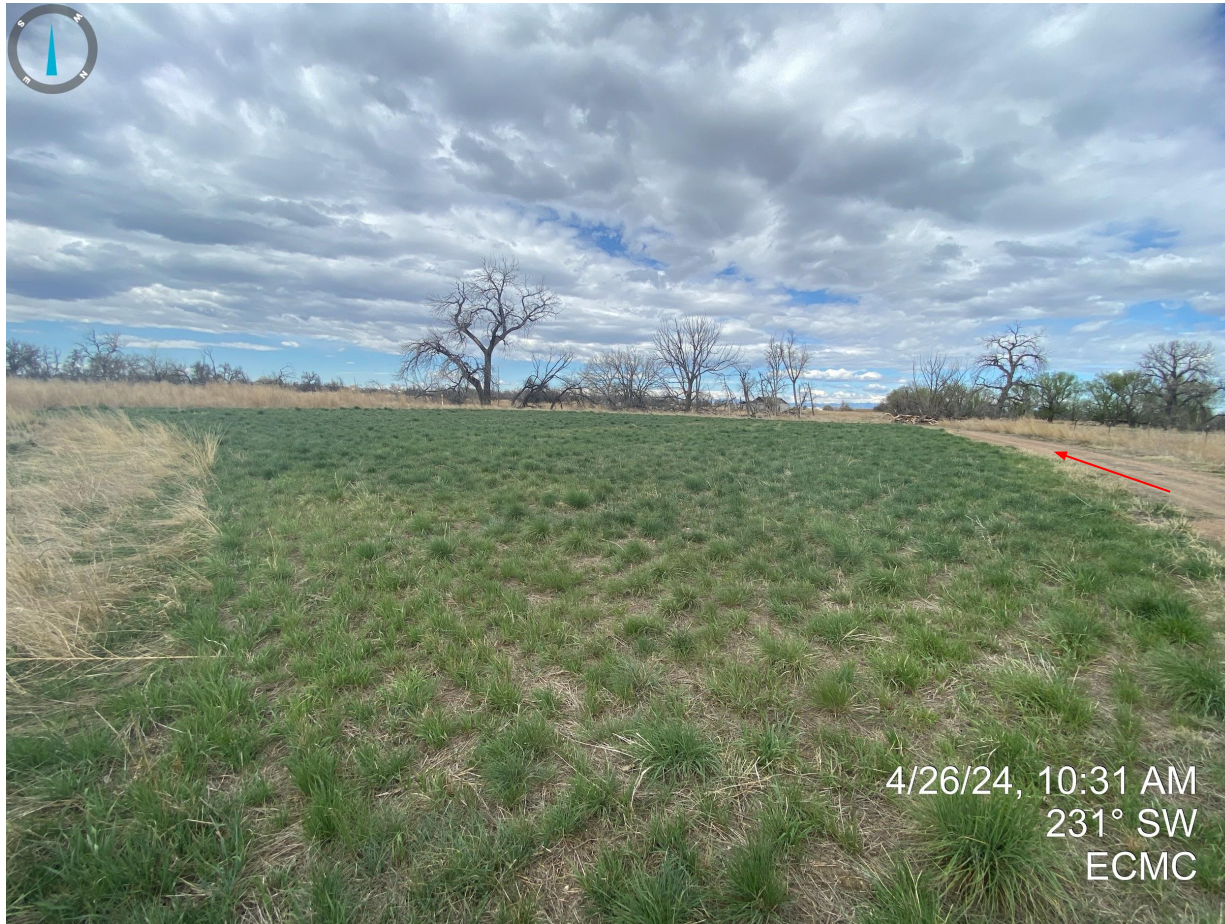
Photo 1. Facing southwest at the former tank battery location. It appears that reclamation activities have been performed and the location is progressing towards Rule 1004 standards and regulations. Access road (red arrow) has not been reclaimed per the 1004 Rules.

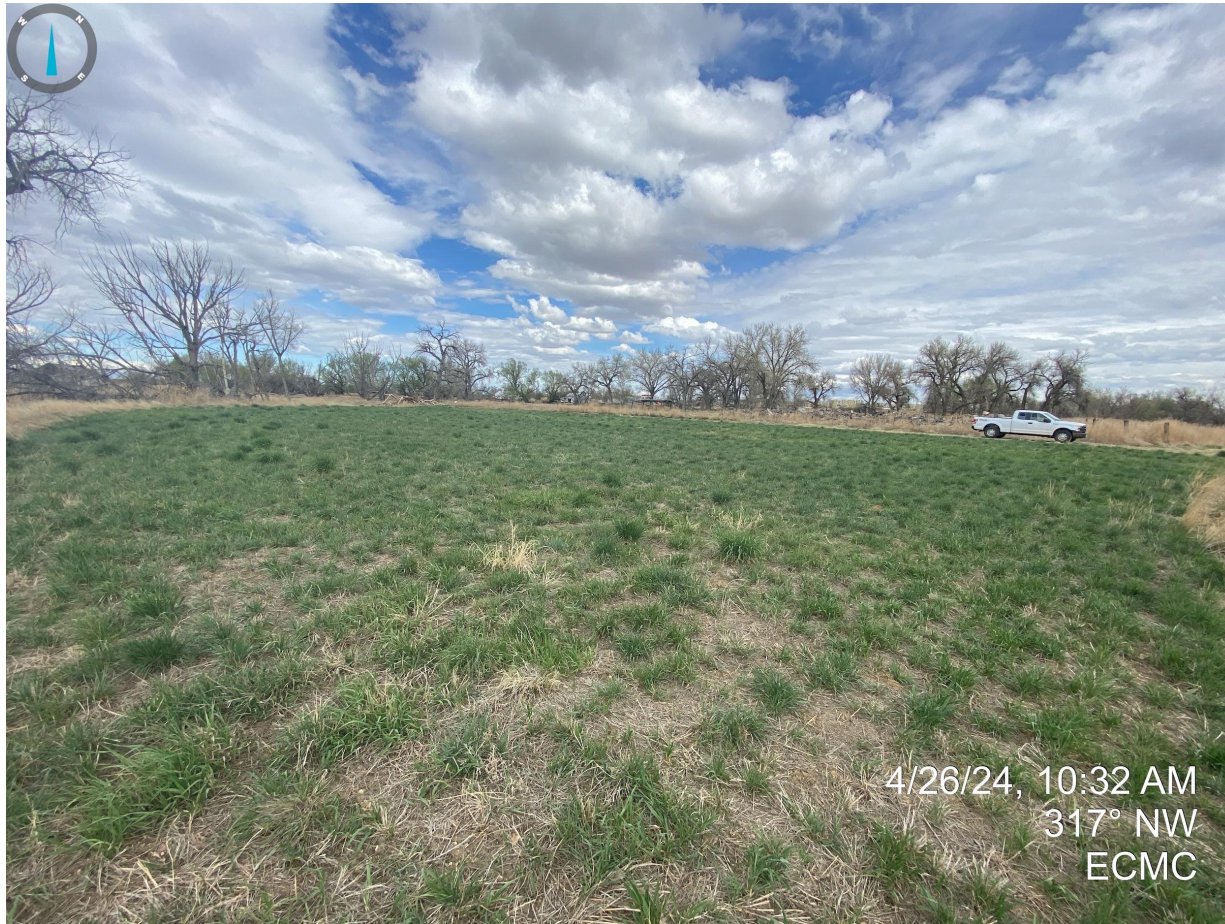
Photo 2. Facing northwest at the former tank battery location; see comments in Photo 1.

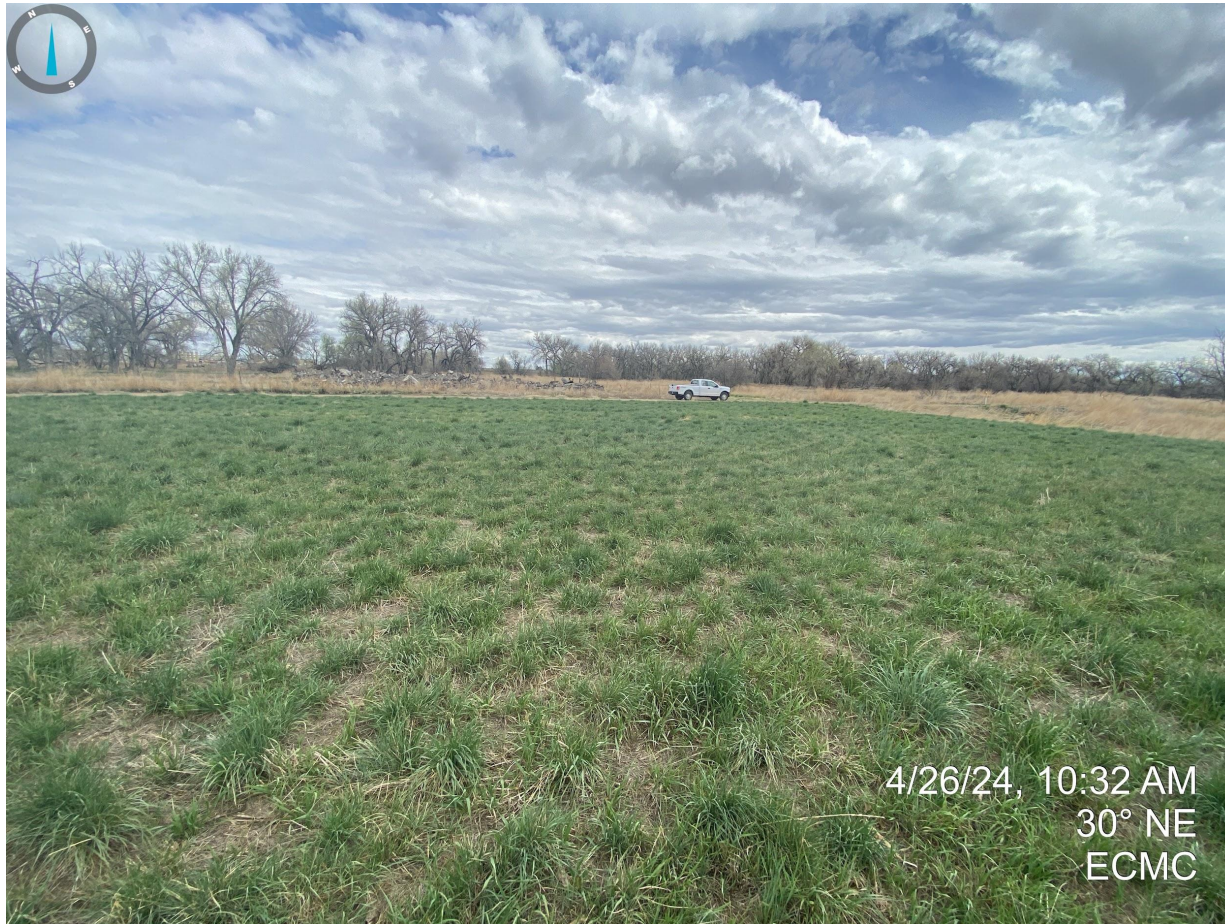
Photo 3. Facing northeast at the former tank battery location; see comments in Photo 1.

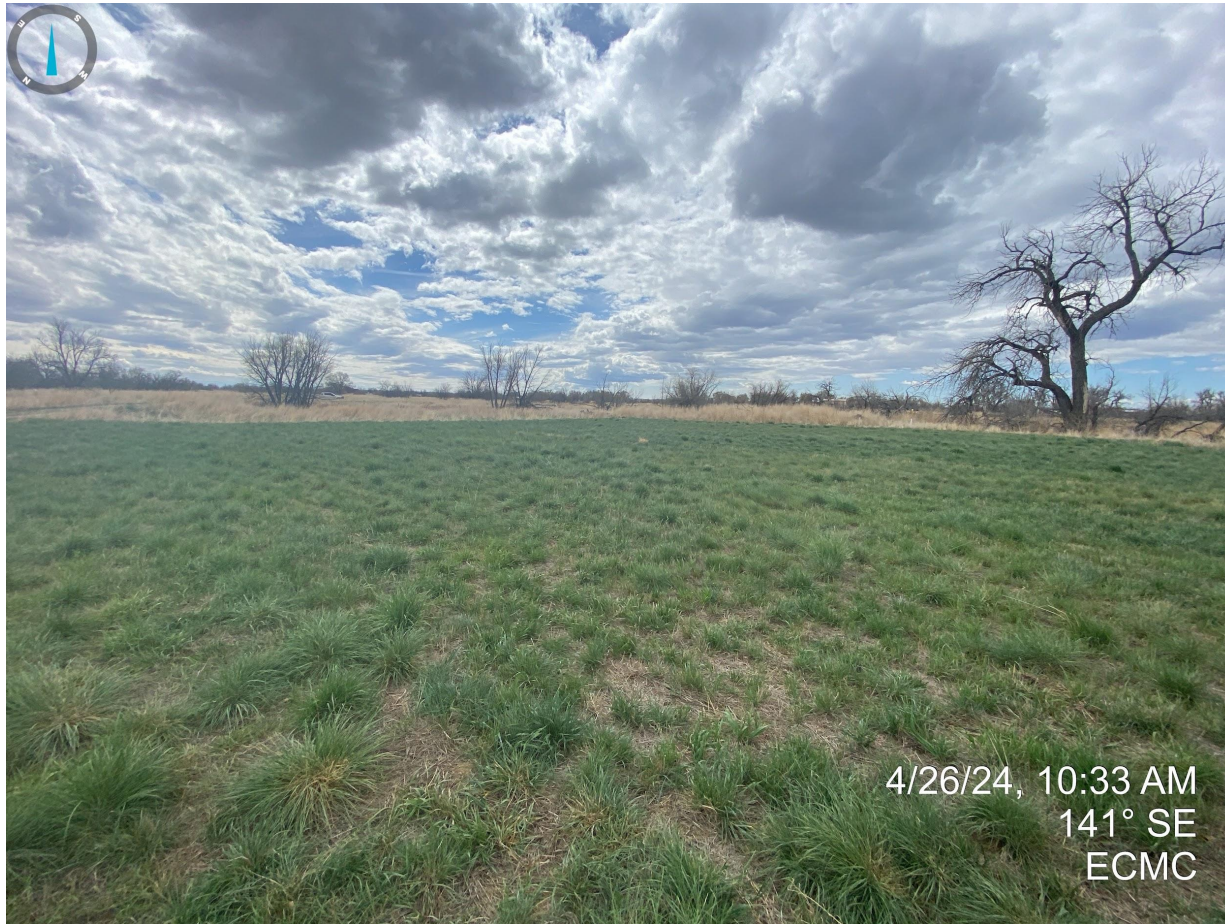
Photo 4. Facing southeast at the former tank battery location; see comments in Photo 1.

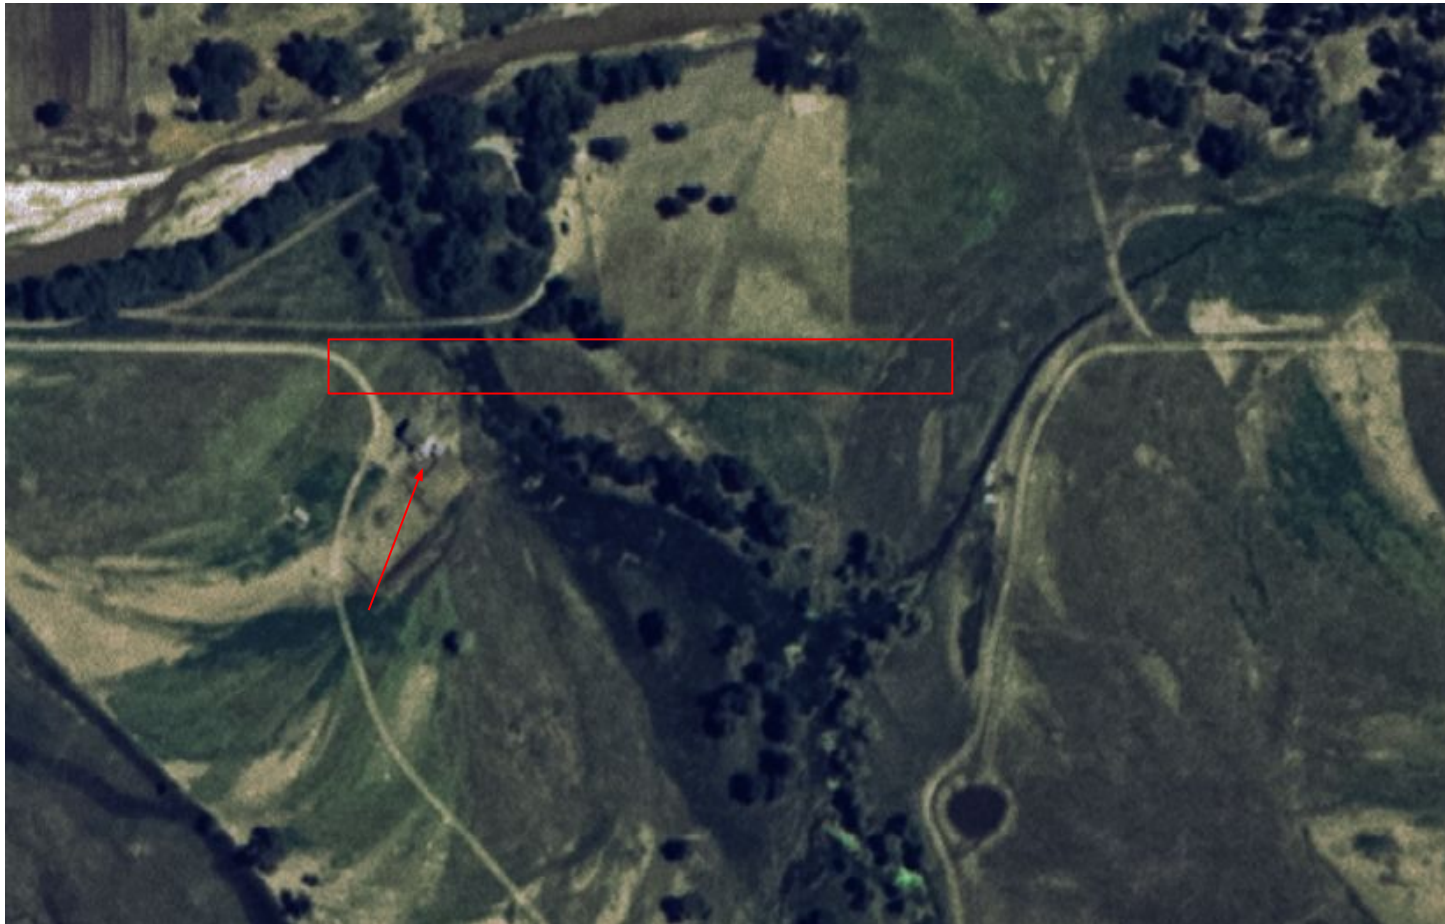
Photo 5. Historical imagery from 07/05/1978 illustrates that portions of the access road (outlined in red) did not exist prior to oil and gas development. Red arrow indicates a reference point (house) for Photo 5 and Photo 6.

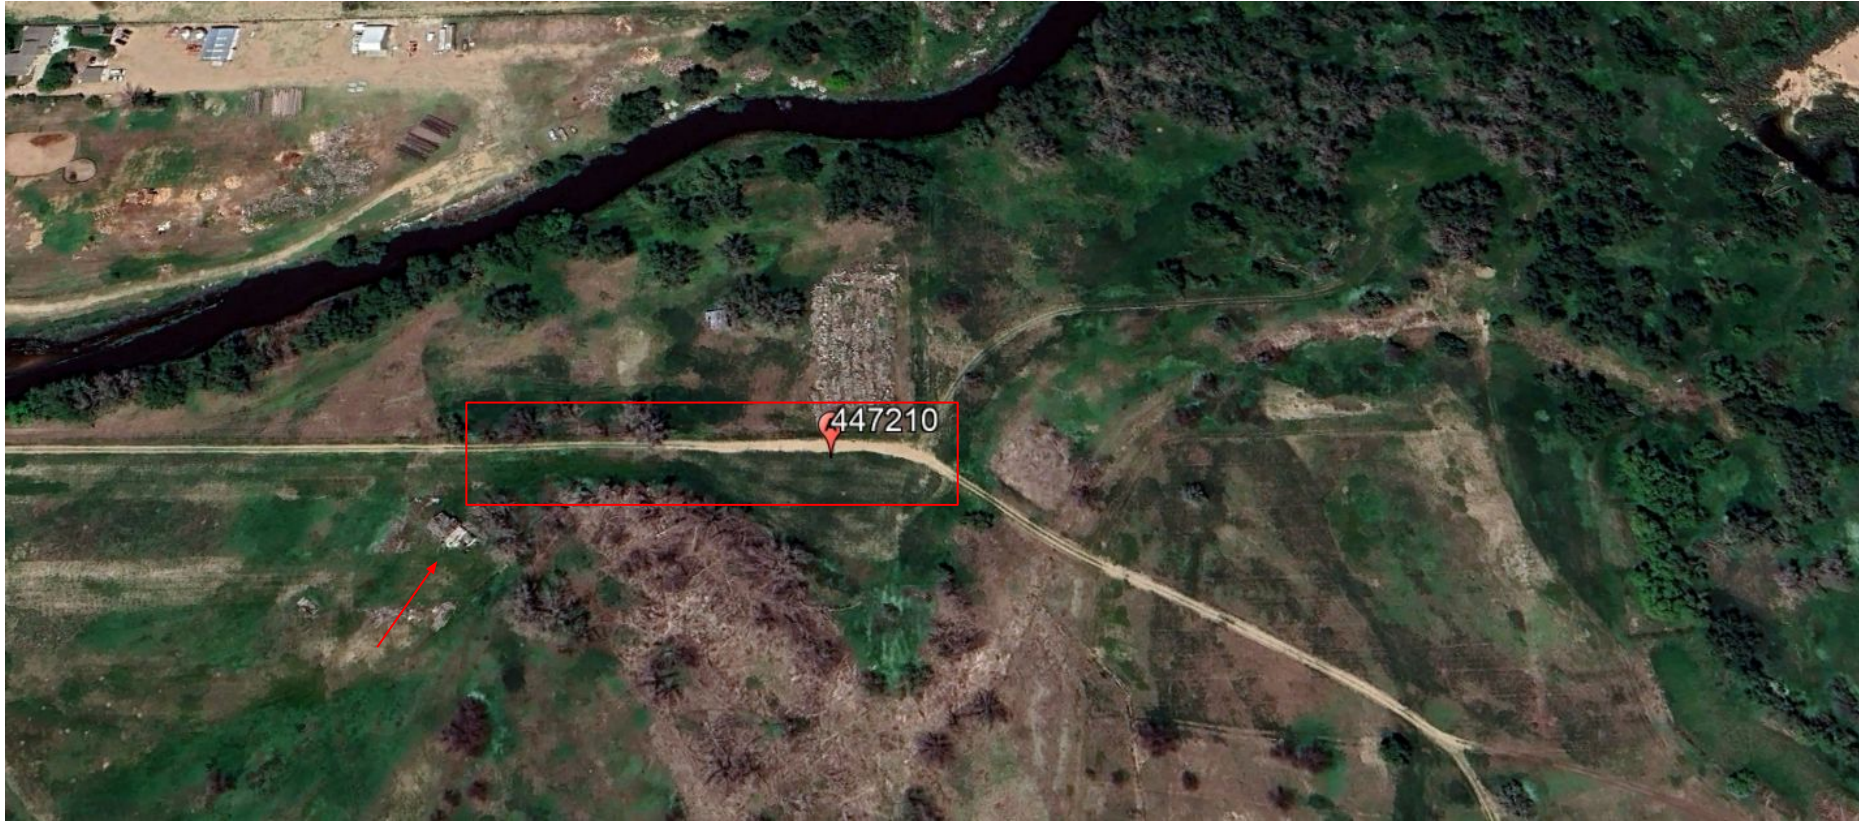
Photo 6. Google Earth aerial imagery taken circa 05/2023 illustrating the highlighted portion of the access road that did not exist prior to oil and gas development.
