# Interim Reclamation and Stormwater Inspection

Operator: EXTRACTION OIL & GAS INC - 10459

Location ID: 440761

Inspection Photos  
Location Name: Arellano 10-L Pad  
Location ID: 440761

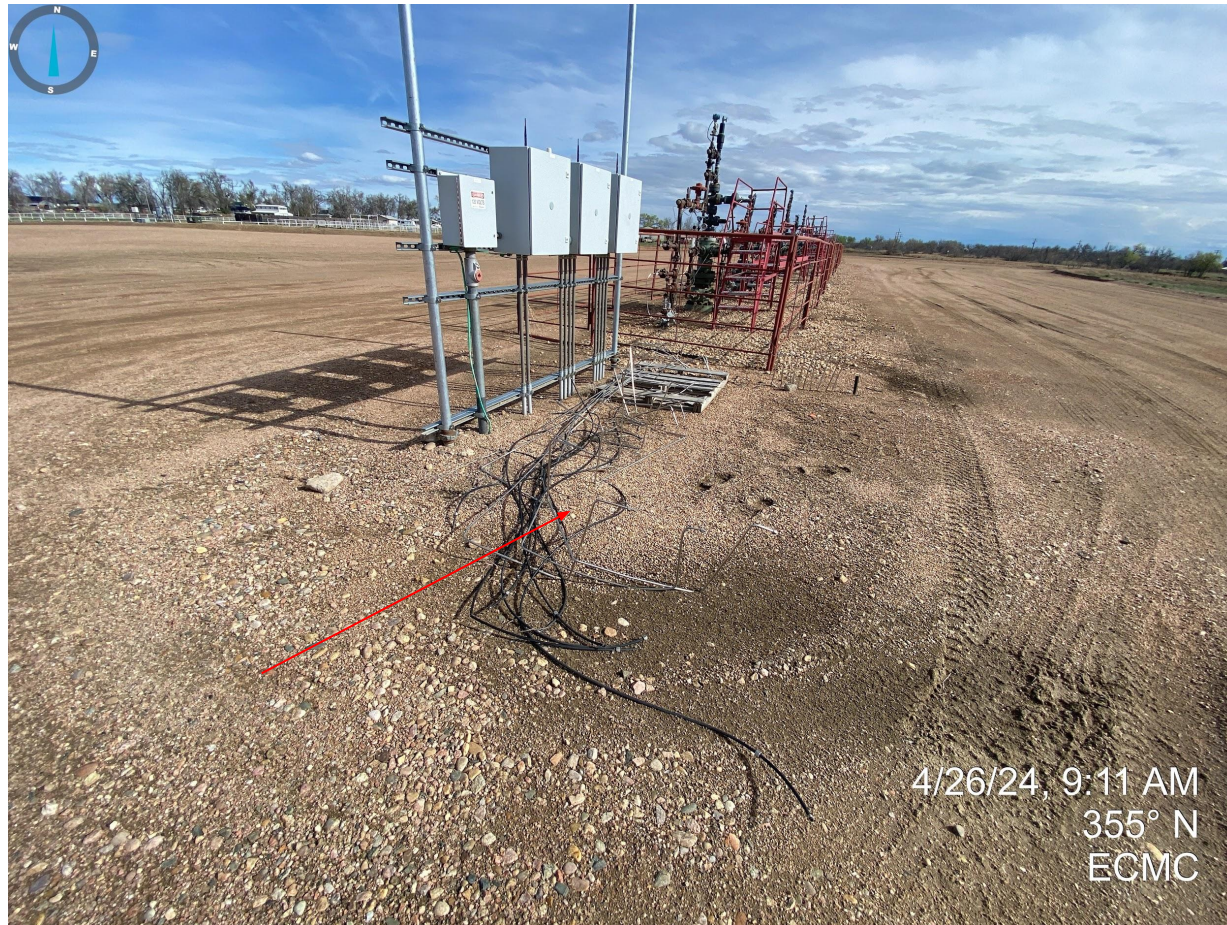
**Photo 1.** Unused equipment near wellheads will need to be returned to service or removed from location.

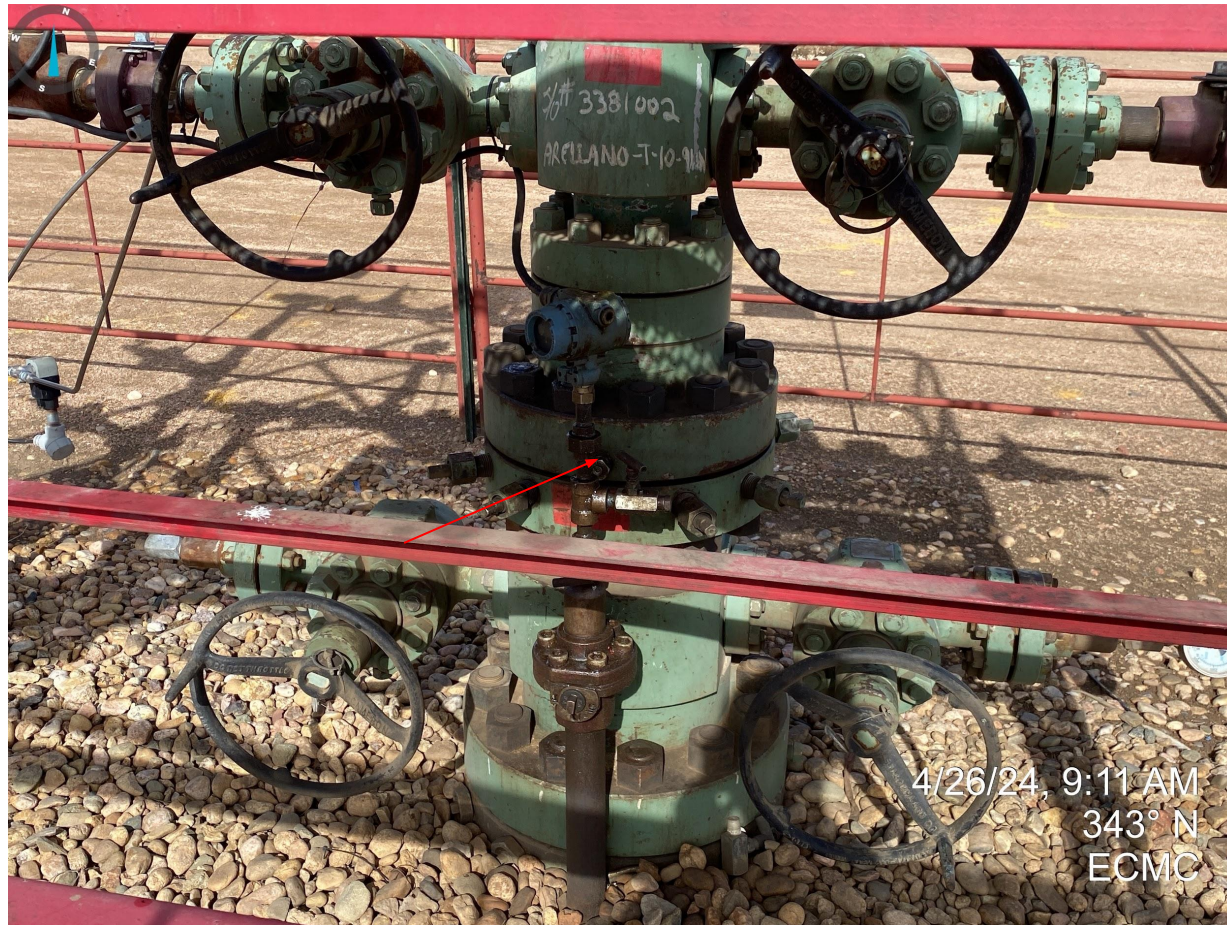
**Photo 2.** Hydrocarbon staining on wellhead equipment - inspect mechanical conditions.

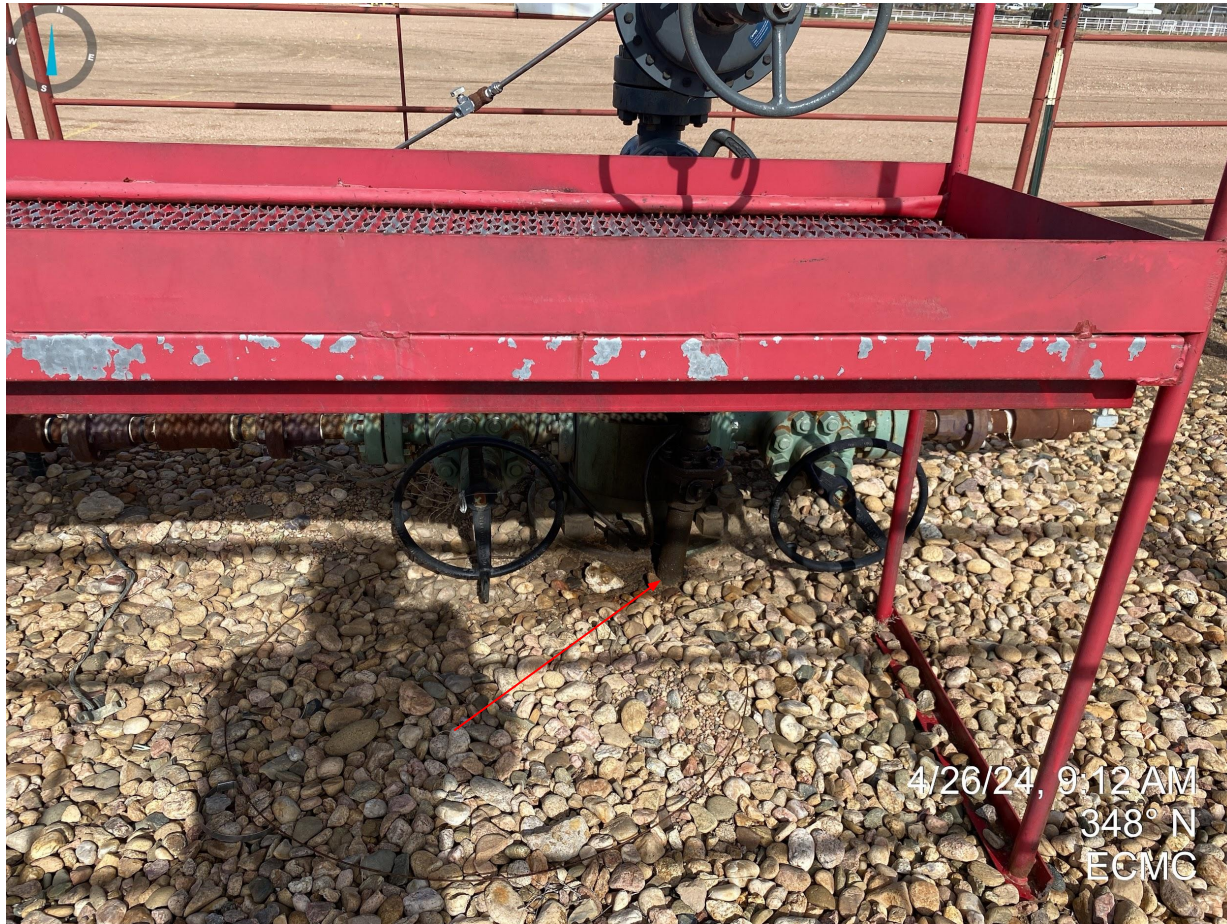
**Photo 3.** Stained soil around wellheads and Hydrocarbon staining on wellhead equipment - inspect mechanical conditions.

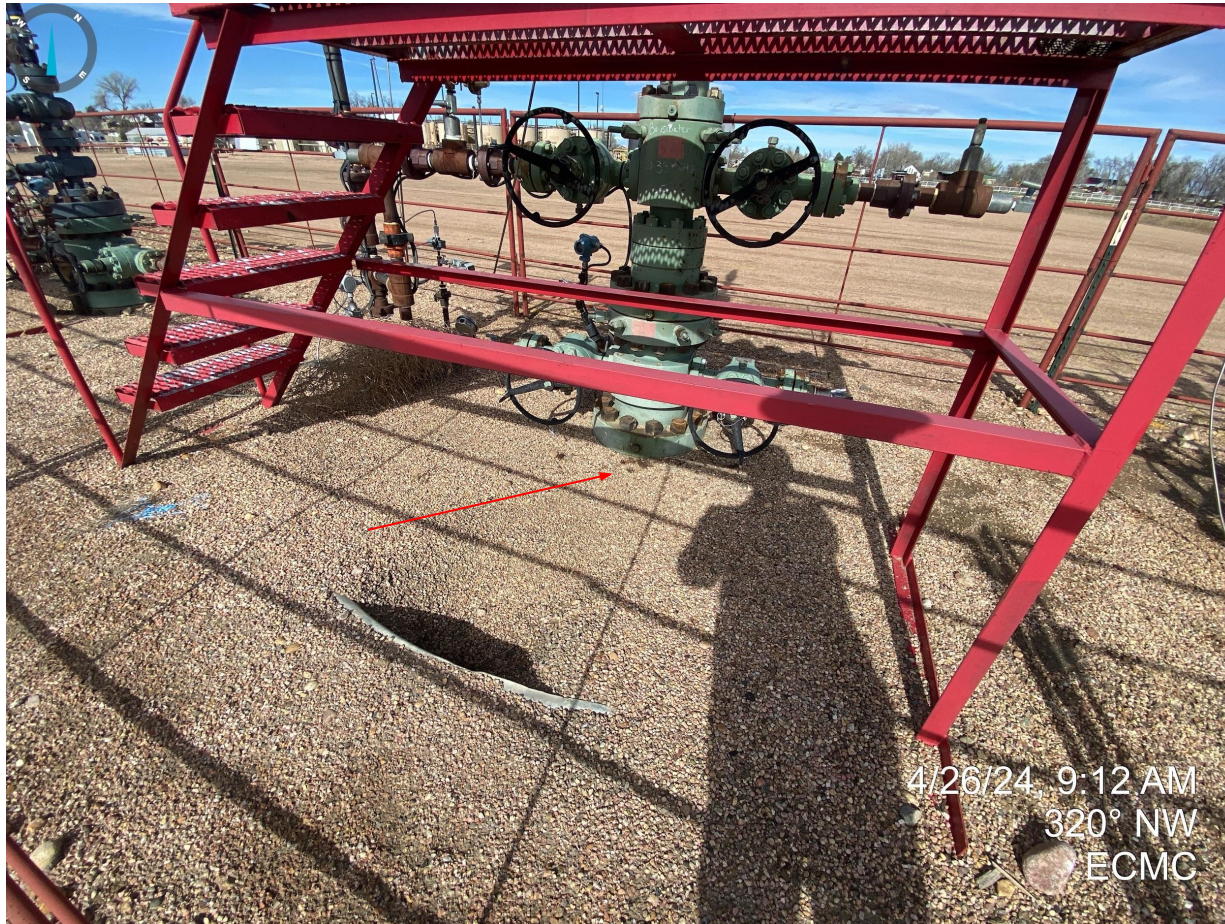
**Photo 4.** Stained soil around wellheads.

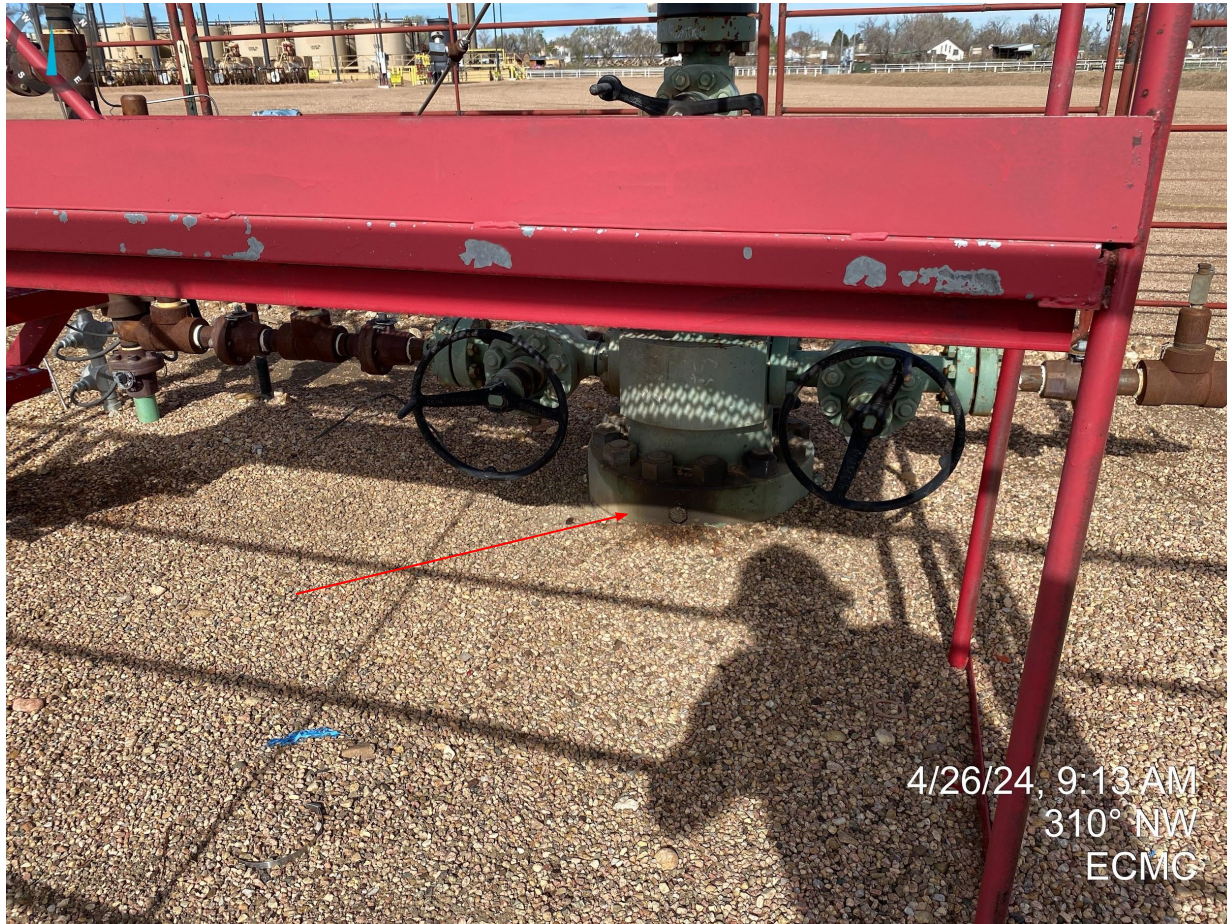
**Photo 5.** Stained soil around wellheads and Hydrocarbon staining on wellhead equipment - inspect mechanical conditions.

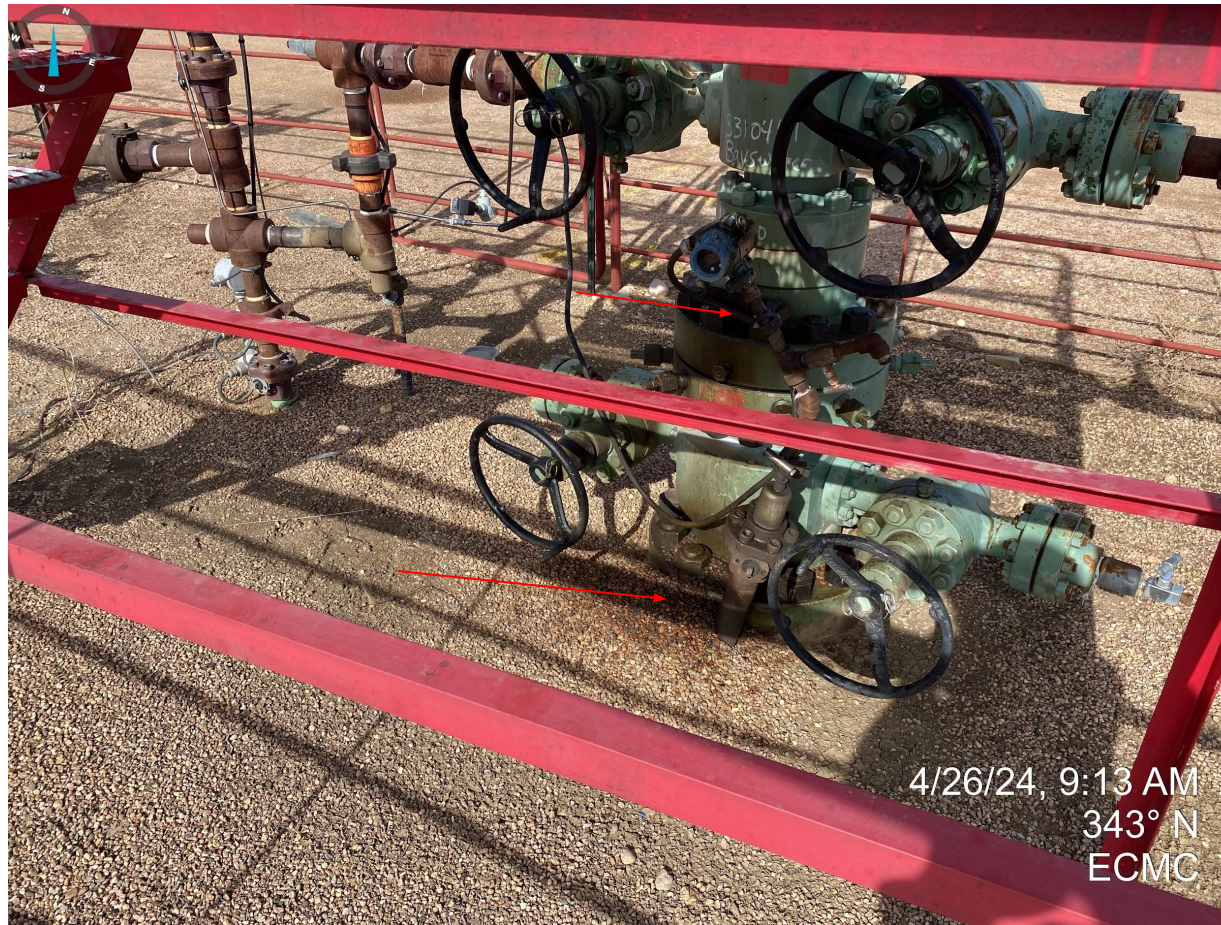
**Photo 6.** Stained soil around wellheads and Hydrocarbon staining on wellhead equipment - inspect mechanical conditions.

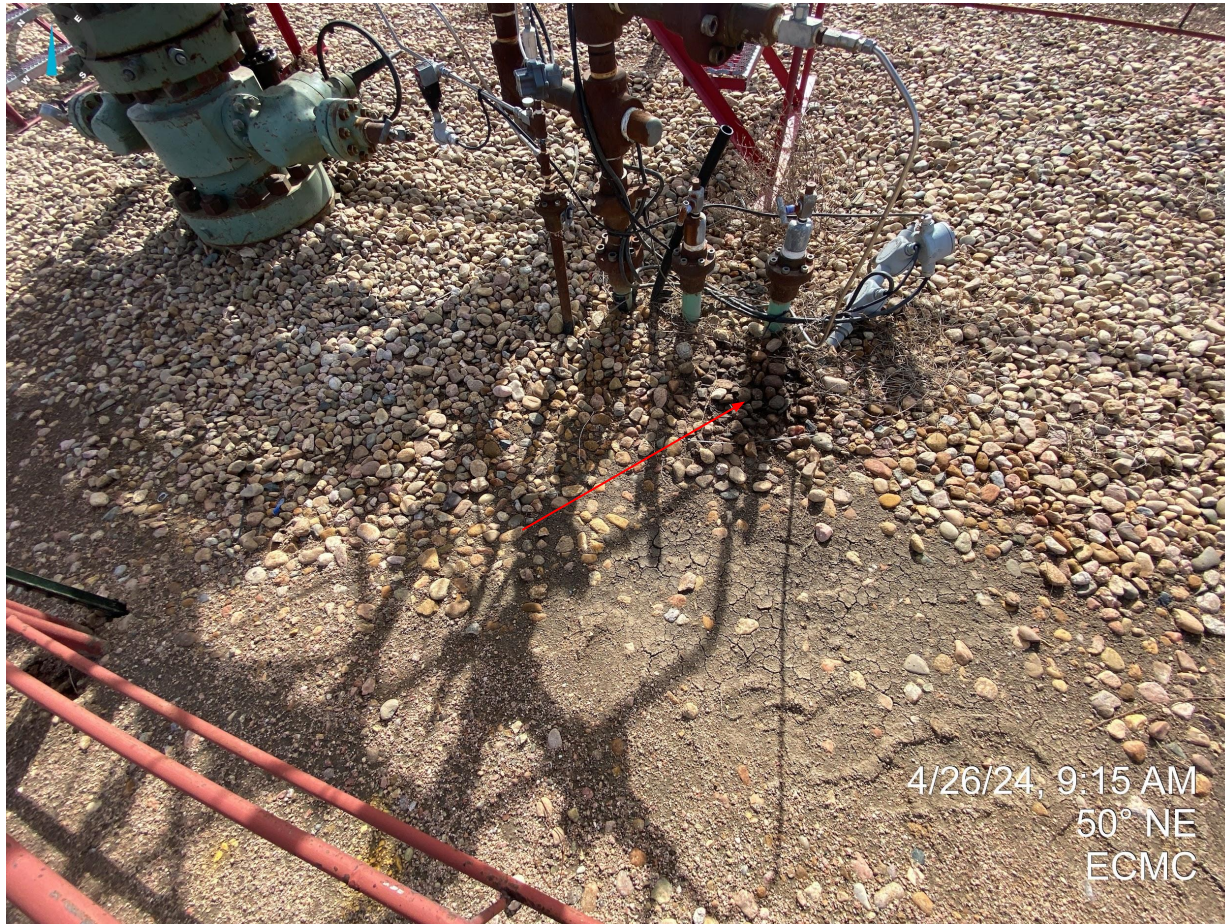
**Photo 7.** Stained soil around wellheads and Hydrocarbon staining on wellhead equipment - inspect mechanical conditions.

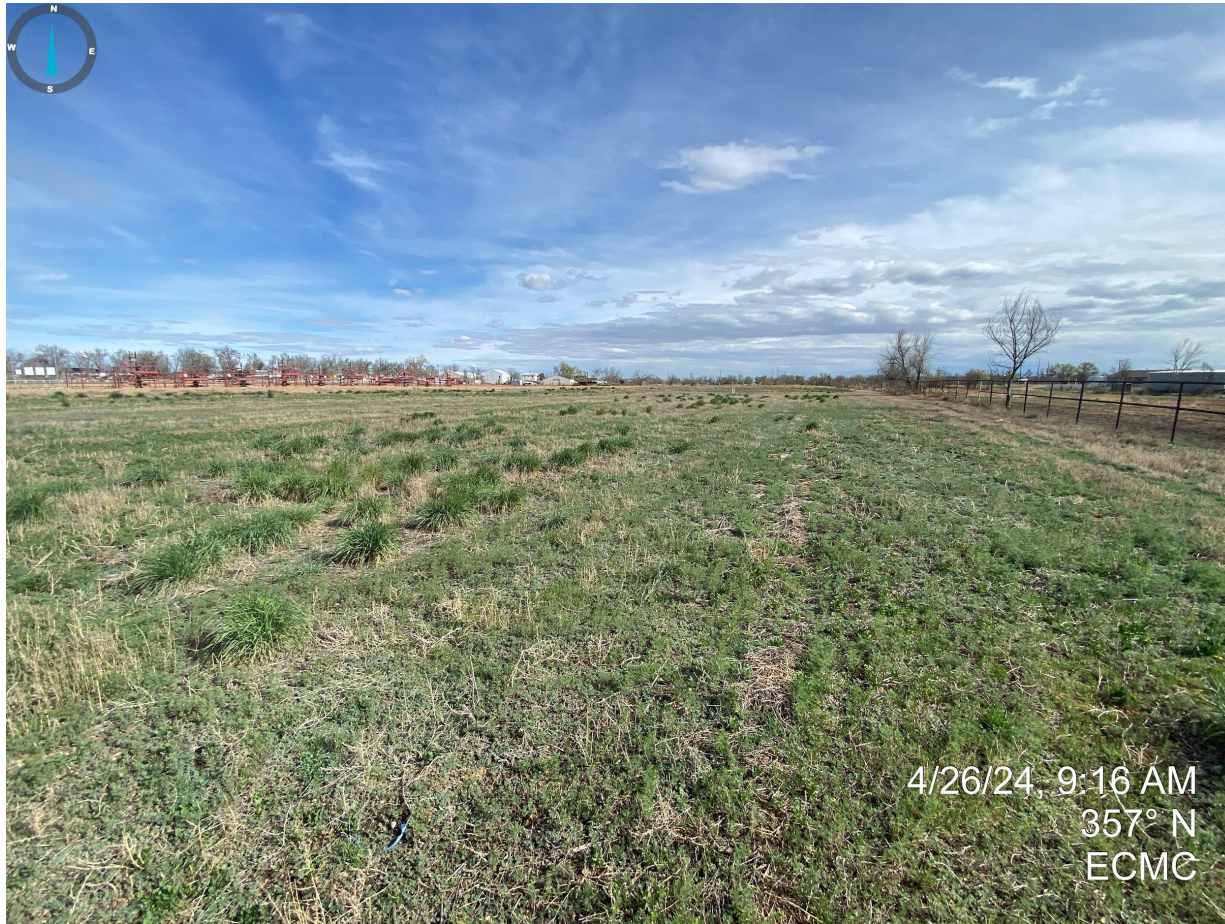
**Photo 8.** Eastern interim areas are predominantly undesirable vegetation (e.g. kochia). Additional reclamation activities are required.

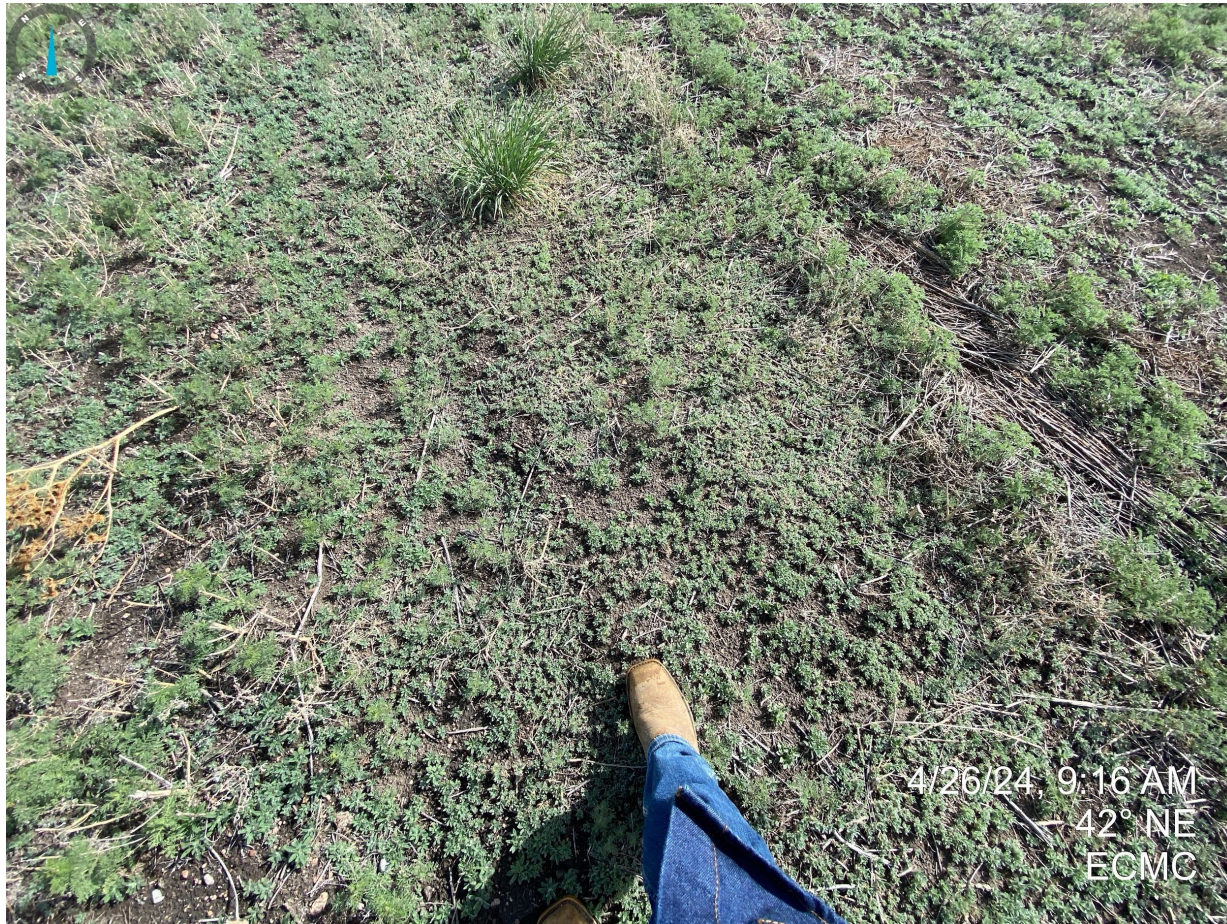
**Photo 9.** Close up photo of Kochia.

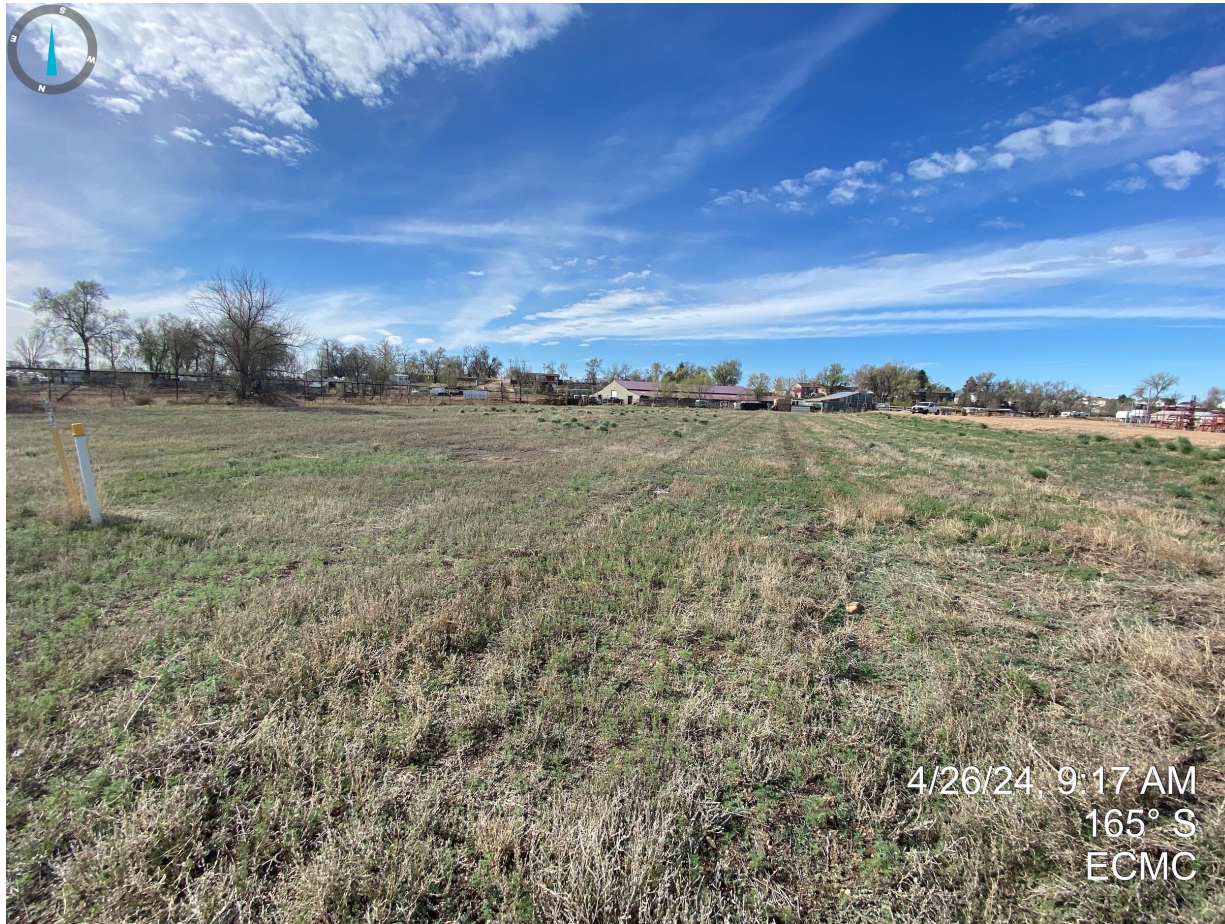
**Photo 10.** Eastern interim areas are predominantly undesirable vegetation (e.g. kochia). Additional reclamation activities are required.

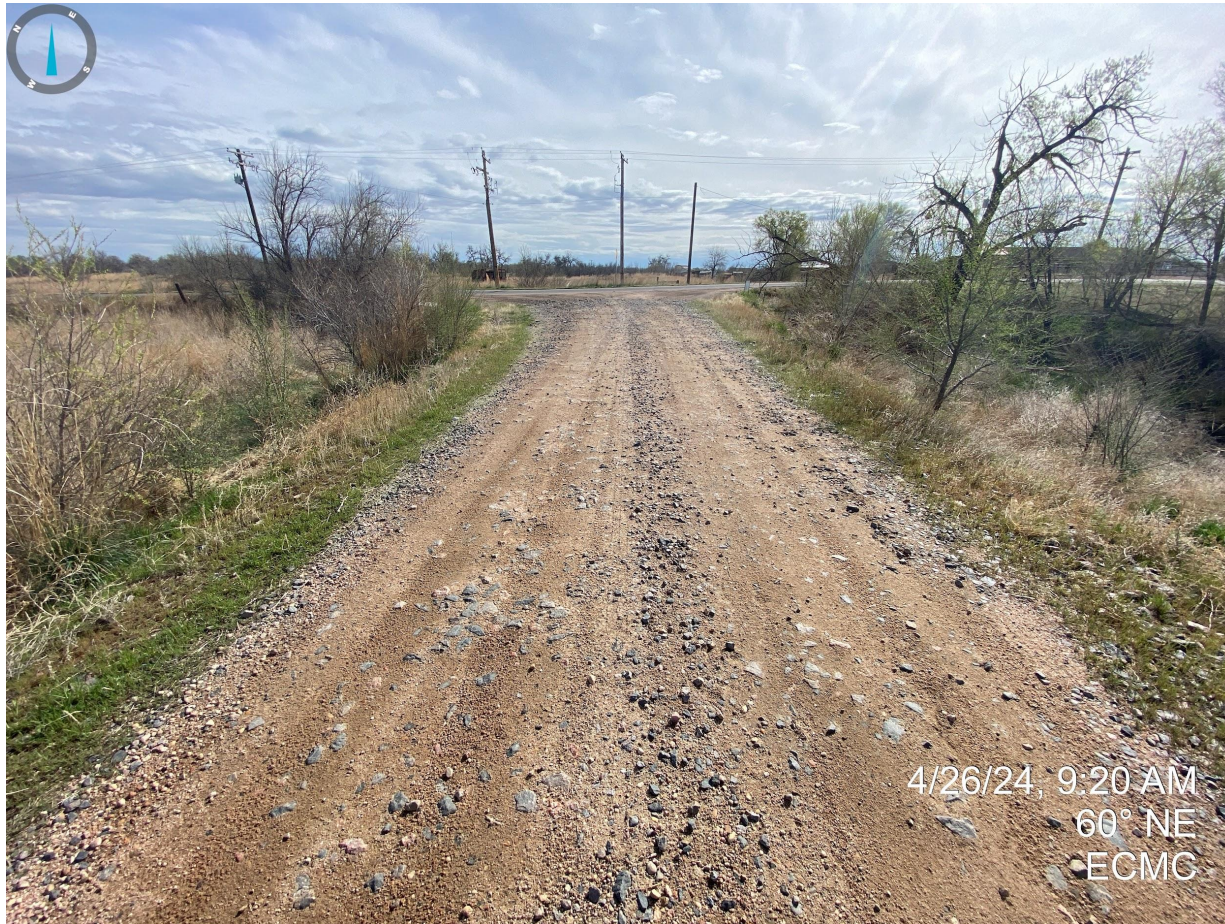
**Photo 11.** Vehicle track out pad requires maintenance.

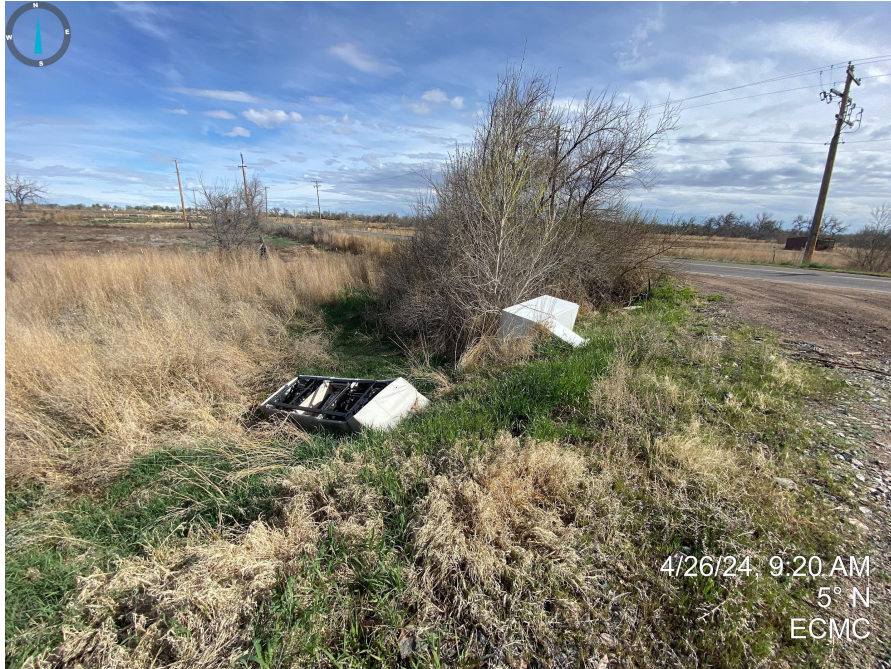
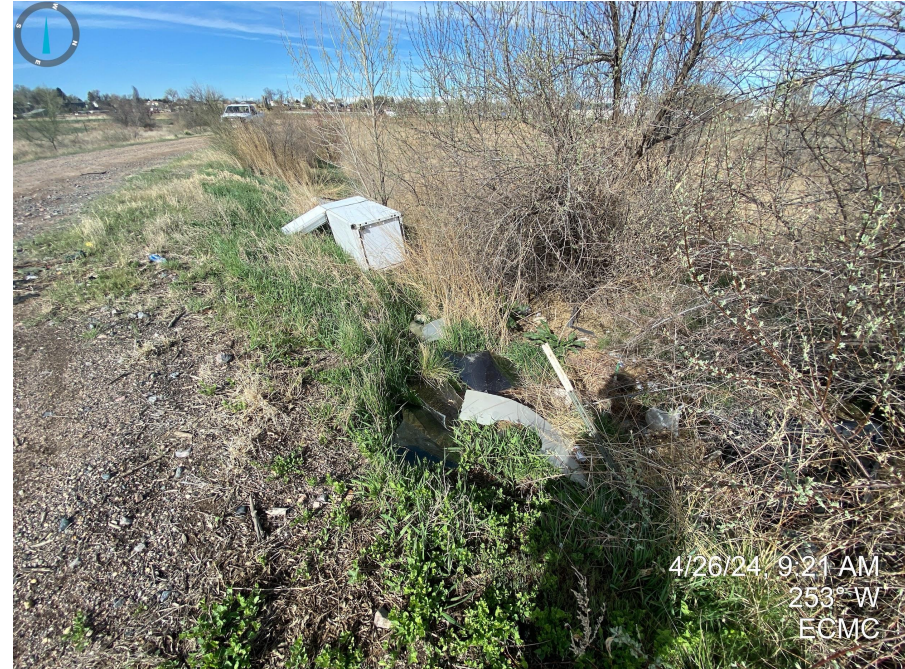
**Photo 12 & 13.** Trash observed near the location's entrance. Operator shall self inspect the entire location and remove any trash/debris.
