COLORADO
Oil & Gas Conservation
Commission
Department of Natural Resources

Spill/Release ID 483727 REM 28246 Photo #1 area of former discharge.

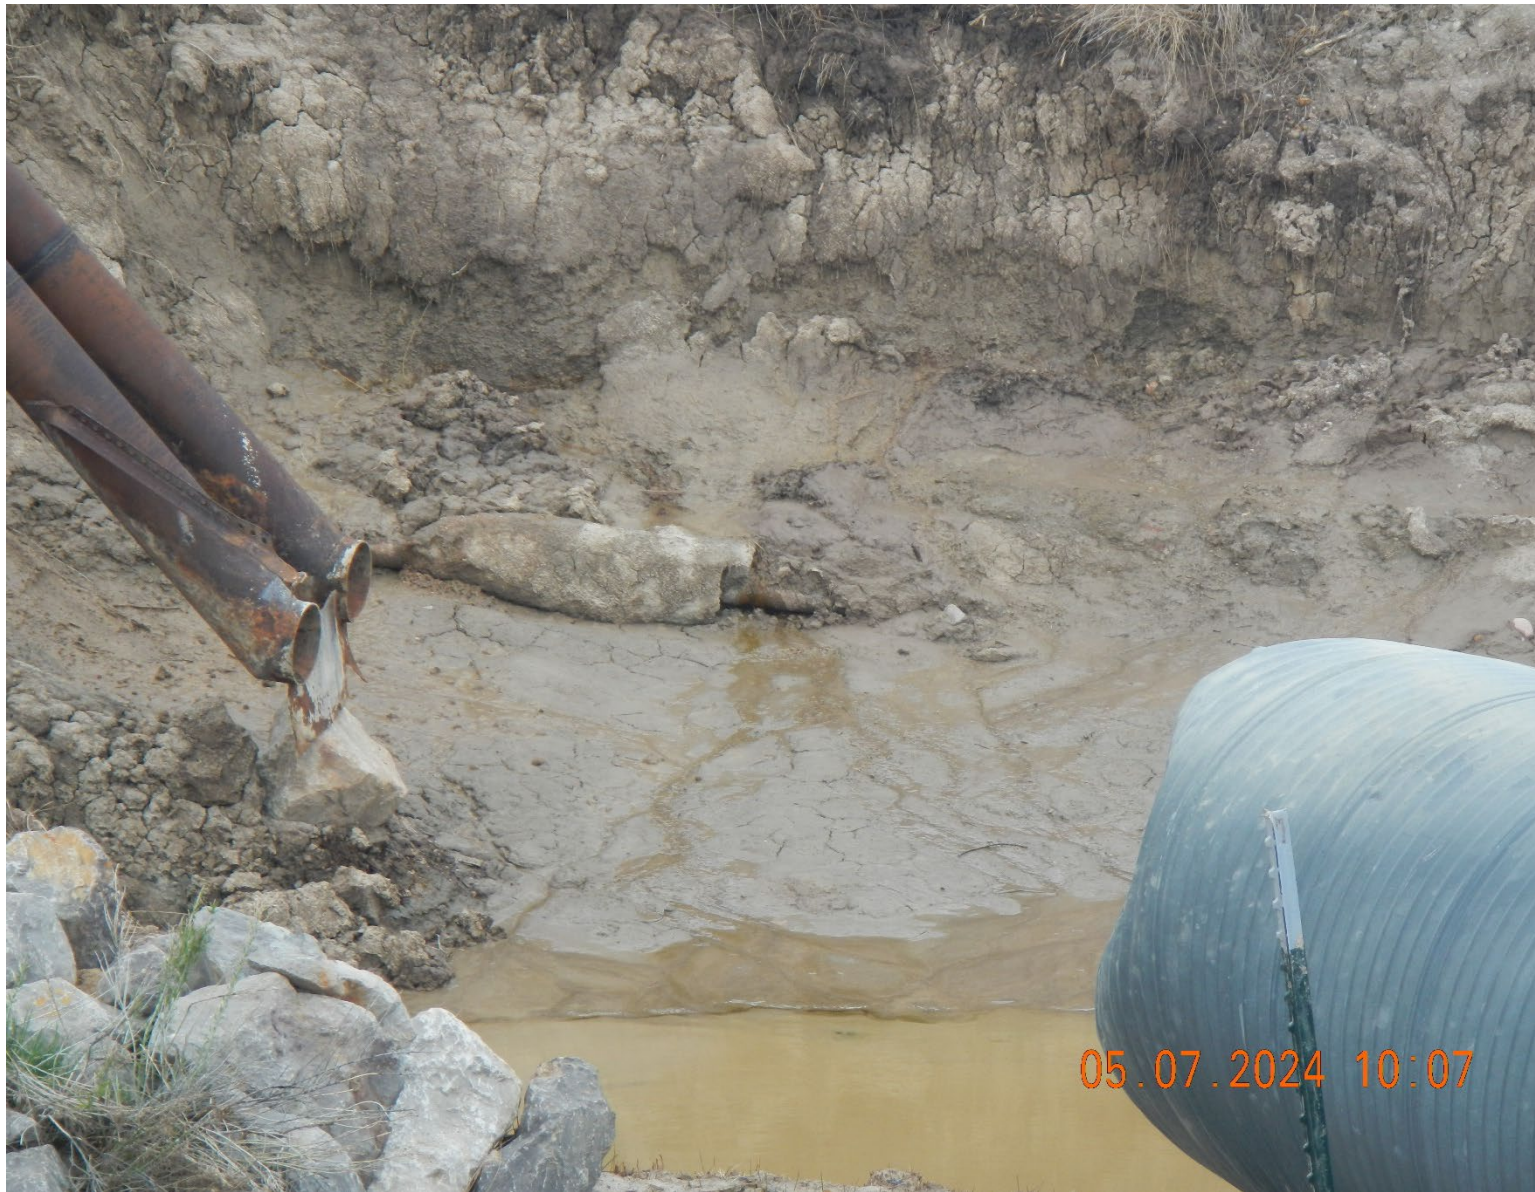
Spill/Release ID 483727 REM 28246 Photo #2 close-up of photo #1.

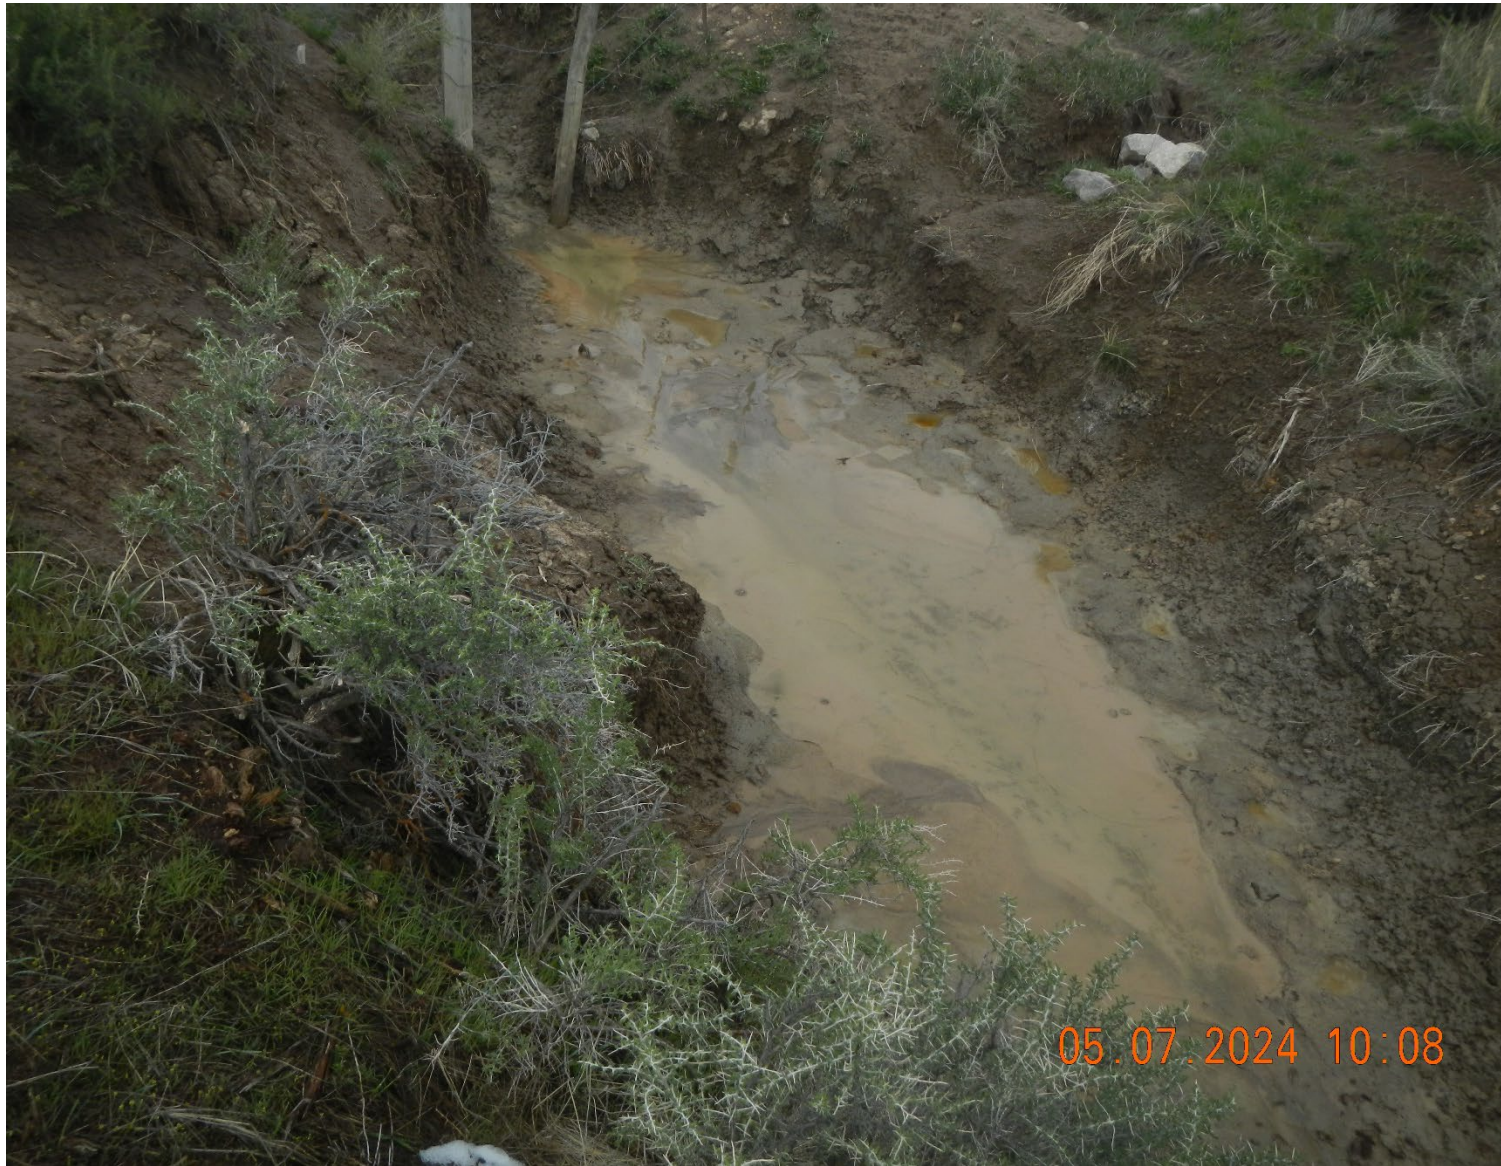
Spill/Release ID 483727 REM 28246 Photo #4 Close-up of photo #3. No obvious Hydrocarbon staining or sheen.

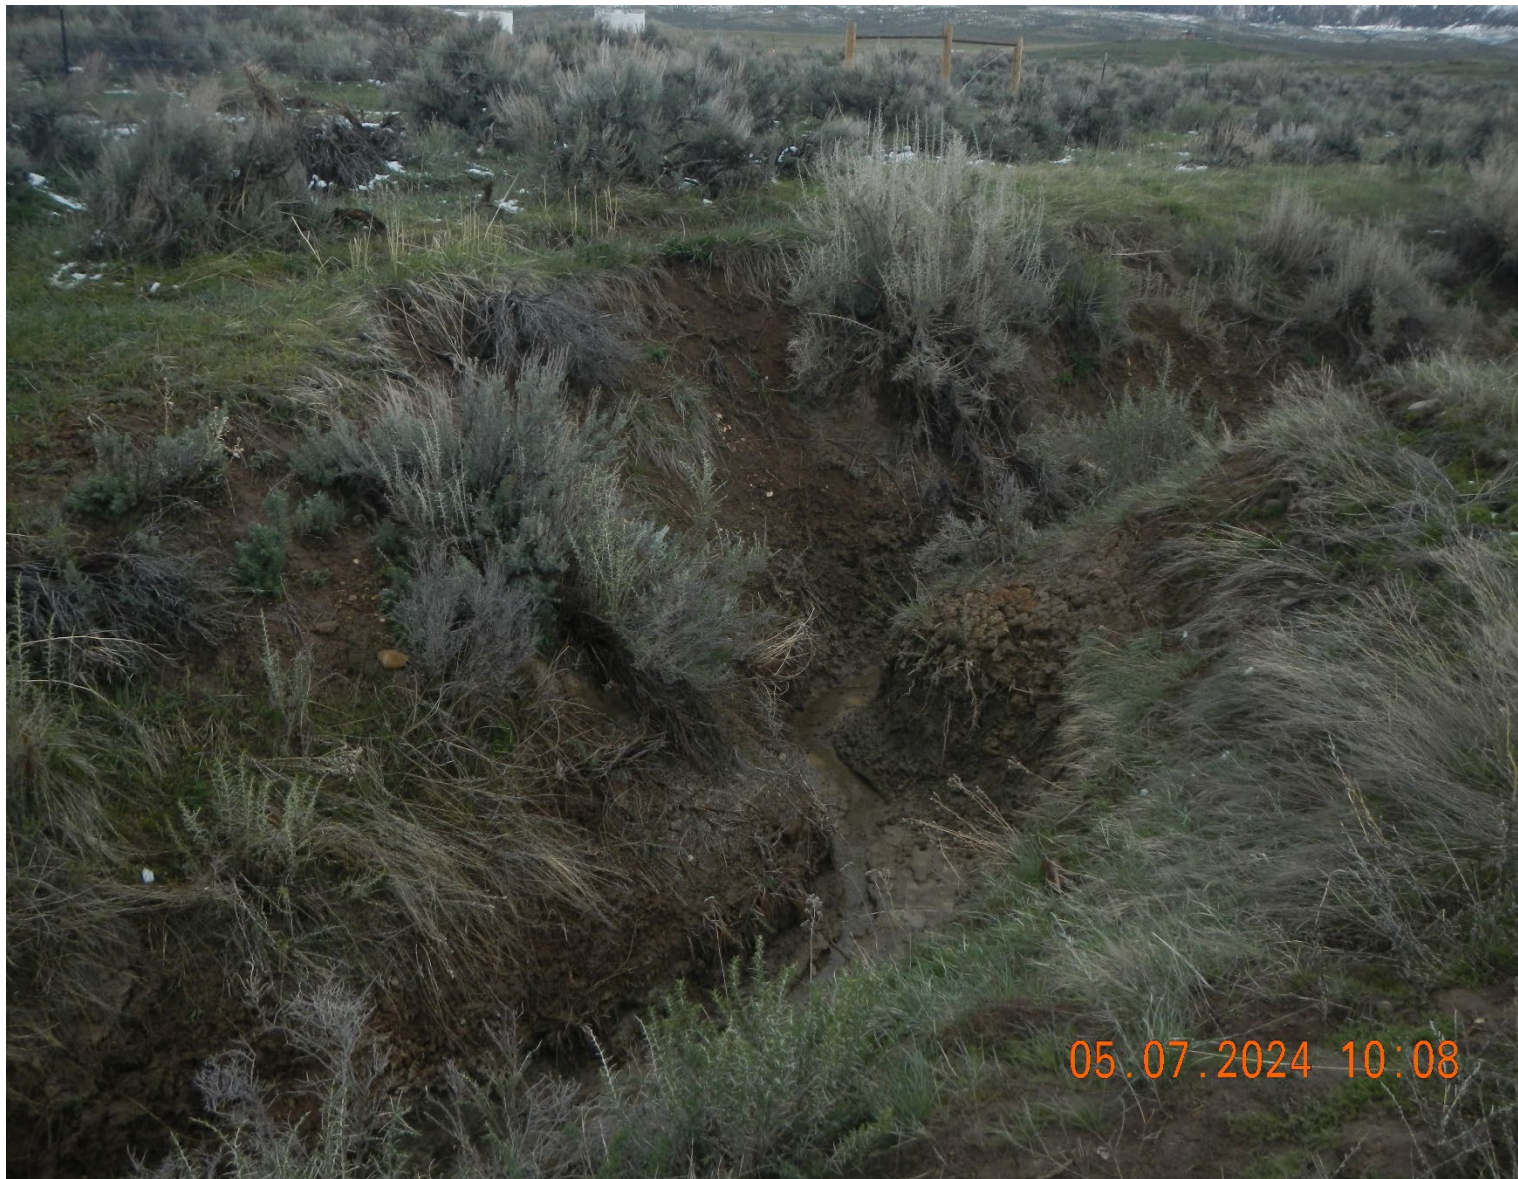
Spill/Release ID 483727 REM 28246 Photo #5 The Gulch was observed from the former discharge to area where POC had ended their excavation activity in 2023.

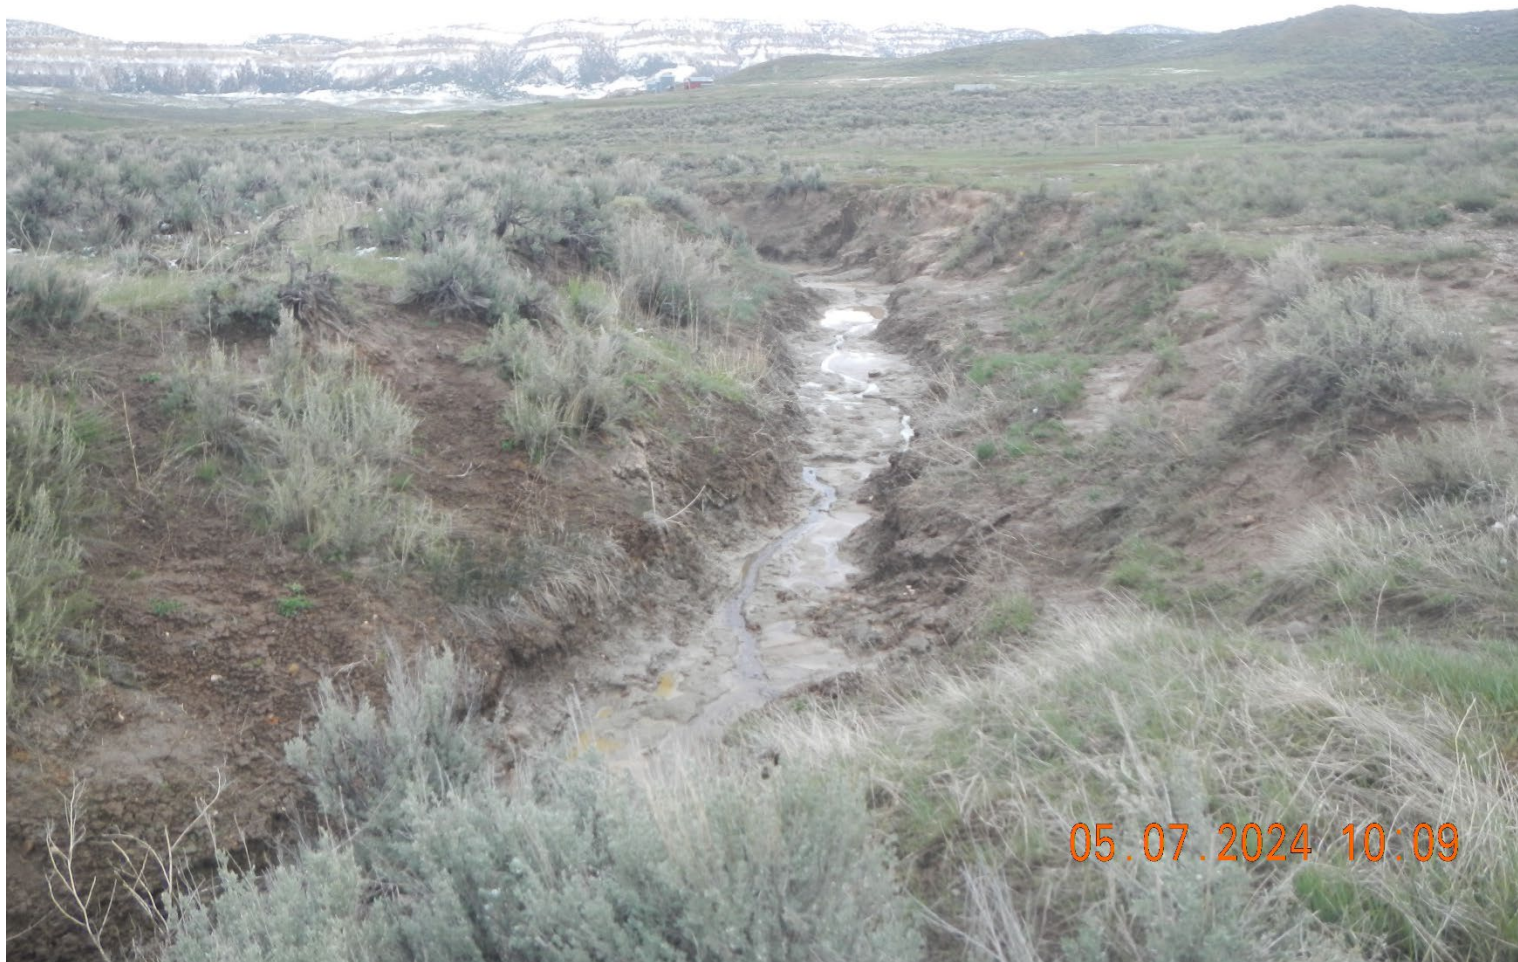
Spill/Release ID 483727 REM 28246 Photo #6 The Gulch was observed from the former discharge to area where POC had ended their excavation activity in 2023.

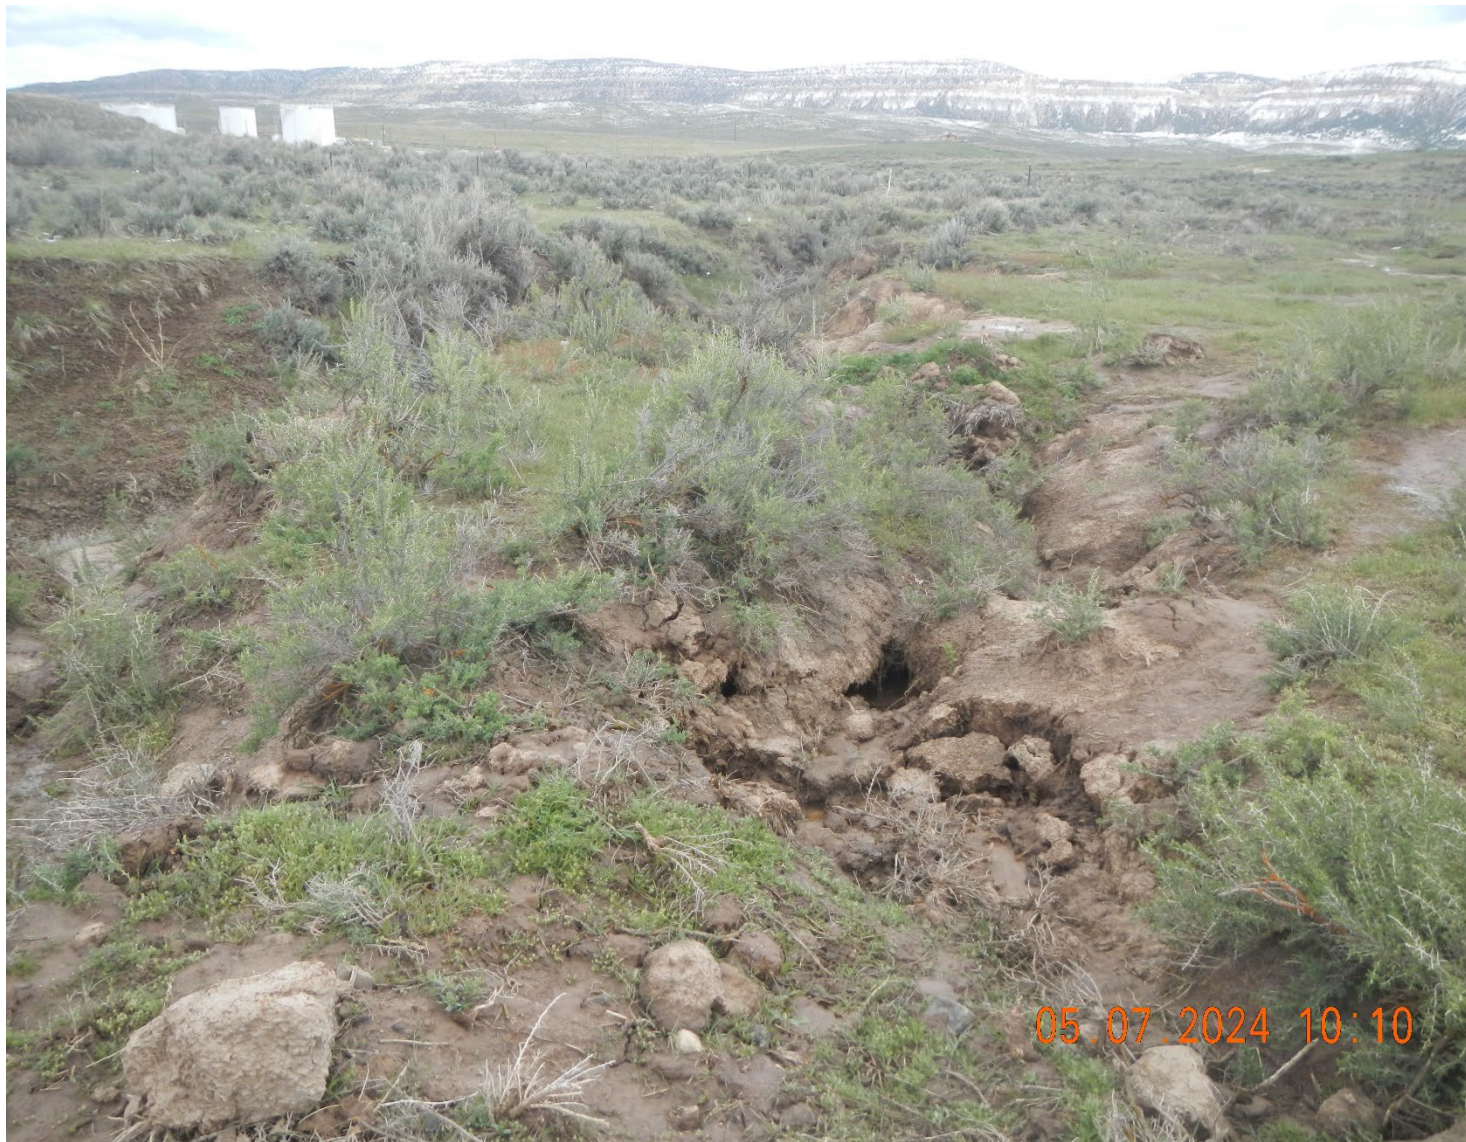
Spill/Release ID 483727 REM 28246 Photo #7 The Gulch was observed from the former discharge to area where POC had ended their excavation activity in 2023.

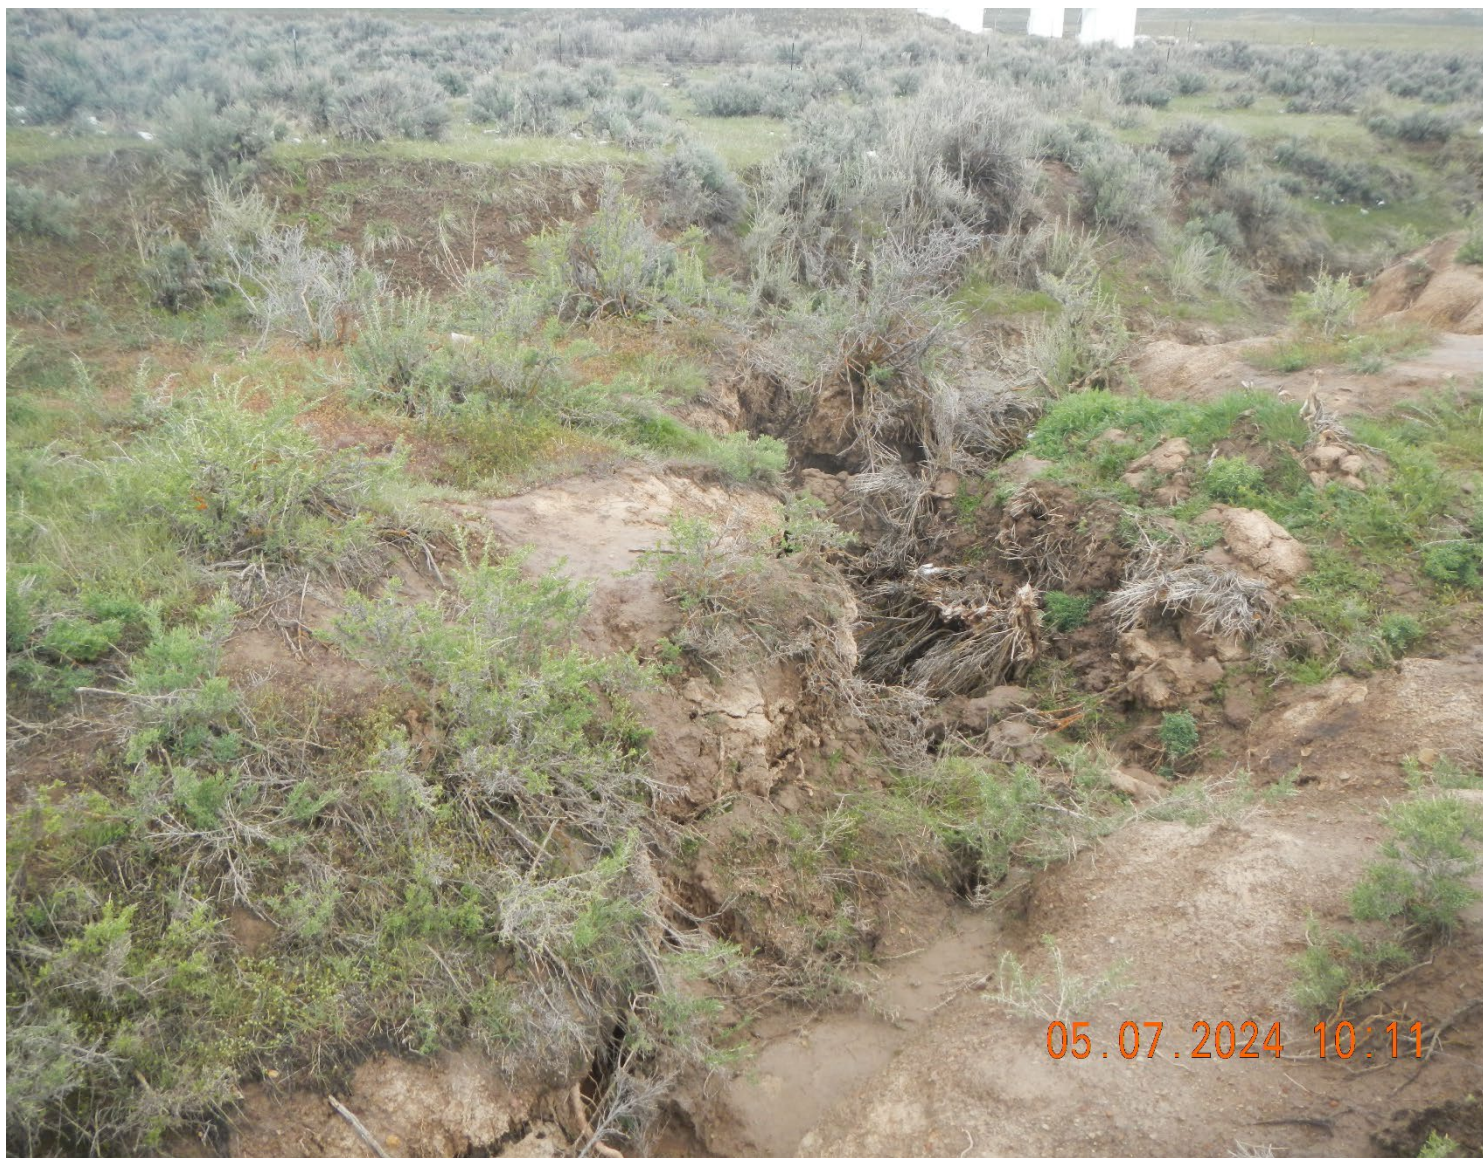
Spill/Release ID 483727 REM 28246 Photo #8 The Gulch was observed from the former discharge to area where POC had ended their excavation activity in 2023.

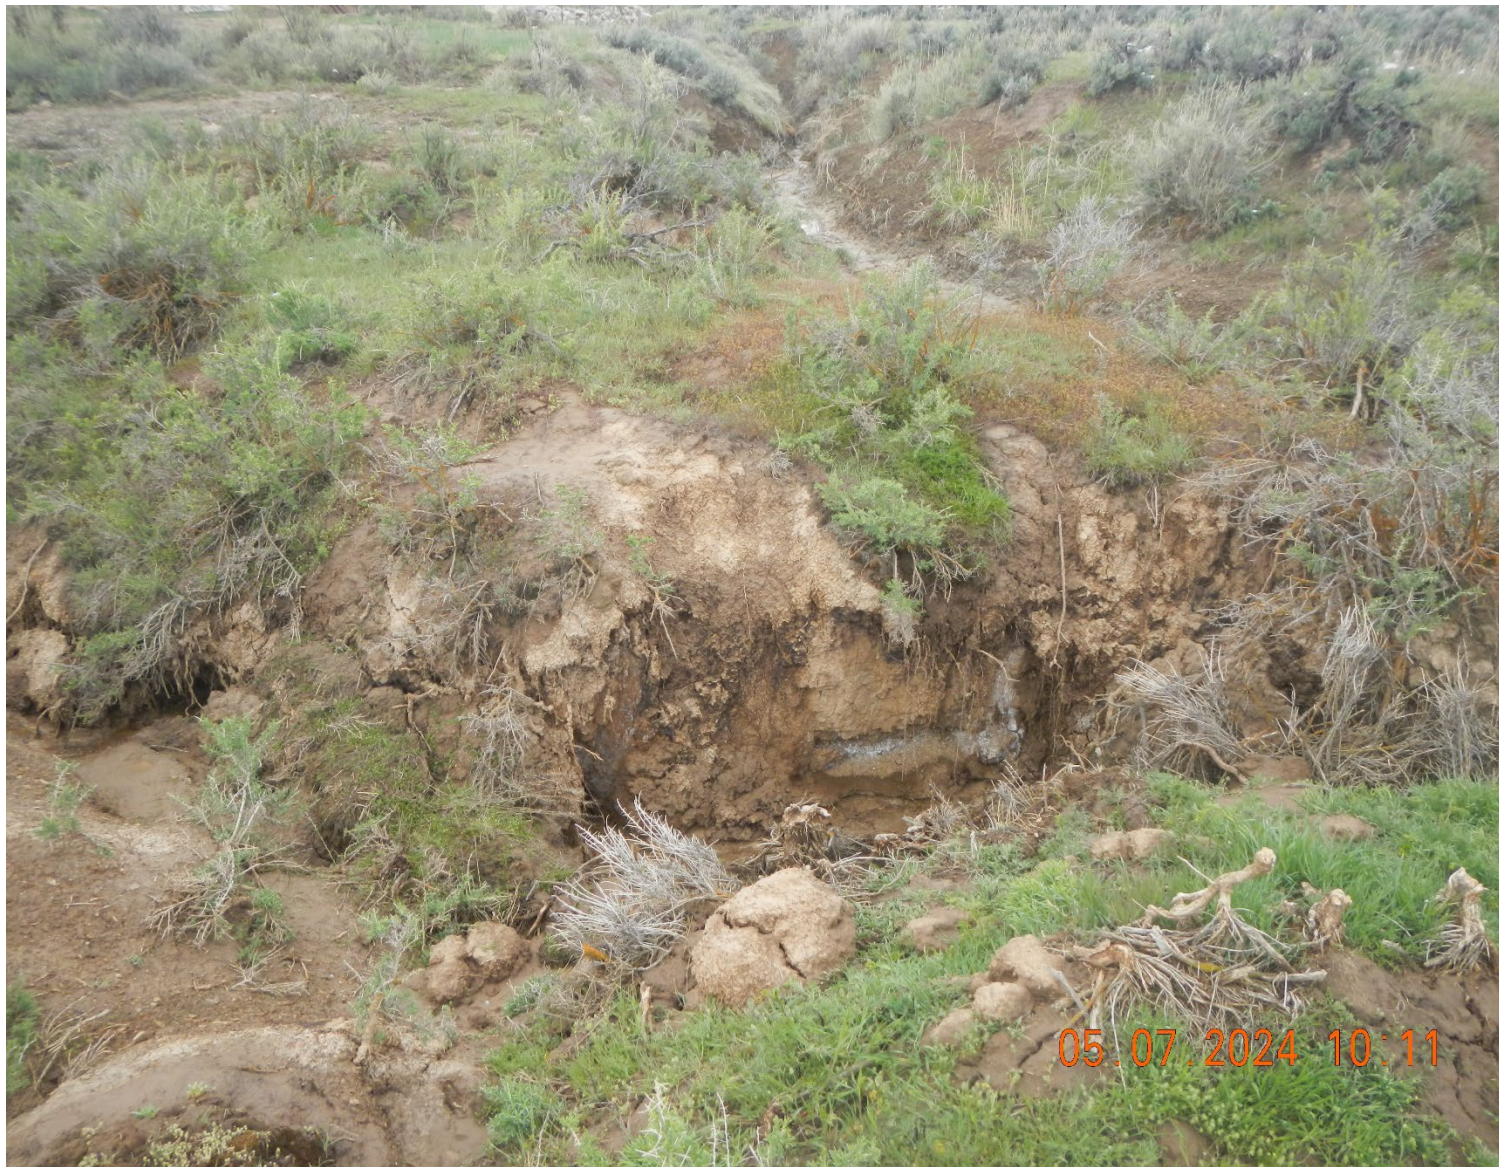
Spill/Release ID 483727 REM 28246 Photo #9. The Gulch was observed from the former discharge to area where POC had ended their excavation activity in 2023.

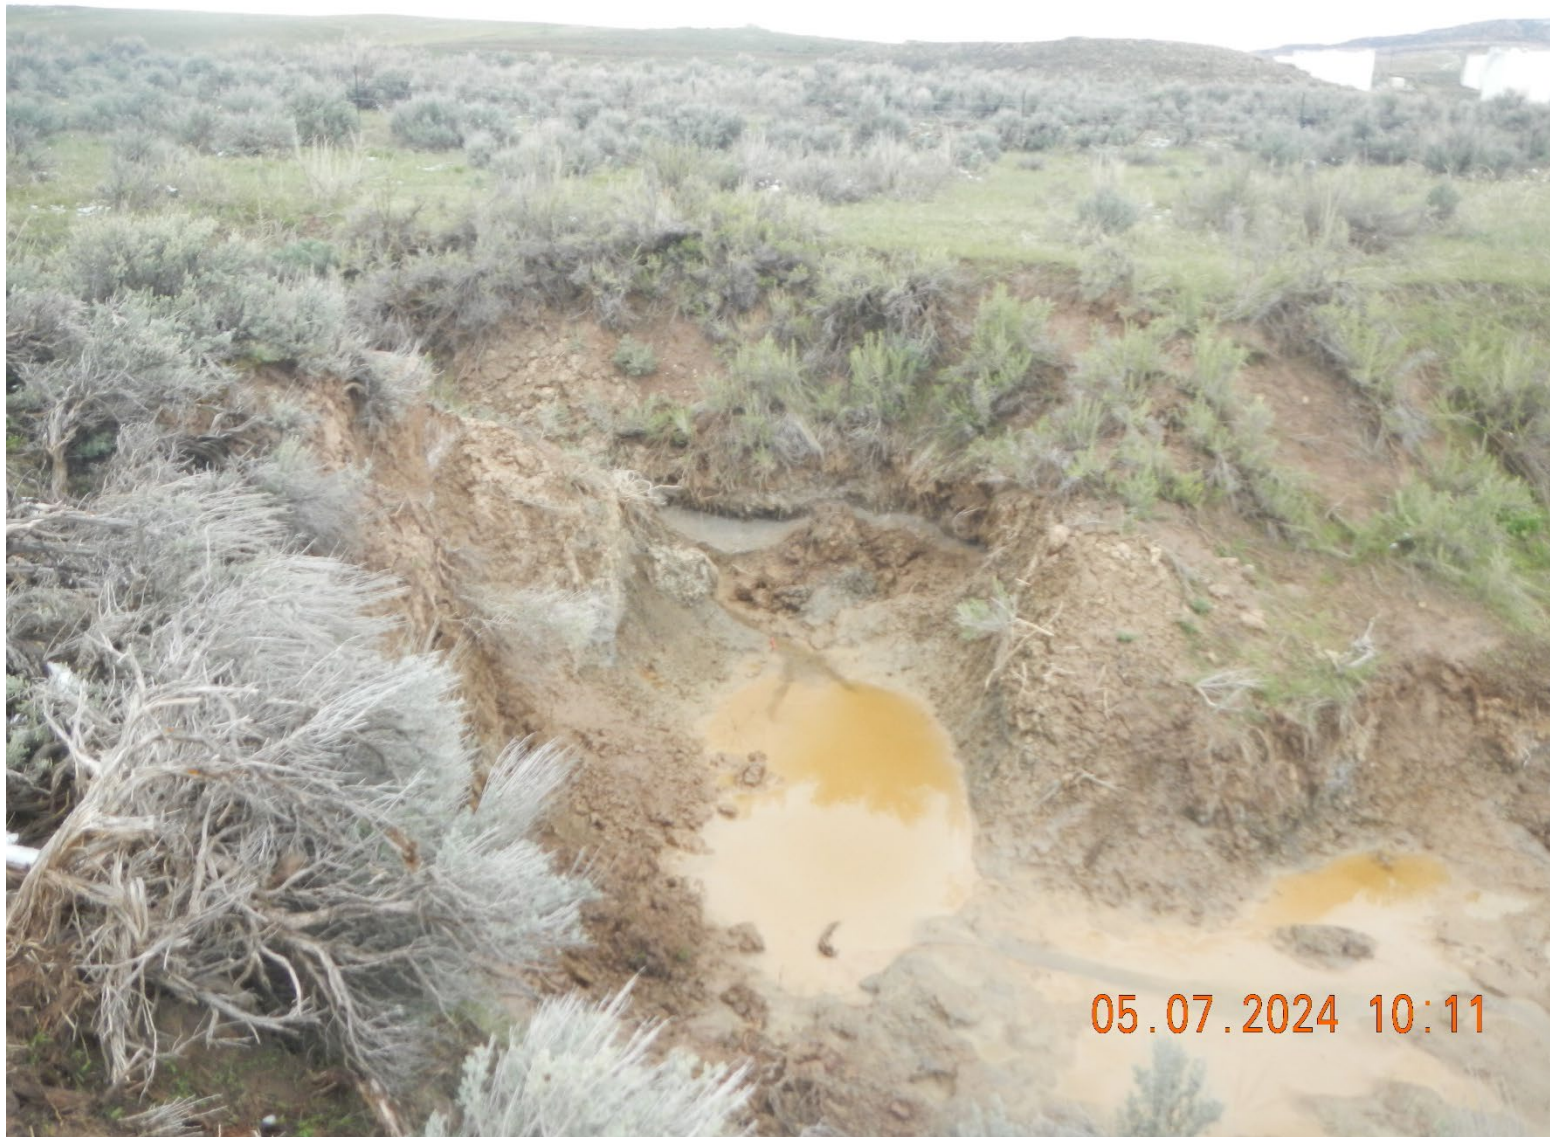
Spill/Release ID 483727 REM 28246 Photo #10. The Gulch was observed from the former discharge to area where POC had ended their excavation activity in 2023.

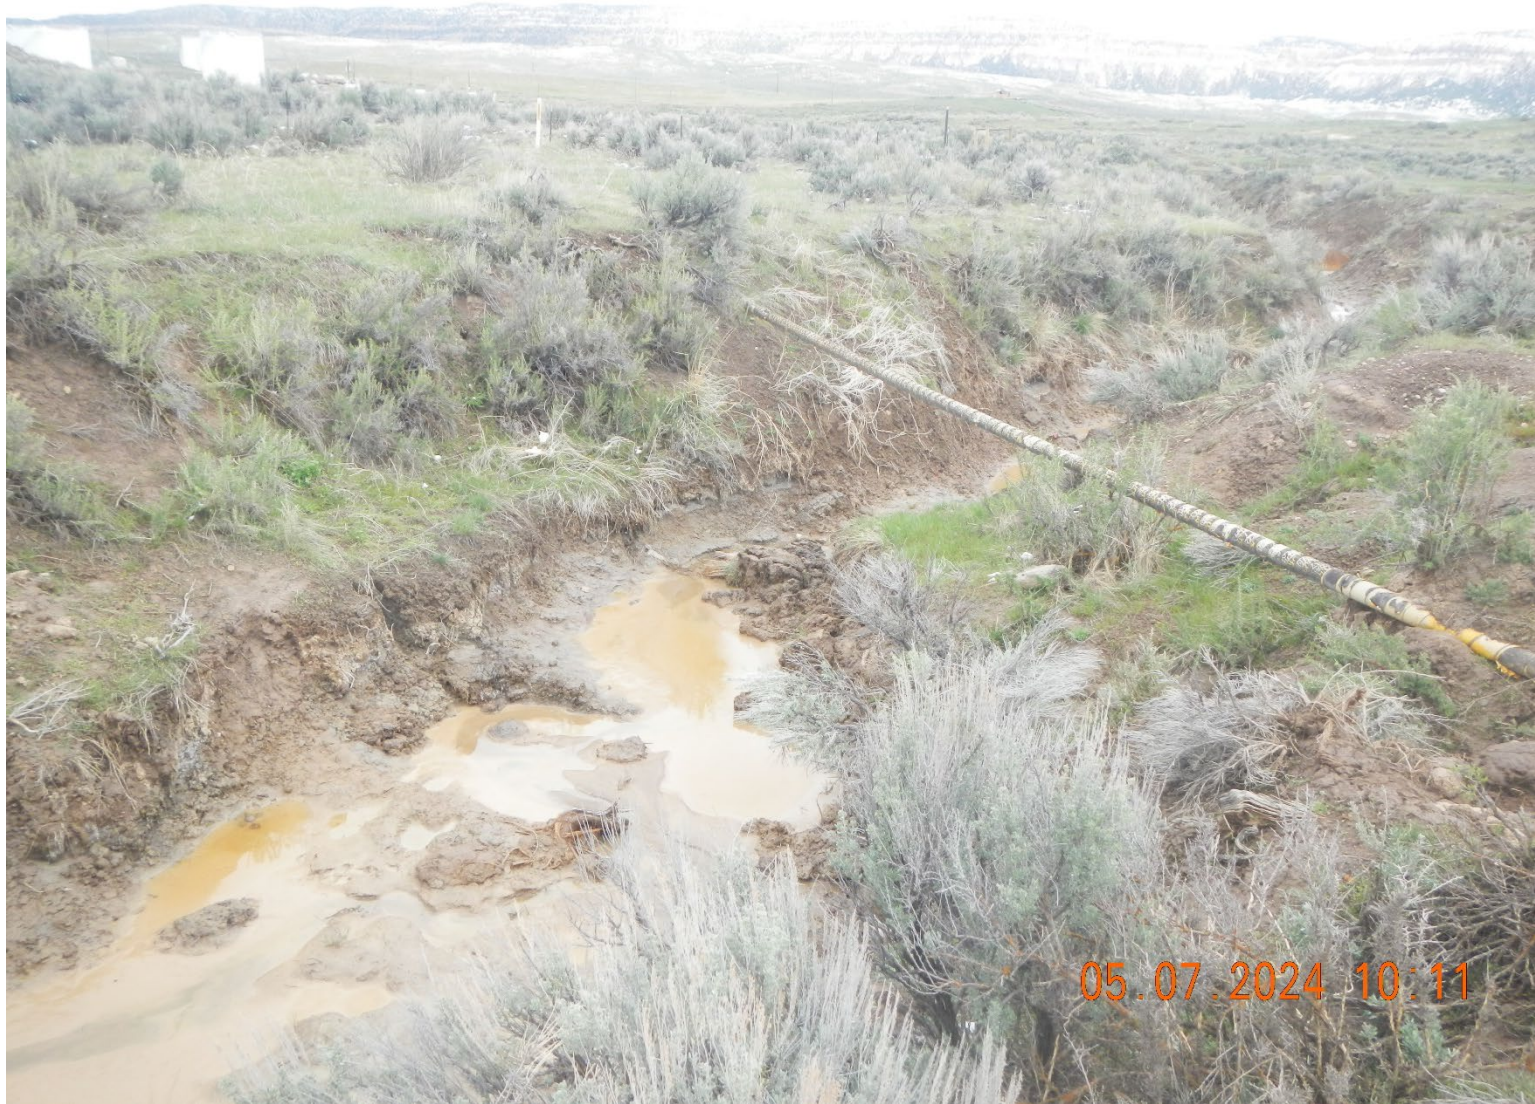
Spill/Release ID 483727 REM 28246 Photo #11 The Gulch was observed from the former discharge to area where POC had ended their excavation activity in 2023.

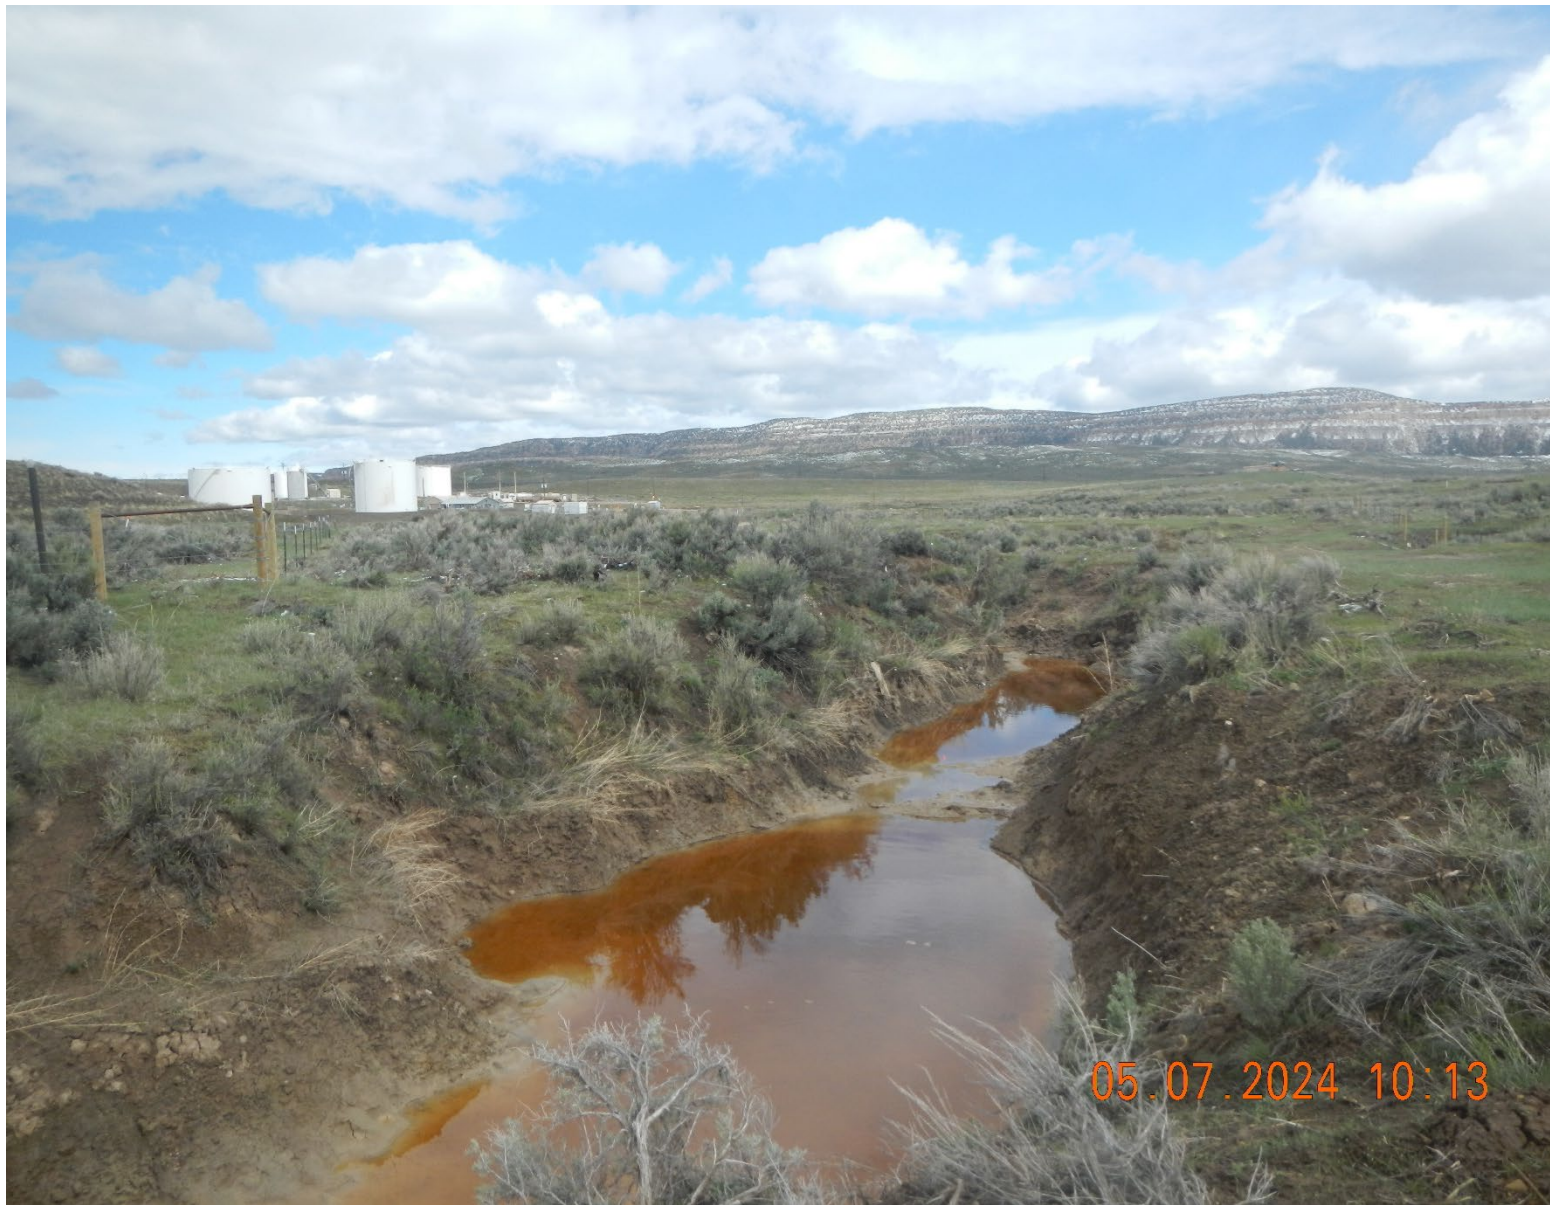
Spill/Release ID 483727 REM 28246 Photo #12 The Gulch was observed from the former discharge to area where POC had ended their excavation activity in 2023. the Operator shall collect a sample for the pooled water for Table 915-1 Organic Compounds in Groundwater and Groundwater Inorganic Parameters.

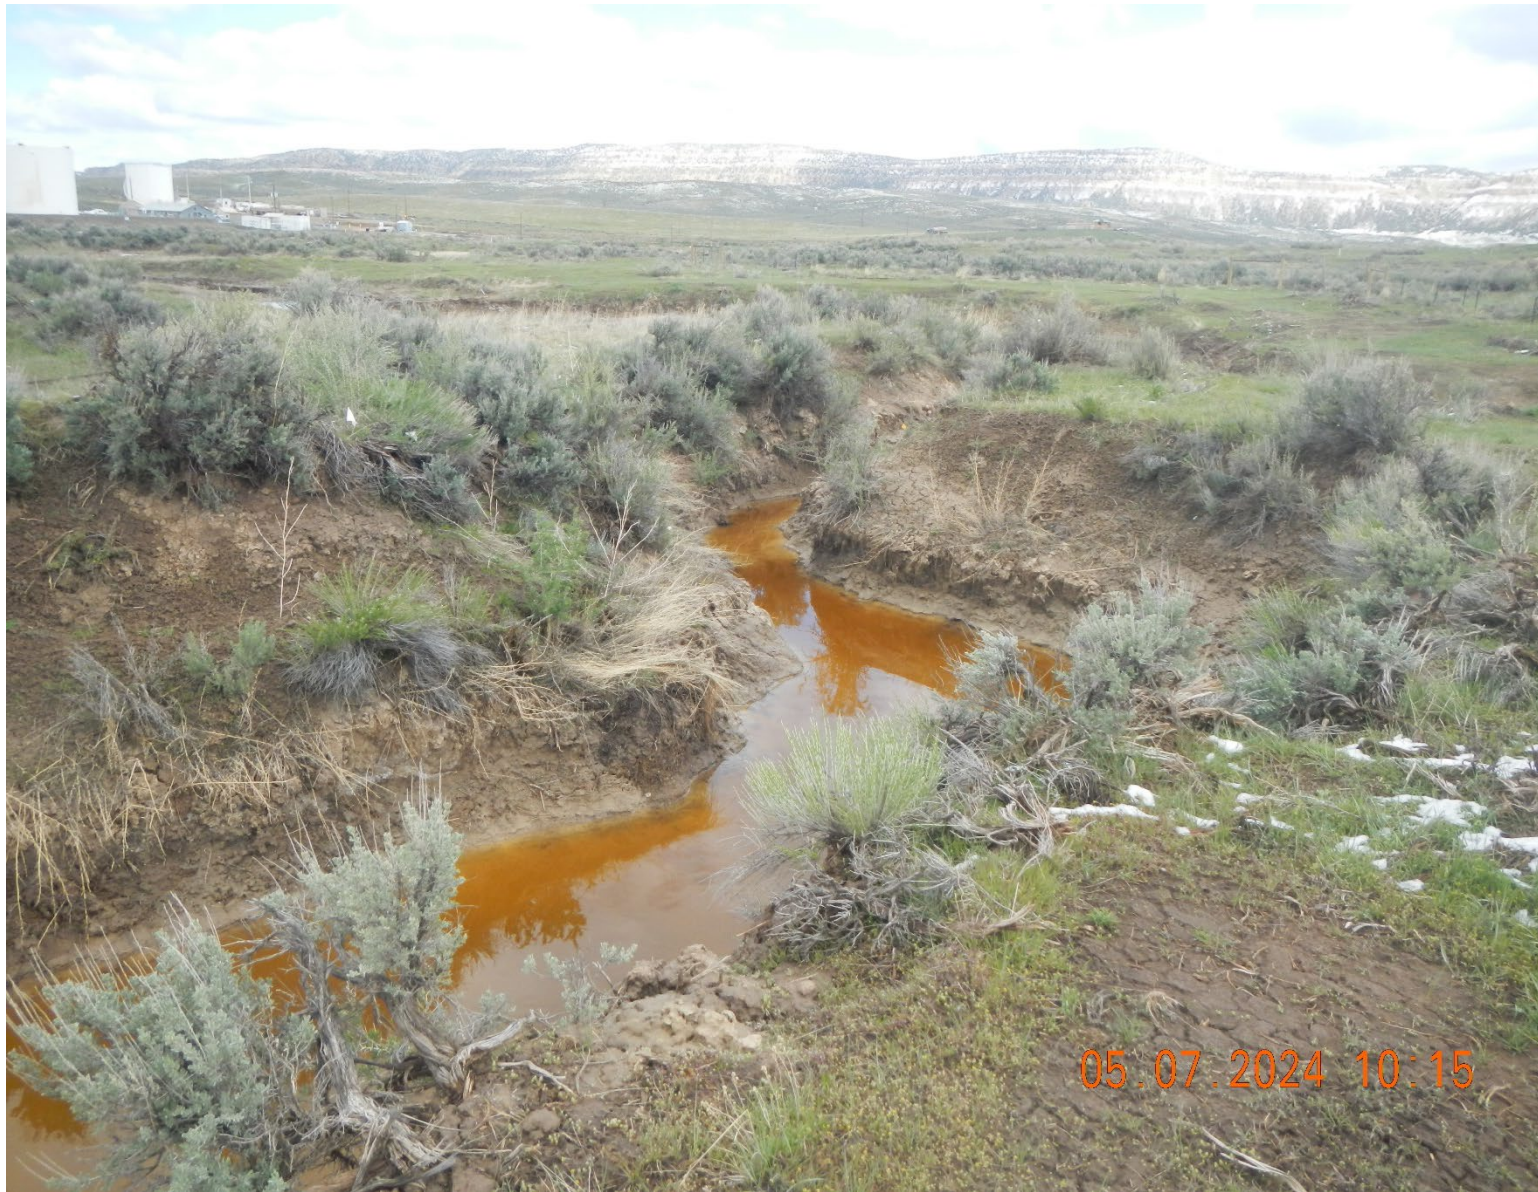
Spill/Release ID 483727 REM 28246 Photo #13. The Gulch was observed from the former discharge to area where POC had ended their excavation activity in 2023.

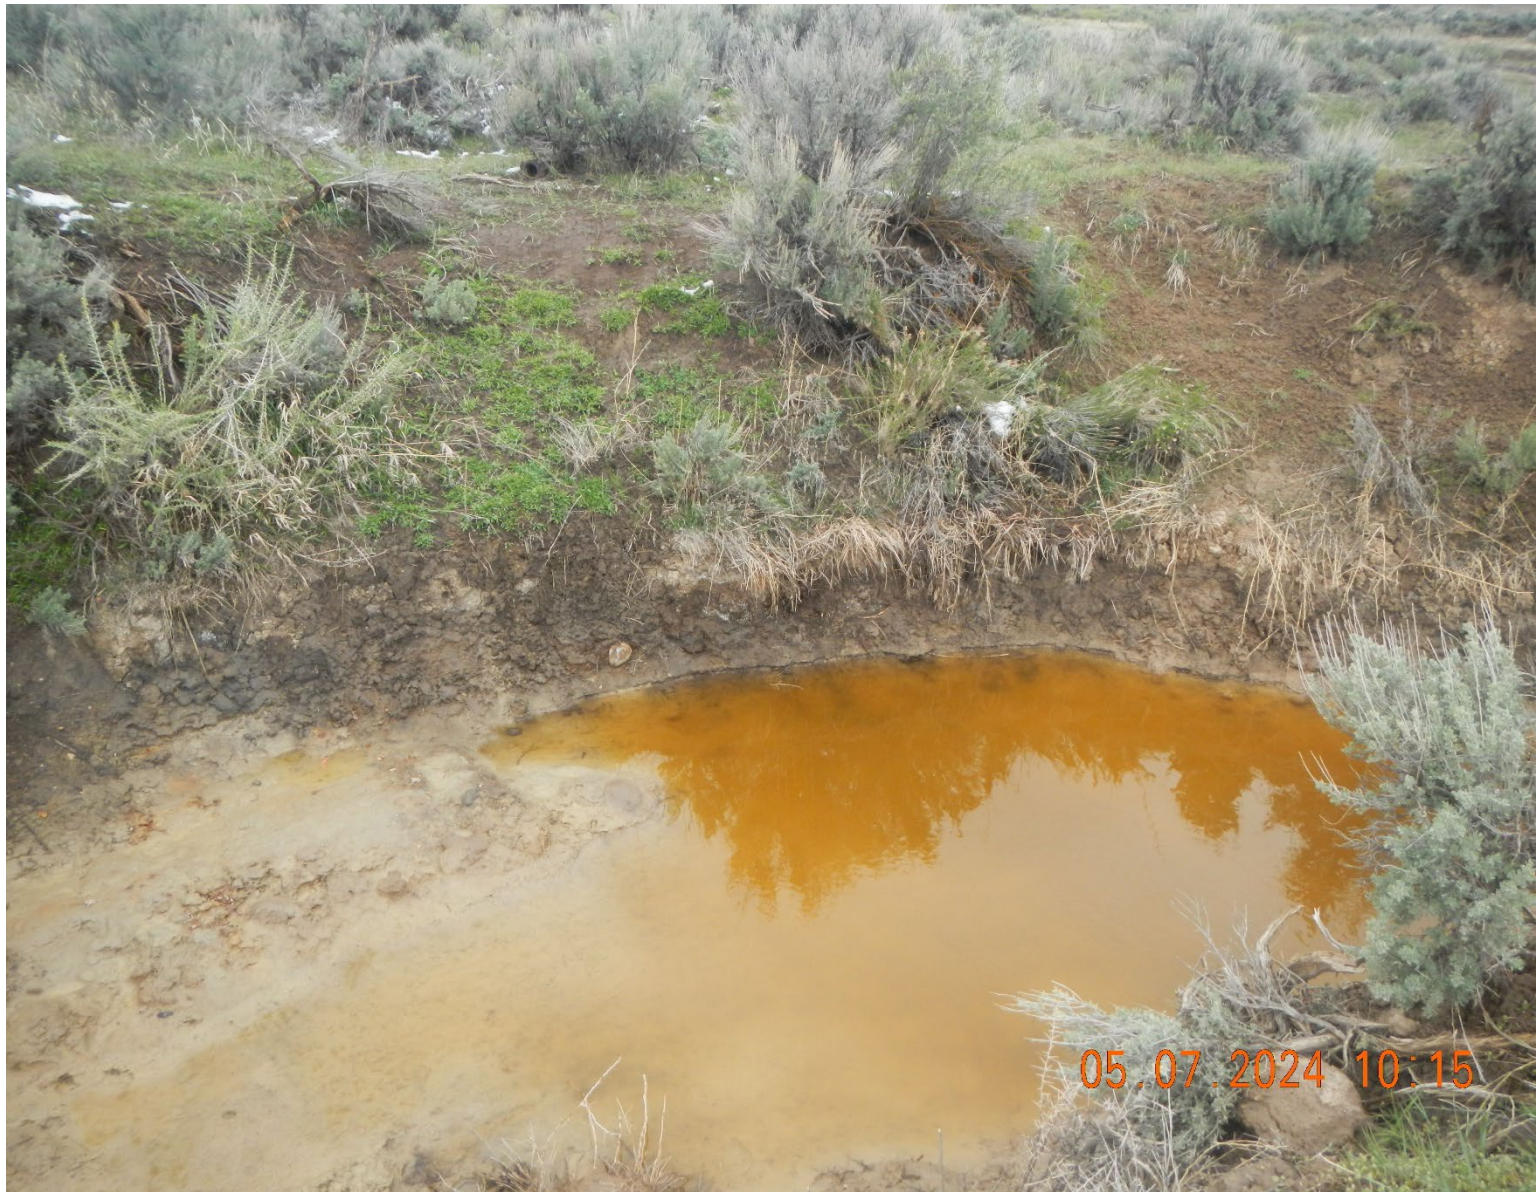
Spill/Release ID 483727 REM 28246 Photo #14. The Gulch was observed from the former discharge to area where POC had ended their excavation activity in 2023.

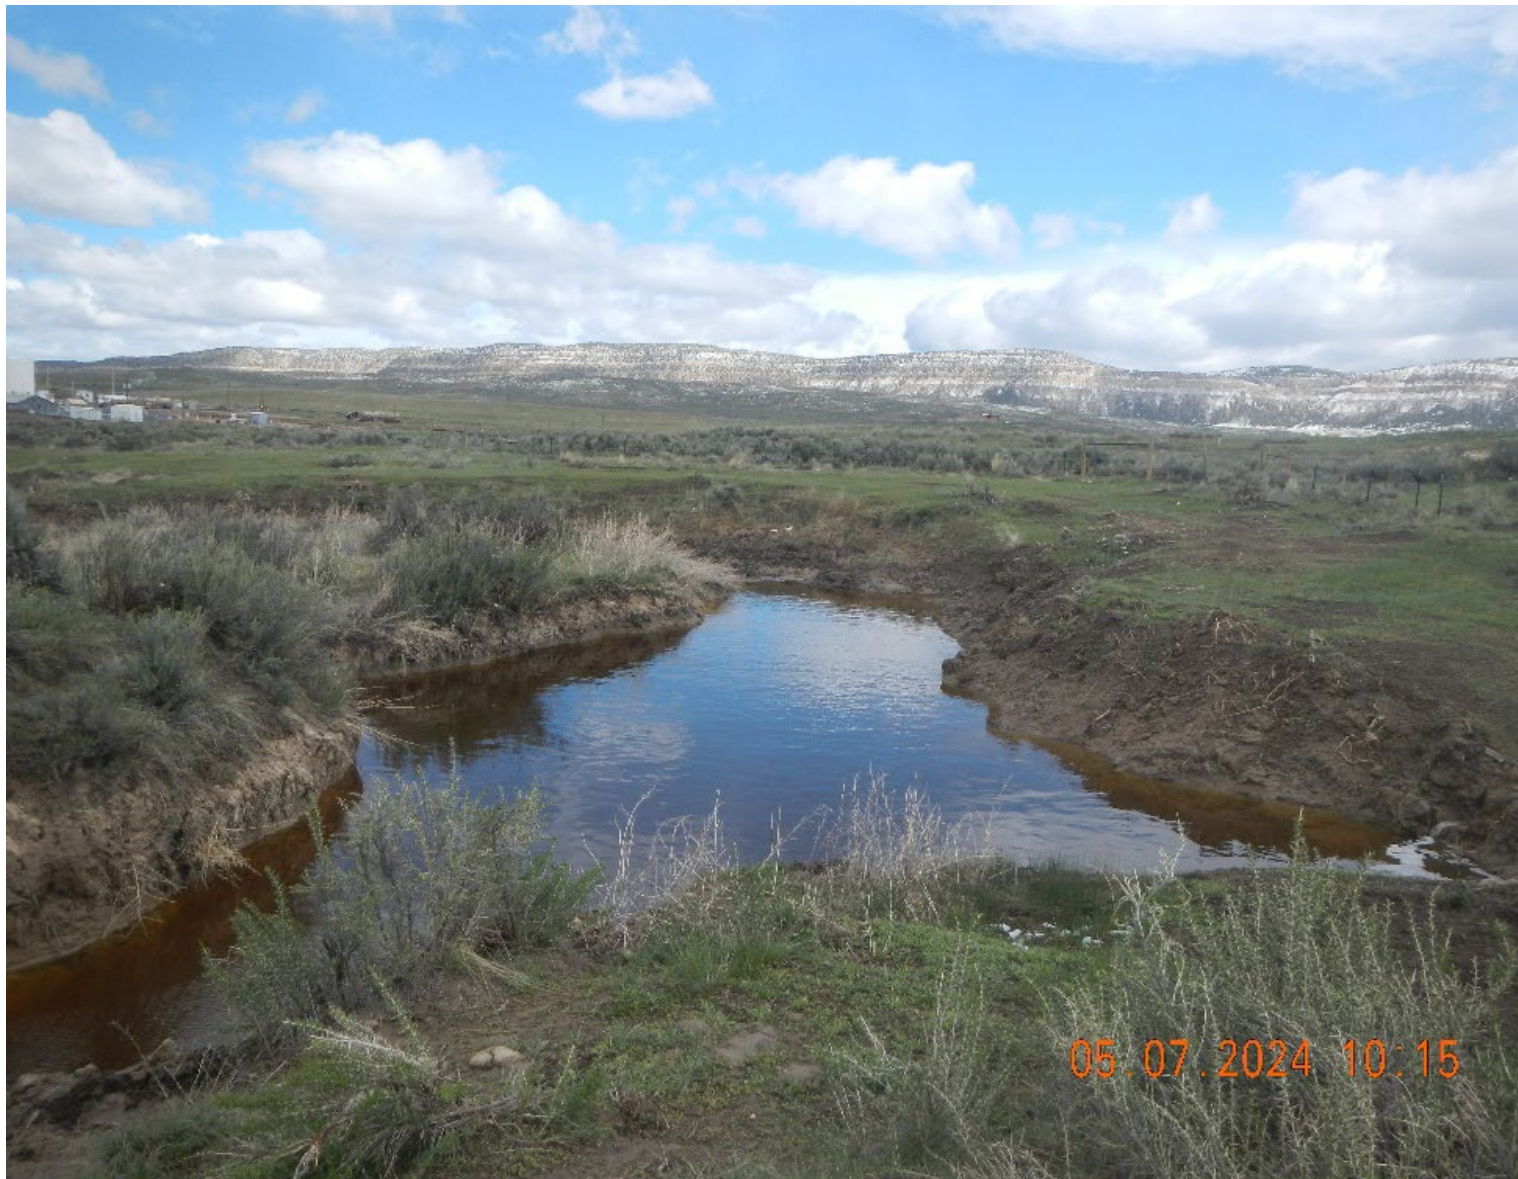
Spill/Release ID 483727 REM 28246 Photo #15. The Gulch was observed from the former discharge to area where POC had ended their excavation activity in 2023. This pool is the end of 2023 activity. the Operator shall collect a sample for the pooled water for Table 915-1 Organic Compounds in Groundwater and Groundwater Inorganic Parameters.
