COLORADO
Oil & Gas Conservation
Commission
Department of Natural Resources

Spill/Release ID 483727 REM 28246 Photo #1 area of former discharge.

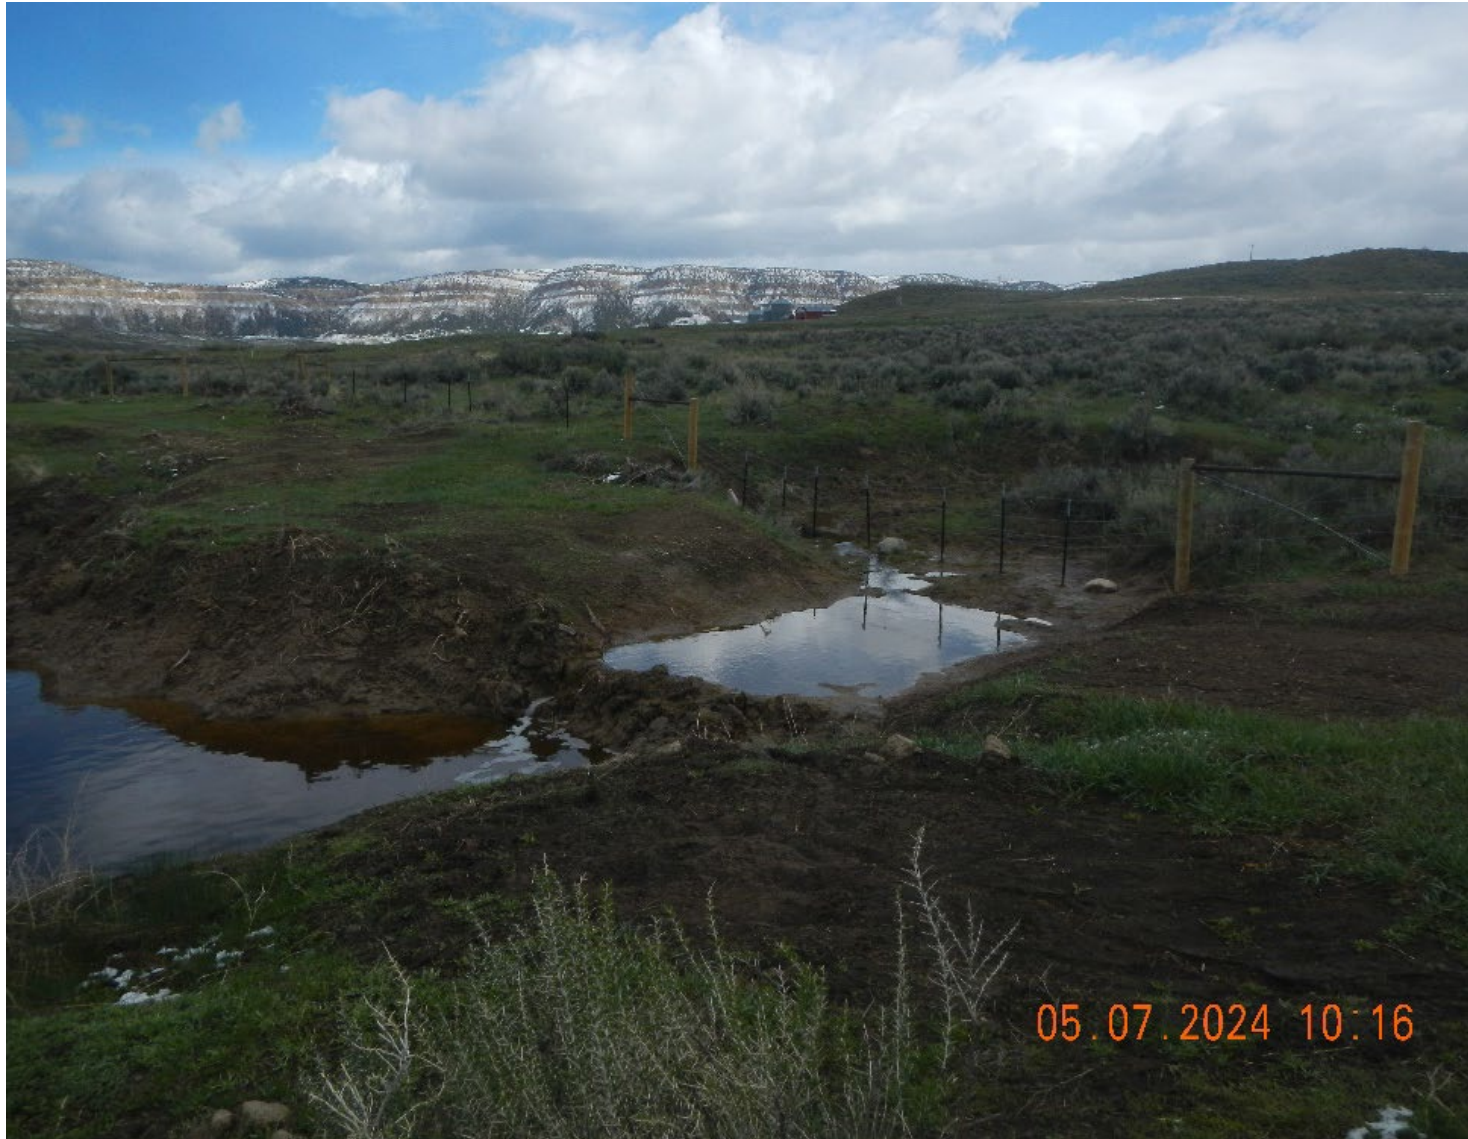
Spill/Release ID 483727 REM 28246 Photo #16 Area where surface water from another drainage was draining to Seeping Spring Gulch
