Inspection Photos

Operator: GUNNISON ENERGY LLC #10515

Location ID: 334446

Inspection Doc: 696205820

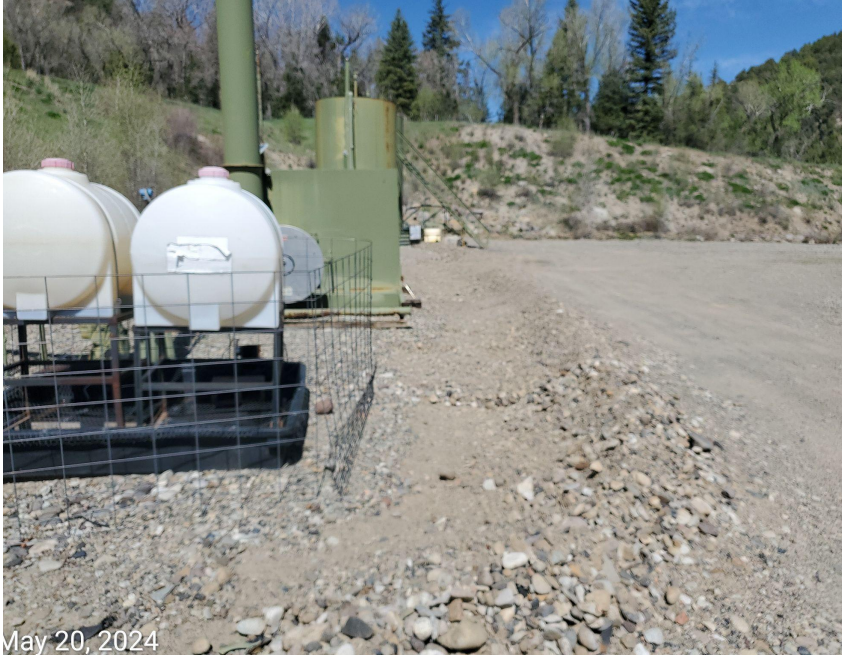
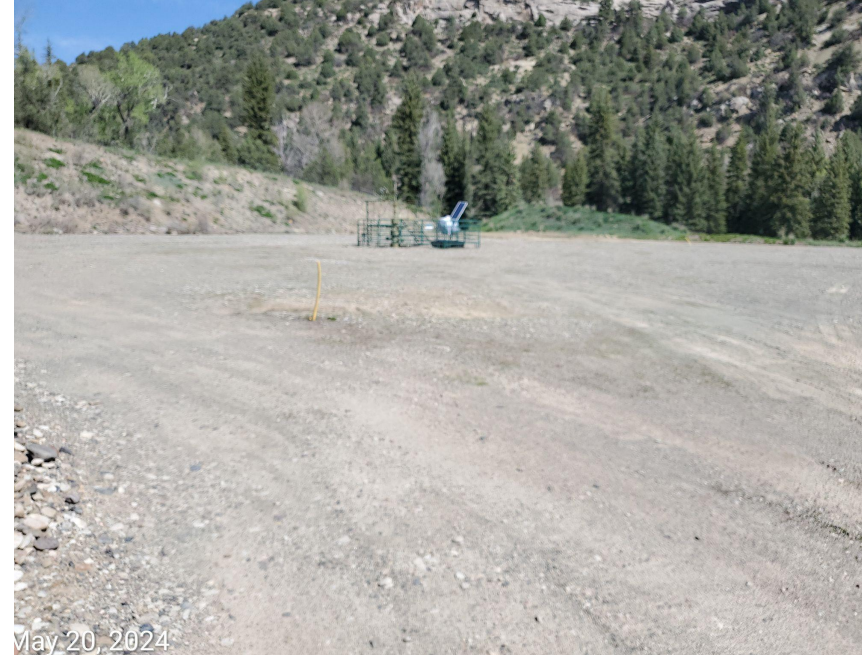
Photo 1: Photos 1-2 taken from the south end of the working pad surface. Photos provide an overview of the Location from north, northeast, southeast to south. Photos also show interim reclamation to reduce the Location to areas only needed for production has not been performed in accordance with 1003 Rules.

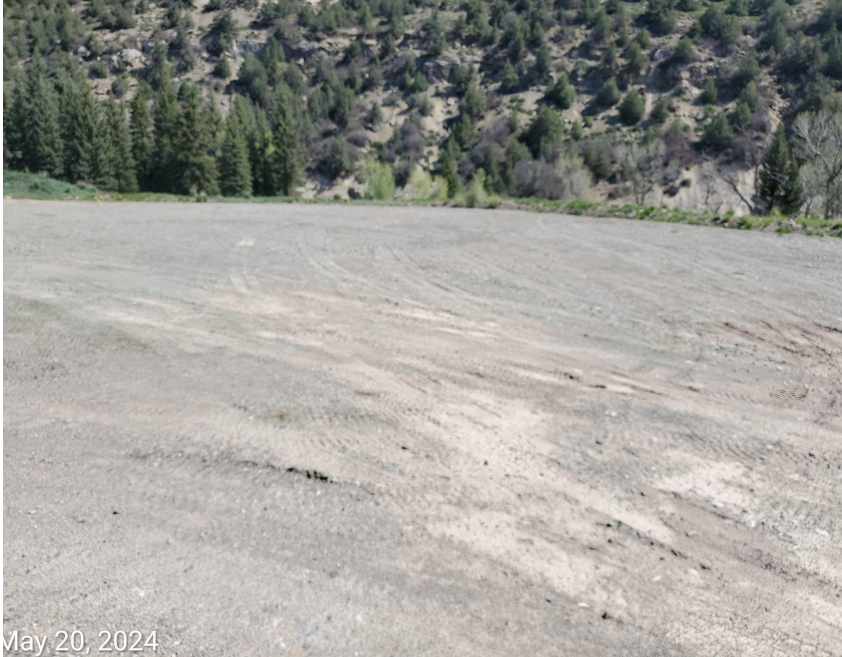
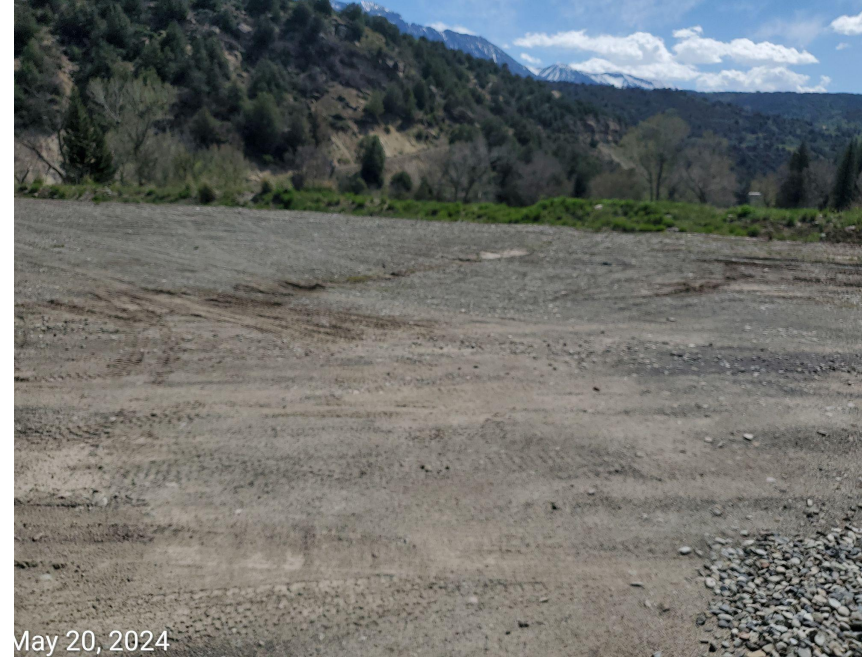
Photo 2: See comments under photo 1.

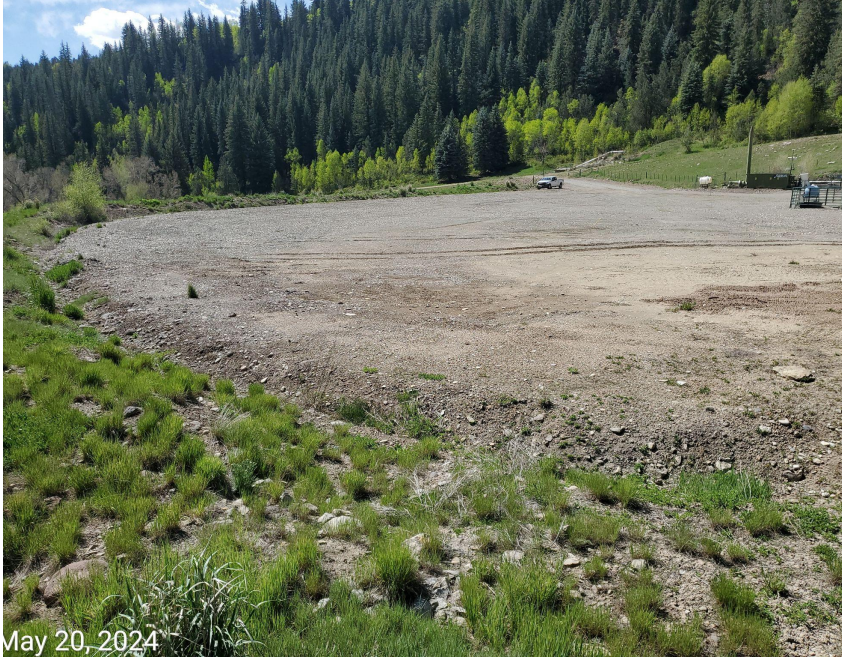
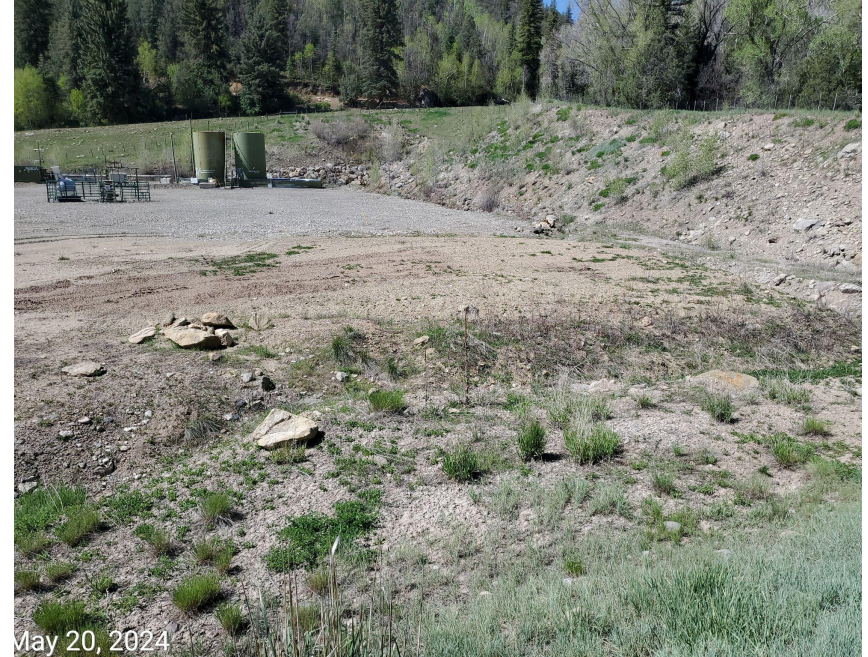
Photo 3: Photos taken from north end of the Location facing southeast and southwest. interim reclamation to reduce the Location to areas only needed for production has not been performed in accordance with 1003 Rules.

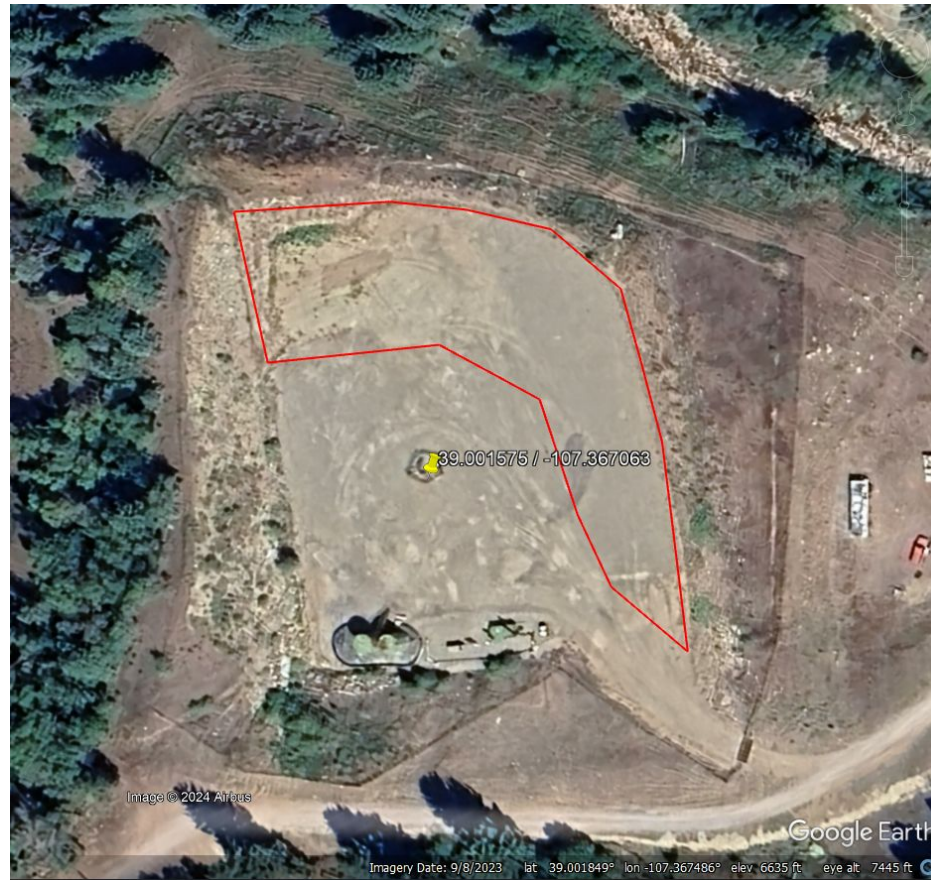
Photo 4: 2023 Google Earth aerial imagery. Photo provides an overview of the Location. Red polygon represent approximate ($\frac{3}{4}$ acres) areas of the current working pad surface not reasonably needed for production.

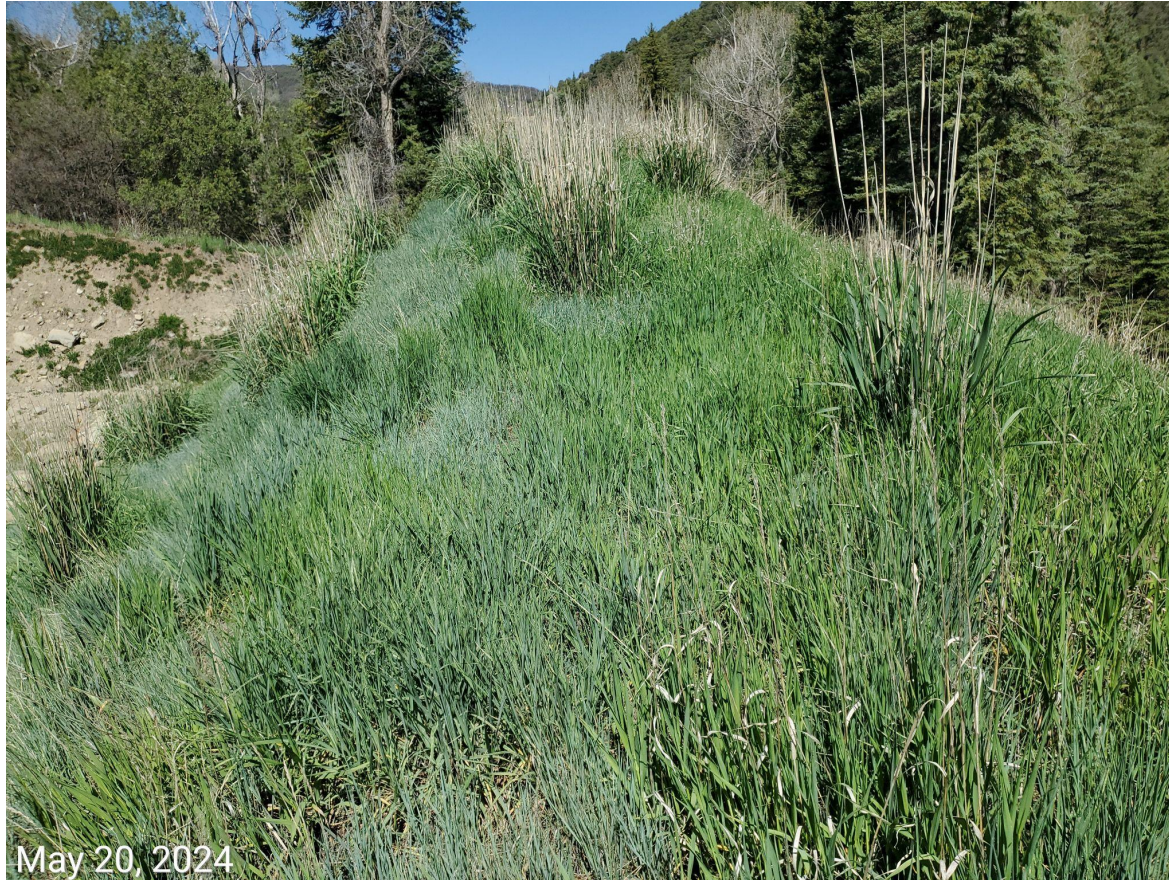
Photo 5: Topsoil stockpile on the northwest end of the Location.

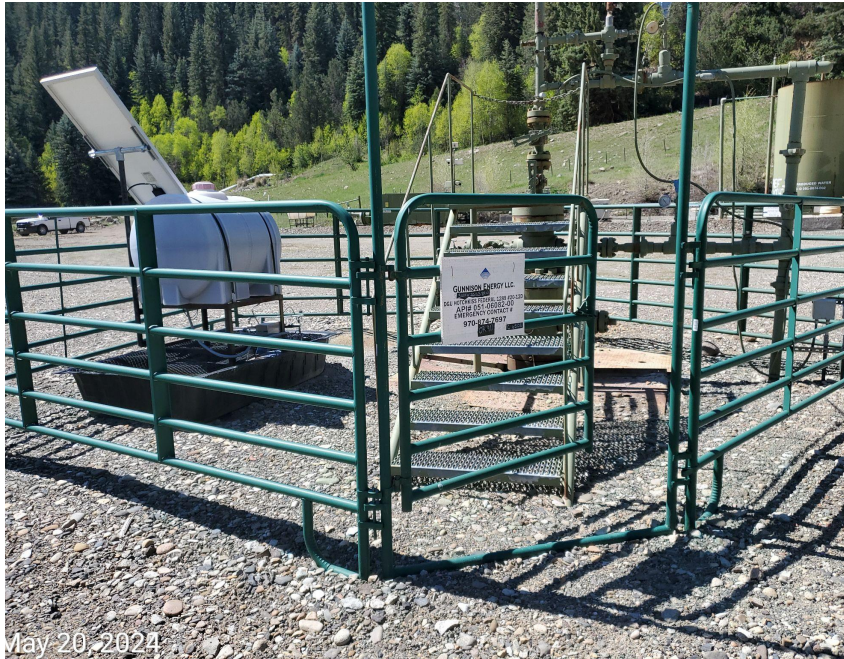
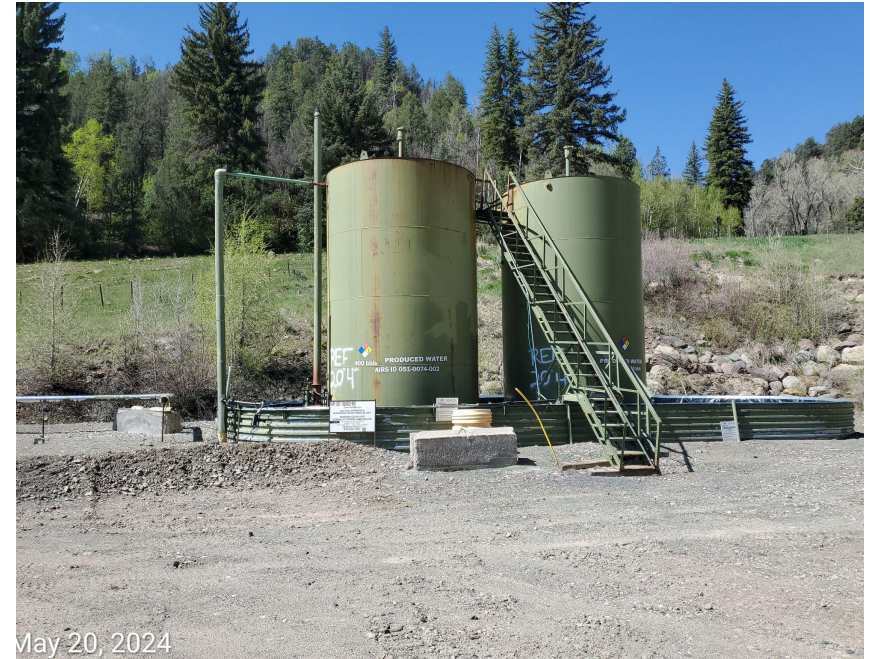
Photo 6: Well and tank battery facility.
