Inspection Photos

Operator: GUNNISON ENERGY LLC - 10515

Location ID: 324464

Inspection Doc: 696205838

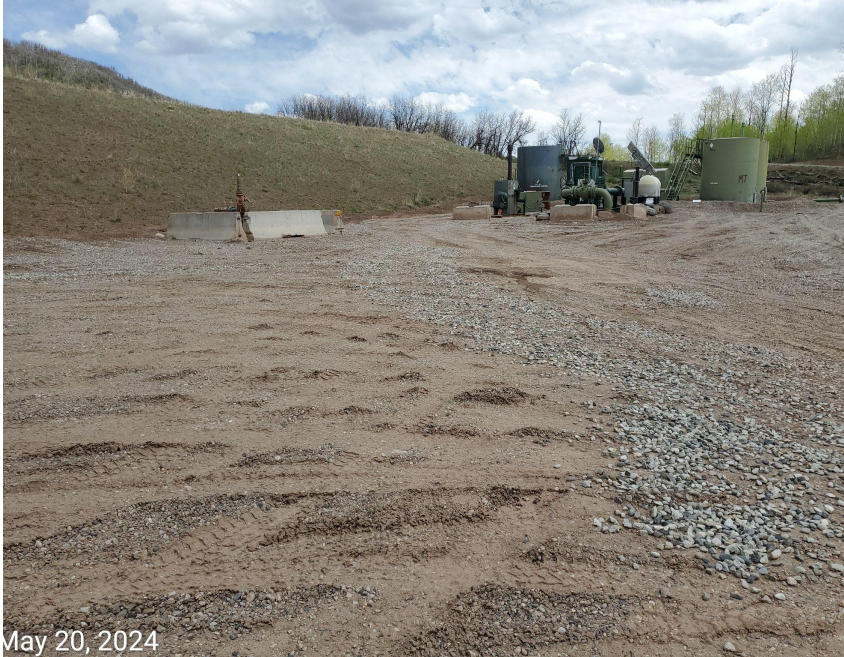
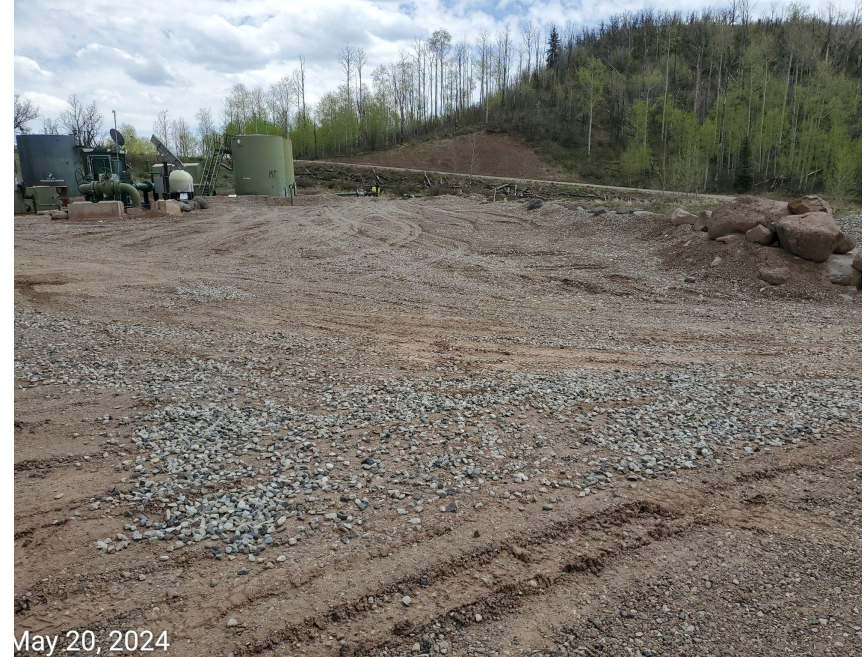
Photo 1: Photos taken from the northwest end of the Location, facing east and southeast. Photos provide an overview of the working pad surface.

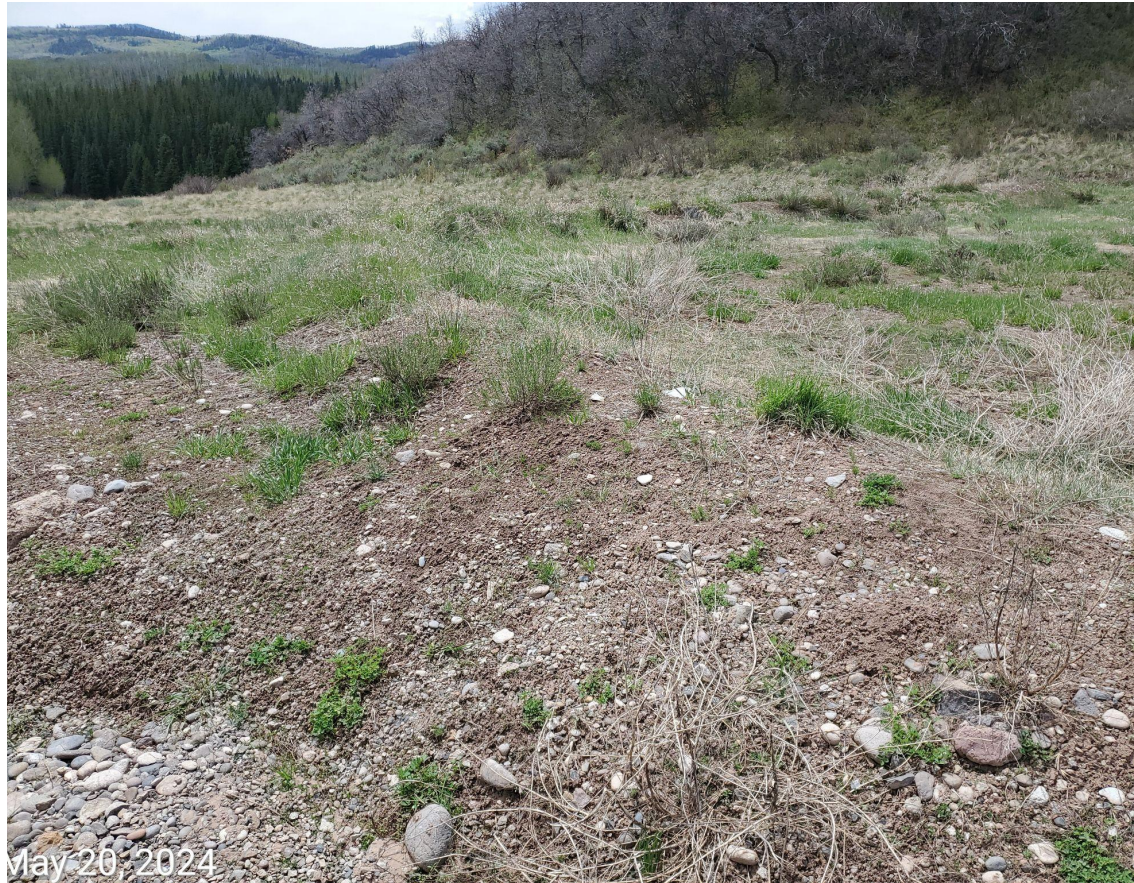
Photo 2: Photo shows areas on the north end of the Location where production equipment was previously located- areas have not been reclaimed pursuant to 1003.b requirements.

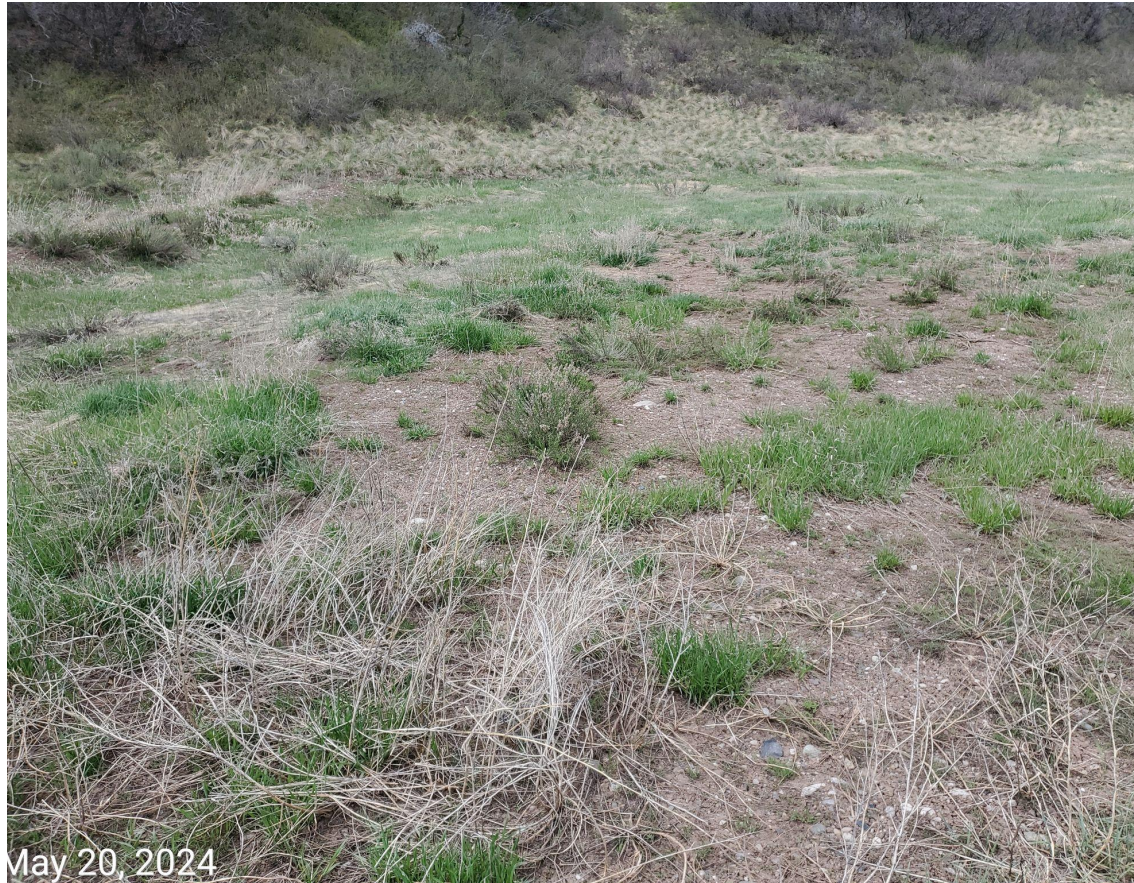
Photo 3: Photo taken from off-site areas northwest of the location where Operator had improperly stored equipment. Disturbed areas remain apparent.

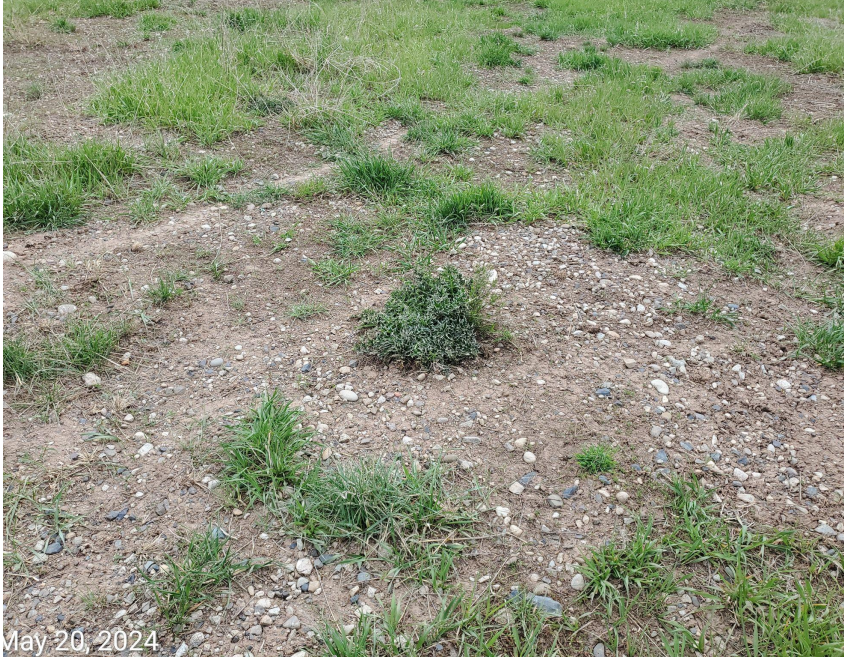
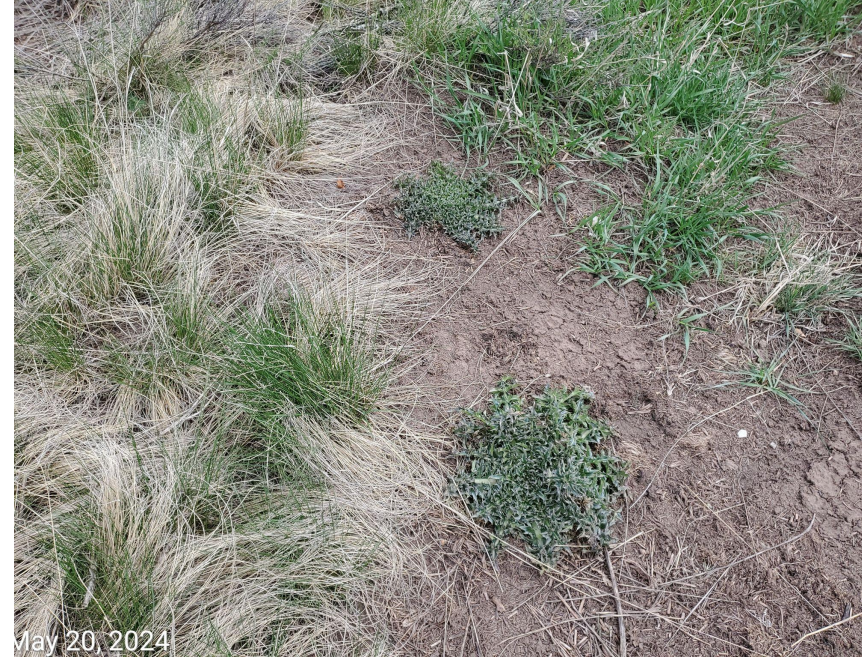
Photo 4: Photos 4-6 examples showing noxious weed establishment on the Location, and off-site adjacent areas where Operator disturbed during improper equipment storage.

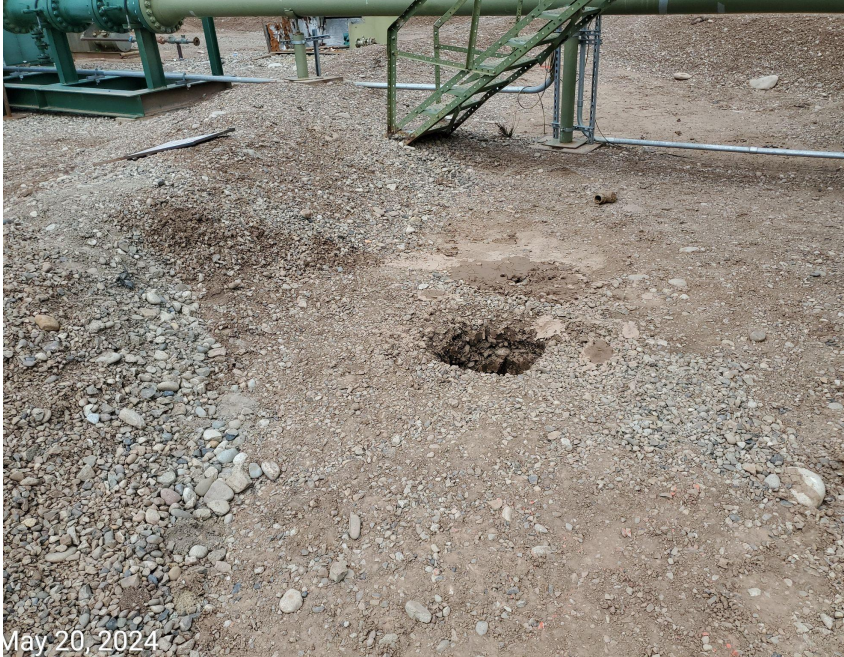
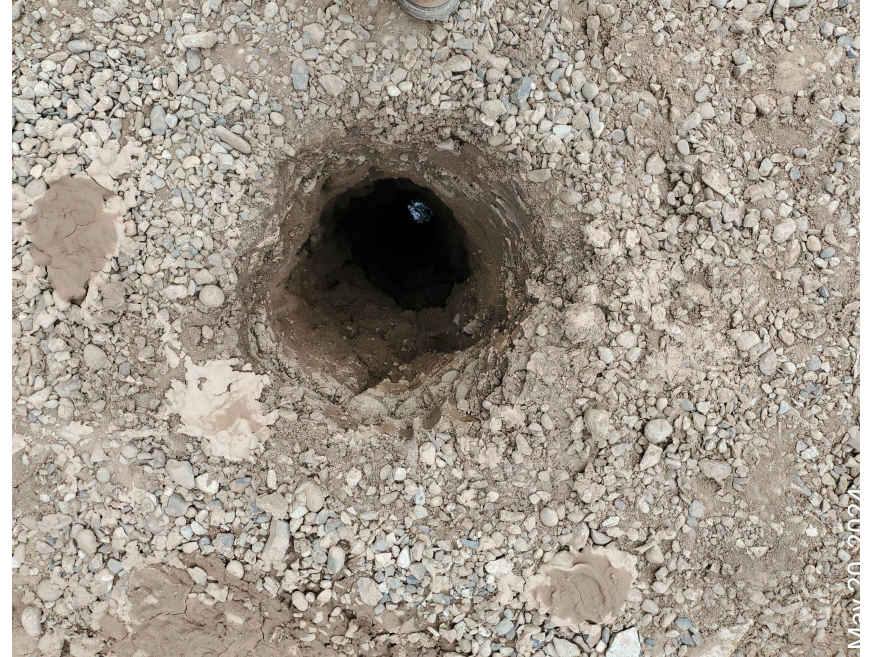
Photo 7: Photo 7-8 tank from the tank battery facility. Photos show holes drilled by Operator; fencing to restrict access by people or wildlife has not been installed.
