ELU M12-496 Pad Geologic Hazard Map NWSW / SWSW, Section 12, T4S R96W, 6th P.M. Rio Blanco County, Colorado

330 Grand Avenue, Unit C Grand Junction, CO 81501 970-549-1015	
		Survey Date:	
Figure 1		Date Drawn:	11/27/2023
		Drawn By:	Nathan Baier
		Scale:	1 inch = 2,000 ft

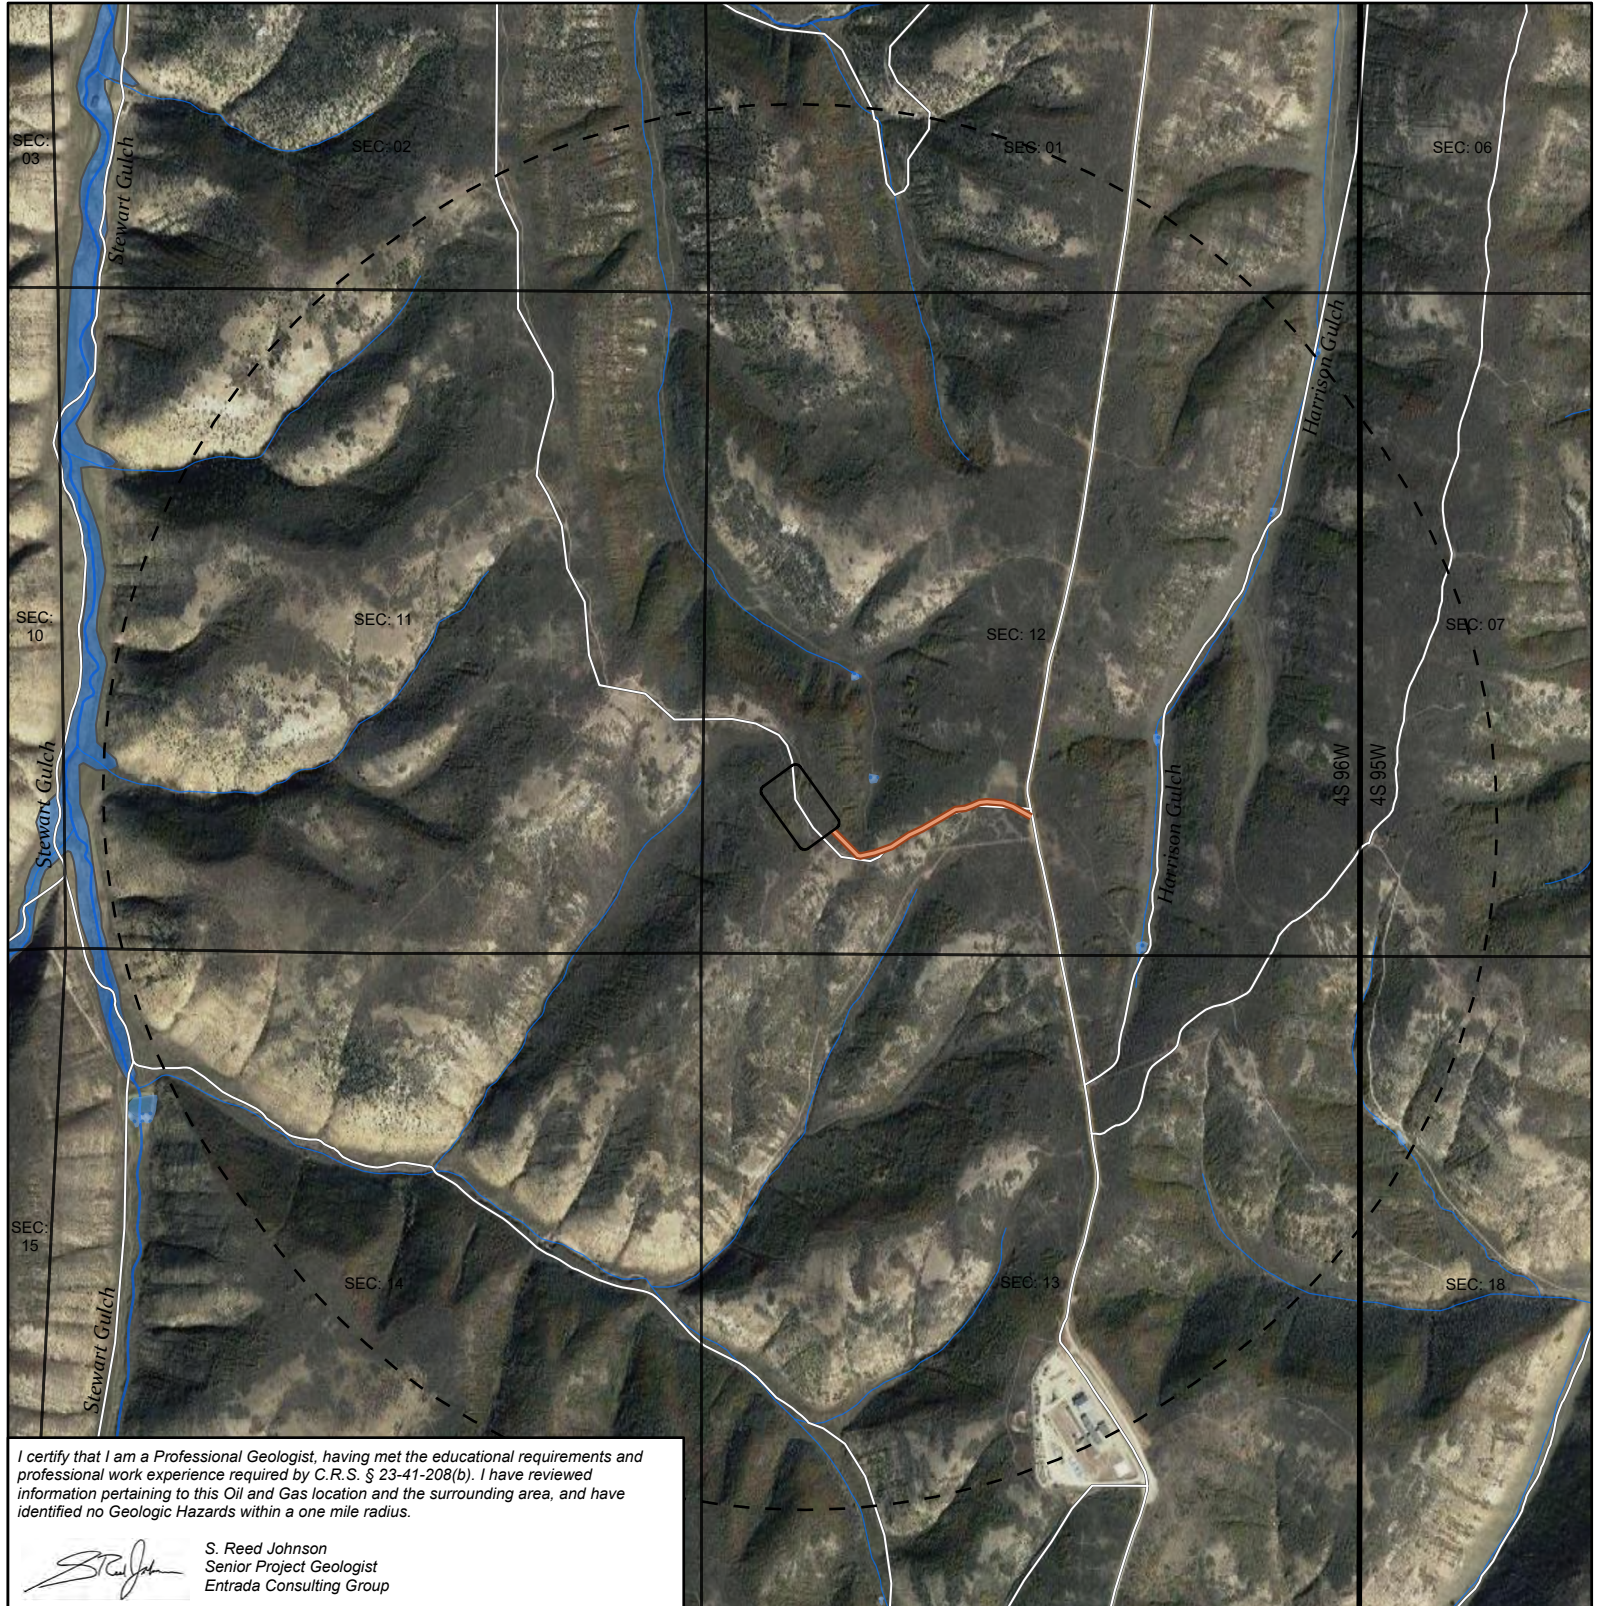
I certify that I am a Professional Geologist, having met the educational requirements and professional work experience required by C.R.S. § 23-41-208(b). I have reviewed information pertaining to this Oil and Gas location and the surrounding area, and have identified no Geologic Hazards within a one mile radius.

100-Year Floodplain, Rio Blanco County (1)
