Final Reclamation and Stormwater Inspection

Operator: PDC Energy Inc - 69175

Location ID: 310395

Location Name: GUTTERSEN-63N63W 8NWNE

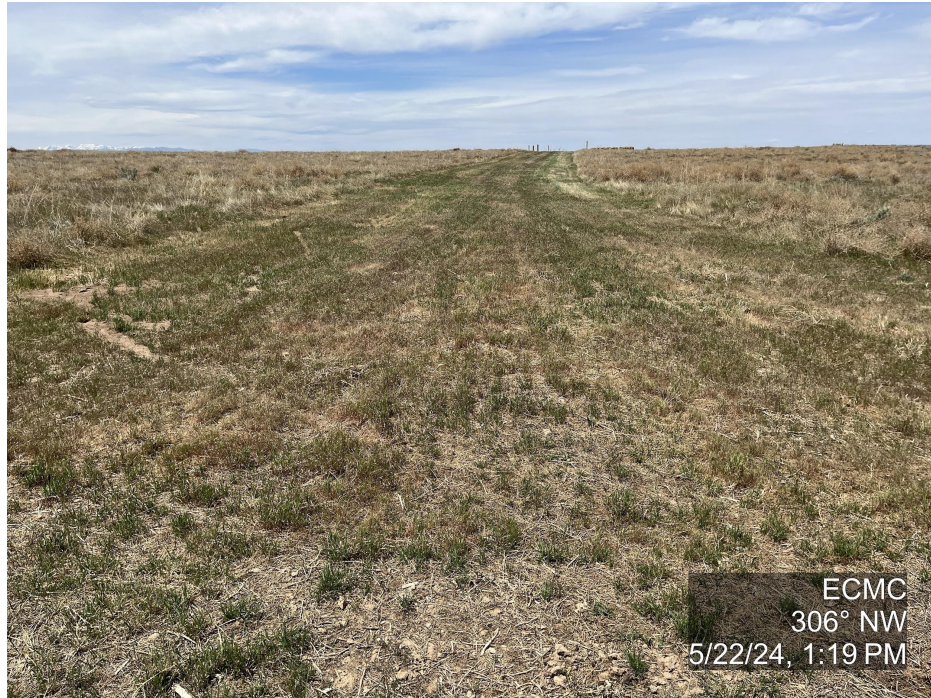
Photo 1. The photo was taken at the entrance to the well location facing Northwest. The photo illustrates the access road is vegetated and mowed but is dominated by cheatgrass.

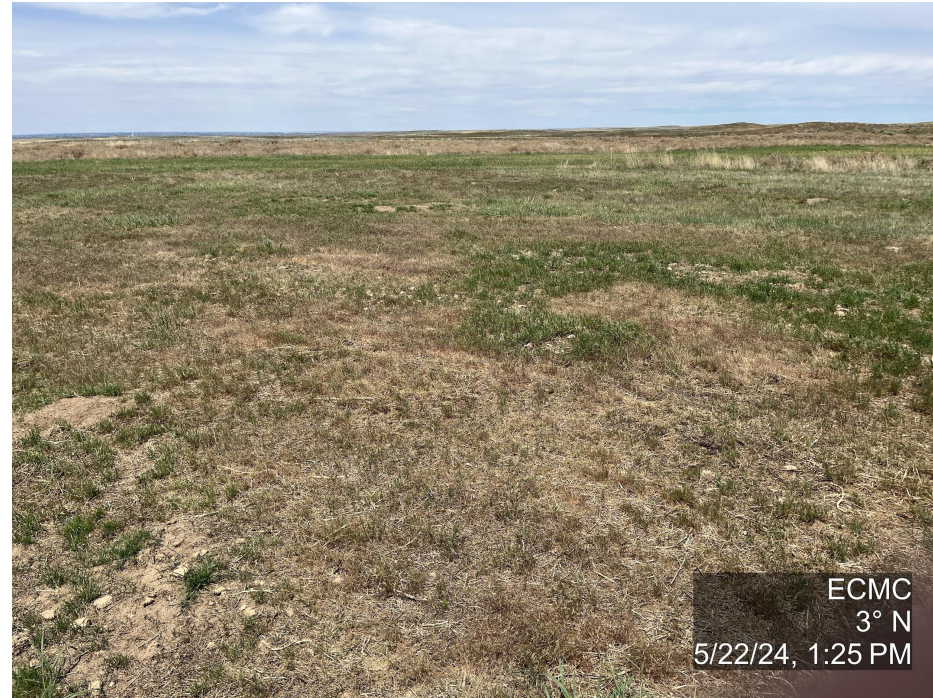
Photo 2. The photo was taken at the well location facing North. The photo illustrates the location has been seeded at some point and mowed but is dominated by cheatgrass.

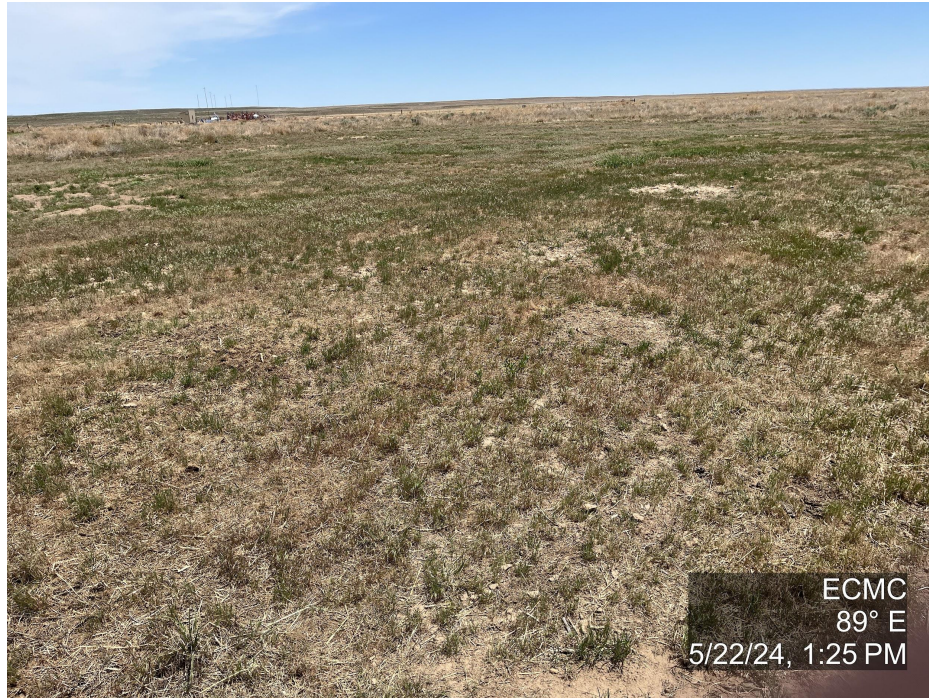
Photo 3. The photo was taken at the well location facing East. Refer to the comment for photo 2.

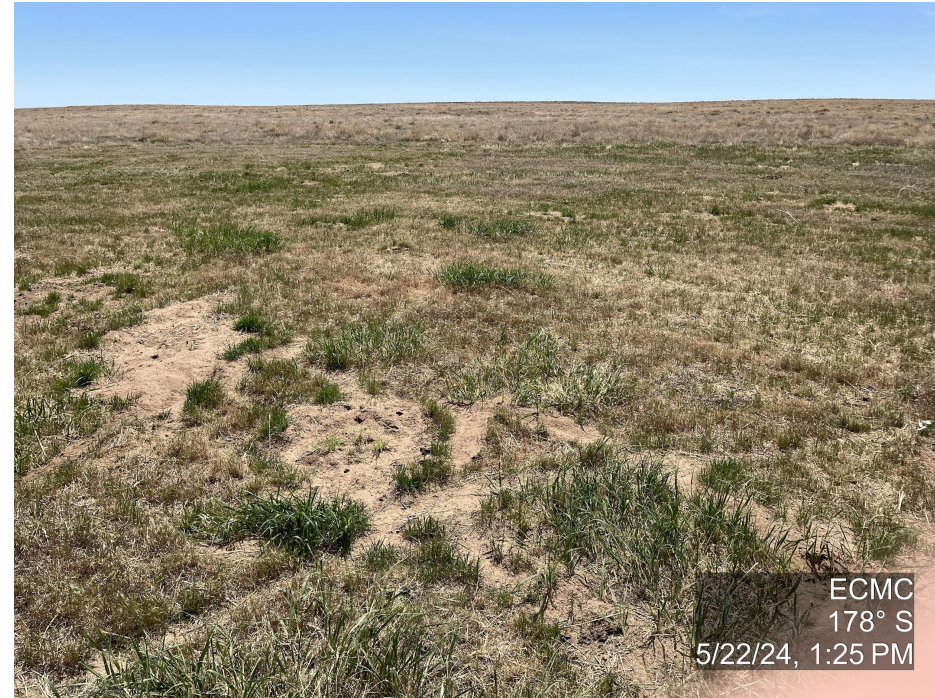
Photo 4. The photo was taken at the well location facing South. Refer to the comment for photo 2.

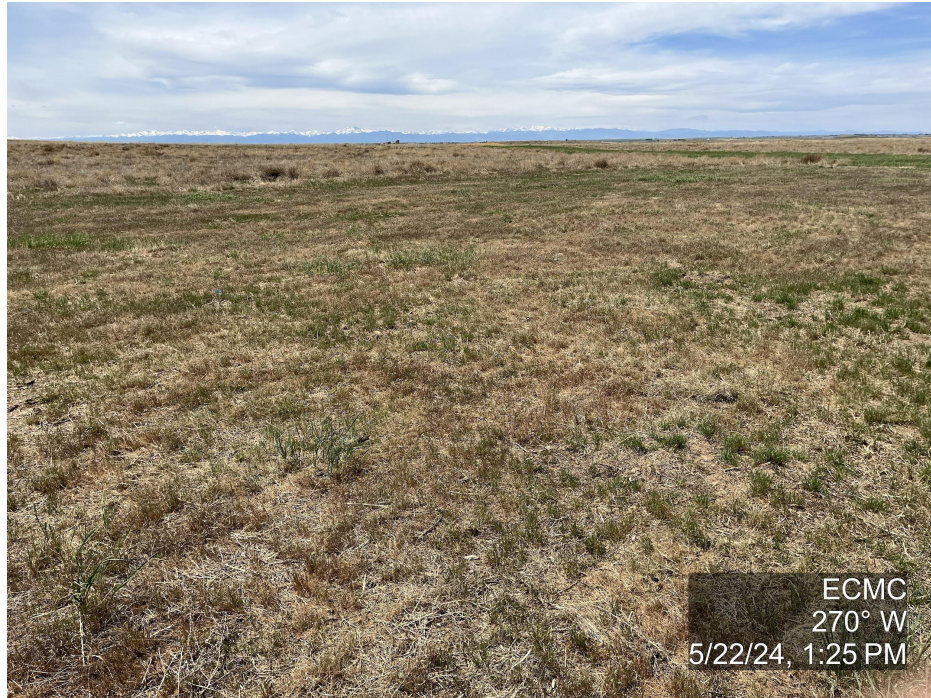
Photo 5. The photo was taken at the well location facing West. Refer to the comment for photo 2.

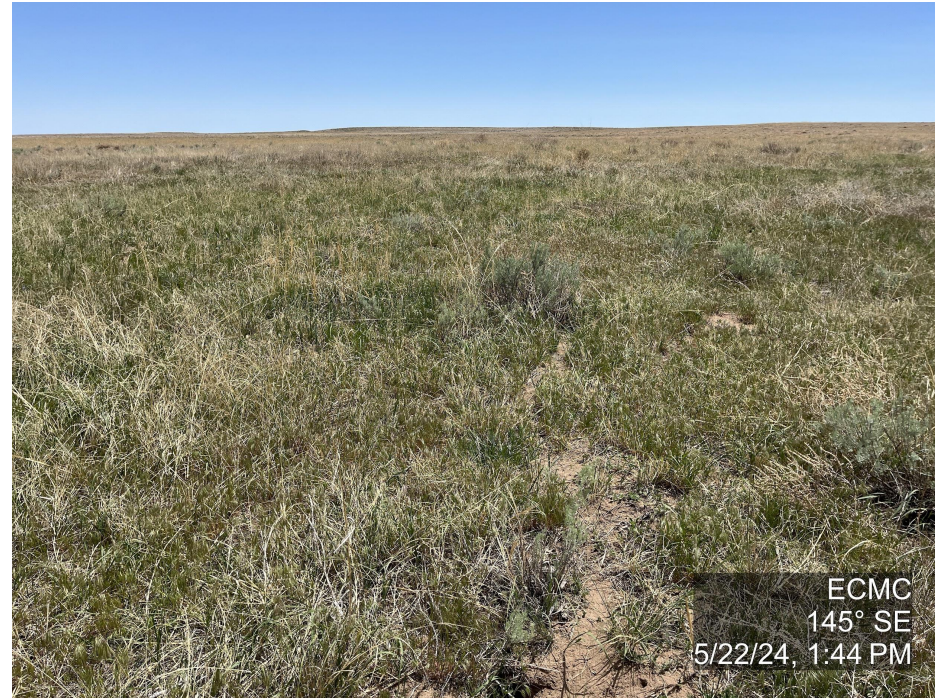
Photo 6. The reference photo was taken near the well location facing Southeast. The photo illustrates that reference areas are dominated by bluestem, yucca, sand dropseed, sand sagebrush, etc..
