## Attachment B

<b>SITE NAME:</b> Bunn M 1-34 Wellhead							<b>DATE:</b> 3/7/2024	<b>REM. PROJECT #:</b> 32673	<b>WEATHER:</b> 40s overcast		
<b>SITE DIRECTIONS:</b> F street and N 59th Ave, NE 1 mile, then N into site							<b>CLIENT:</b> PDC				
<b>LEGALS AND LAT/LONG:</b> 40.441871, -104.757396							<b>TASMAN PERSONNEL:</b> JH				
<b>SOIL TYPES:</b> Well Graded Sand - SW							<b>SURFACE GRADIENT:</b> Southwest				
<b>SOIL SAMPLING</b>							<b>FACILITY INFRASTRUCTURE</b>				
Date/Time	Soil Sample ID	PID (ppm)	Visual	Olfactory	Photo?	Grab or Lab Sample?	EQUIPMENT		Quantity		
							Above Ground Storage Tank (AST)				
3/7/2024 10:30	WHS01-E @ 0-6"	0.0	No Staining	No Odor	Yes	Grab	Buried or Partially Buried Vessel				
3/7/2024 10:35	WHS01-S @ 0-6"	0.0	No Staining	No Odor	Yes	Grab	Separator				
3/7/2024 11:50	WHS01-N @ 0-6"	0.1	No Staining	No Odor	Yes	Grab	Emission Control Device (ECD)				
3/7/2024 11:55	WHS01-W @ 0-6"	0.1	No Staining	No Odor	Yes	Grab	Dump Line

## FLOWLINE ABANDONMENT FORM

<b>SITE NAME:</b> Bunn M 1-34							<b>DATE:</b> 3/8/2024	<b>REM. PROJECT #:</b> 32673	<b>WEATHER:</b> Cloudy/Snow 50s		
<b>SITE DIRECTIONS:</b> 59th ave/F ST: E on F(0.858mi); north onto th

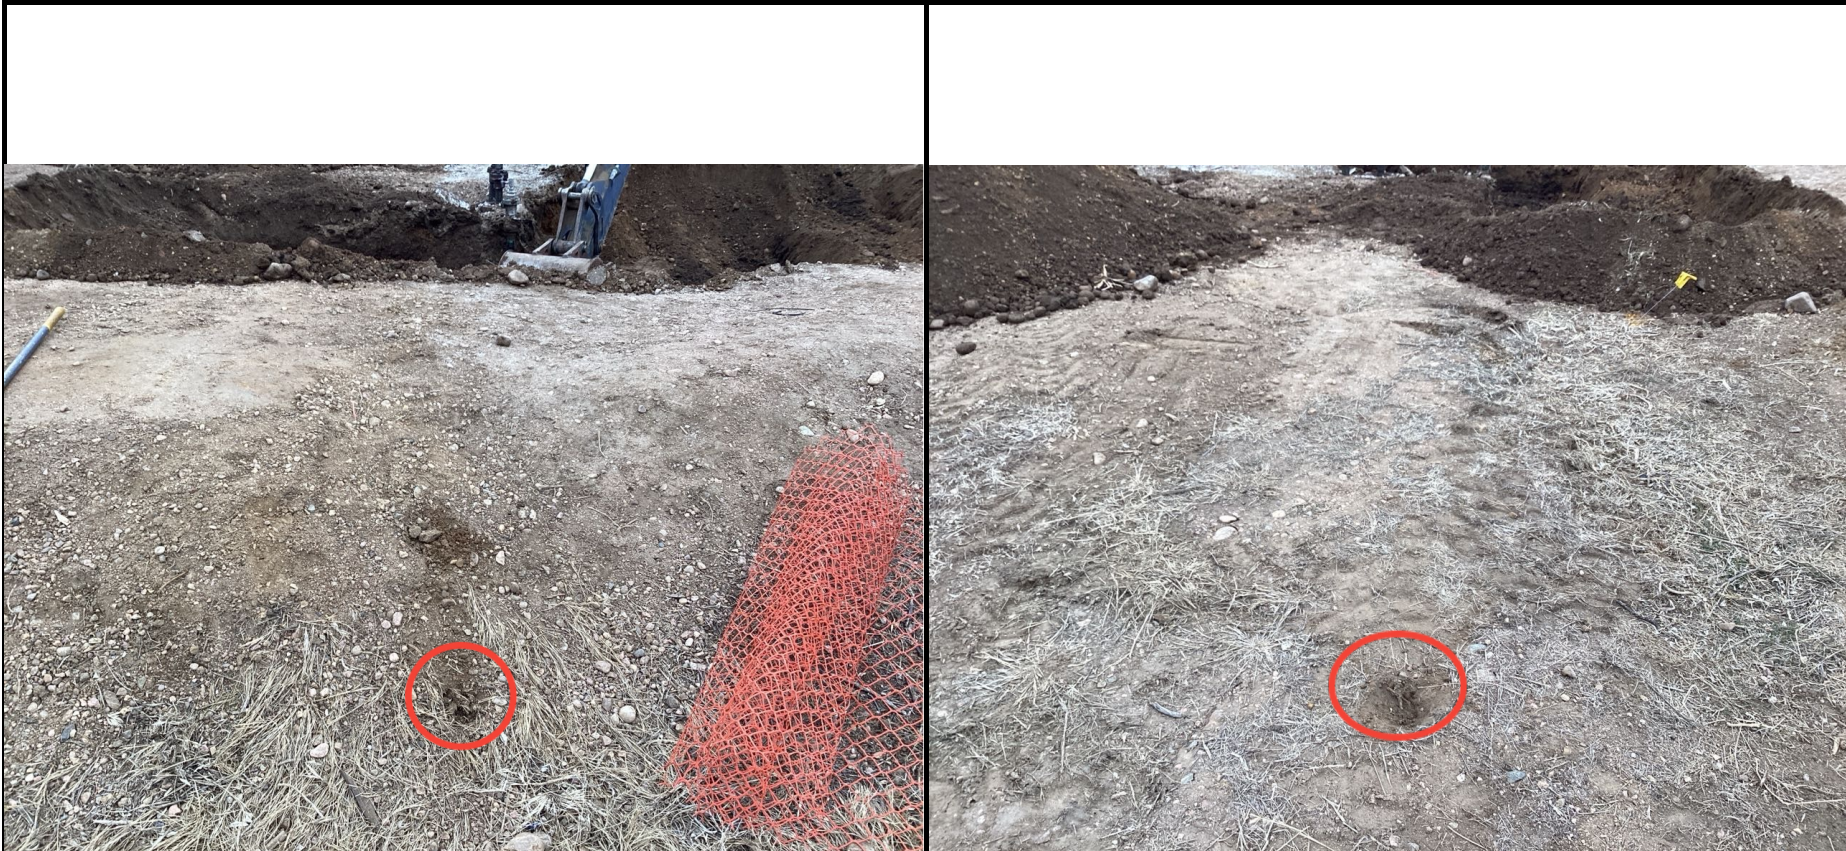
**Notes/Conditions:** WHS01-E @ 0-6"

**Notes/Conditions:** WHS01-S @ 0-6"

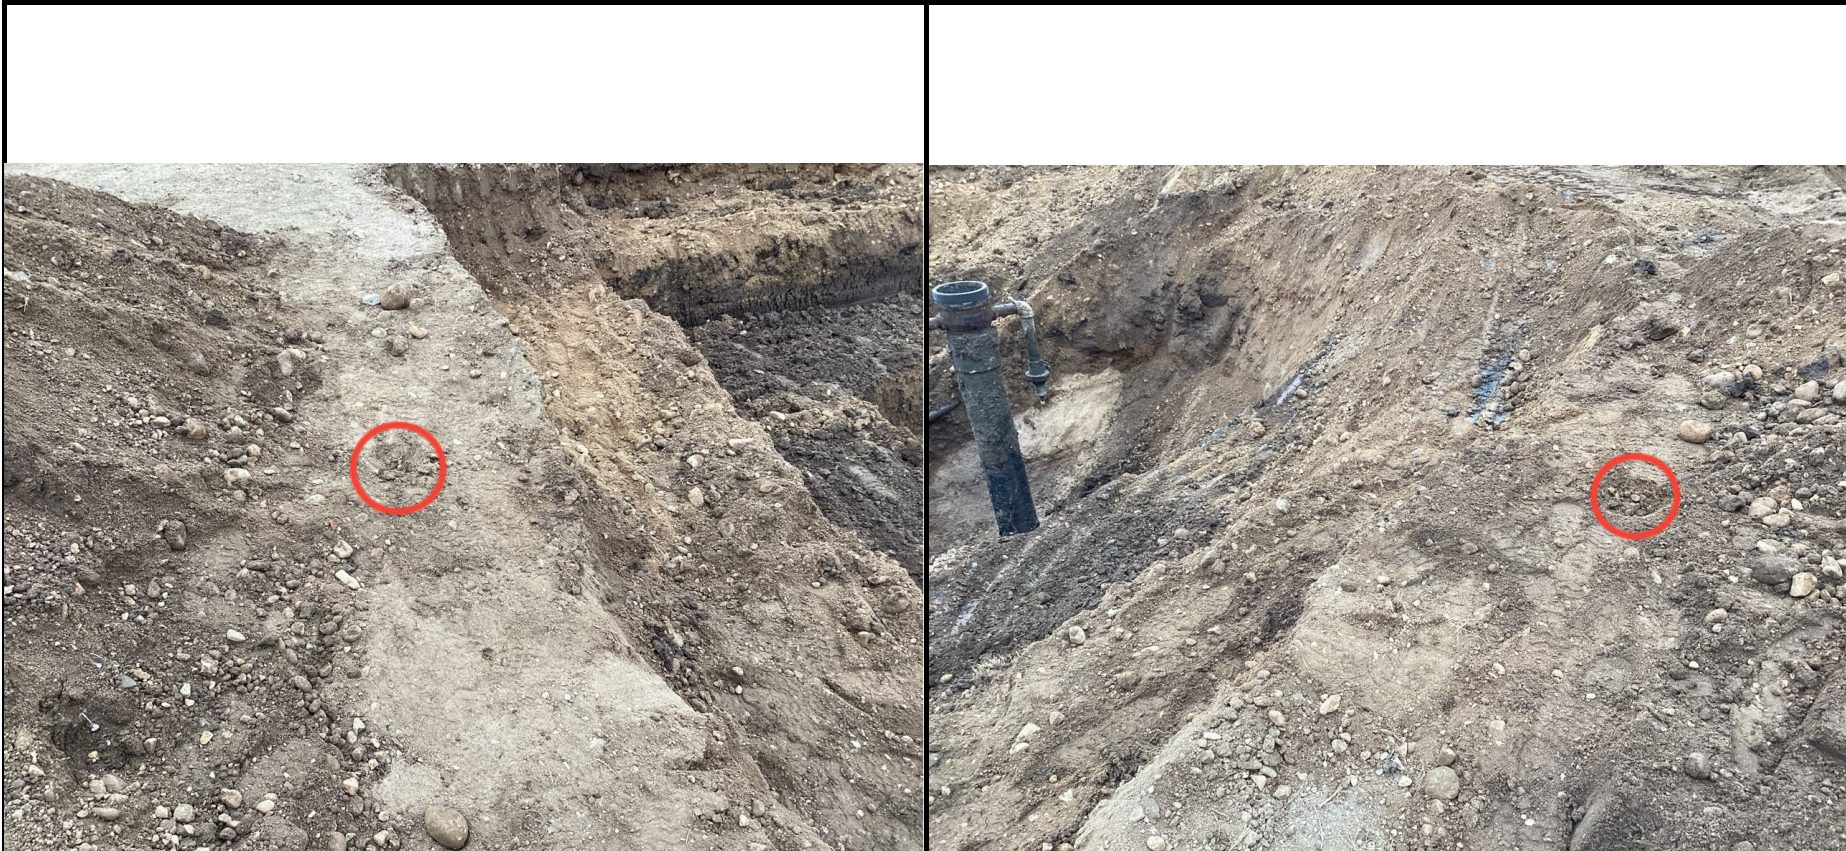
**Notes/Conditions:** WHS01-N @ 0-6"

**Notes/Conditions:** WHS01-W @ 0-6"

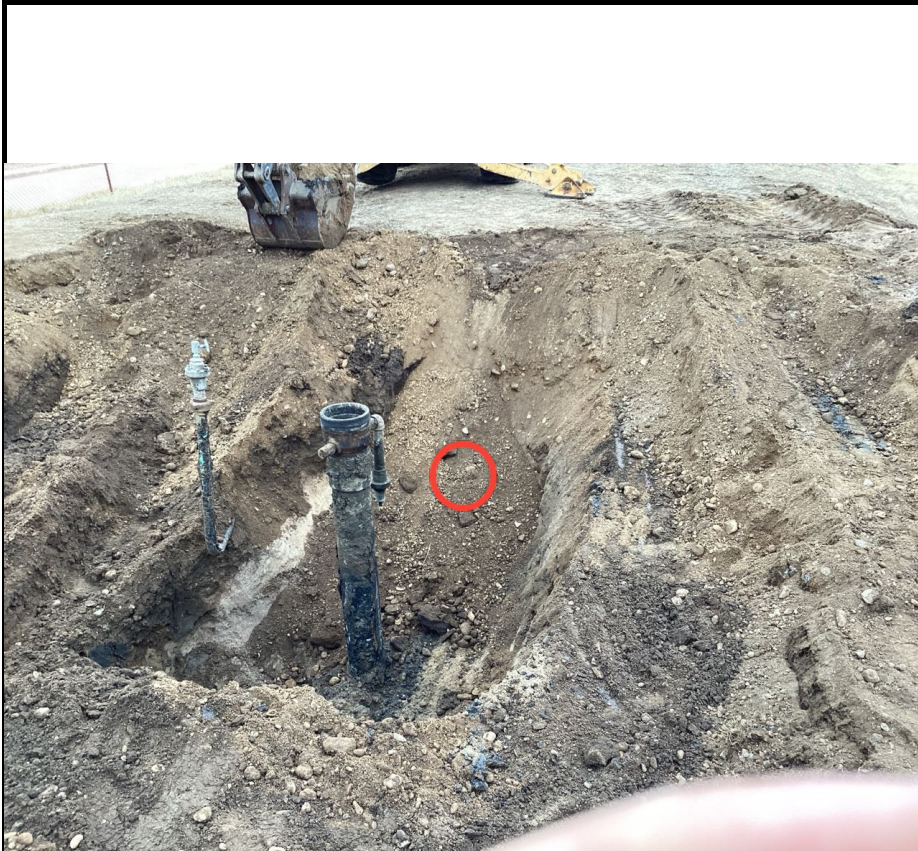
<b>Equipment ID:</b>		<b>Equipment Type:</b>	
<b>Material:</b>	<b>Volume:</b>	<b>Contents:</b>	
<b>Notes/Conditions:</b> WH01-S @ 4'

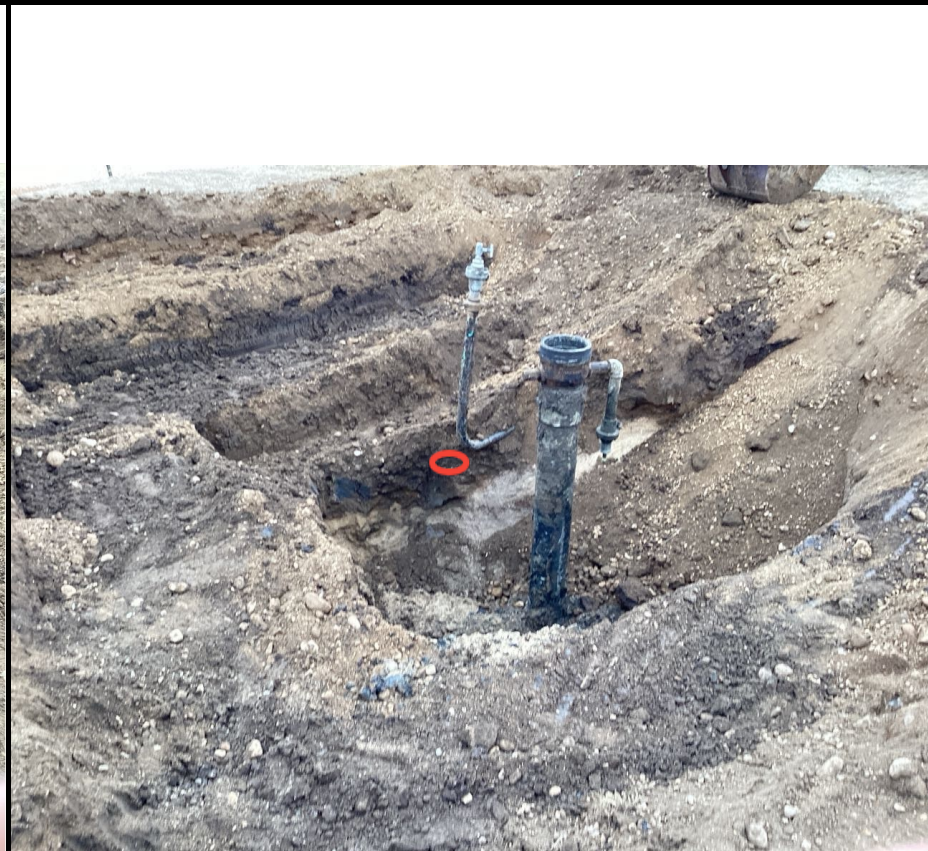
<b>Equipment ID:</b>		<b>Equipment Type:</b>	
<b>Material:</b>	<b>Volume:</b>	<b>Contents:</b>	
<b>Notes/Conditions:</b> WH01-E @ 4'

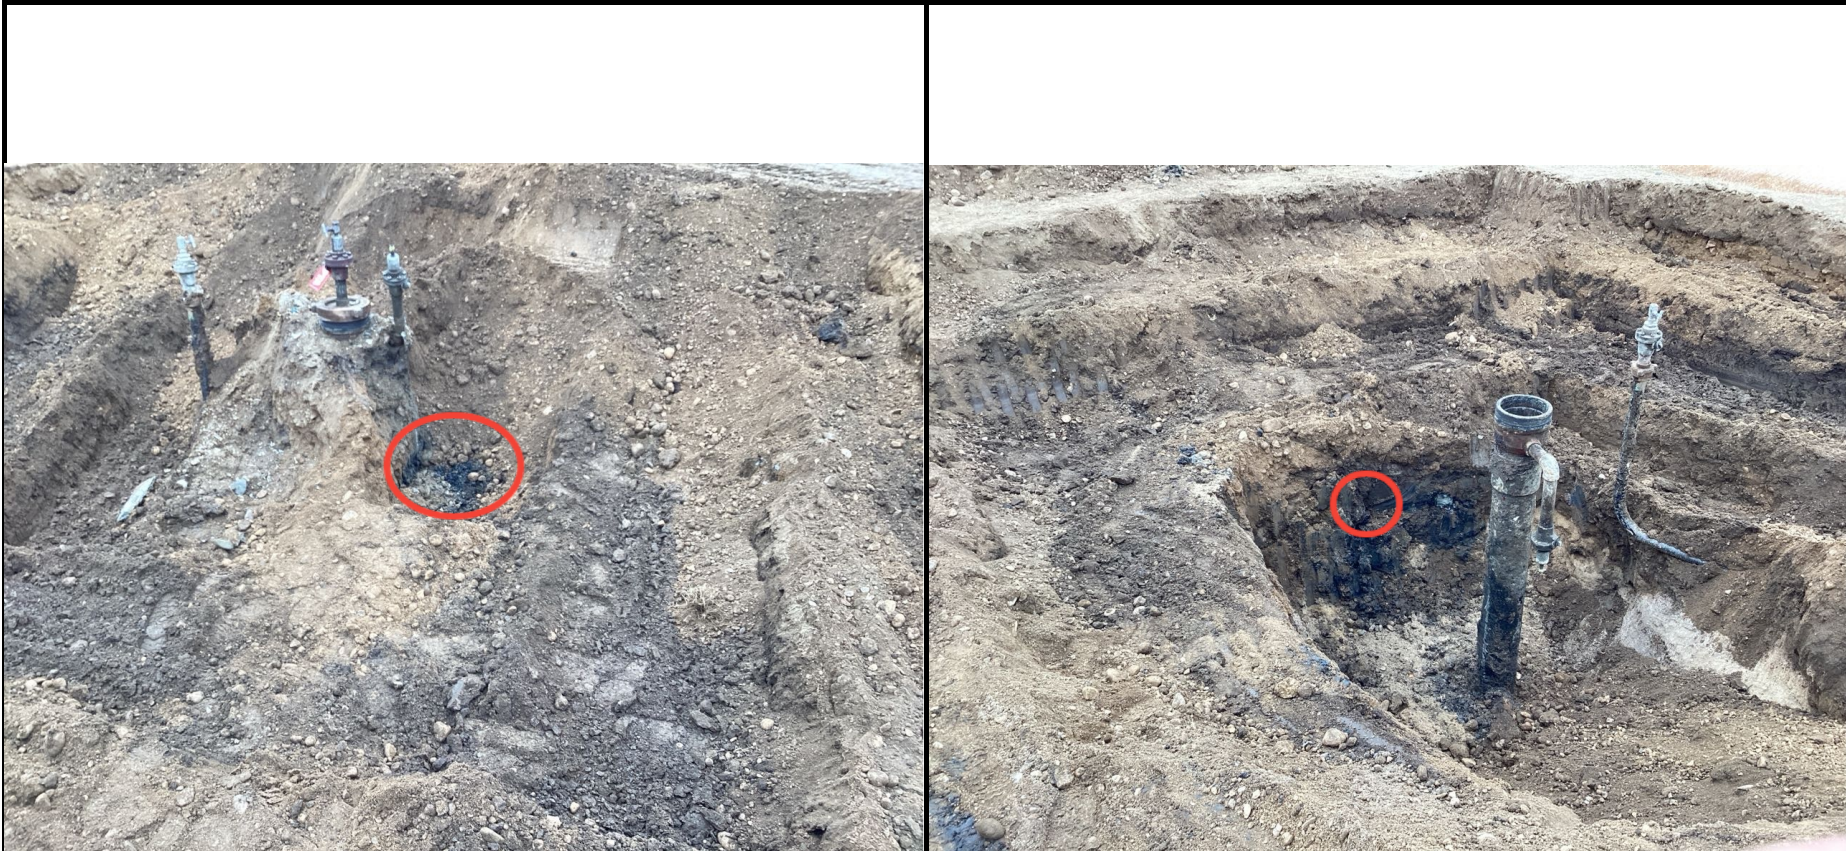
<b>Equipment ID:</b>		<b>Equipment Type:</b>		<b>Equipment ID:</b>		<b>Equipment Type:</b>	
<b>Material:</b>	<b>Volume:</b>	<b>Contents:</b>		<b>Material:</b>	<b>Volume:</b>	<b>Contents:</b>	
<b>Notes/Conditions:</b> WC01 @ 4'				<b>Notes/Conditions:</b> WH01-N @ 4'

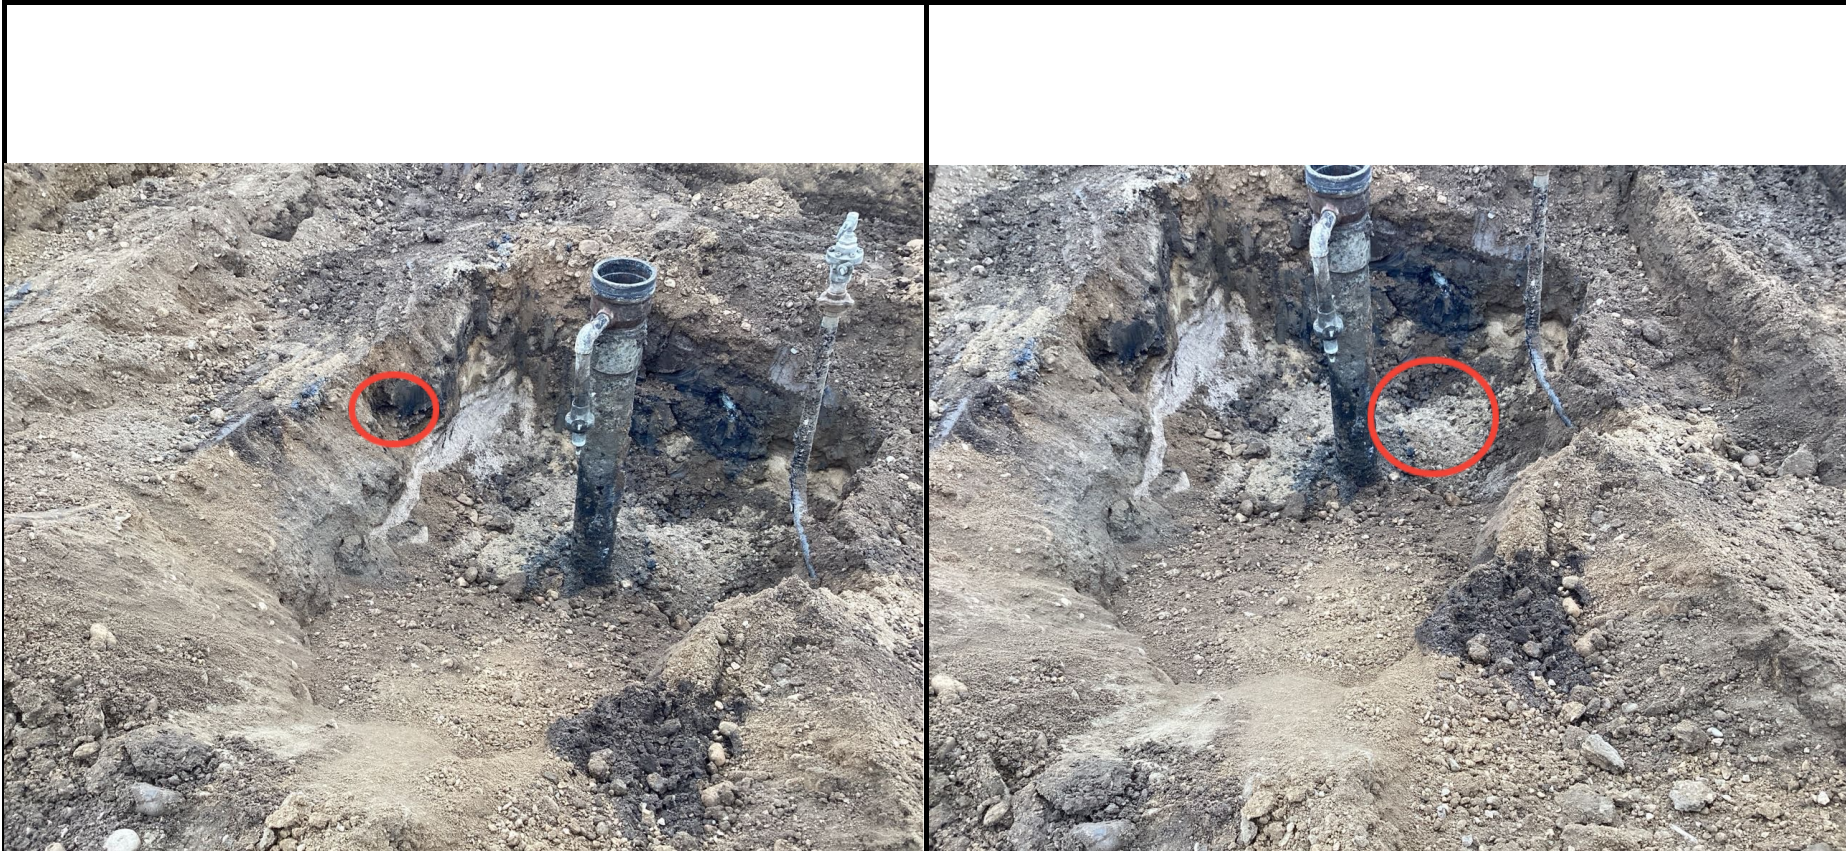
**Notes/Conditions:** WH01-W @ 4'

**Notes/Conditions:** WH01-B @ 6'

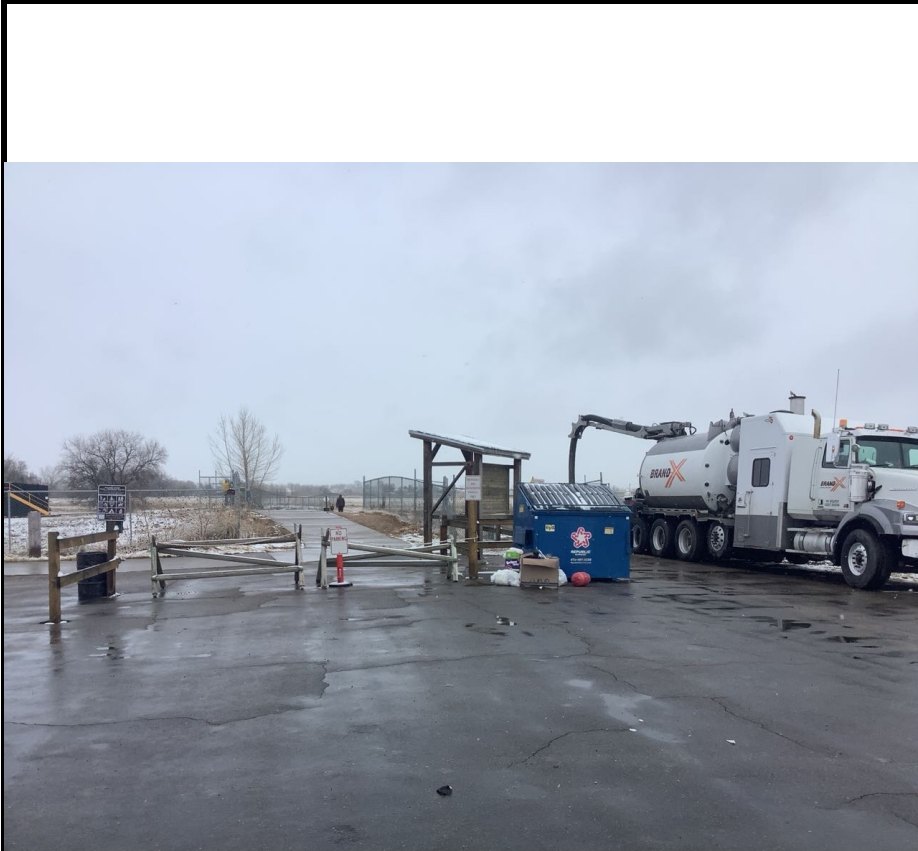
<b>Equipment ID:</b>		<b>Equipment Type:</b>	
<b>Material:</b>	<b>Volume:</b>	<b>Contents:</b>	
<b>Notes/Conditions:</b> Site photo facing north

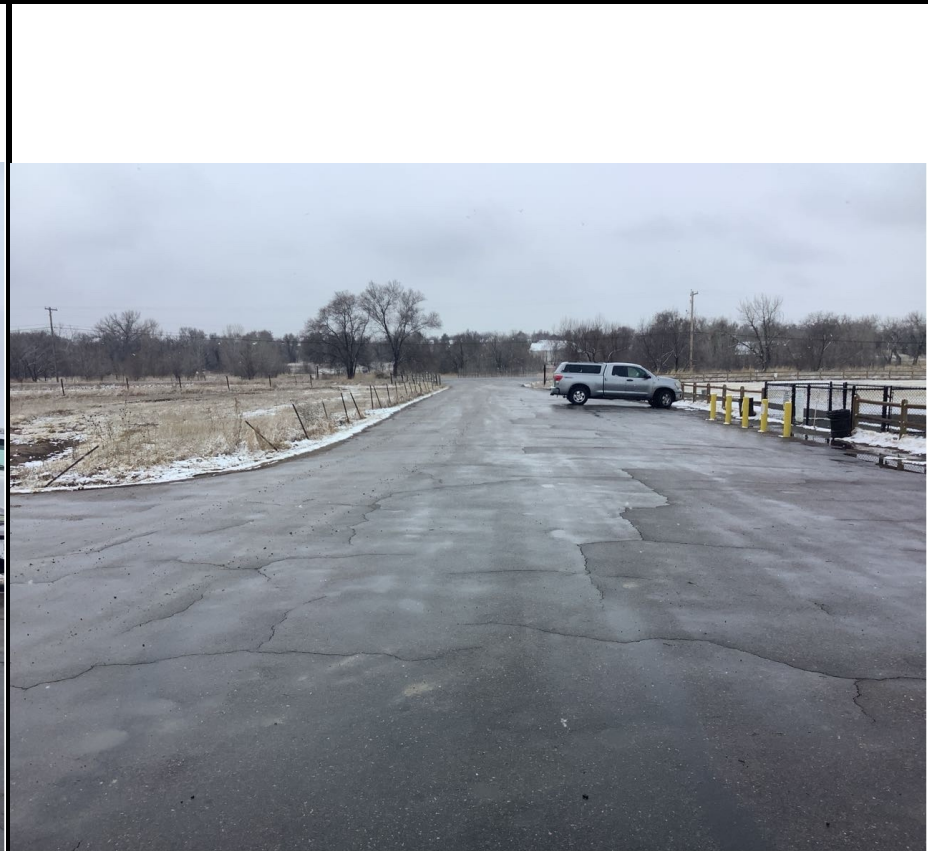
<b>Equipment ID:</b>		<b>Equipment Type:</b>	
<b>Material:</b>	<b>Volume:</b>	<b>Contents:</b>	
<b>Notes/Conditions:</b> Site photo facing south

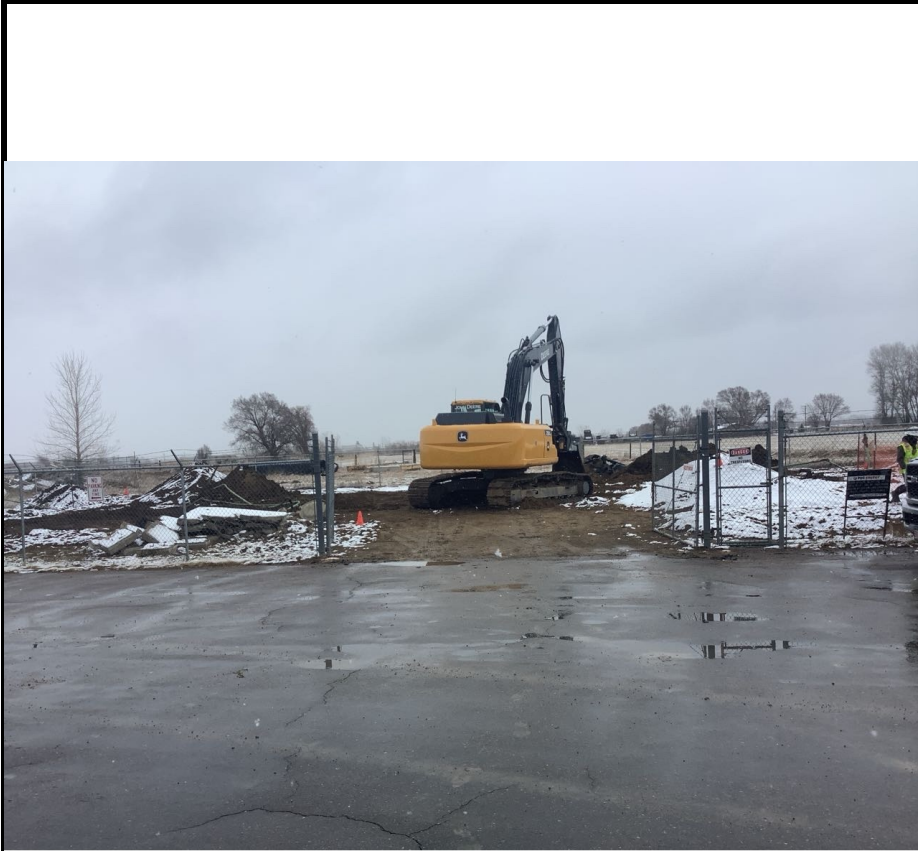
<b>Equipment ID:</b>		<b>Equipment Type:</b>	
<b>Material:</b>	<b>Volume:</b>	<b>Contents:</b>	
<b>Notes/Conditions:</b> Site photo facing east

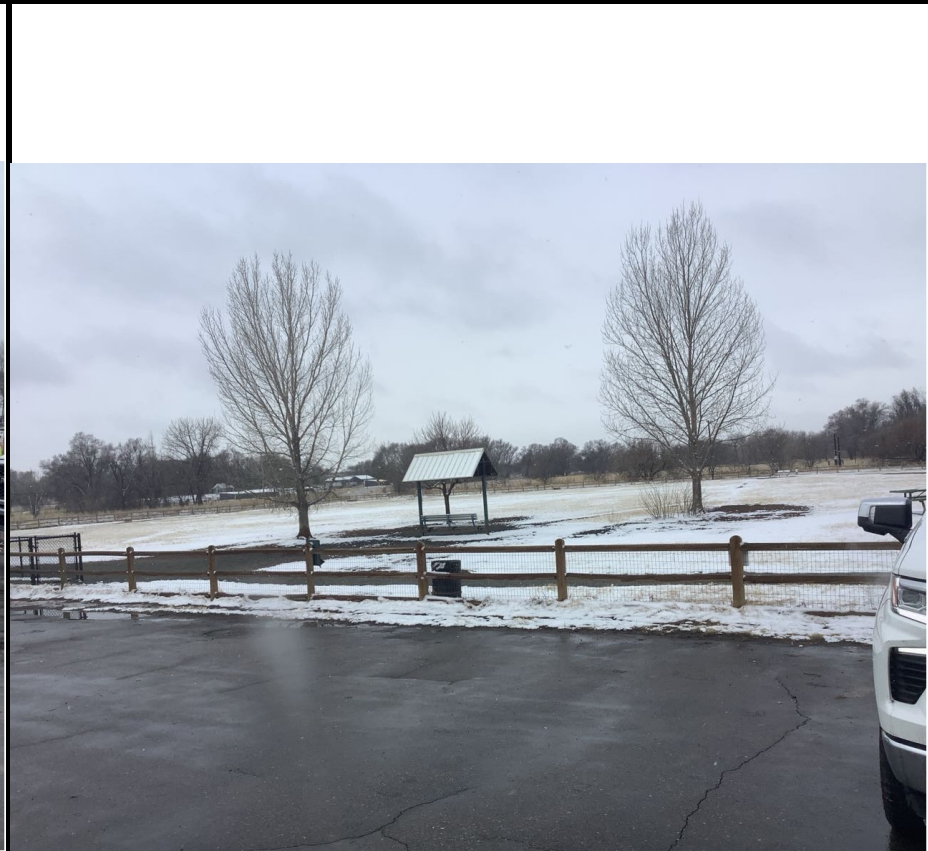
<b>Equipment ID:</b>		<b>Equipment Type:</b>	
<b>Material:</b>	<b>Volume:</b>	<b>Contents:</b>	
<b>Notes/Conditions:</b> Site photo facing west

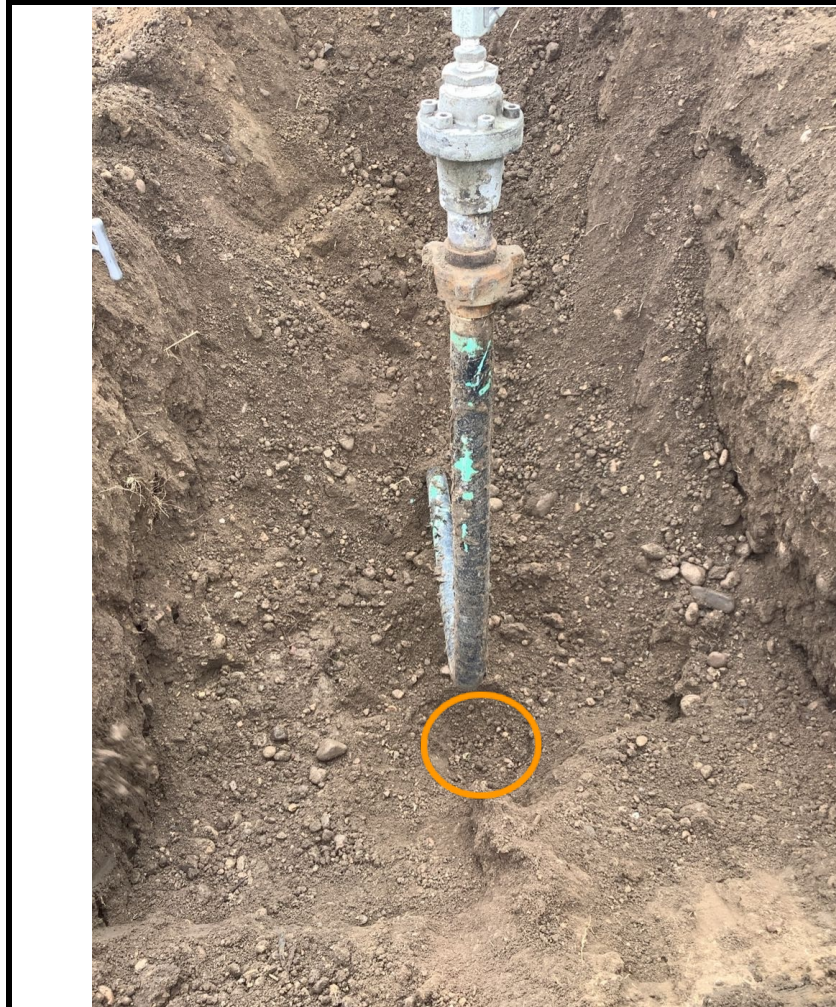
<b>Equipment ID:</b> FL01-01 @4'	<b>Equipment Type:</b> Flowline	
<b>Material:</b> Steel	<b>Volume:</b>	<b>Contents:</b> Oil/Gas/Water
<b>Notes/Conditions:</b> Sample was taken by the backhoe

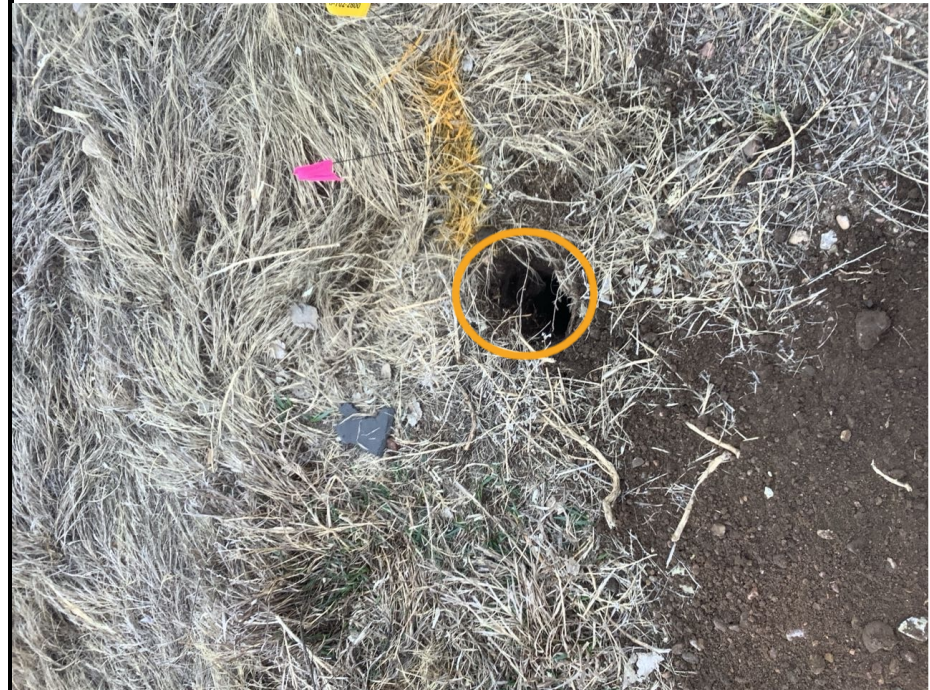
<b>Equipment ID:</b> FL01-02 @4'	<b>Equipment Type:</b> Flowline	
<b>Material:</b> Steel	<b>Volume:</b>	<b>Contents:</b> Oil/Gas/Water
<b>Notes/Conditions:</b> Sample was taken with the hand auger after the line was pulled

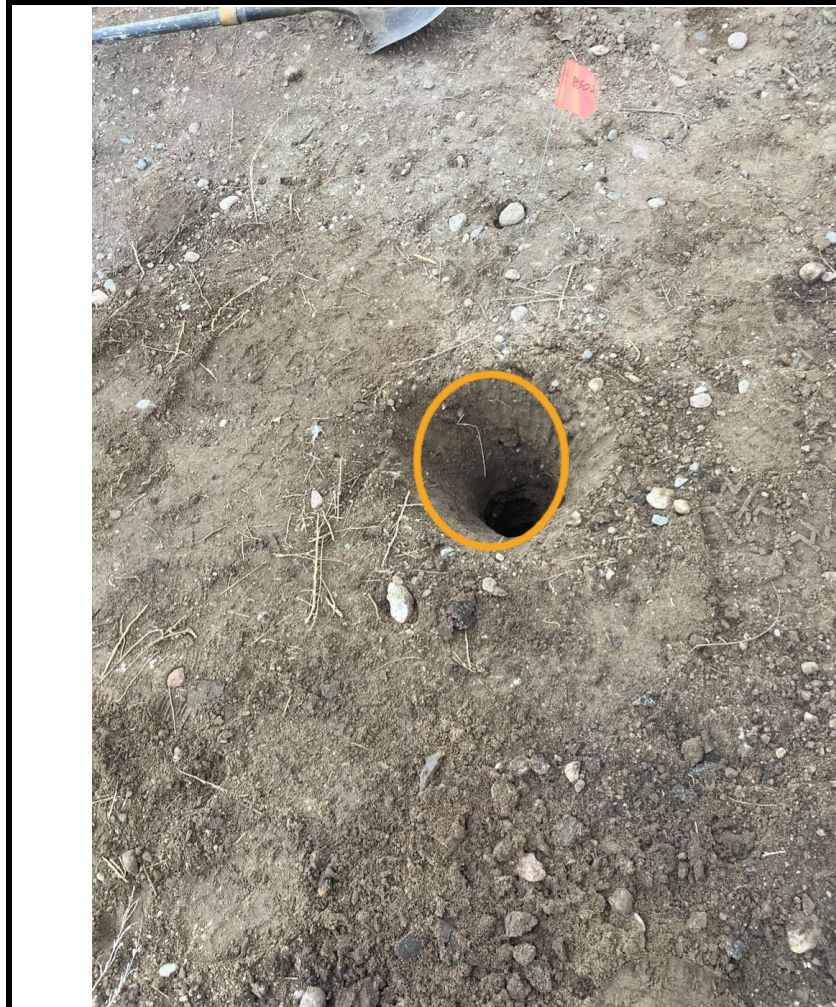
<b>Equipment ID:</b> FL01-03@4'	<b>Equipment Type:</b> Flowline	
<b>Material:</b> Steel	<b>Volume:</b>	<b>Contents:</b> Oil/Gas/Water
<b>Notes/Conditions:</b> Sample taken with the hand auger after the line was pulled

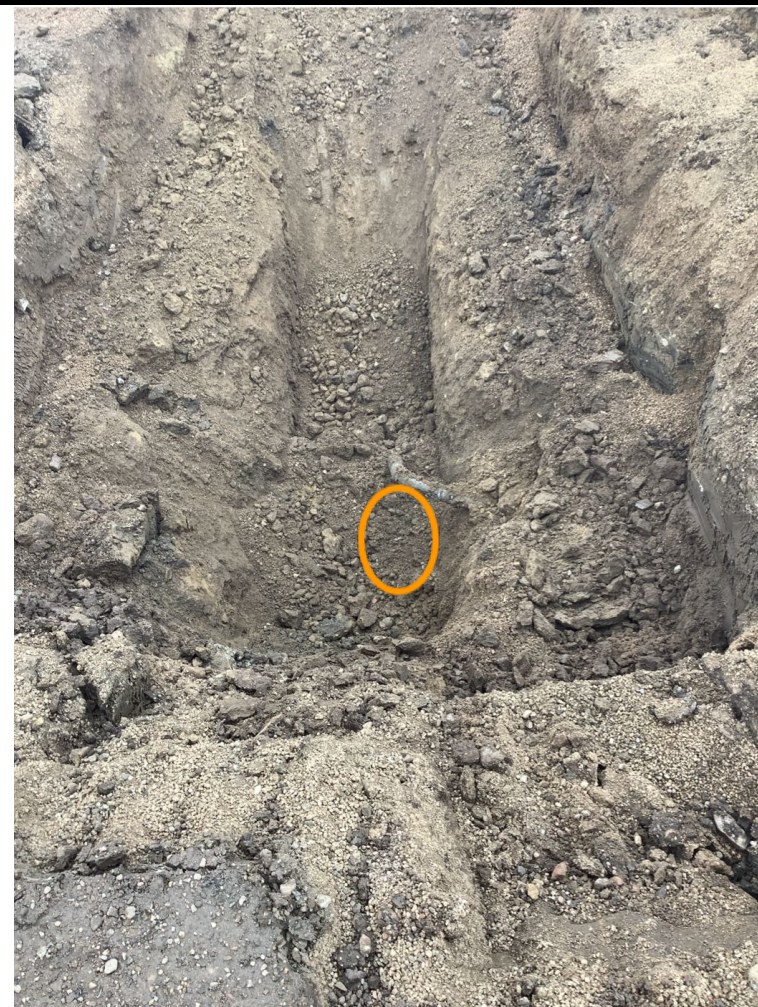
<b>Equipment ID:</b> FL01-04@5'	<b>Equipment Type:</b> Flowline	
<b>Material:</b> Steel	<b>Volume:</b>	<b>Contents:</b> Oil/Gas/Water
<b>Notes/Conditions:</b> Sample was taken with the backhoe

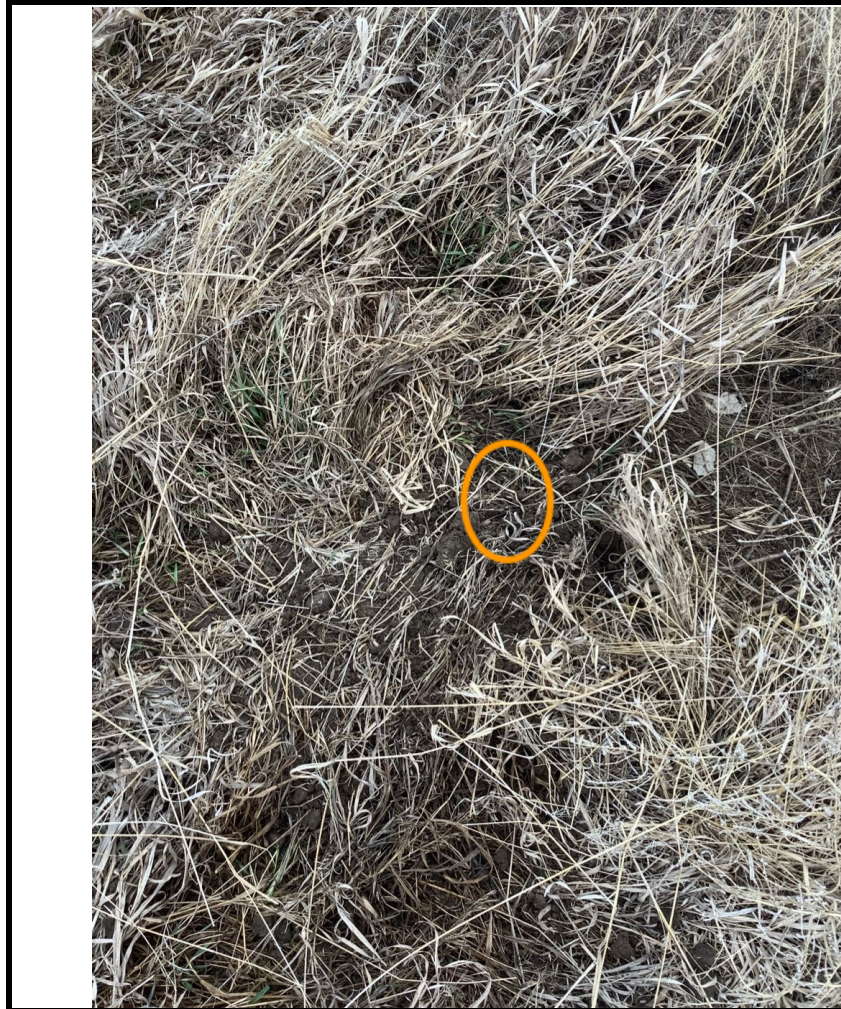
<b>Equipment ID:</b> FL01-05 @ 4'		<b>Equipment Type:</b> Flowline		<b>Equipment ID:</b>		<b>Equipment Type:</b>	
<b>Material:</b> Steel		<b>Volume:</b>		<b>Material:</b>		<b>Volume:</b>	
<b>Contents:</b> Oil/Gas/Water		<b>Notes/Conditions:</b> Sample taken with the hand auger After the line was pulled		<b>Material:</b>		<b>Volume:</b>	
<b>Notes/Conditions:</b>				<b>Material:</b>		<b>Volume:</b>

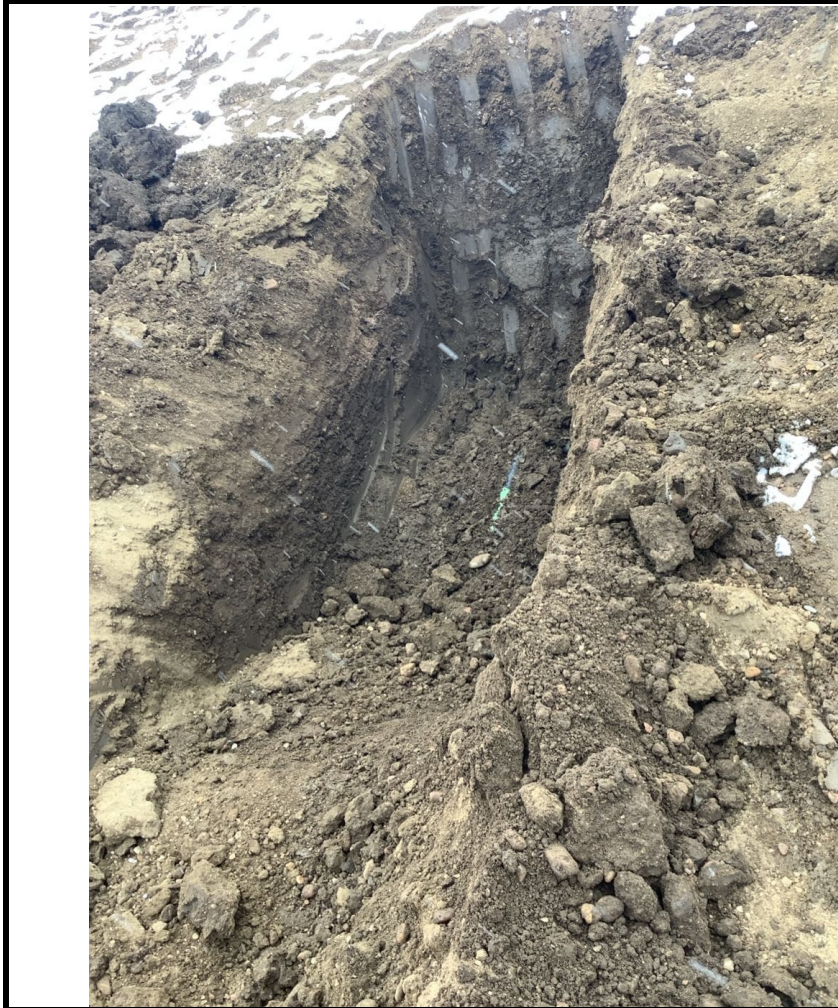
<b>Equipment ID:</b> DL01-01	<b>Equipment Type:</b> Dump Line	
<b>Material:</b> Steel	<b>Volume:</b>	<b>Contents:</b> Oil/Gas/Water
<b>Notes/Conditions:</b> DL01-01 before sample was taken from the 90degree turn

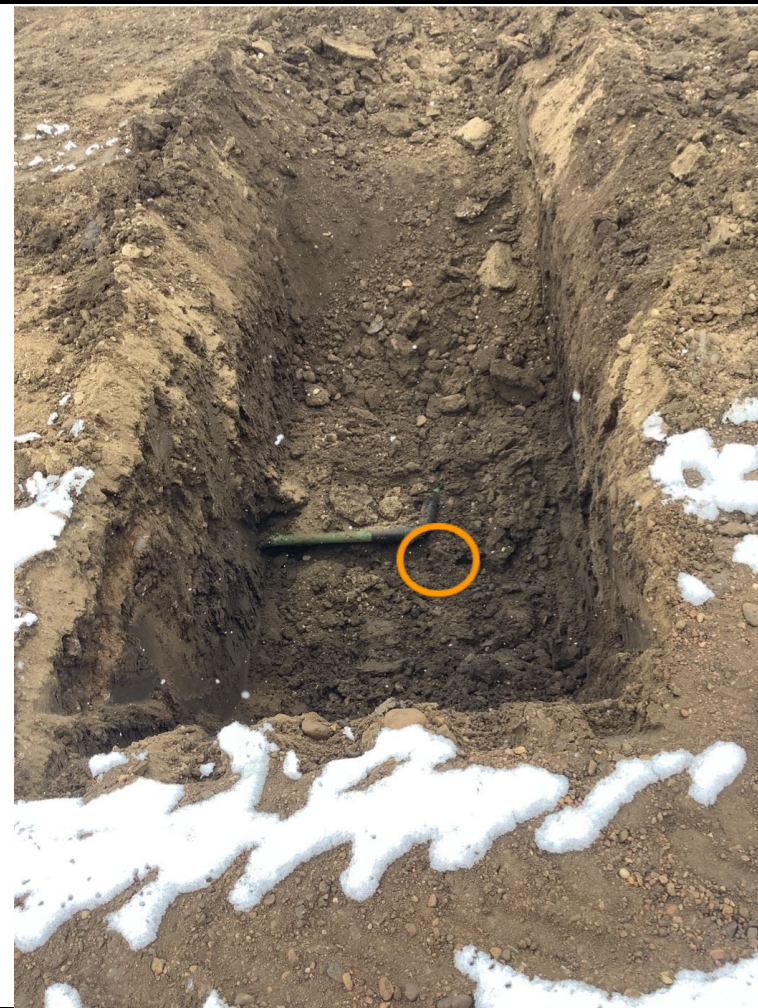
<b>Equipment ID:</b> DL01-01	<b>Equipment Type:</b> Dump Line	
<b>Material:</b> Steel	<b>Volume:</b>	<b>Contents:</b> Oil/Gas/Water
<b>Notes/Conditions:</b> Sample taken from the 90 degree turn from the Separator dump-line heading over to the AST Sample was SM with some moisture but had no signs of staining or HC odor Sample was taken with an excavator

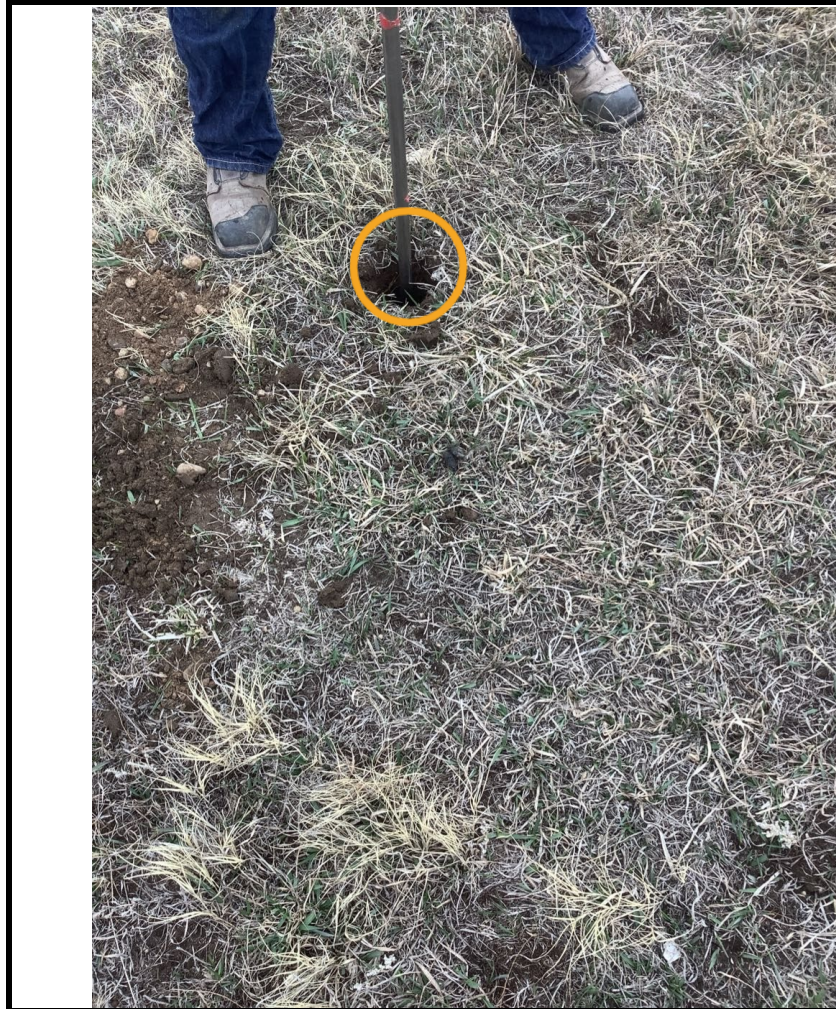
<b>Equipment ID:</b> BKG01		<b>Equipment Type:</b>	
<b>Material:</b>	<b>Volume:</b>	<b>Contents:</b>	
<b>Notes/Conditions:</b> Background sample taken with a hand auger ( ) of the wellhead at the following depths 0.5', 4', 5', and 6'. All samples submitted to the lab for analysis of metals only.

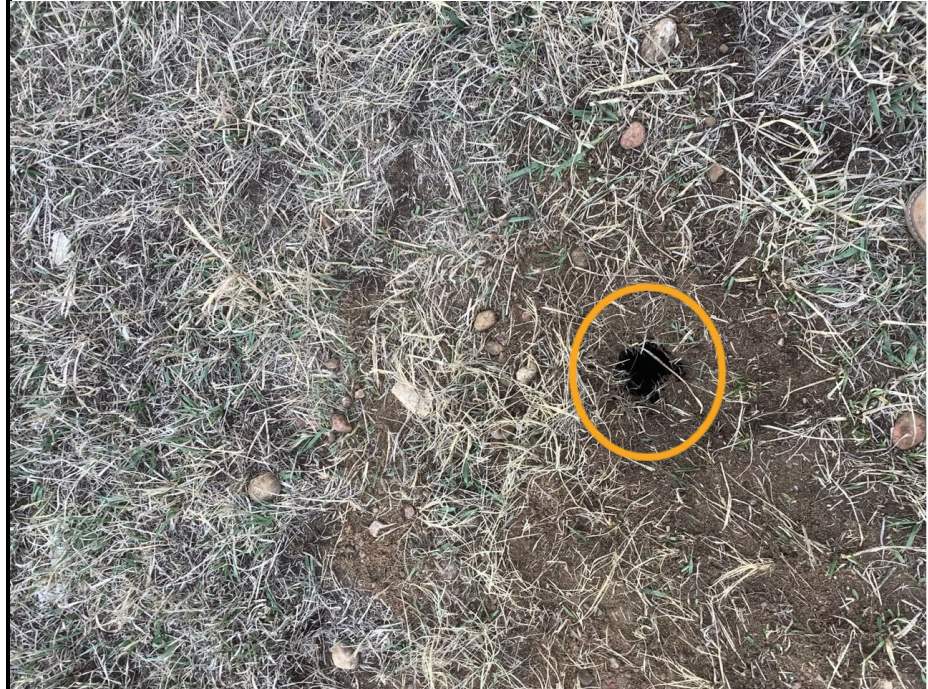
<b>Equipment ID:</b> BKG02		<b>Equipment Type:</b>	
<b>Material:</b>	<b>Volume:</b>	<b>Contents:</b>	
<b>Notes/Conditions:</b> Background sample taken with a hand auger ( ) of the facility pad at the following depths 0.5', 4', 5', and 6'. All samples submitted to the lab for analysis of metals only.
