2023 Big Mountain Viper Reclamation Plan Weld County, Colorado

MARCH 2023

Taproot Rockies Midstream, LLC

SWCA Environmental Consultants

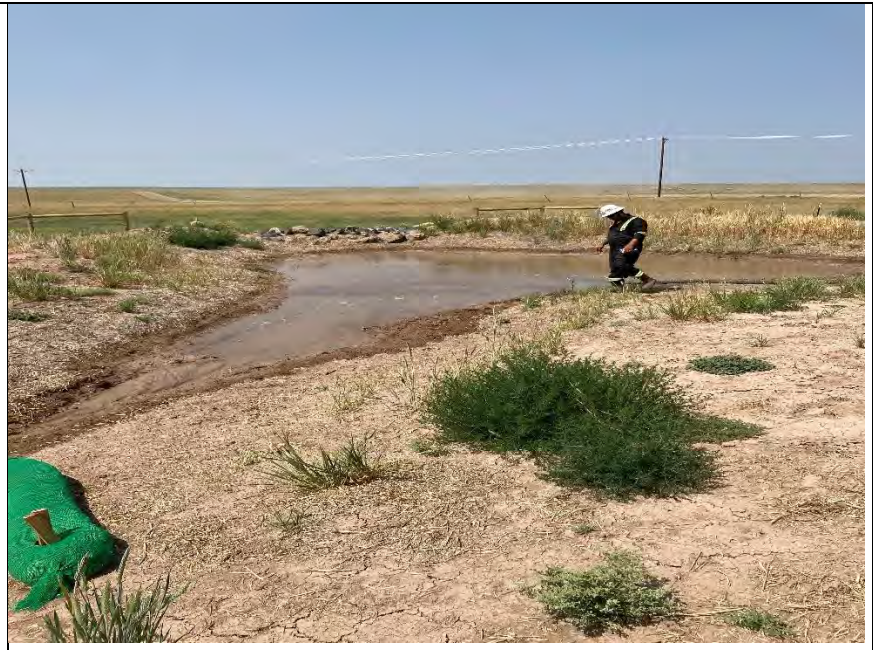
Photo: 3

SW side of property spill retention system.

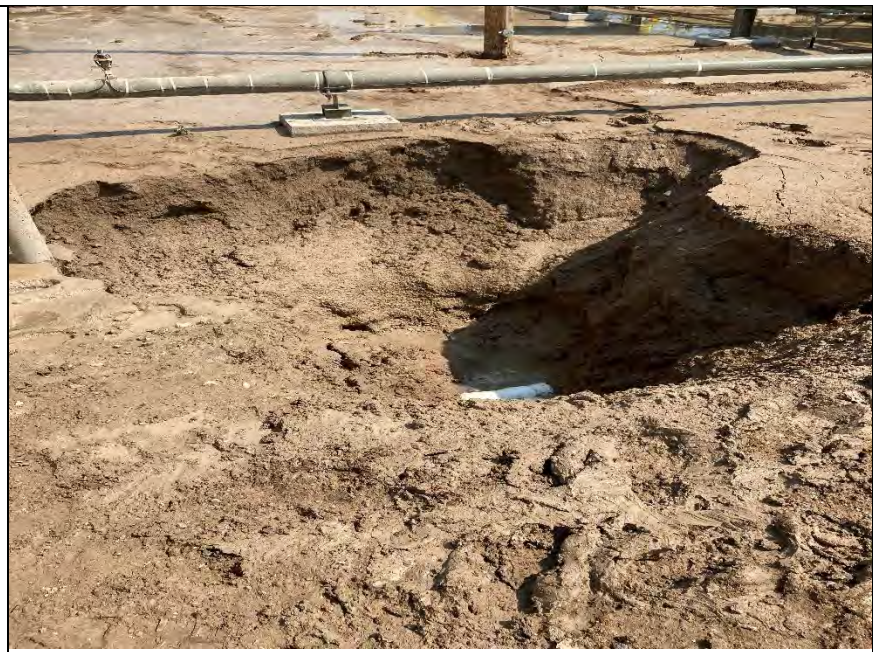
Photo: 4

The operator for the Bison Oil & Gas Big Mountain Viper (BMV) pad called John Beacom at 5:39 AM 7/26/2021 to report a leak. John immediately notified the 24 hour control center to shutdown the produced water system. The BMV pipeline was isolated from the rest of the system and the rest of the system was slowly brought back online. The leak seems to have been contained on the pad, including a spill containment area at the edge of the pad. Clean-up work has begun. Further investigation showed that the BMV produced water LACT unit started up around 10:50 PM on 7/25/2021 and the discharge pressure gradually increased to 600 psig as it normally does. At about 11:01 PM the line pressure rapidly dropped to 70 psig, which indicates this was the start of the leak. The pump ran until 3:12am 7/26/2021 when it shutdown normally. The pump was still down when the leak was discovered at 5:39 AM. Initial exposure of the leak indicates a premature failure in the 4" Shawcor Flexpipe.

Source of produced water release caused by underground pipe failure.

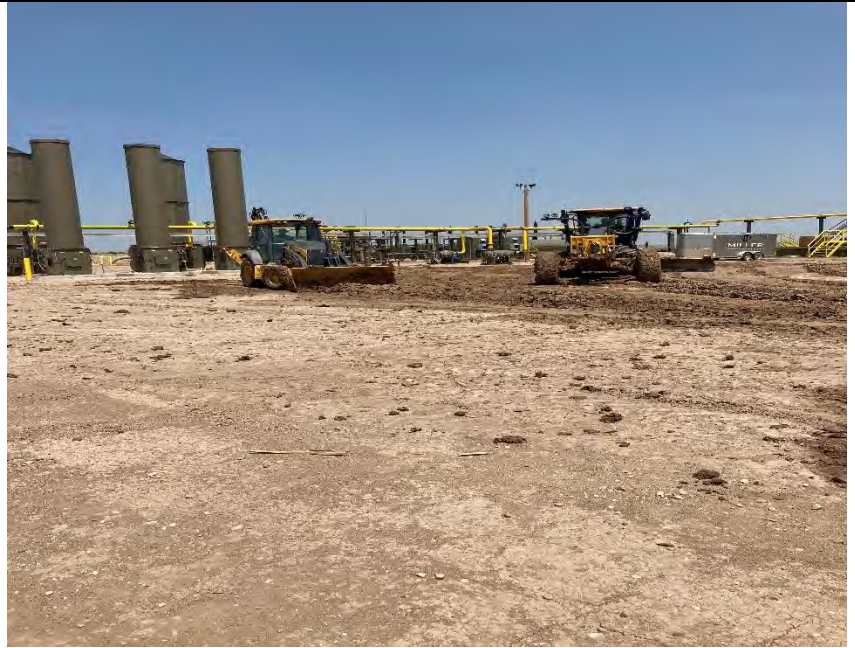
Photo: 5

Performing minor surface
scrape of affected area.

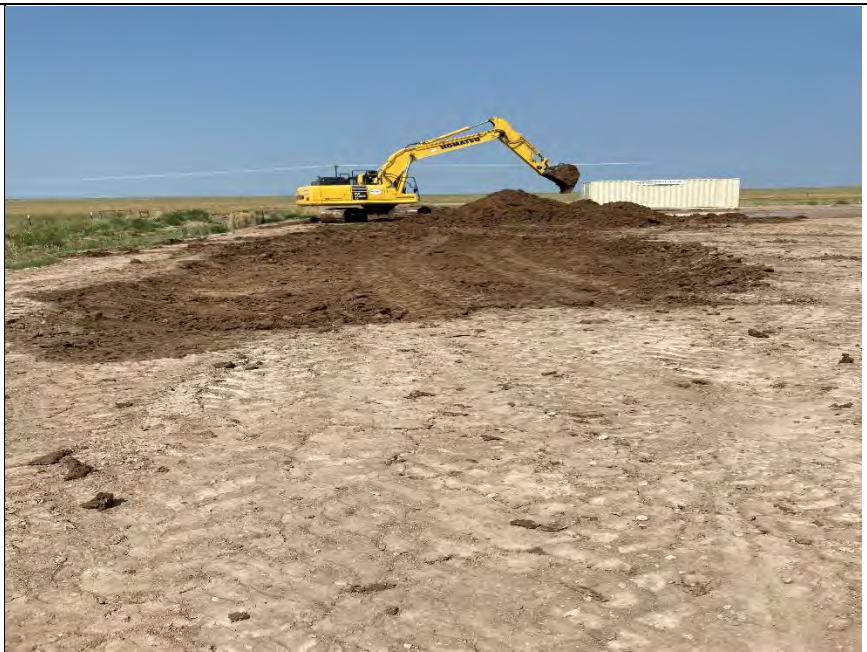
Photo: 6

SW view of surface scrape.

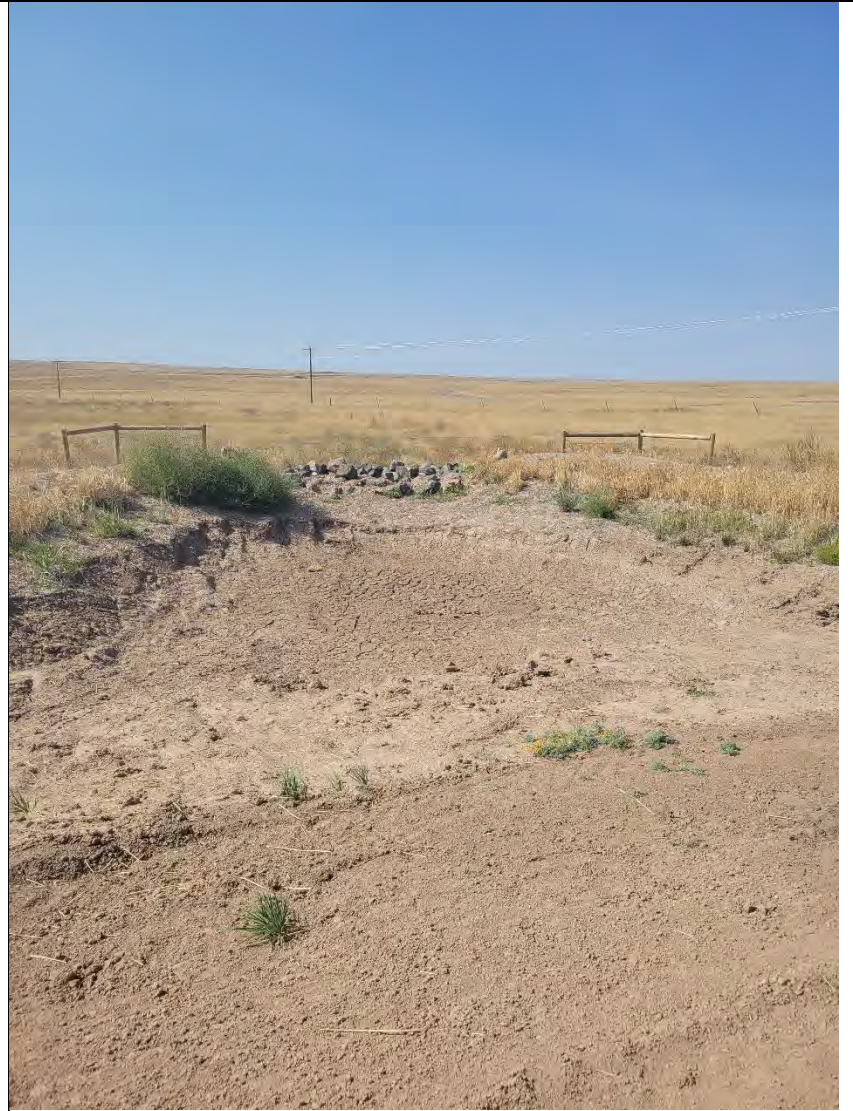
Photo: 7

Retention pond after
excavation

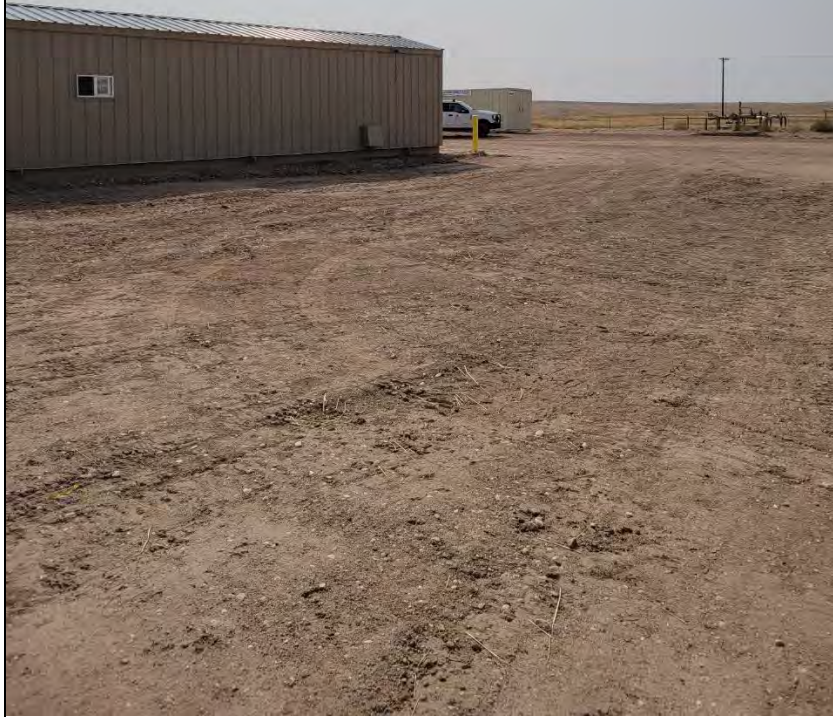
Photo: 8

Shallow excavation in the area north of the LACT units.
