# Final Reclamation and Stormwater Inspection

Operator: Noble Energy Inc - 100322

Location ID: 309878

Inspection Photos  
Location Name: Sledge C 9-28  
Location ID: 309878

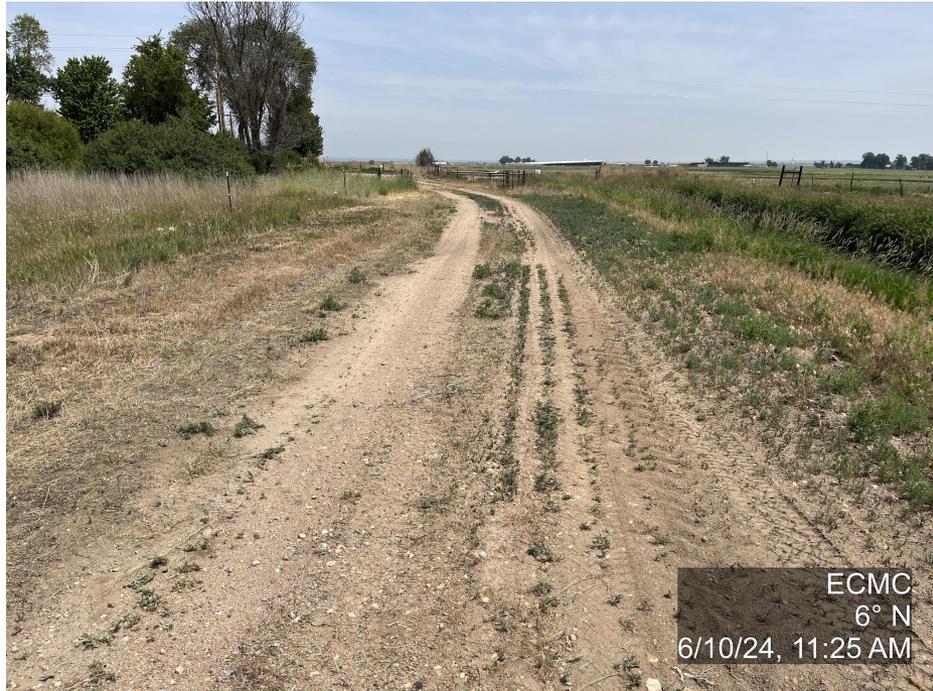
**Photo 1.** The photo was taken at the entrance to the well location facing North. The photo illustrates the historic access road leading up to the entrance to the well location.

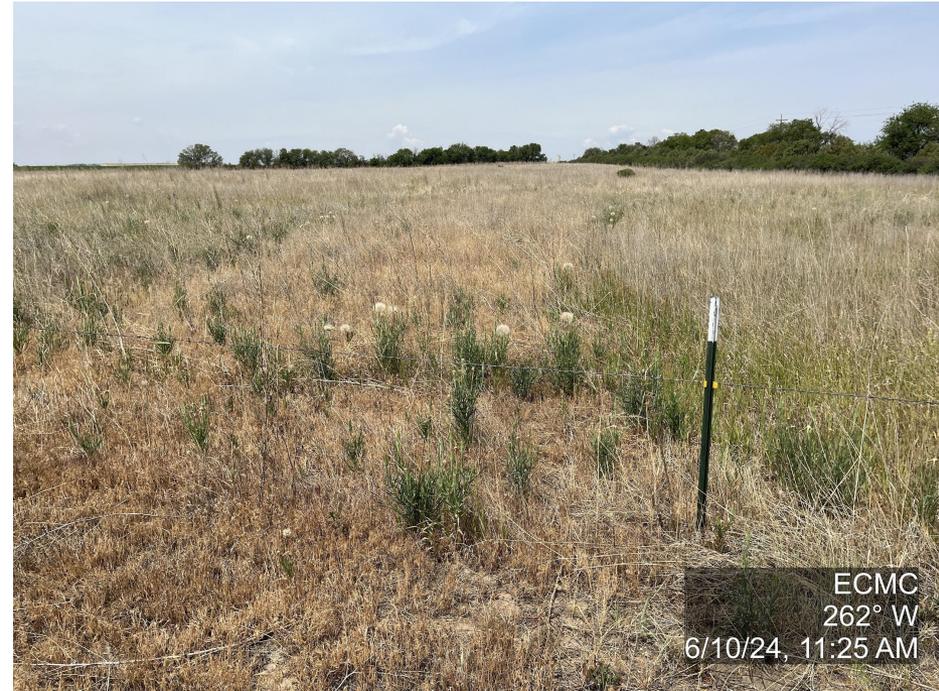
**Photo 2.** The photo was taken at the entrance to the well location facing West. The photo illustrates the well and entrance.

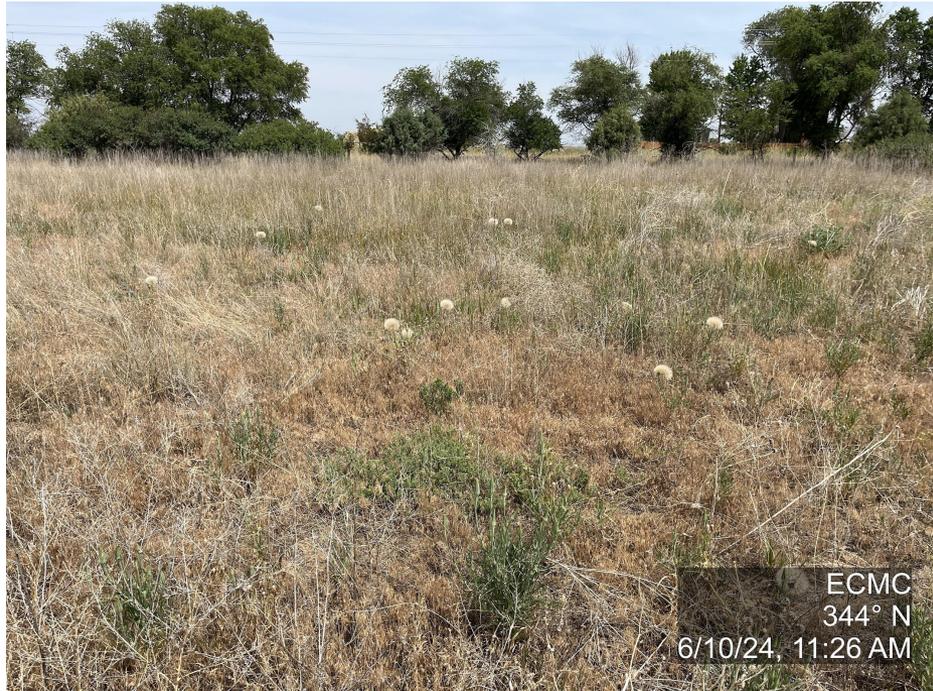
**Photo 3.** The photo was taken at the well location facing North. The photo illustrates the well location is dominated by Cheatgrass with some other grass species and Yellow salsify.

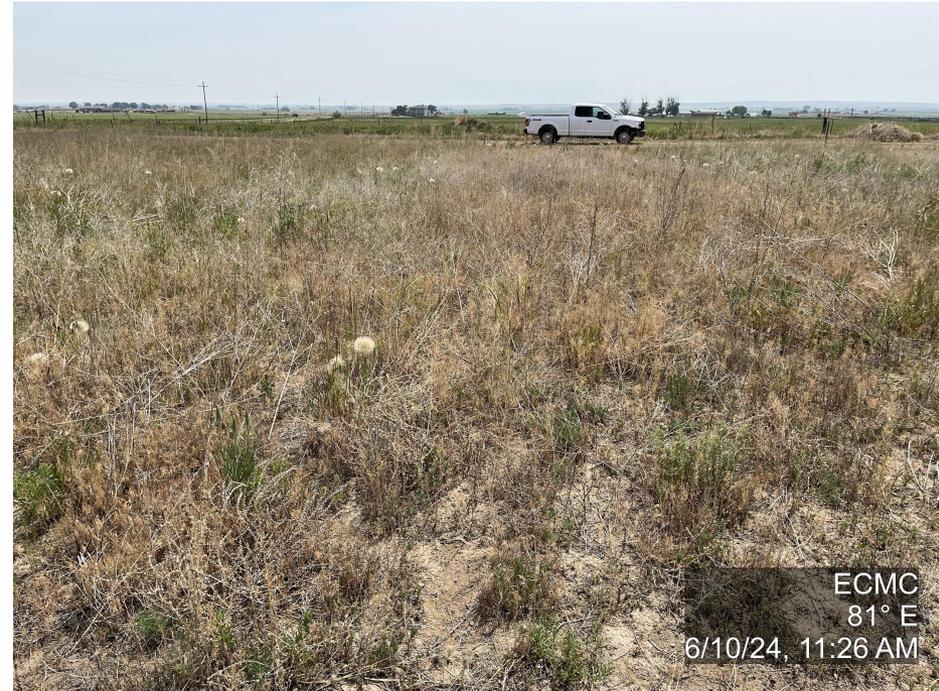
**Photo 4.** The photo was taken at the well location facing East. Refer to the comment for photo 3.

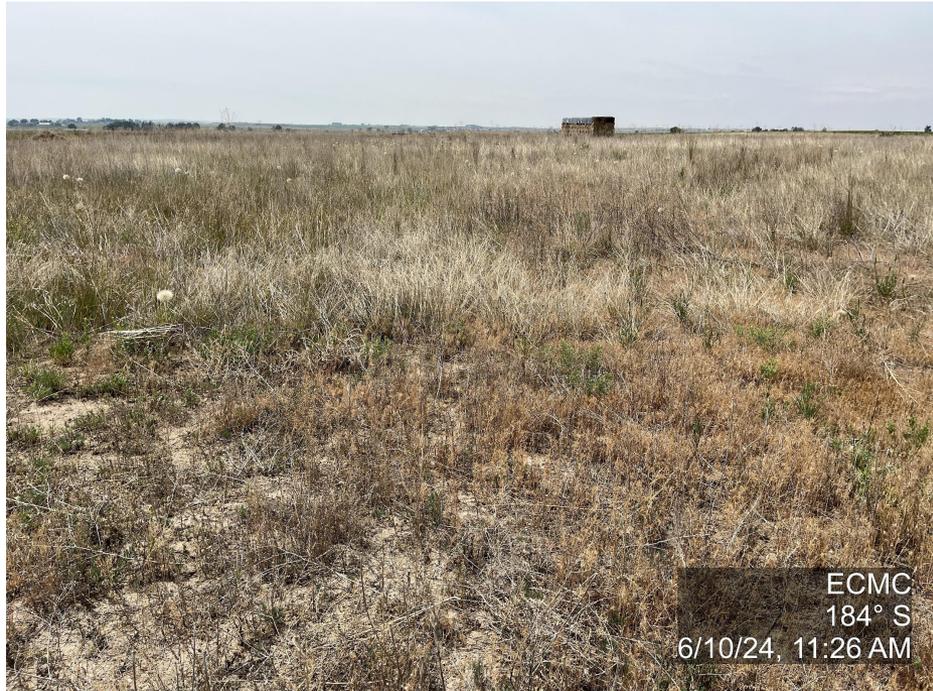
**Photo 5.** The photo was taken at the well location facing South. Refer to the comment for photo 3.

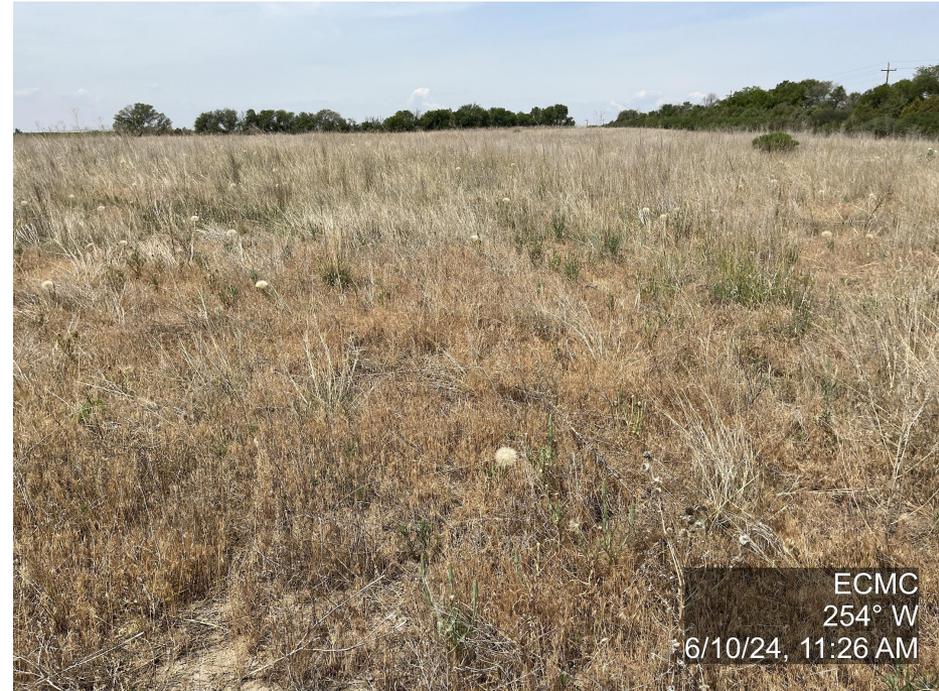
**Photo 6.** The photo was taken at the well location facing West. Refer to the comment for photo 3.

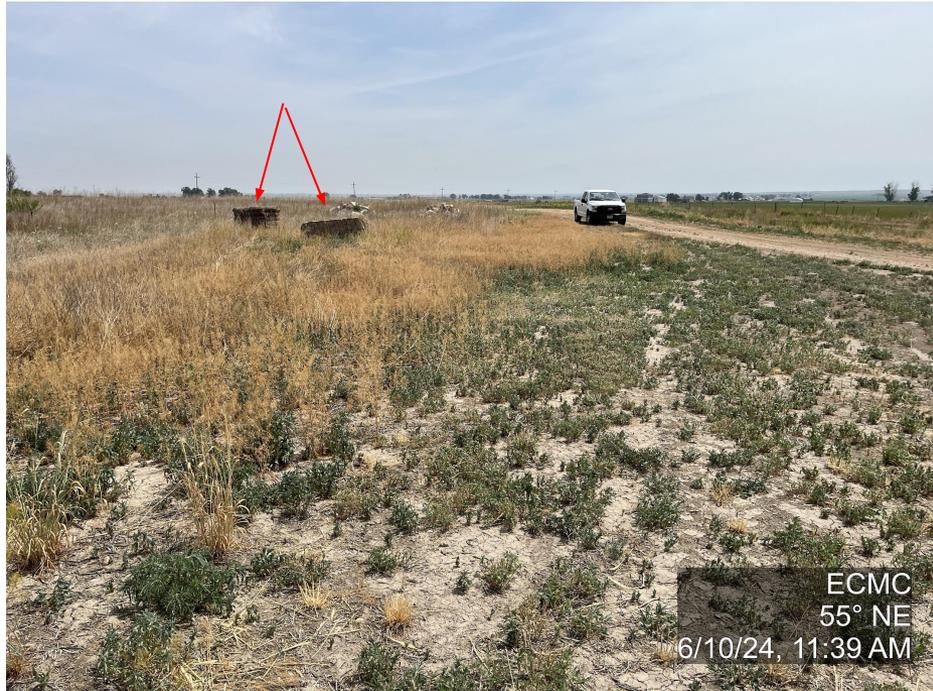
**Photo 7.** The photo was taken at the tank battery location facing Northeast. The photo illustrates the tank battery location is dominated by annual weeds including Field bindweed and hay bales stored on location.

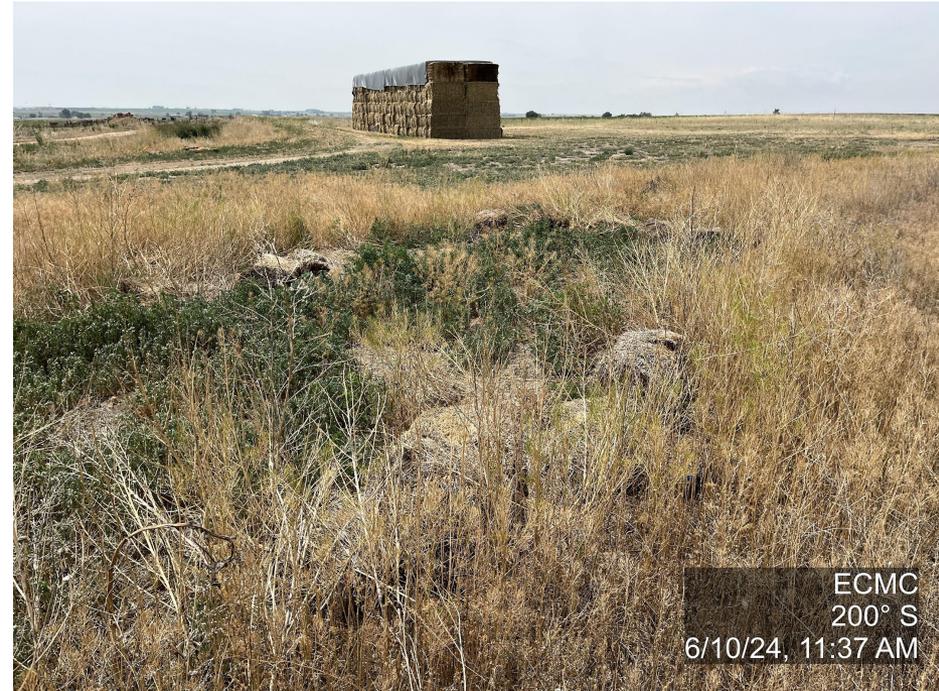
**Photo 8.** The photo was taken at the tank battery location facing South. The photo illustrates broken hay bale debris on the location as well as a dominance of annual weeds.

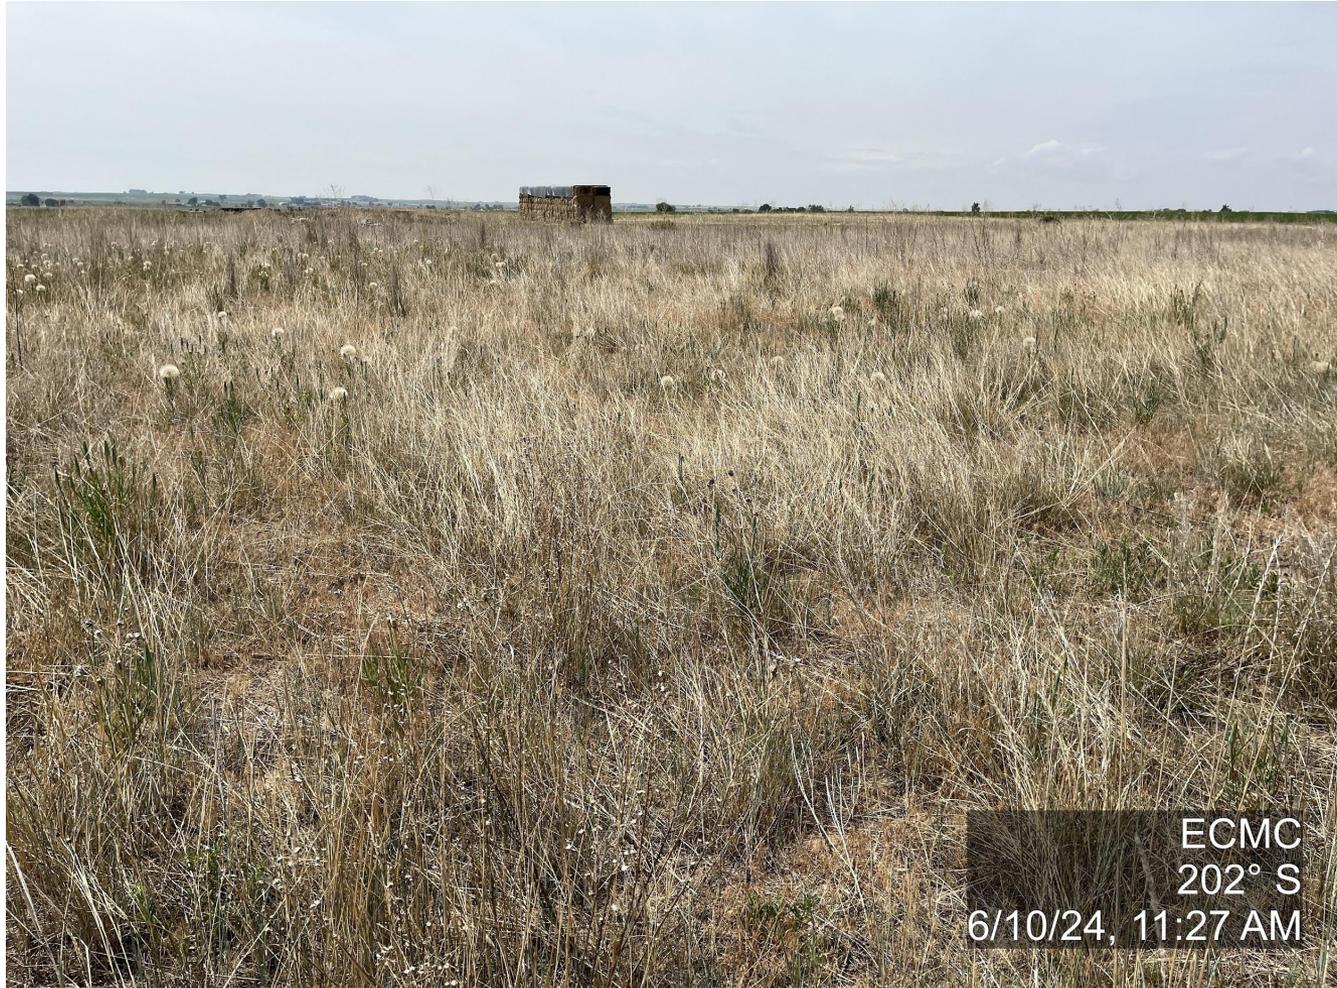
**Photo 9.** The reference photo was taken South of the well location facing South.
