Inspection Photos

Operator: Hilcorp Energy Company - 10133

Location ID: 326481

Inspection Photos
Location Name: Argenta 34-10 32-1
Location ID: 326481

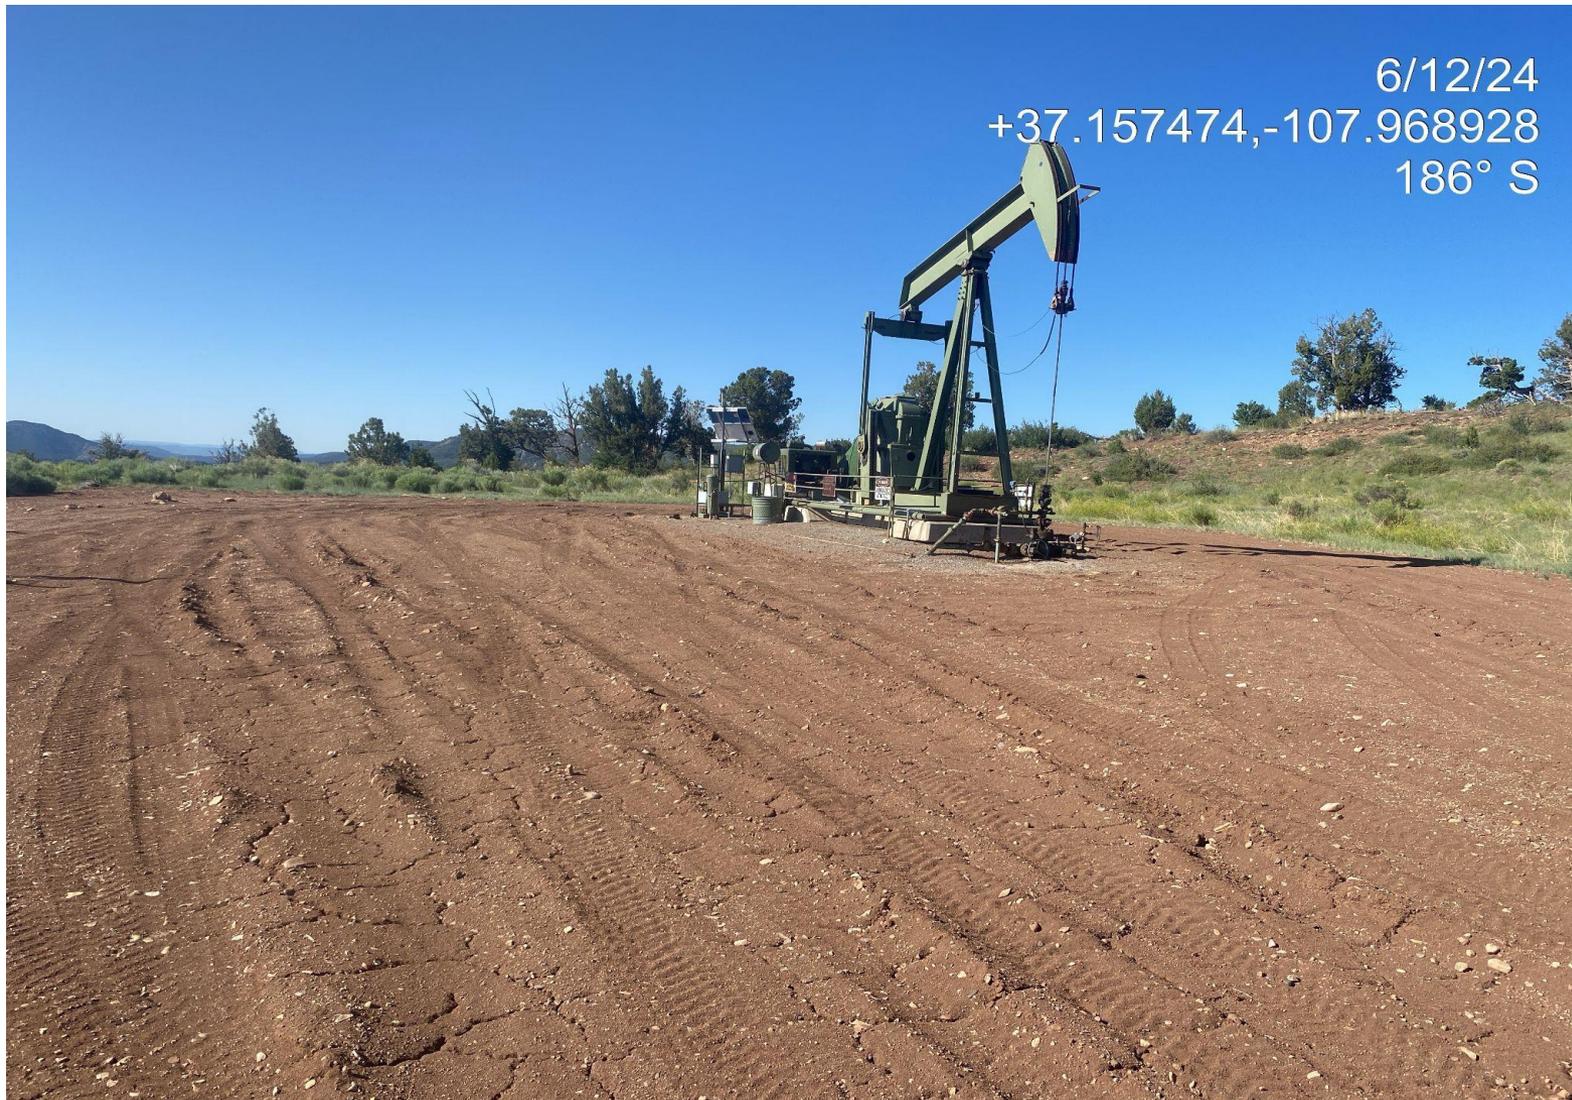
Photo 1. View of the well pad taken from the access road facing center.

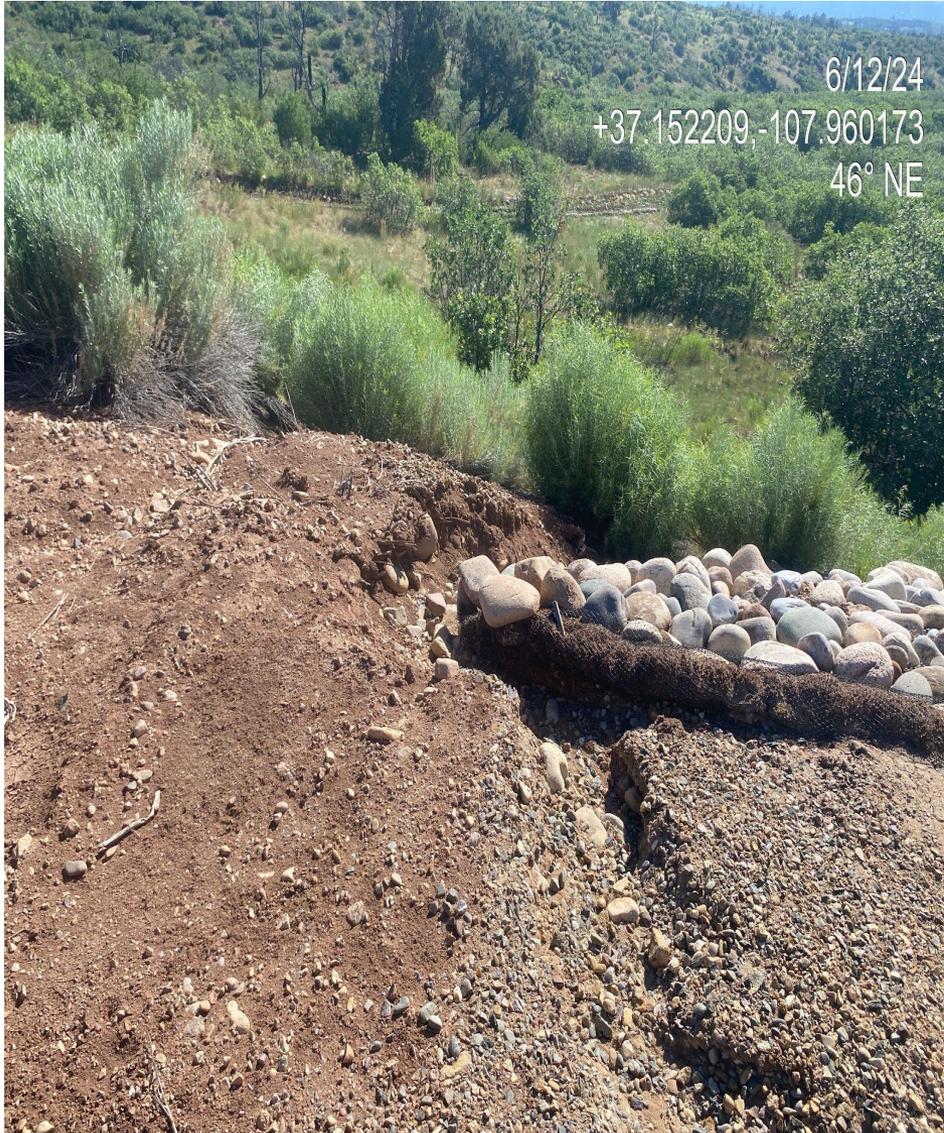
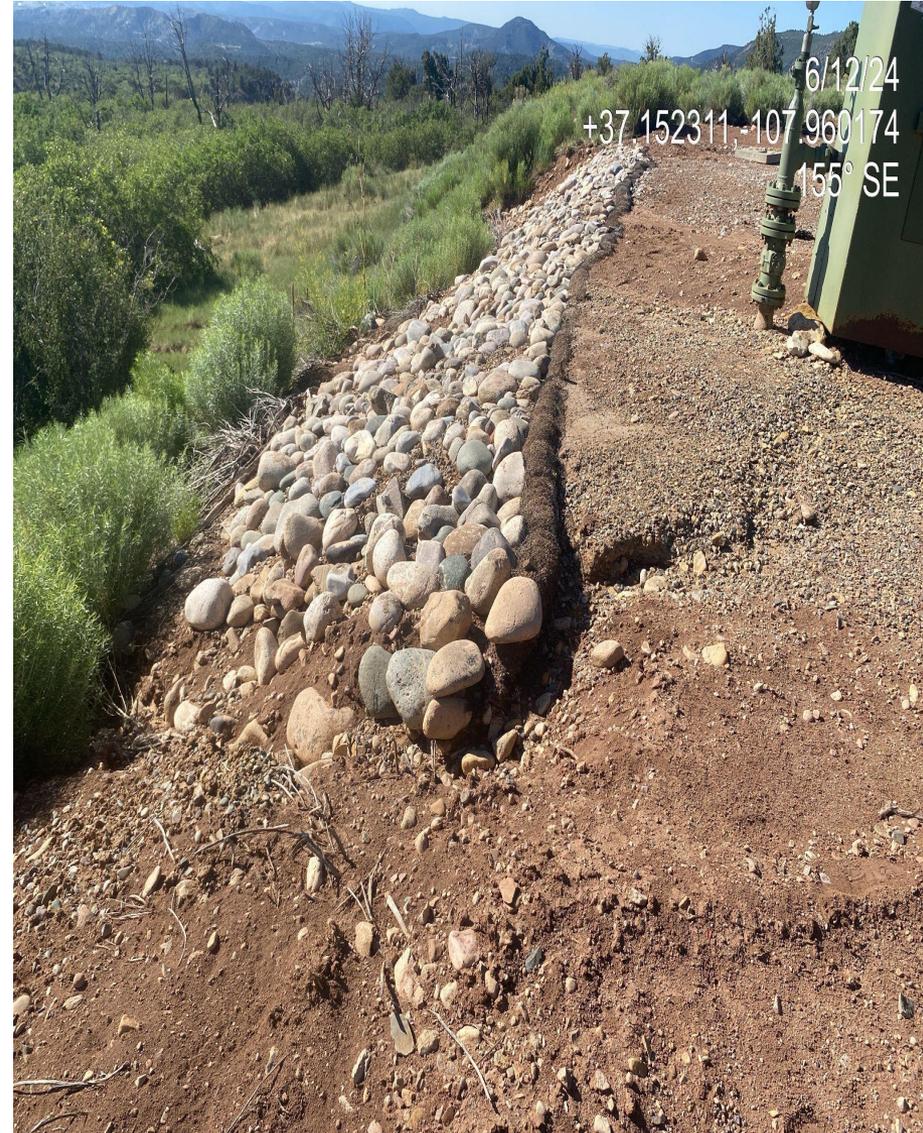
Photo 2. View of rill erosion forming along the edge of current storm water BMPs on the eastern edge of the location. Maintenance is needed in this area.

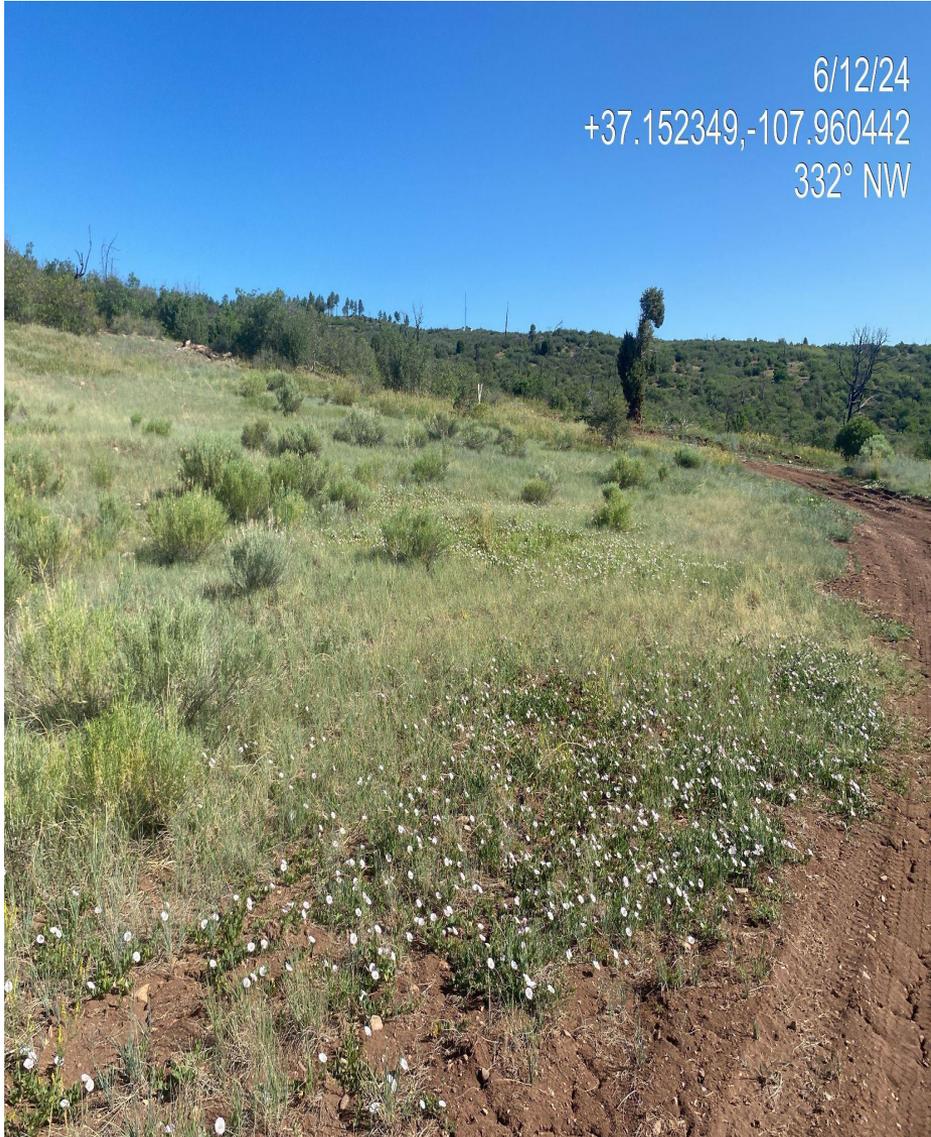
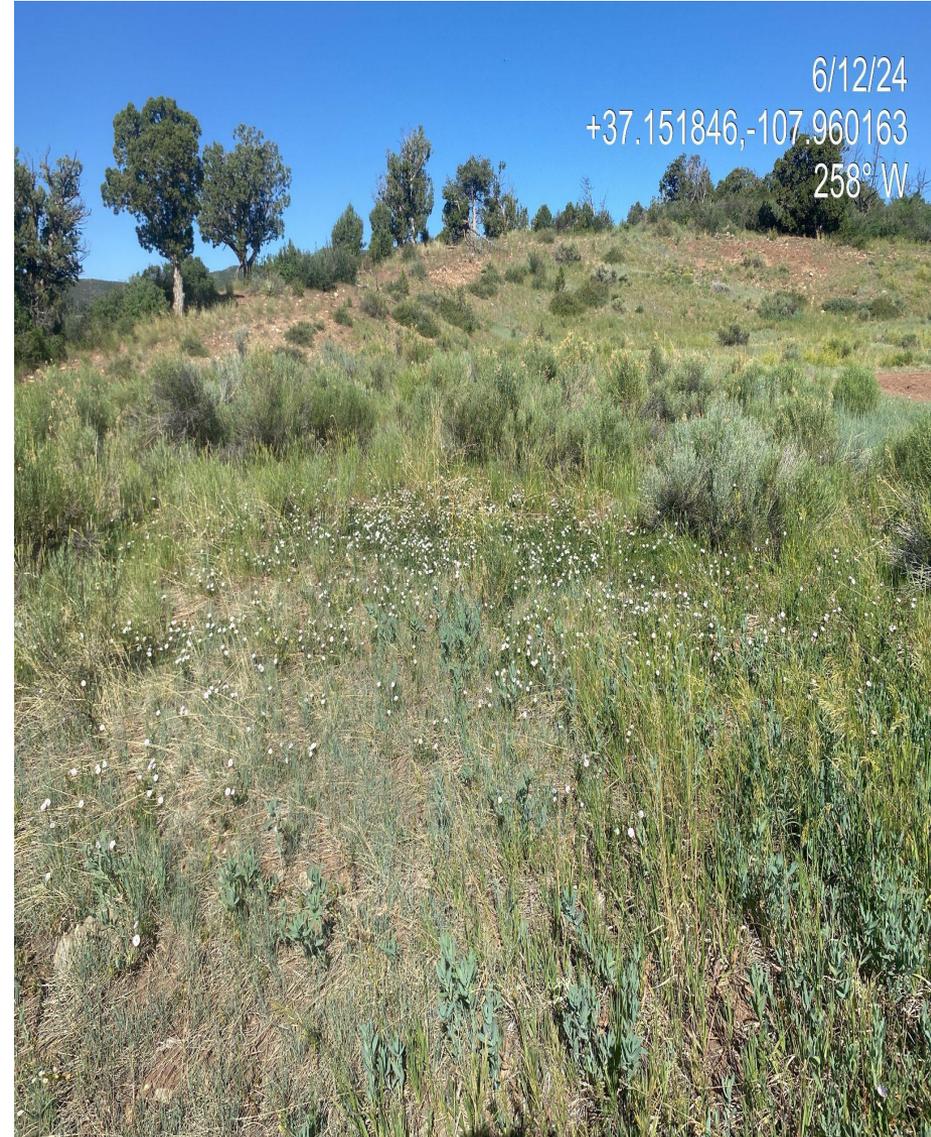
Photo 3. Two large patches of a noxious weed (field bindweed) observed in the western and southern portions of the interim reclamation area.

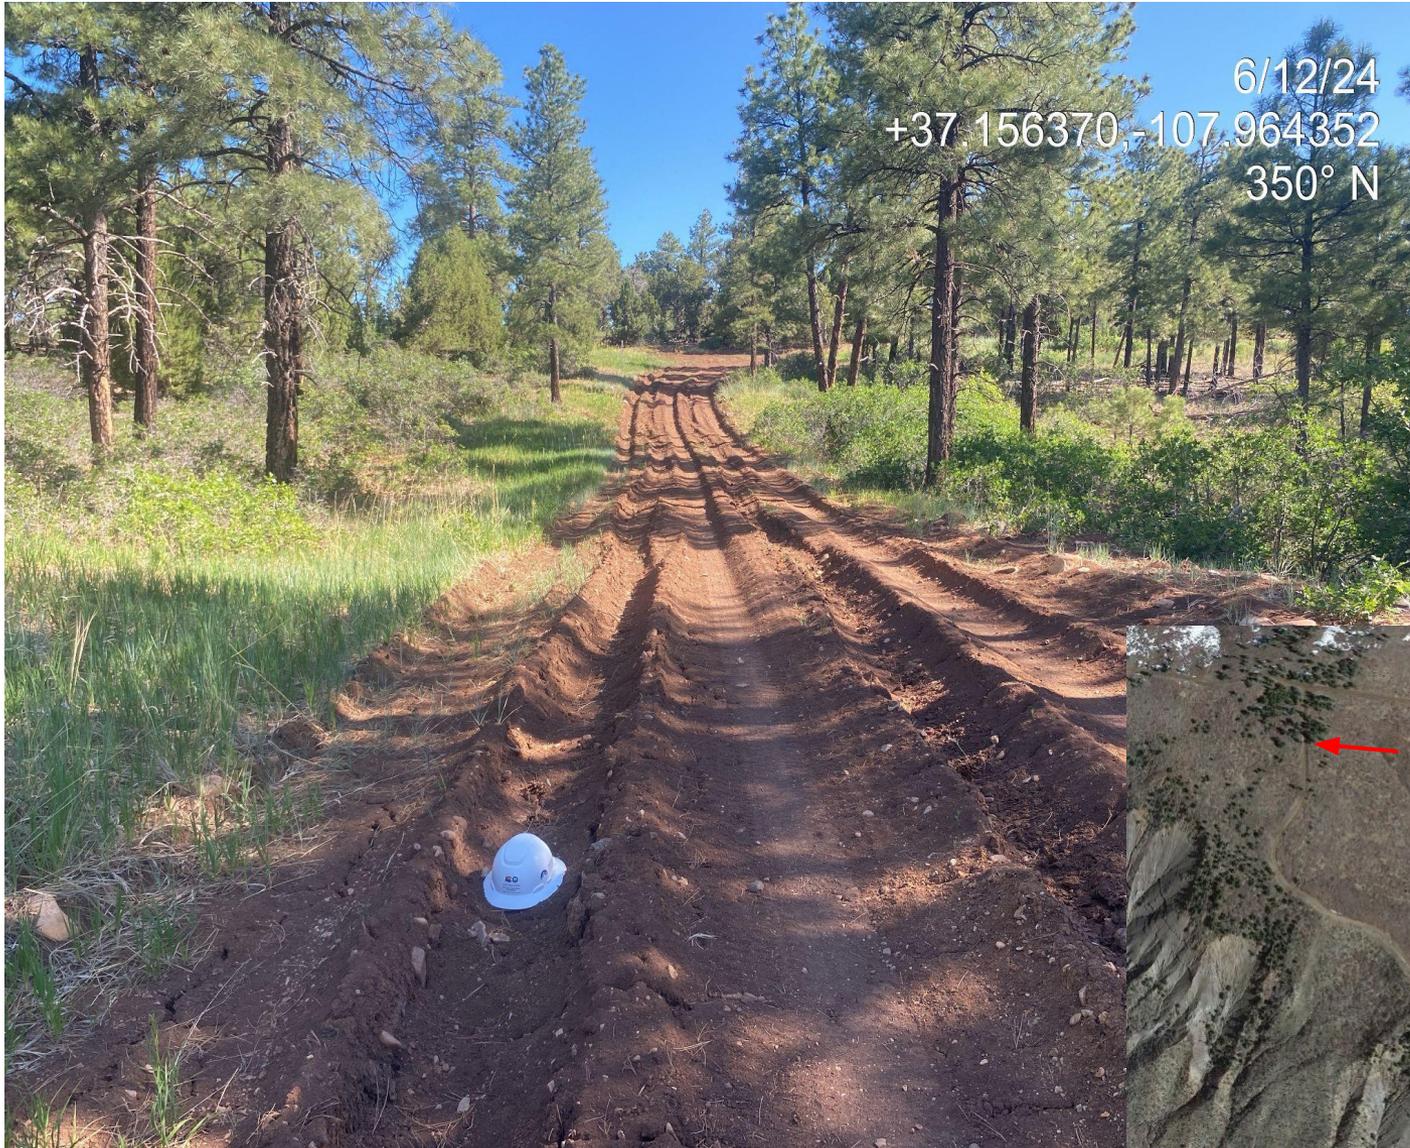
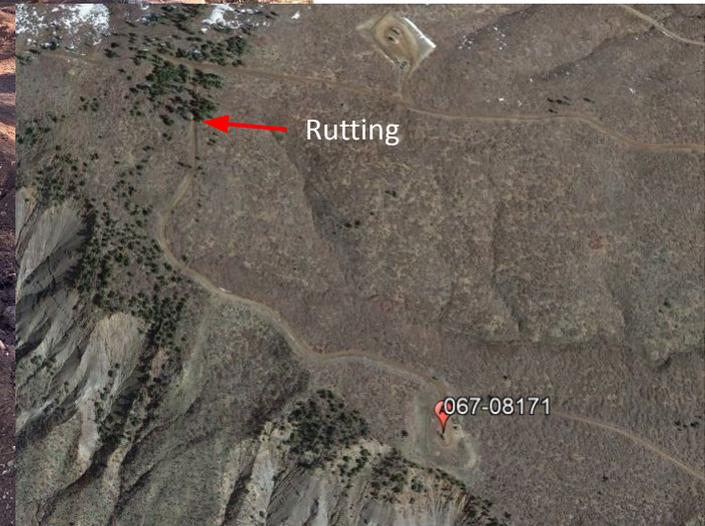
Photo 4. View of severe rutting occurring along the access road, ruts appear to be 10-12 inches deep in some areas. Additional stabilization/grading is needed to minimize degradation of access road.
