Final Reclamation and Stormwater Inspection

Operator: NOBLE ENERGY INC - 100322

Location ID: 330715

Inspection Photos
Location Name: Wiedeman 3-11
Location ID: 330715

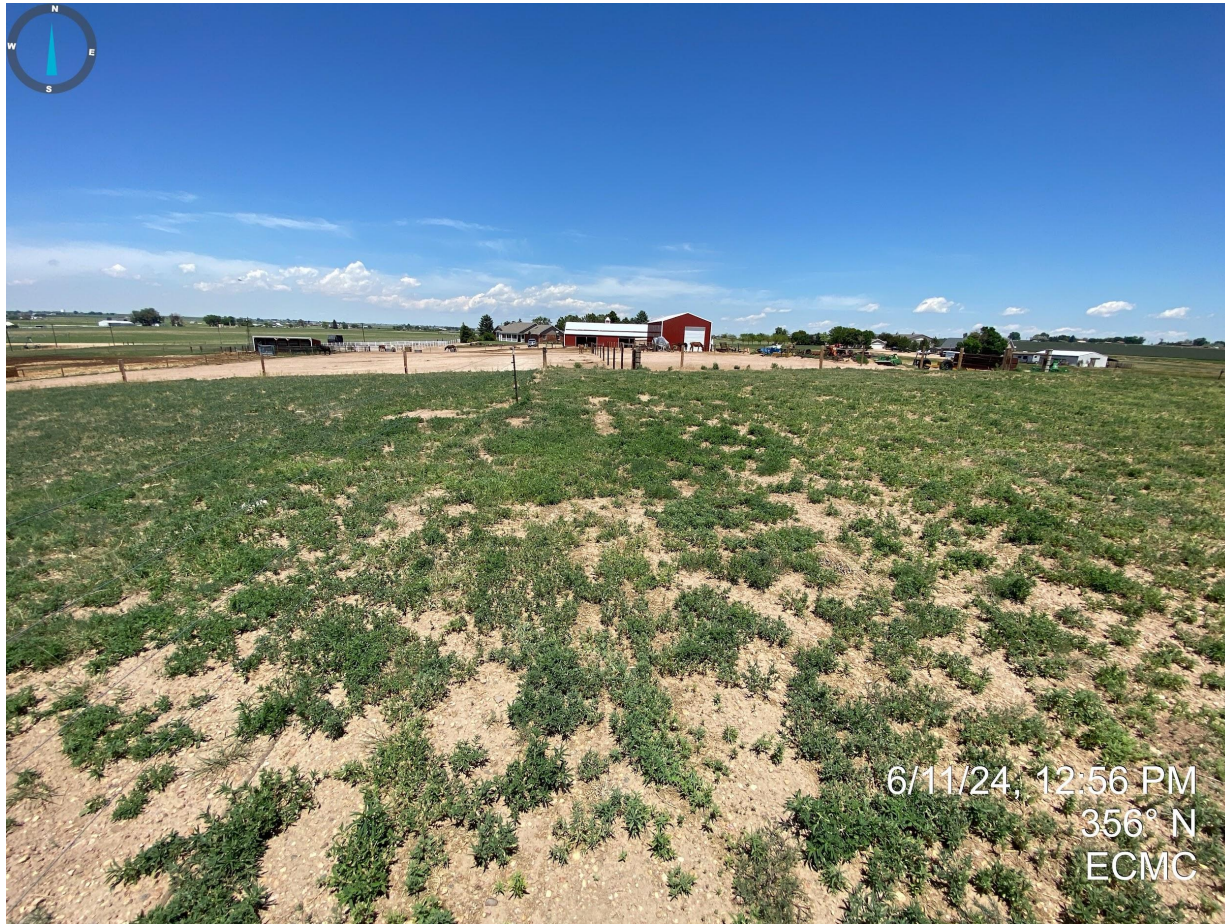
Photo 1. Facing north. The former well location is predominantly undesirable vegetation (kochia). Additional reclamation activities are required to establish vegetation with total perennial, non-invasive uniform plant cover of at least eighty (80) percent of reference area levels.

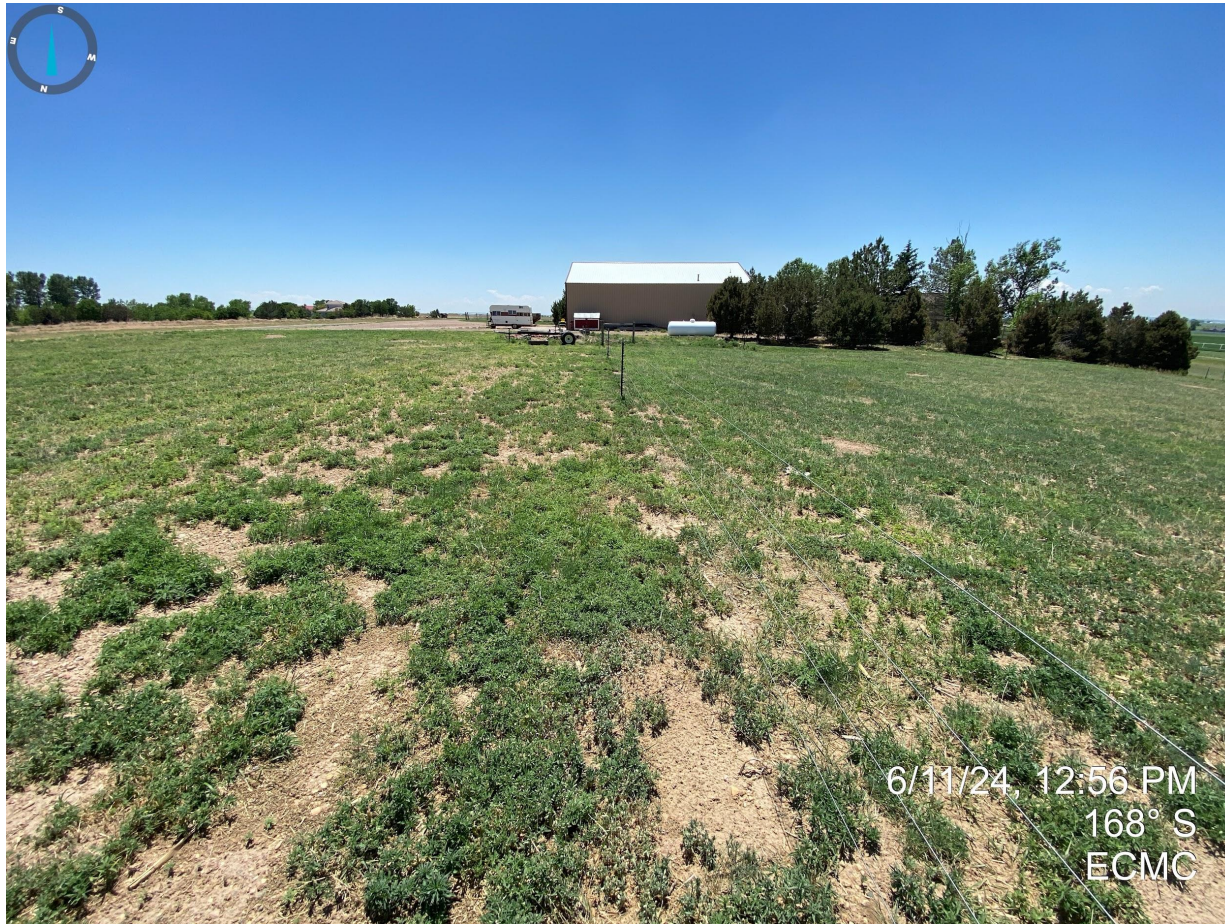
Photo 2. Facing south; see comments in Photo 1.

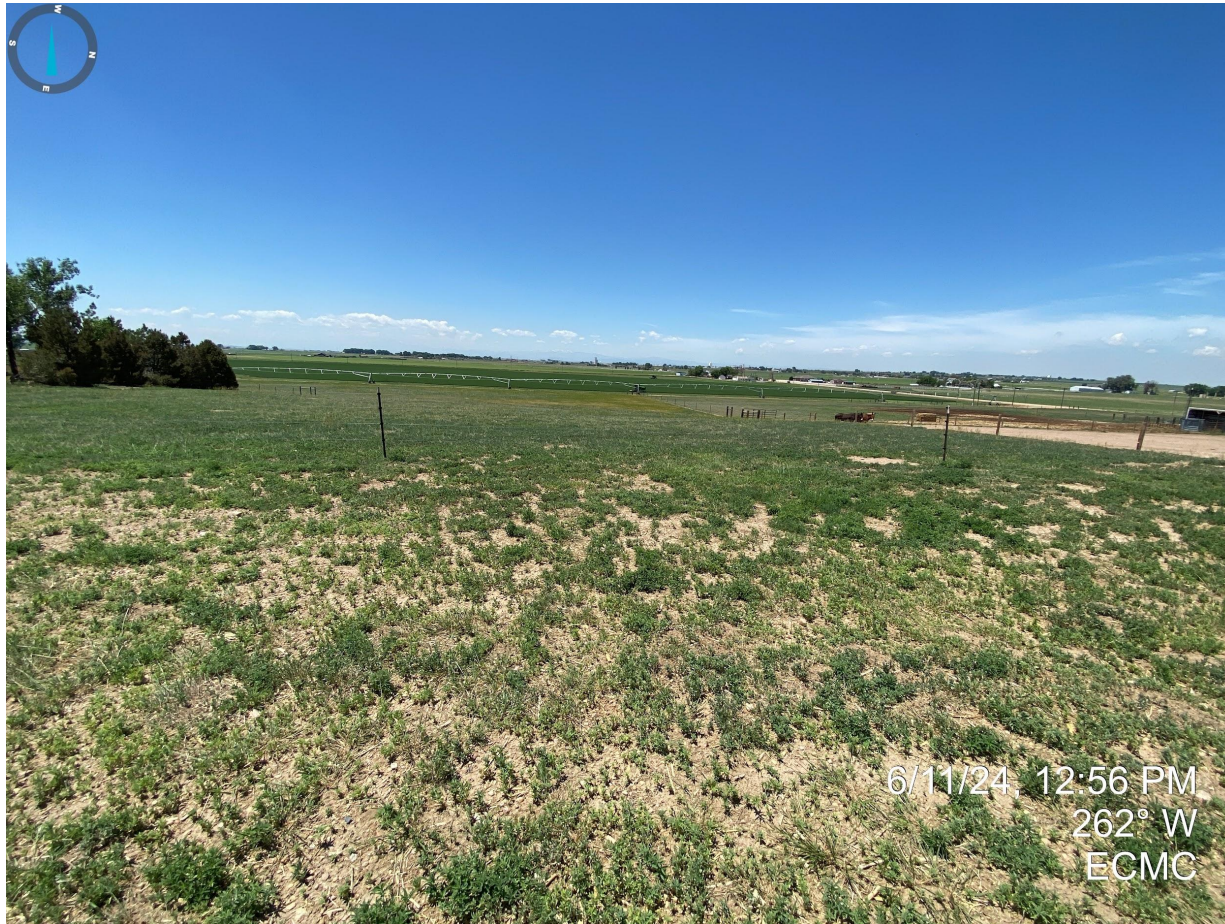
Photo 3. Facing west; see comments in Photo 1.

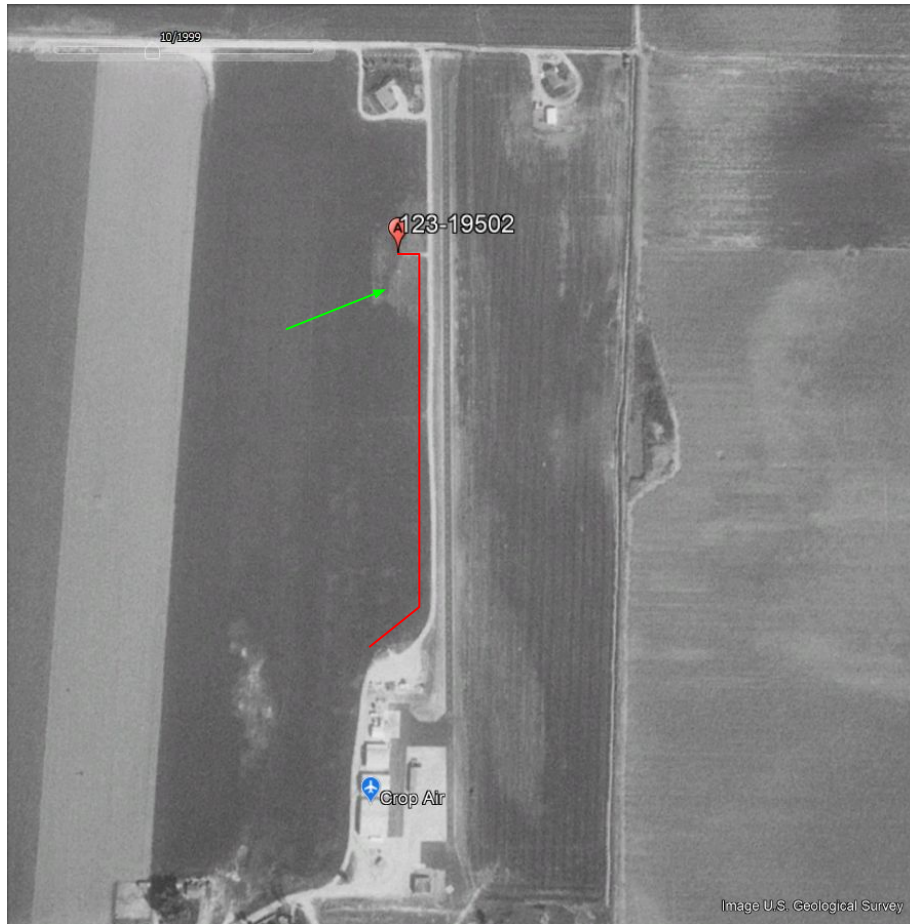
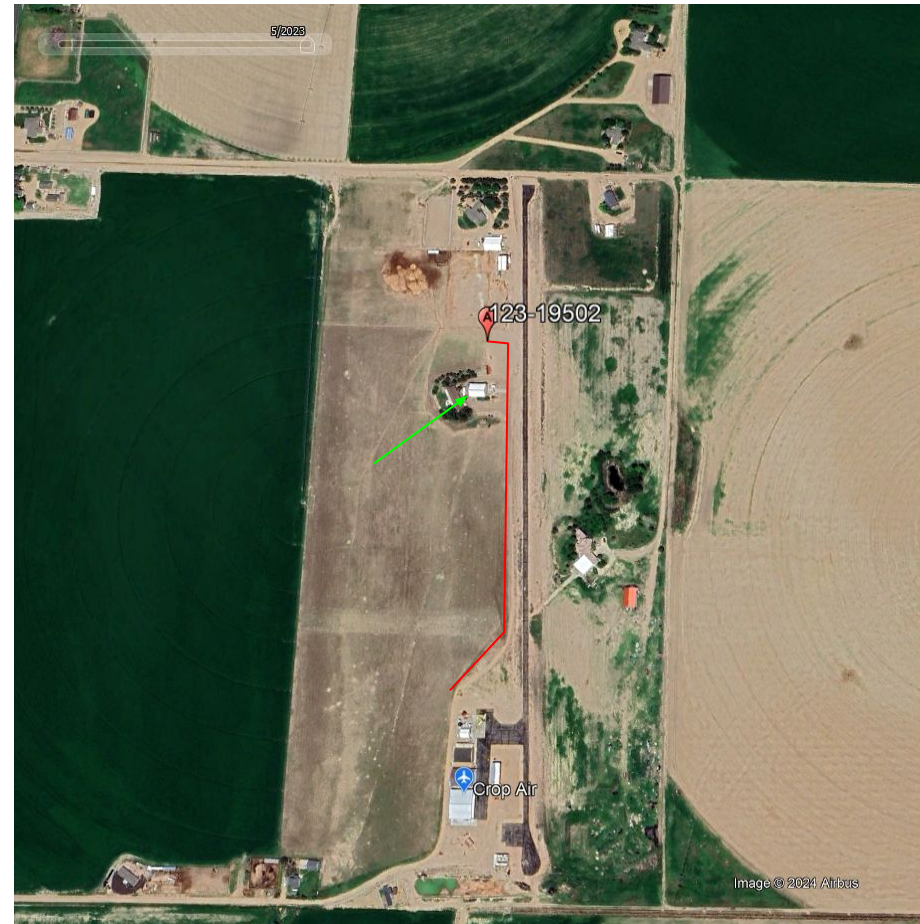
Photos 4 & 5. Google Earth aerial imagery taken circa 10/1999 (left photo) illustrates that the access road to Well API 123-19502 was constructed prior to any residential housing, indicated by green arrow. Google Earth aerial imagery taken circa 05/2023 (right photo) illustrates that the access road remains after the well was plugged and abandoned. The access road will need to be reclaimed or a variance requested.

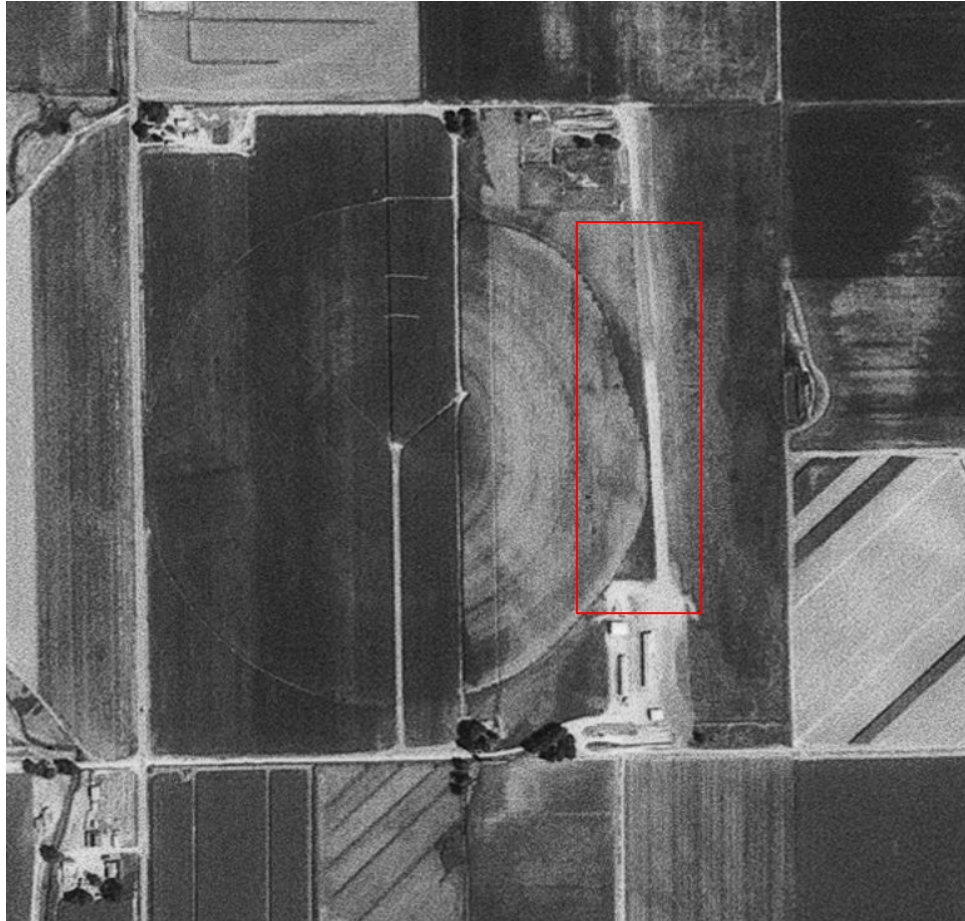
Photo 6. Aerial imagery taken 09/07/1978 illustrates that the access road did not exist prior to oil and gas development in the area.
