# Inspection Photos

**Operator:** ANSCHUTZ EXPLORATION CORP  
#3104

**Location ID:** 315979

**Inspection Doc:** 696205883

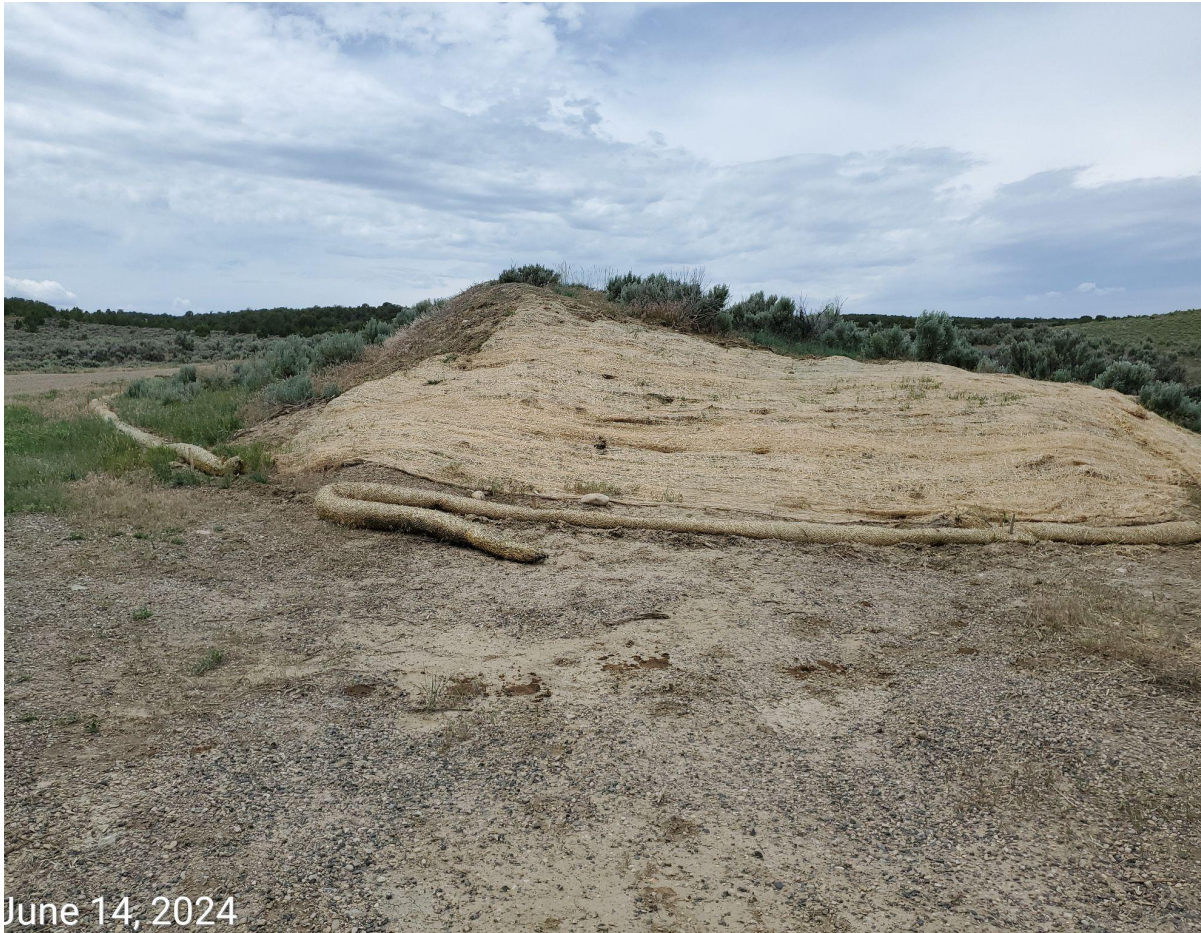
**Photo 1:** Photo shows soil stockpile on the south end of the Location.

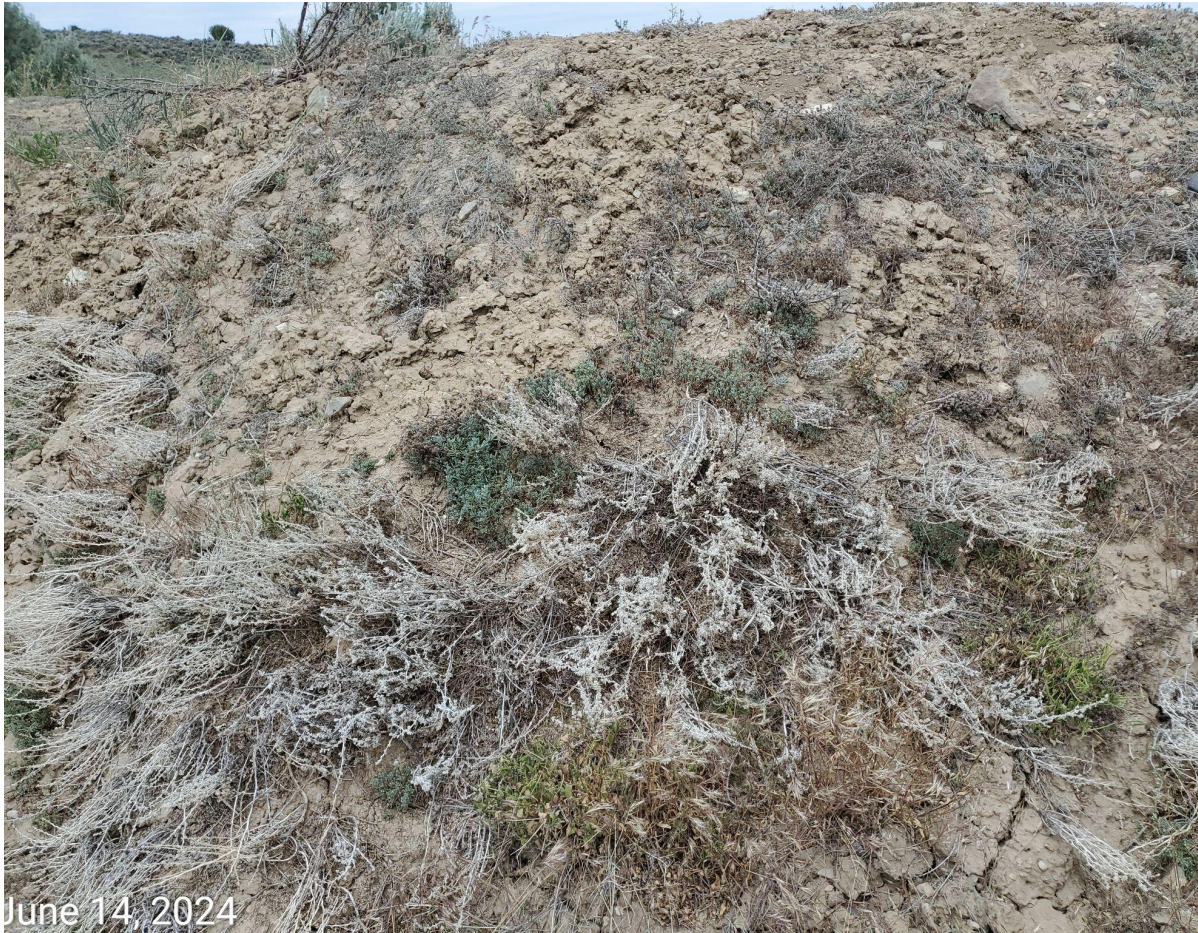
**Photo 2:** Continued from photo 1. Photo shows Halogeton establishment/germination on the stockpiles. Weed management efforts have not been performed.

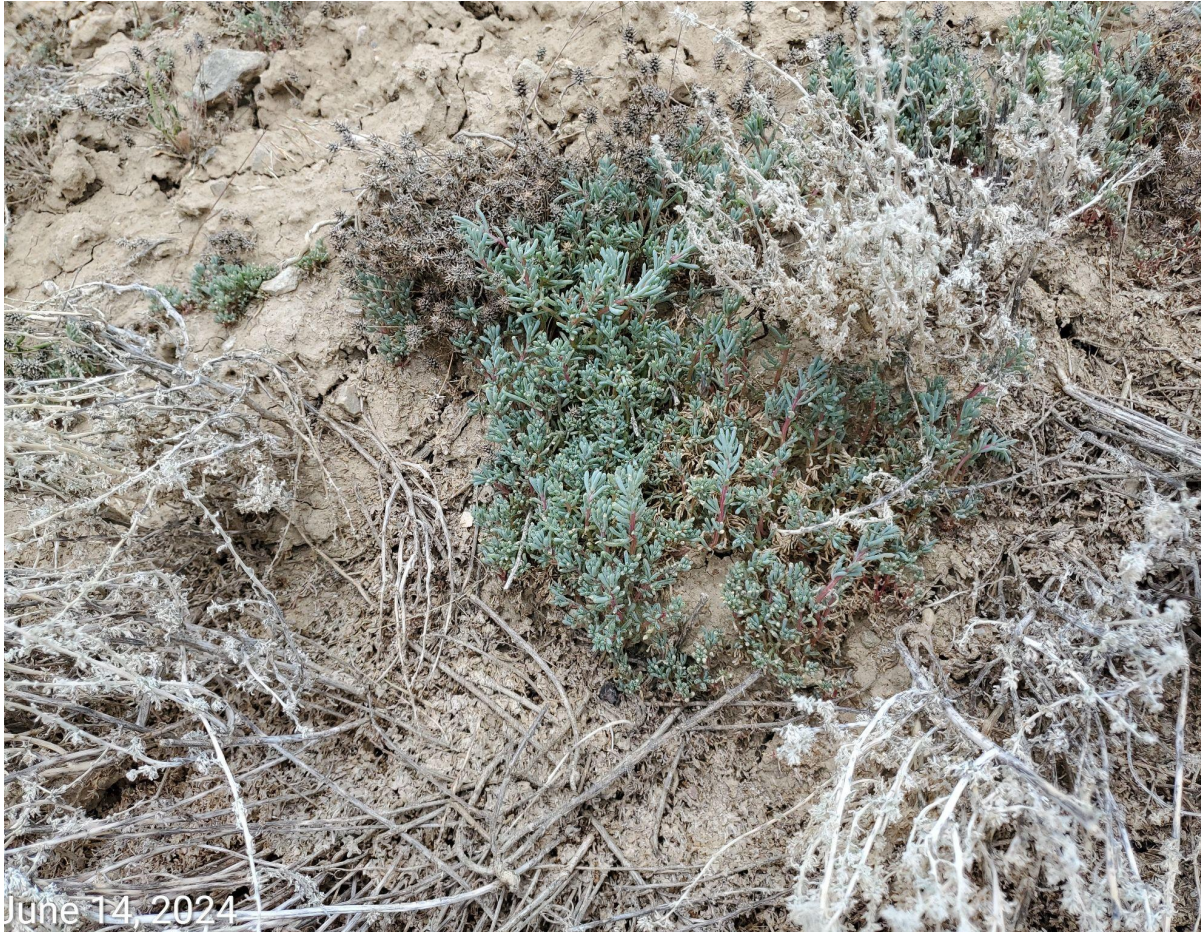
**Photo 3:** See comments under photo 2.

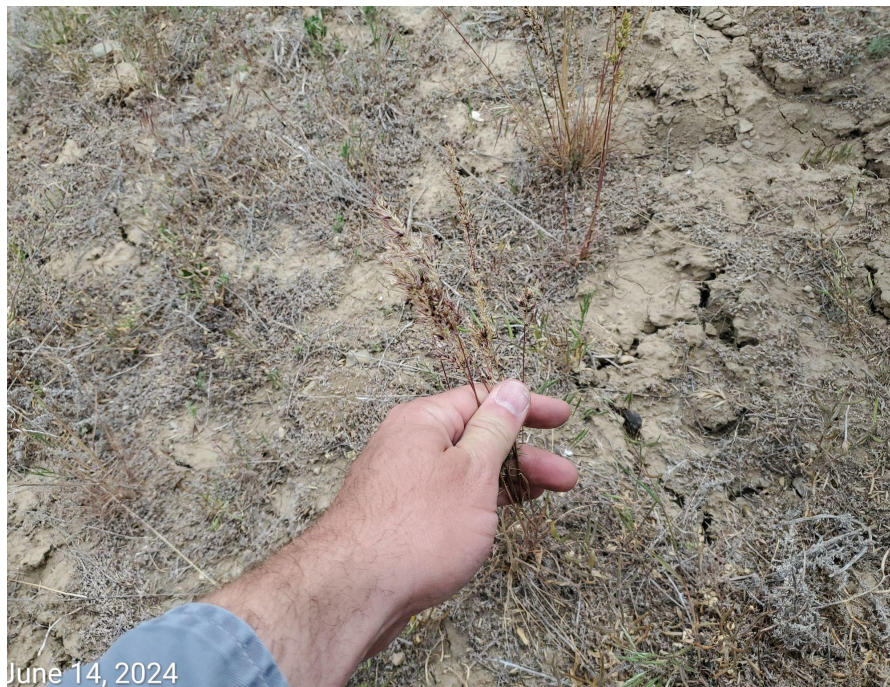
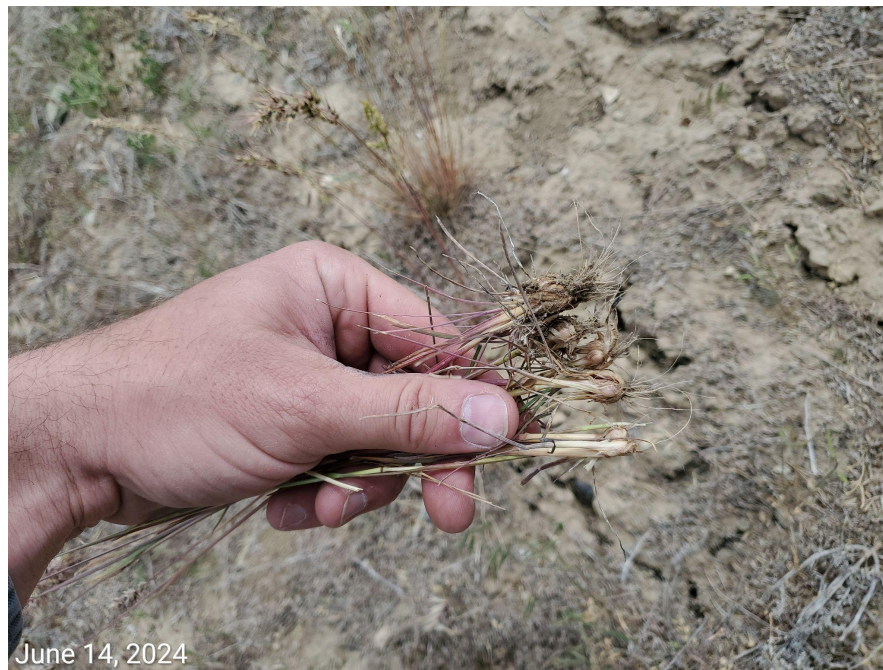
**Photo 4:** Continued from previous photos. Photo shows Bulbous Bluegrass establishment on the soil stockpiles of the Location. Plants have matured and seeded out.
