# Inspection Photos

**Operator:** TEP ROCKY MOUNTAIN LLC - 96850

**Location ID:** 334713

**Inspection Doc:** 696205885

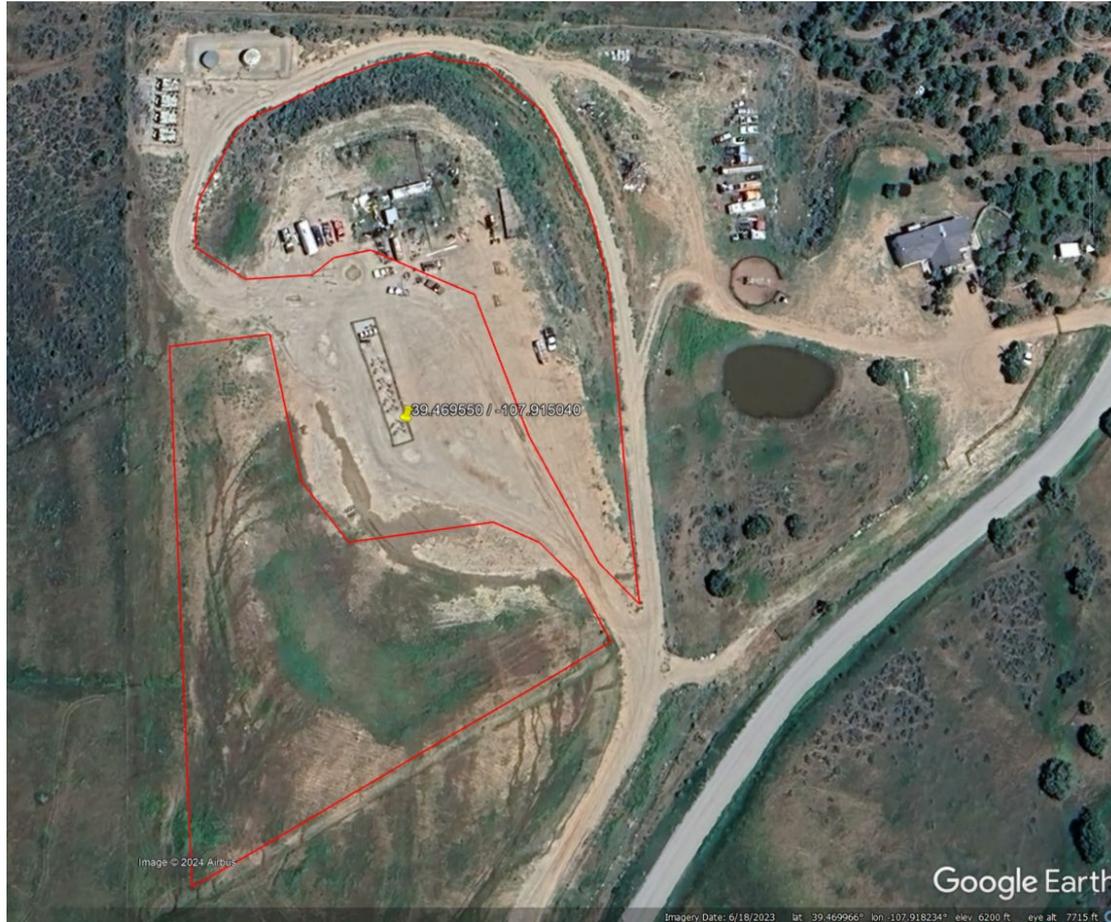
**Photo 1:** 2023 Google Earth aerial imagery. Red polygons represent approximate areas of the Location not necessary for production requiring reclamation in pursuant to 1003 Rules- reclamation work including, but not limited to, compaction alleviation, recontouring/regrading the cut and fill slopes, and revegetation required.
