Inspection Photos
Location Name: Foster State
Location ID: 081-07821
Remediation Project: 35750
Inspection Date: 6/17/2024

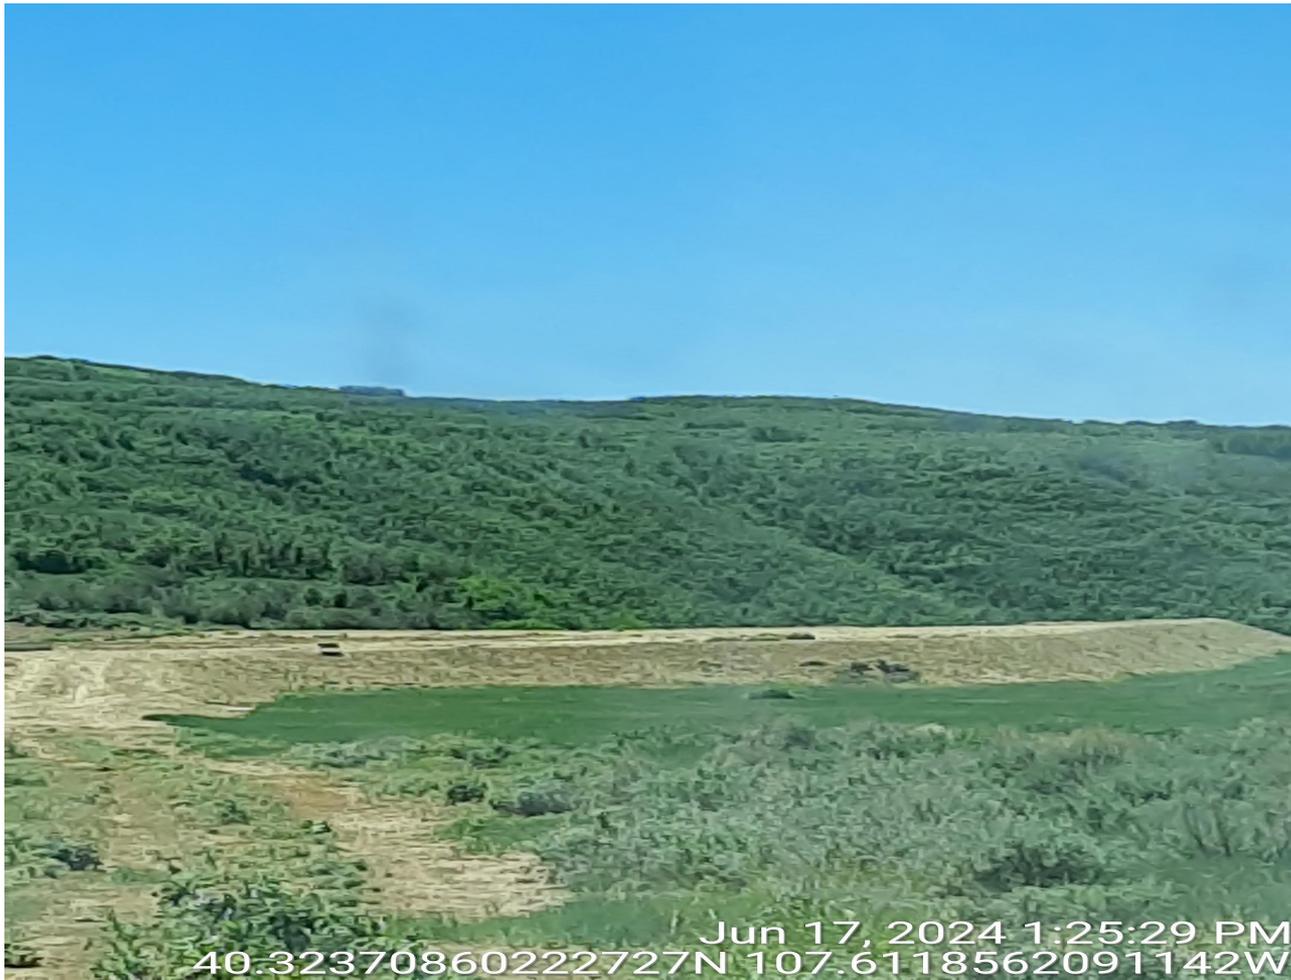
Jun 17, 2024 1:25:29 PM
40.32370860222727N 107.6118562091142W

Foster State well pad as
seen from the Deer
Creek 1pad.

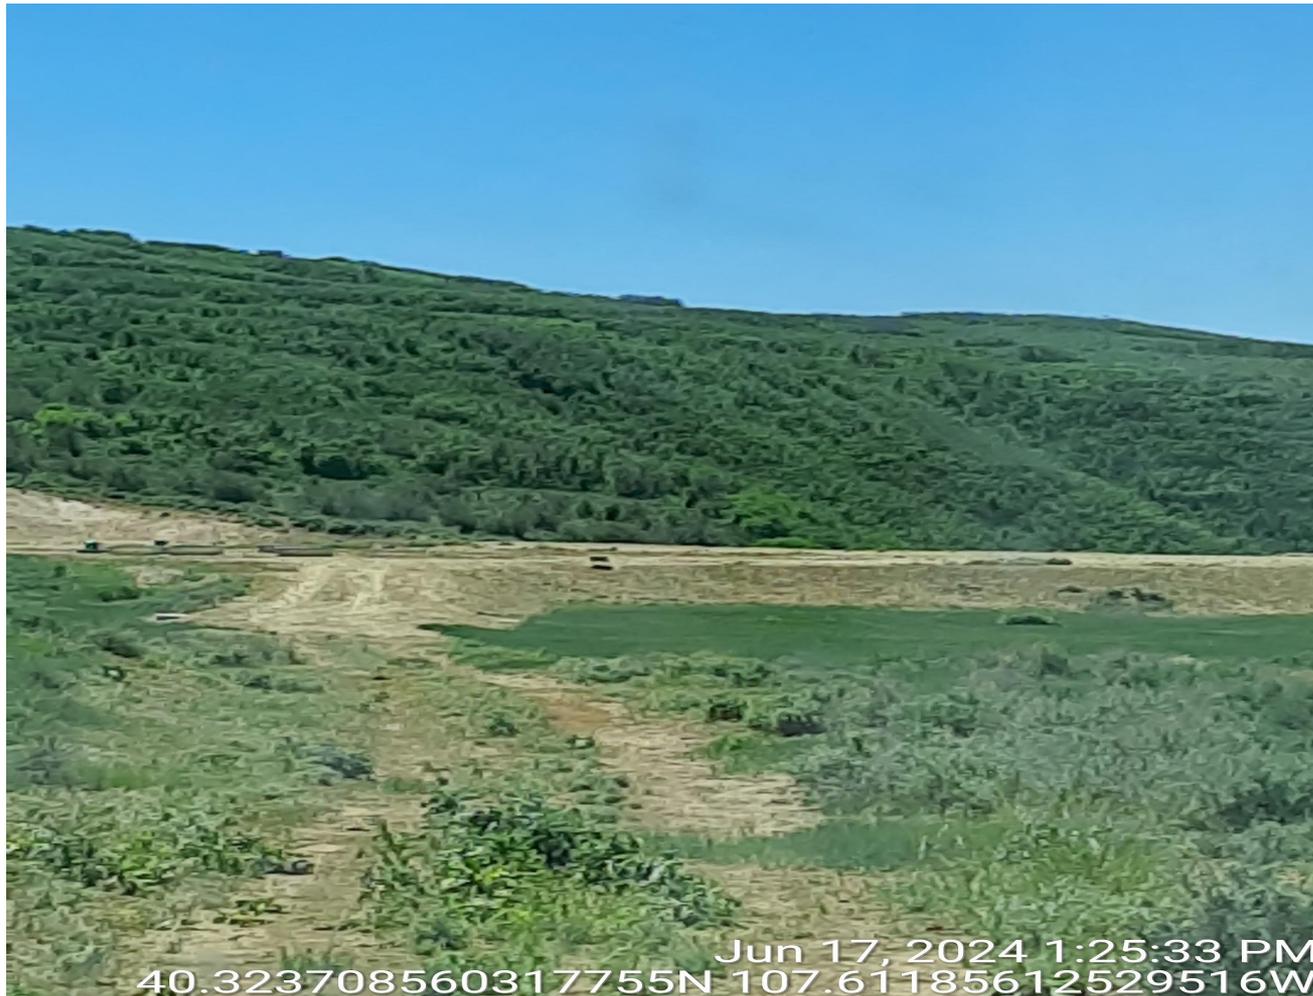
Jun 17, 2024 1:25:33 PM
40.323708560317755N 107.61185612529516W

Foster State well pad as
seen from the Deer
Creek 1pad.

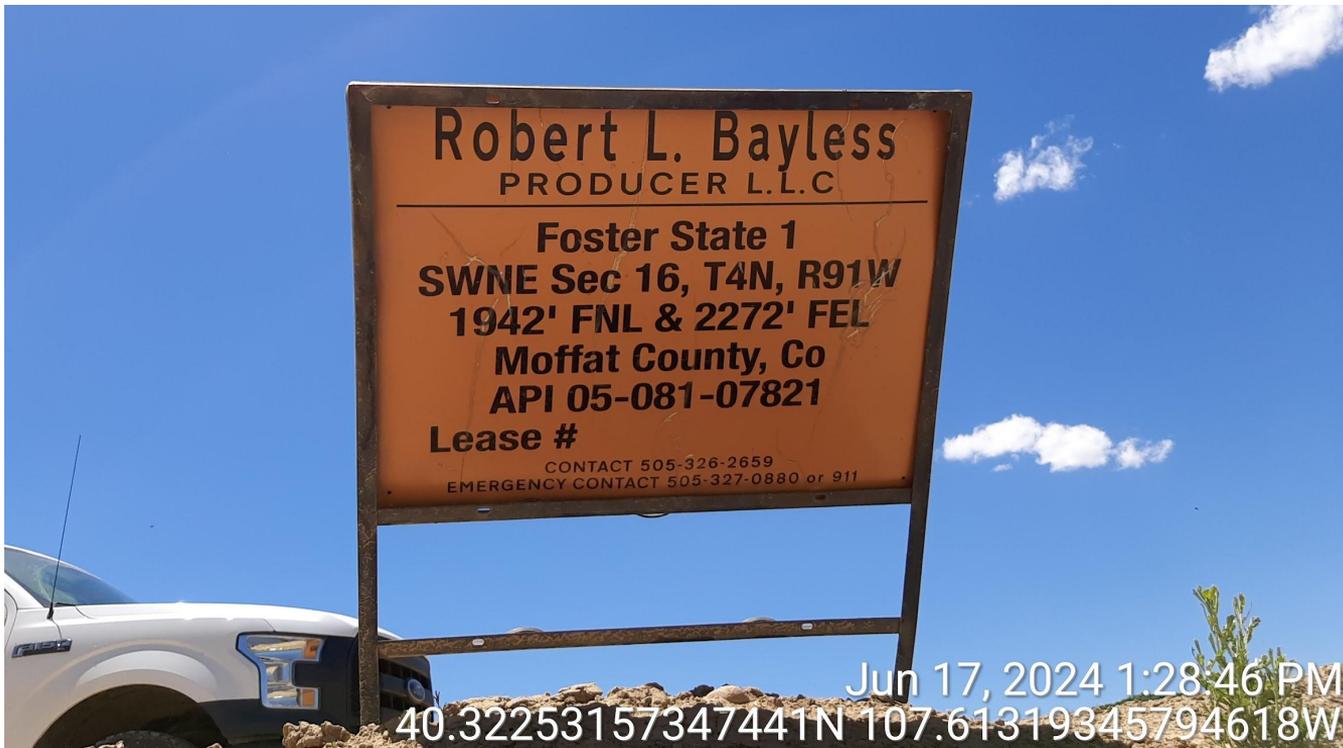
Sign at entry to location.

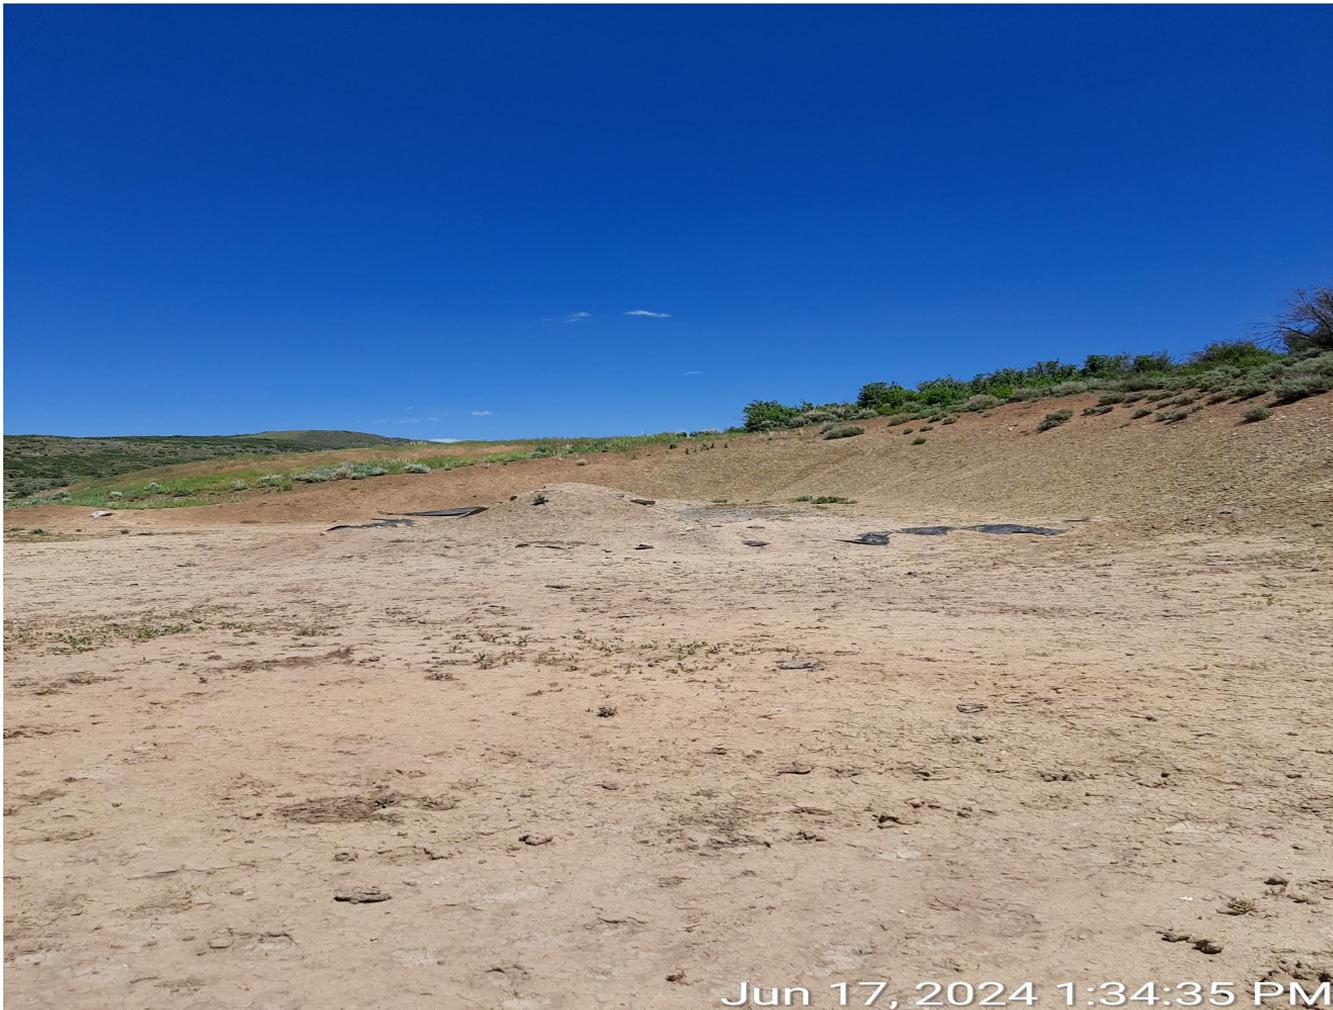
Looking North. There was a buried liner and soil piled on top. It is believed this is a former cuttings area. Soil stored inside this bermed/lined area should be sampled for TABLE 915-1. The liner MUST be removed and not buried

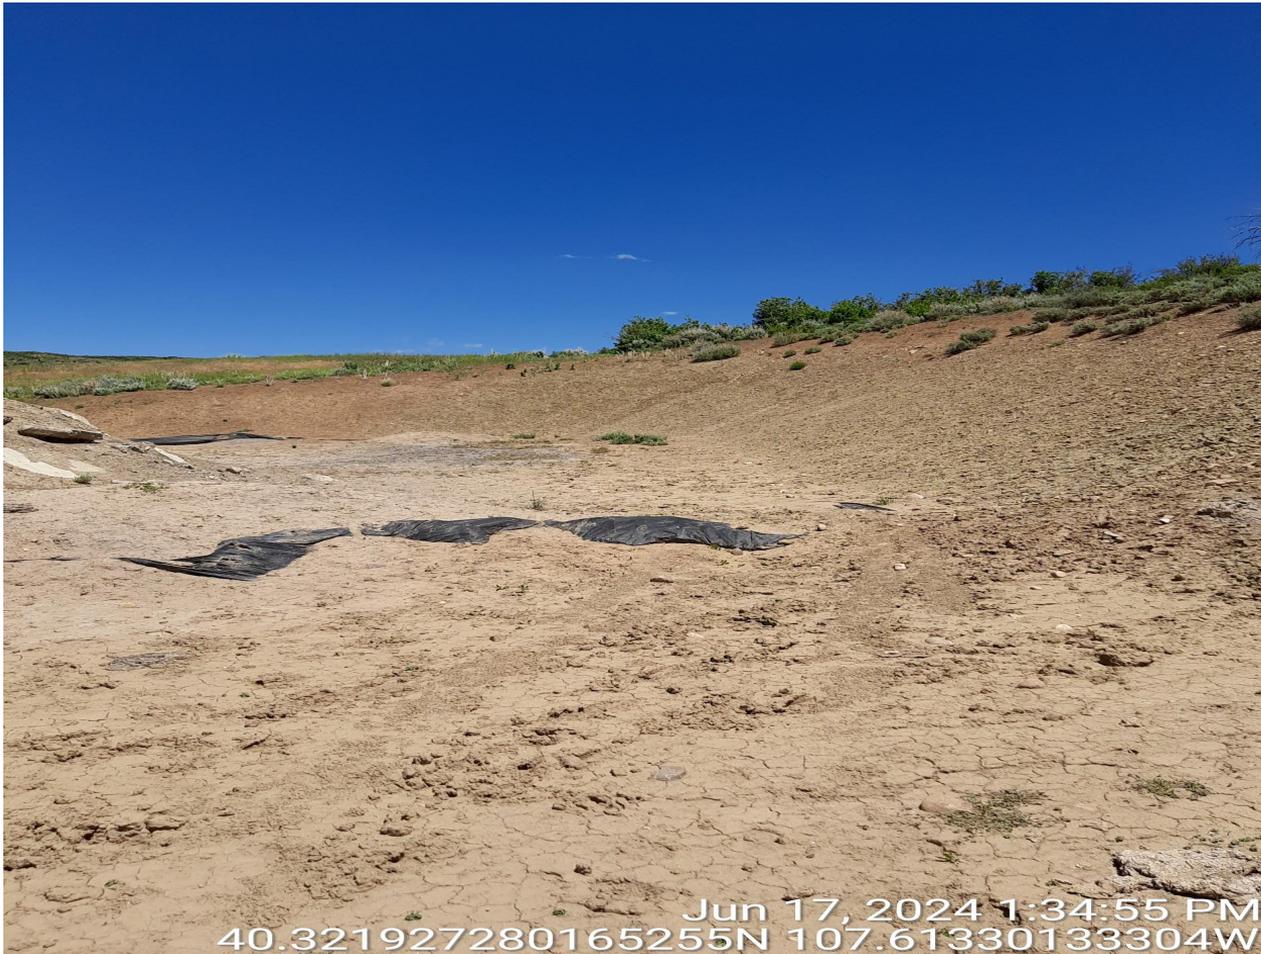
Photo shows north west
side of pad where
lined/bermed area is.

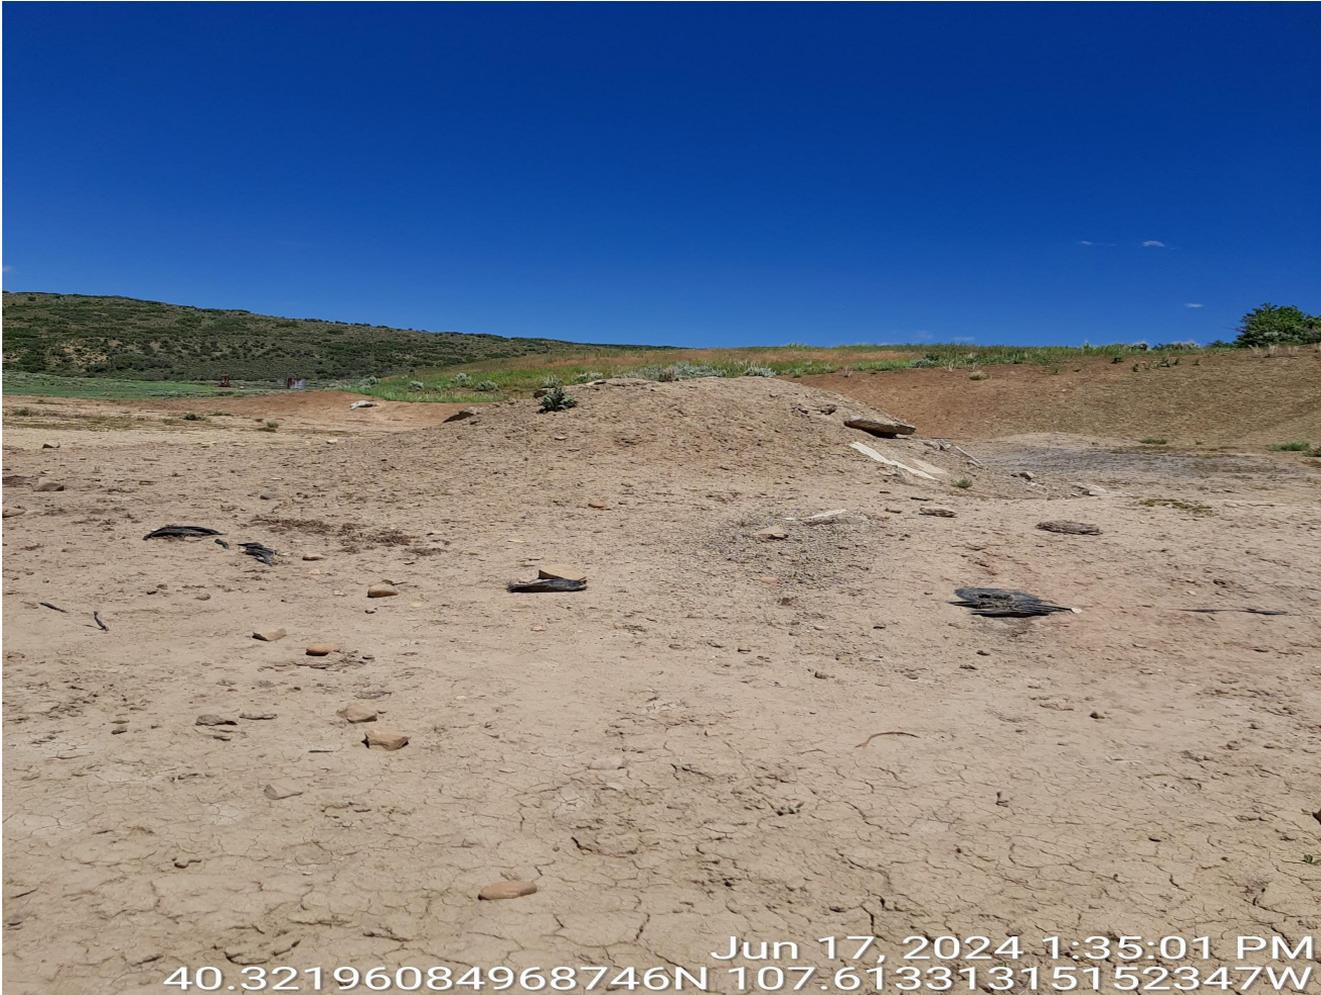
Jun 17, 2024 1:35:01 PM
40.32196084968746N 107.61331315152347W

Photo shows soil piled. It is believed this is a former cuttings storage area. Soil stored inside this bermed/lined area should be sampled for Table 915-1. The liner **MUST** be removed and not buried

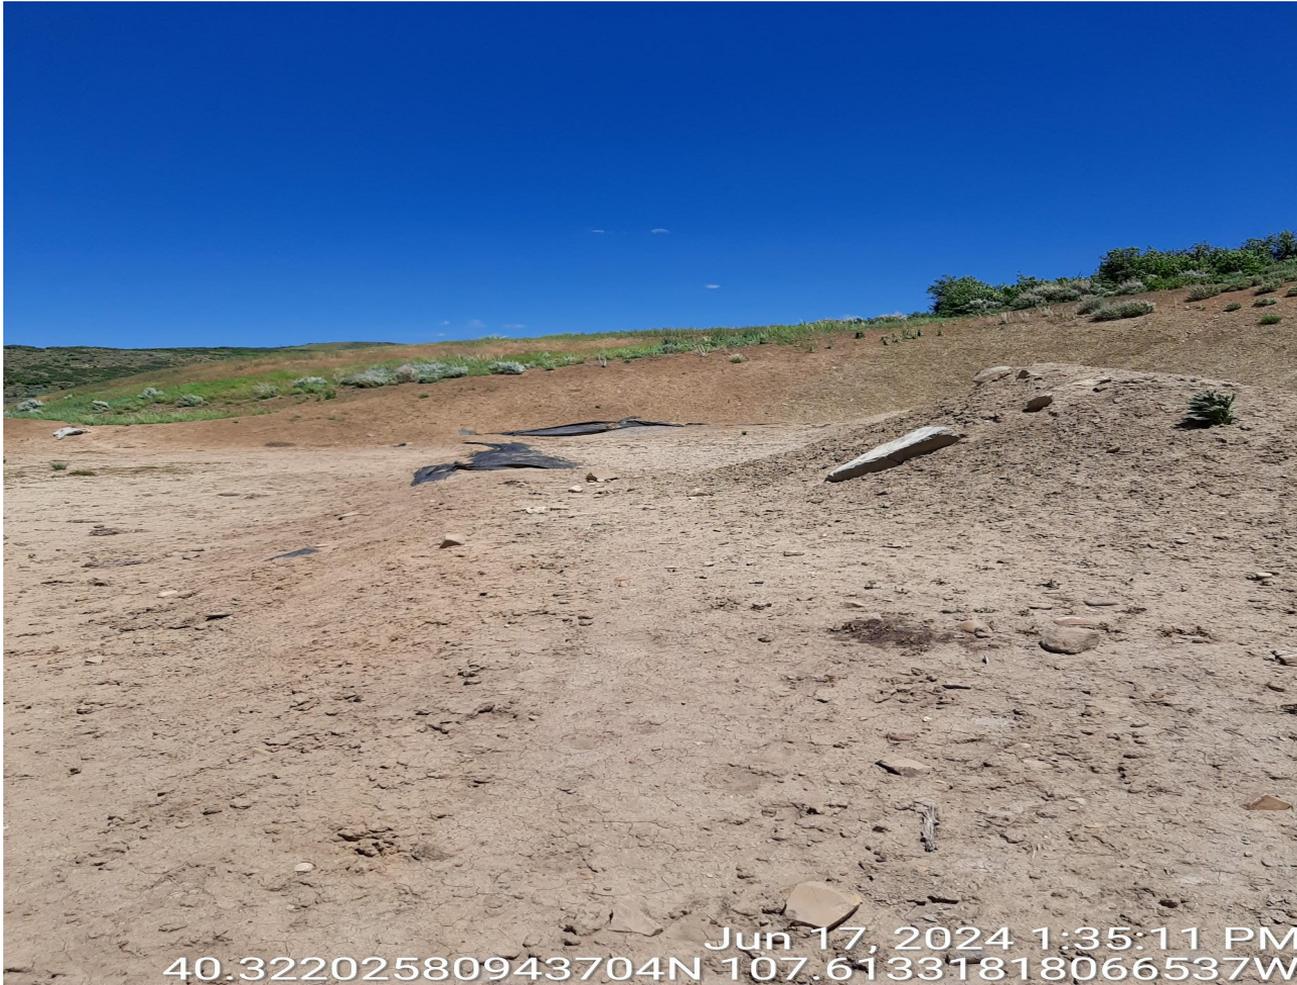
Jun 17, 2024 1:35:11 PM
40.32202580943704N 107.61331818066537W

Photo shows what is believed this is a former cuttings area. Soil stored inside this bermed/lined area should be sampled for Table 915-1. The liner MUST be removed and not buried

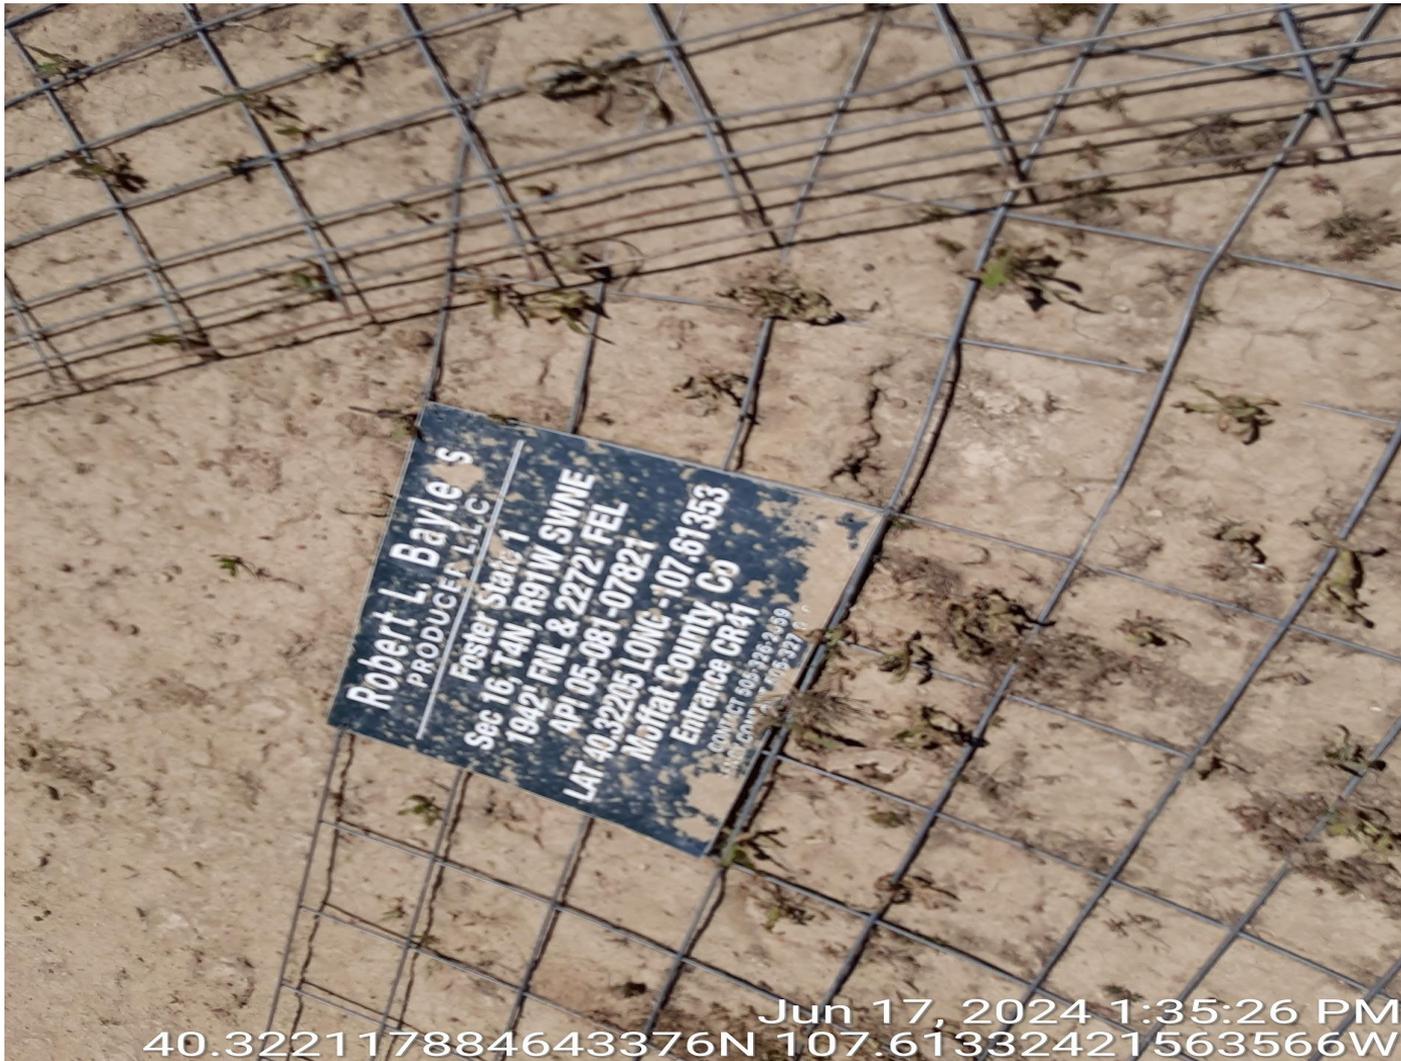
Jun 17, 2024 1:35:26 PM
40.322117884643376N 107.61332421563566W

Sign on ground near what is believed to be the Wellhead, the exact location of the PA wellhead was obvious.

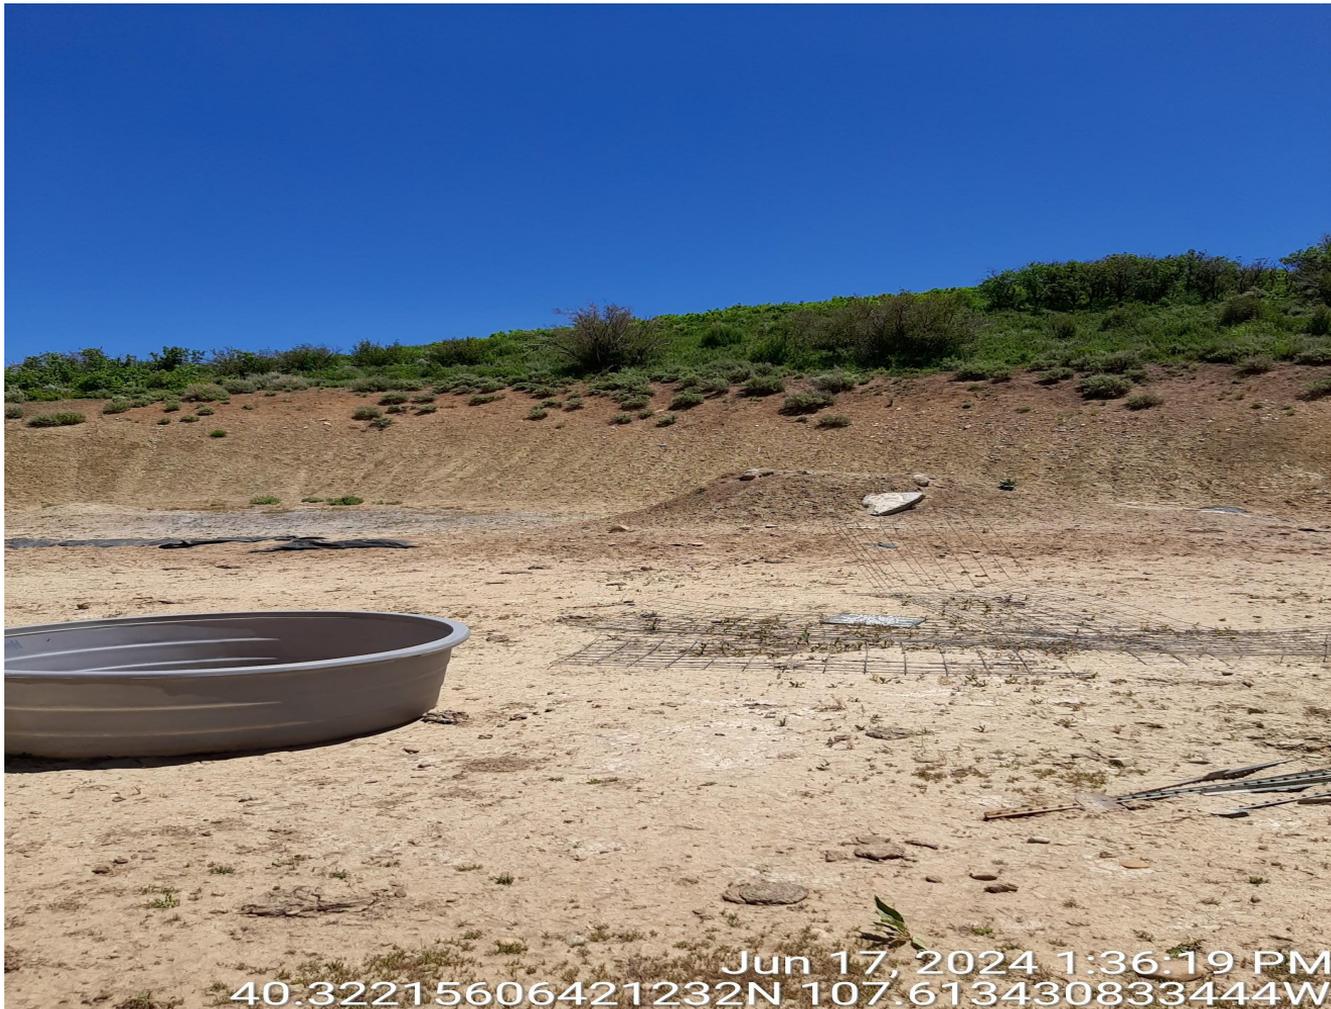
Jun 17, 2024 1:36:19 PM
40.32215606421232N 107.613430833444W

Looking east. Note: stored soil, paneling on ground, stock tanks on pad.

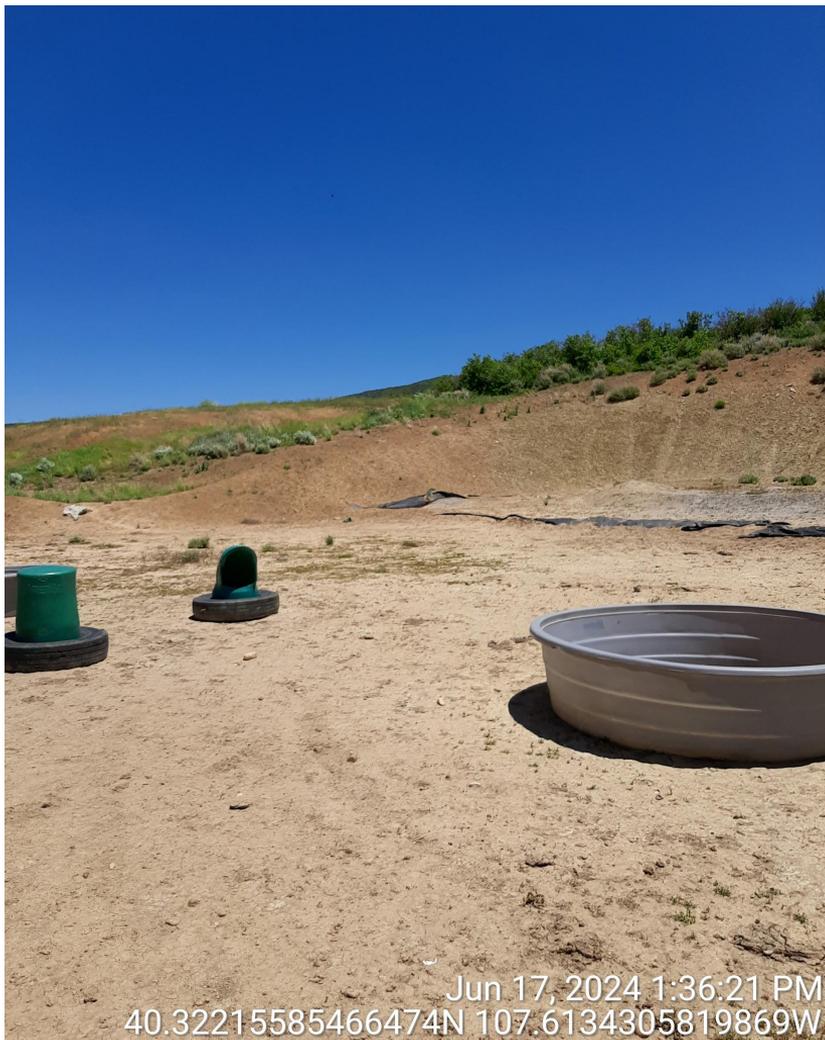
Jun 17, 2024 1:36:21 PM
40.32215585466474N 107.6134305819869W

Photo shows lined soil storage area. Liner must be removed, soil stored in liner shall be sampled for Table 915-1. Livestock supplies on pad.
