Operator: BCEI

Location Name: State Antelope 11-14-1HZ

Loc ID: 420123

Inspection: 696306413

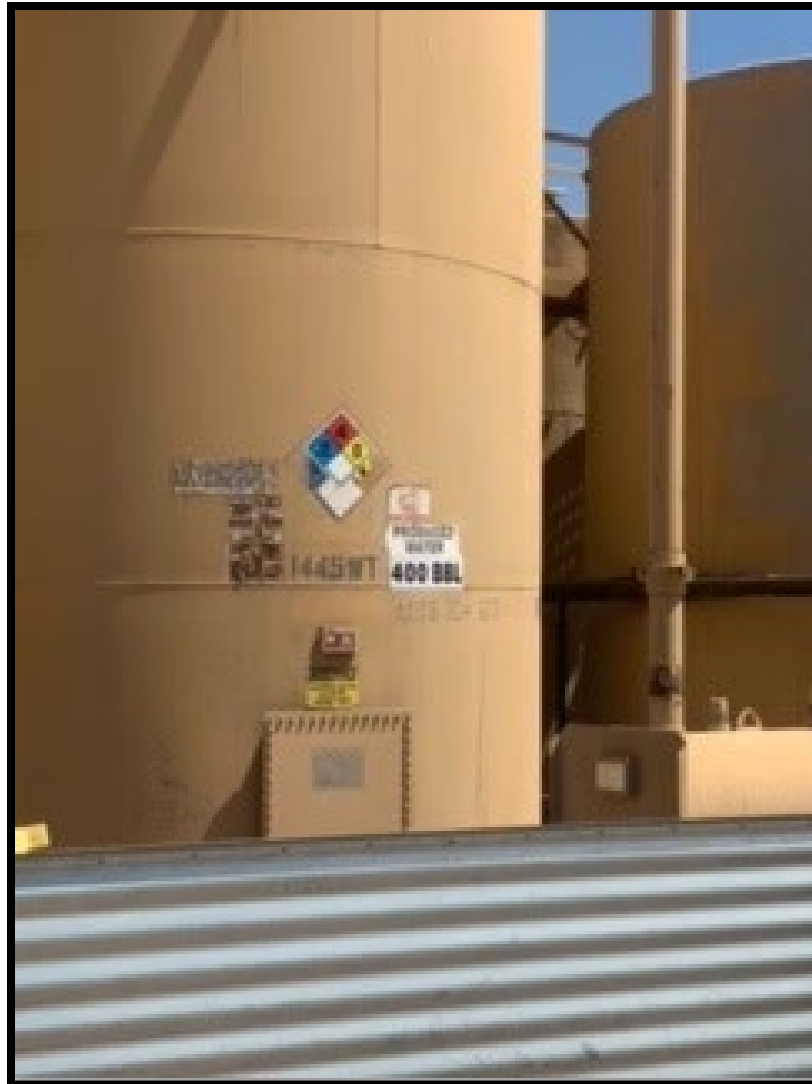
Exhibit A

CA: 144WT Tank - NFPA and Capacity Labels are peeling away North 300 BBL Water Tank Labels - Capacity Label has peeled away; no longer visible.
Install sign to comply with Rule 605.h.

CA Resolution: Operator has reported that new NFPA and Capacity labels have been installed on the identified tanks to comply with Rule 605.h.
