SITE NAME: Hall 42-33 Wellhead & Tank Battery							DATE: 3/28/2024	REM. PROJECT #: 33411	WEATHER: Sunny 40		
SITE DIRECTIONS: From CR31 & CR76, travel south 0.5 mile, east 200 ft., northeast into location							CLIENT: PDC				
LEGALS AND LAT/LONG: 40.533092, -104.776601							TASMAN PERSONNEL: SW				
SOIL TYPES: Clayey Sand - SC							SURFACE GRADIENT: Southwest				
SOIL SAMPLING							FACILITY INFRASTRUCTURE				
Date/Time	Soil Sample ID	PID (ppm)	Visual	Olfactory	Photo?	Grab or Lab Sample?	EQUIPMENT		Quantity		
							Above Ground Storage Tank (AST)		1		
3/28/2024 10:39	ECD01 @0-6"	0.1	No Staining	No Odor	Yes	Grab	Buried or Partially Buried Vessel		1		
3/28/2024 10:41	ECD02@0-6"	0.0	No Staining	No Odor	Yes	Grab	Separator		1		
3/28/2024 10:52	MH01@0-6"	0.0	No Staining	No Odor	Yes	Grab	Emission Control Device (ECD)		2		
3/28/2024 10:55	COMP01@0-6"	0.0	No Staining	No Odor	Yes	Grab	Dump Line		1		
3/28/2024 11:00	WDL01@0-6"	0.1	No Staining	No Odor	Yes	Grab	Wellhead		1

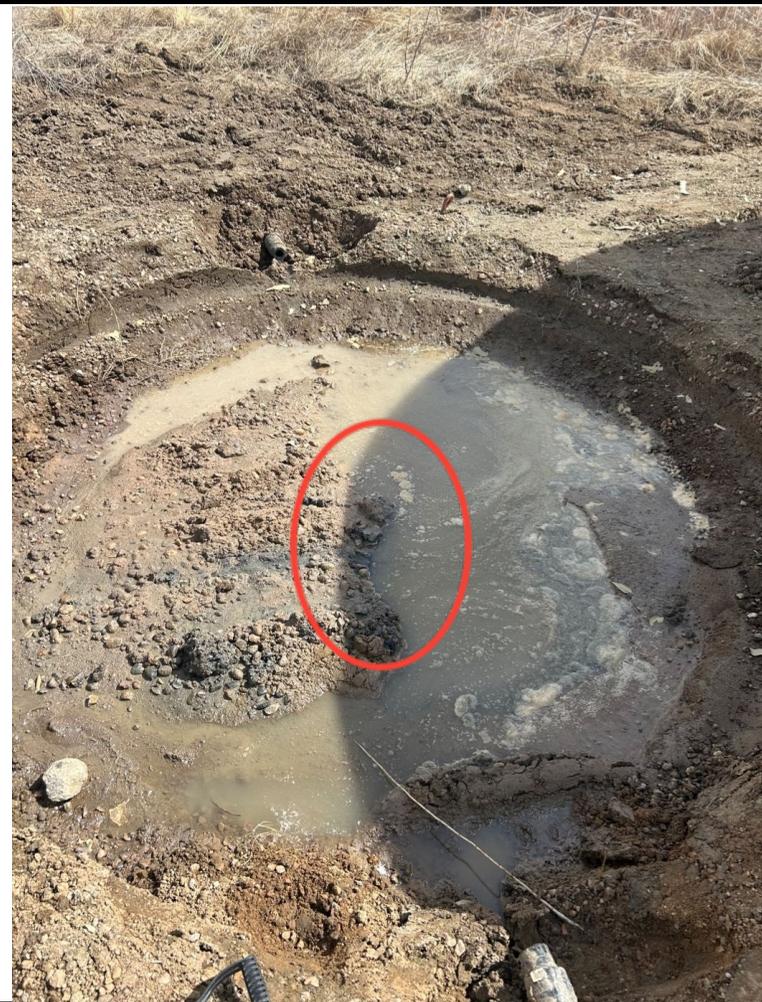
Equipment ID: wDL		Equipment Type:		Equipment ID: PWV01-B/gw01		Equipment Type:	
Material:	Volume:	Contents:		Material:	Volume:	Contents:	
Notes/Conditions:				Notes/Conditions:

3/28/2024 12:04	PWV01-B@2'	6.8	Organic Content	Slight HC Odor	Yes	Lab	Flowline		1		
3/28/2024 12:06	PWV01-N@1'	0.3	No Staining	No Odor	Yes	Grab	Other:				
3/28/2024 12:08	PWV01-E@1'	0.2	No Staining	No Odor	Yes	Grab	Soil Loads Removed				
3/28/2024 12:10	PWV01-S@1'	0.6	No Staining	No Odor	Yes	Grab	IMPACTED SOIL IDENTIFIED? <small>Yes</small>				
3/28/2024 12:14	PWV01-W@1'	1.0	No Staining	No Odor	Yes	Lab	ESTIMATED VOLUME OF IMPACTS:				
3/28/2024 12:19	FLR01@4'	6.0	Organic Content	Strong HC Odor	Yes	Lab	Date	Number	CY		
3/28/2024 12:23	WH01@6'	1.1	Organic Content	Slight HC Odor	Yes	Lab	3/28/2024	1	8		
3/28/2024 12:30	WHS01-N@0-6"	0.8	No Staining	No Odor	Yes	Grab					
3/28/2024 12:35	WHS01-E@0-6"	1.6	No Staining	No Odor	Yes	Lab					
3/28/2024 12:46	WHS01-S@0-6"	1.4	No Staining	No Odor	Yes	Grab					
3/28/2024 12:55	WHS01-W@0-6"	1.3	No Staining	No Odor	Yes	Grab	Total Removed		1	8	
3/28/2024 13:44	SEP01-FL@4'	8.9	HC Staining	HC Odor	Yes	Lab	Disposal Facility: WM - Ault

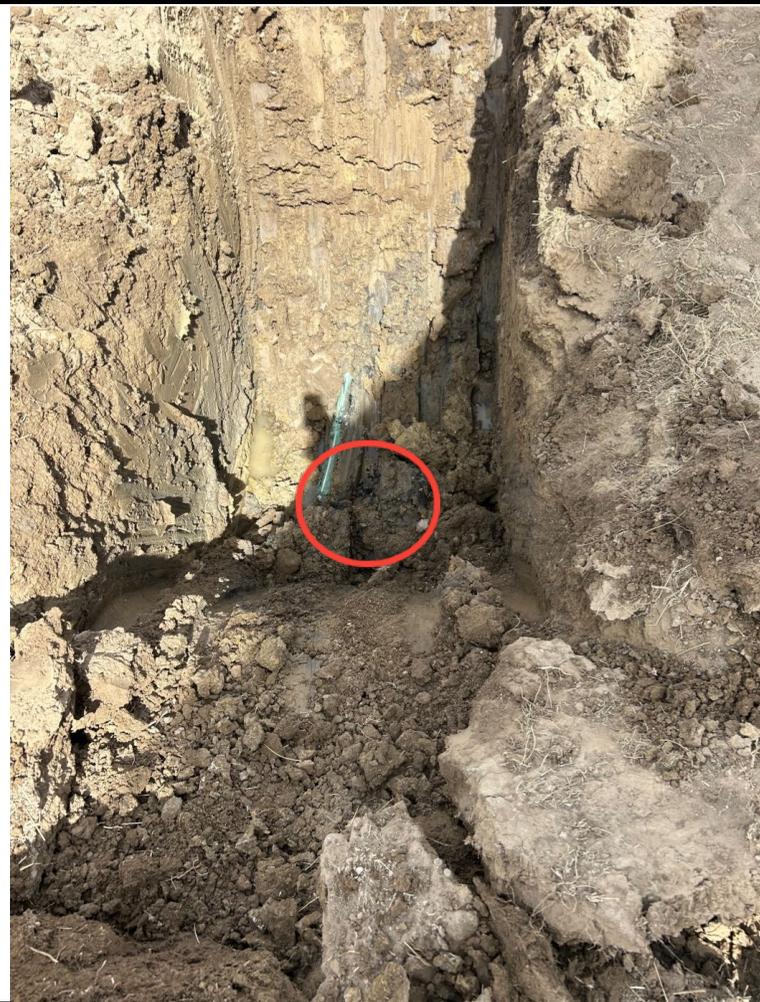
Equipment ID: WHS01-W		Equipment Type:		Equipment ID: FL01		Equipment Type:	
Material:	Volume:	Contents:		Material:	Volume:	Contents:	
Notes/Conditions:				Notes/Conditions:

3/28/2024 13:50	FL01-01@6'	1.0	Organic Content	No Odor	Yes	Lab	Groundwater Recovery				
3/28/2024 13:57	AST01@0-6'	0.4	No Staining	No Odor	Yes	Grab	DATE GW ENCOUNTERED: 3/28/2024		DEPTH: 2'		
3/28/2024 14:27	SEP01-DL@4'	10.0	HC Staining	Slight HC Odor	Yes	Lab	GROUNDWATER IN CONTACT WITH IMPACTED SOIL? Groundwater in contact with soil impacts.				
3/28/2024 14:37	BKG01@4'	0.2	No Staining	No Odor	Yes	Lab					
3/28/2024 14:39	BKG01@6'	0.3	No Staining	No Odor	Yes	Lab	LNAPL OR SHEEN OBSERVED ON GW? <small>Light sheen observed on GW.</small>				
GROUNDWATER SAMPLING							Date		BBLs		
Date/Time	Groundwater Sample ID	Depth Collected	Turbid?	Sheen?	Odor?	Photo?					
3/28/2024 11:14	GW01	2'	Low Turbidity	Light Sheen	Light HC Odor	Yes					
3/28/2024 12:14	GW02	6'	Low Turbidity	Light Sheen	Light HC Odor	Yes					
3/28/2024 14:14	GW03	6'	Low Turbidity	Light Sheen	Light HC Odor	Yes	Total Removed		0		
							Disposal Facility:
