Final Reclamation and Stormwater Inspection

Operator: Extraction Oil & Gas Inc - 10459

Location ID: 327754

Inspection Photos
Location Name: Hippen #2-32
Location ID: 327754

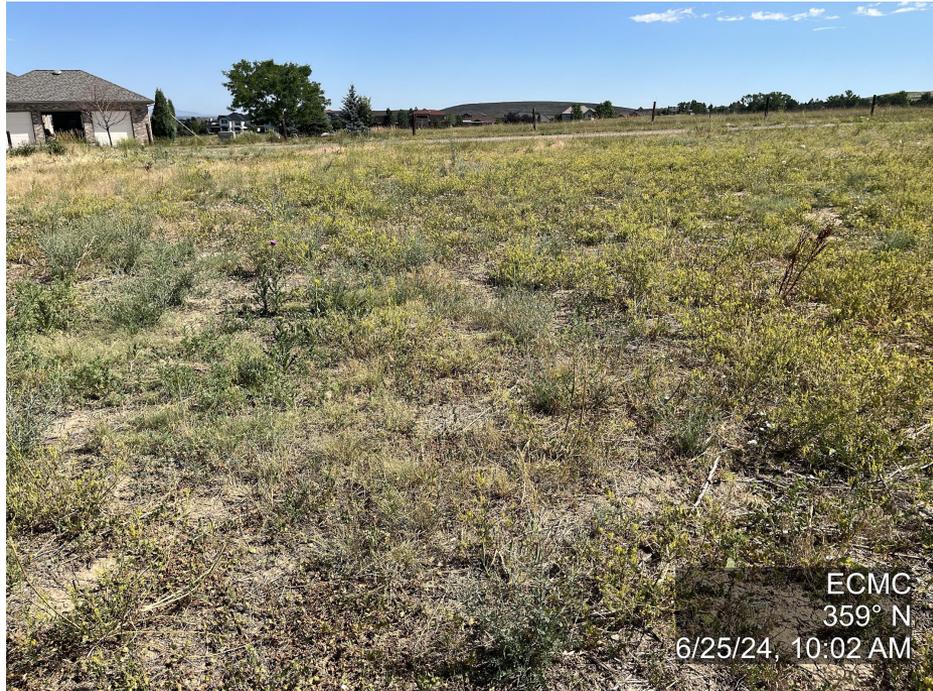
Photo 1. The photo was taken at the well location facing North. The photo illustrates the former well location is dominated by Knapweed, Field bindweed, Sweetclover and cover of Scotch thistle, Quackgrass and Smooth brome.

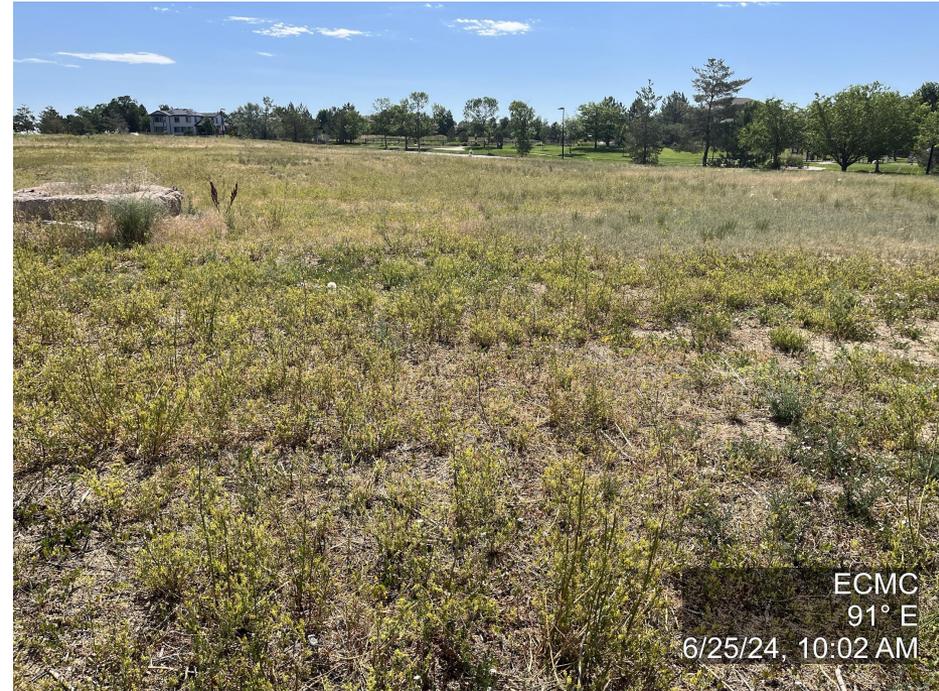
Photo 2. The photo was taken at the well location facing East. Refer to the comment for photo 1.

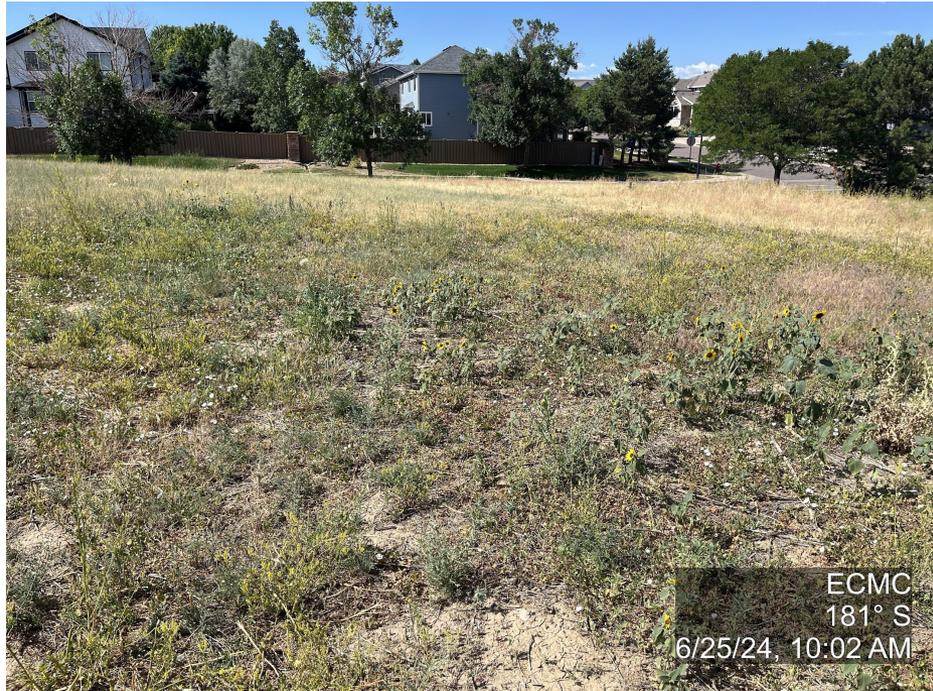
Photo 3. The photo was taken at the well location facing South. Refer to the comment for photo 1.

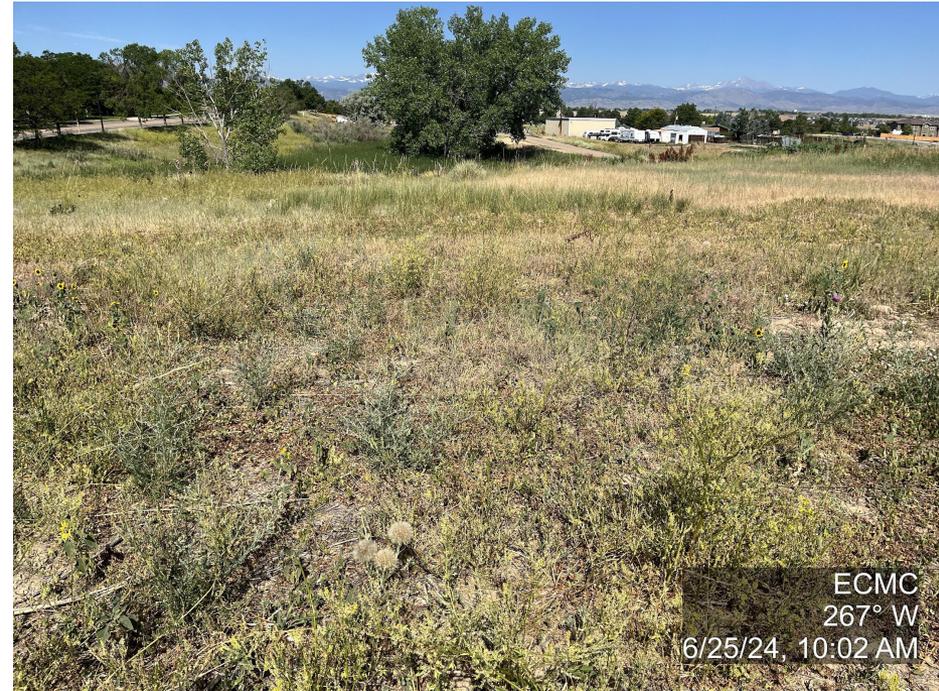
Photo 4. The photo was taken at the well location facing West. Refer to the comment for photo 1.

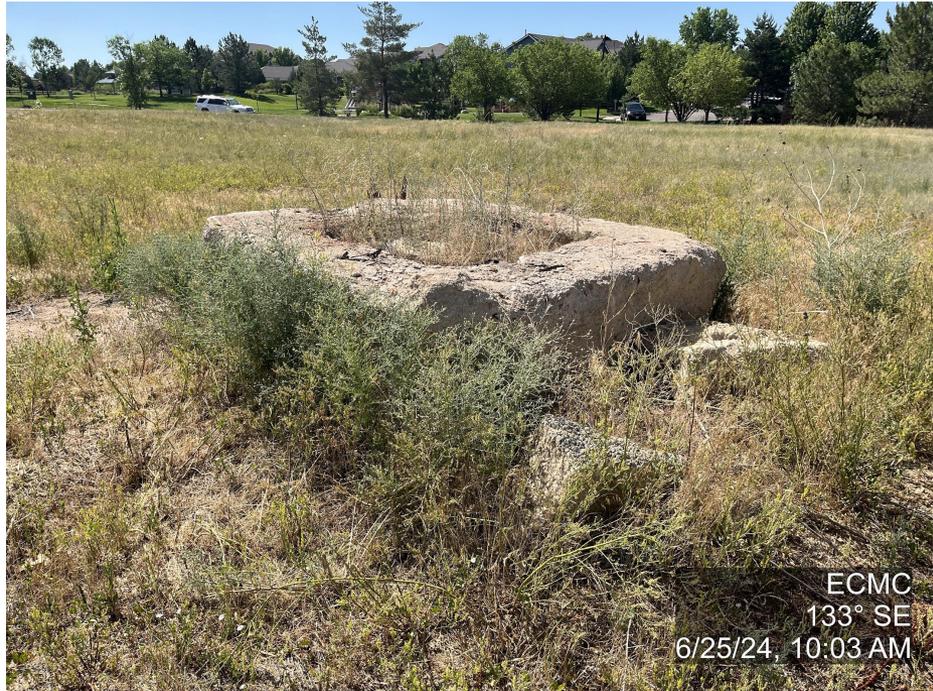
Photo 5. The photo was taken at the well location facing Southeast. The photo illustrates large blocks left at the well location that are accumulating noxious weeds.

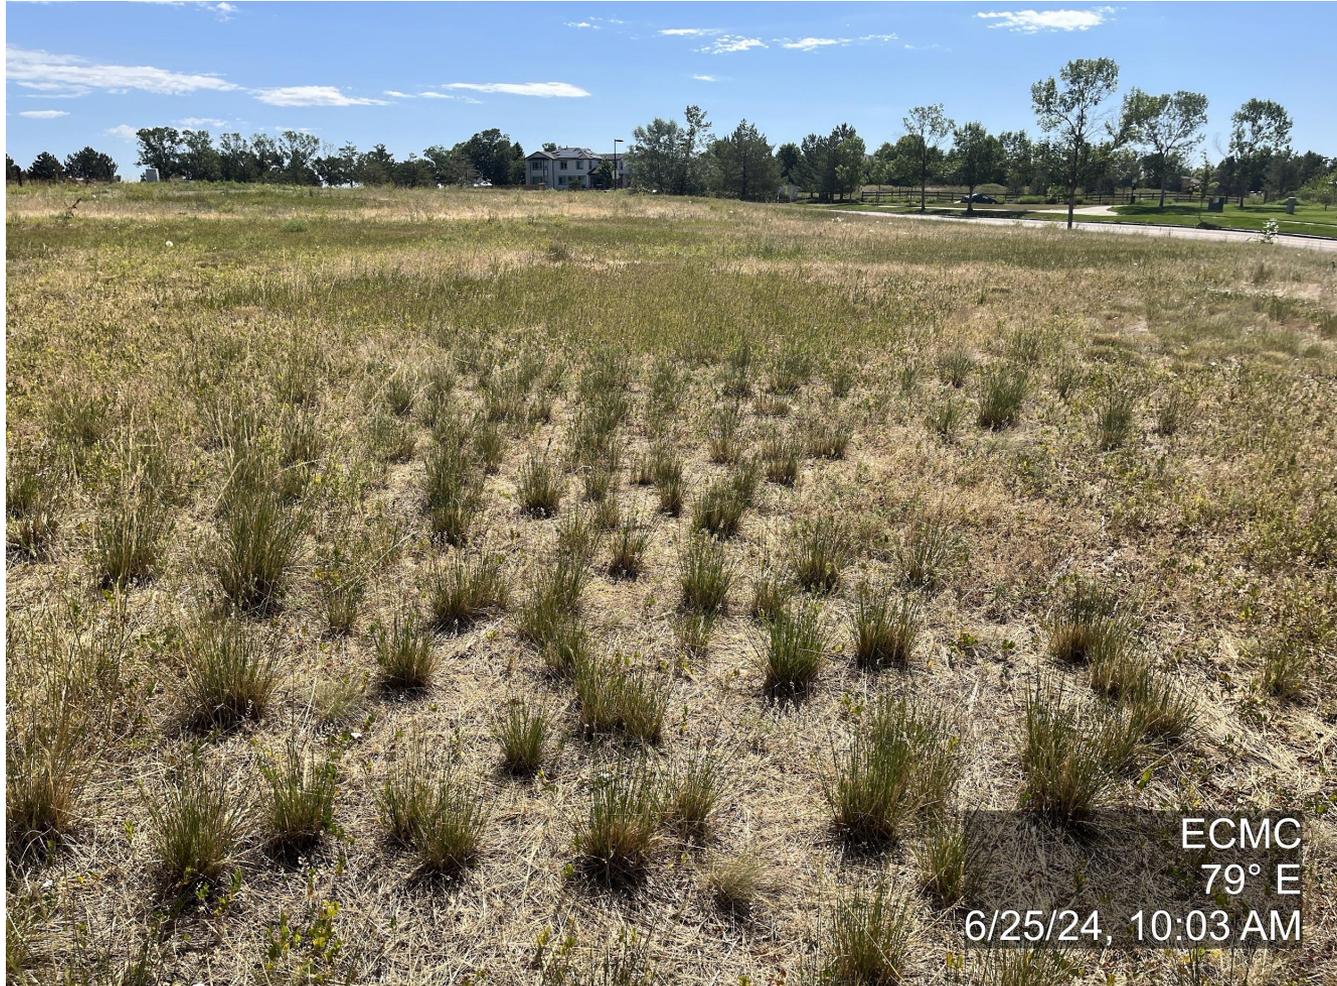
Photo 7. The reference photo was taken near the well location facing East. The photo illustrates reference areas are dominated by Smooth brome.
