**Operator: BCEI**  
**Location Name: Antelope F-15 PAD**  
**Loc ID: 429977**  
**Inspection: 696306463**

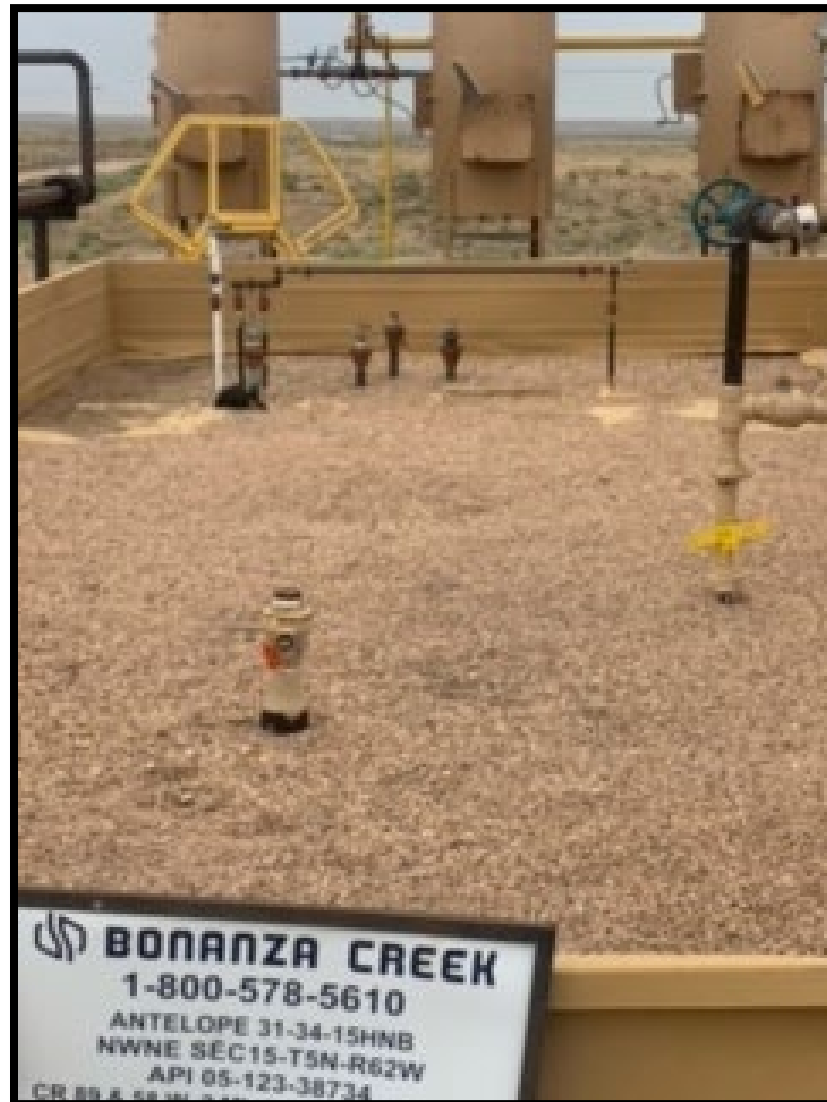
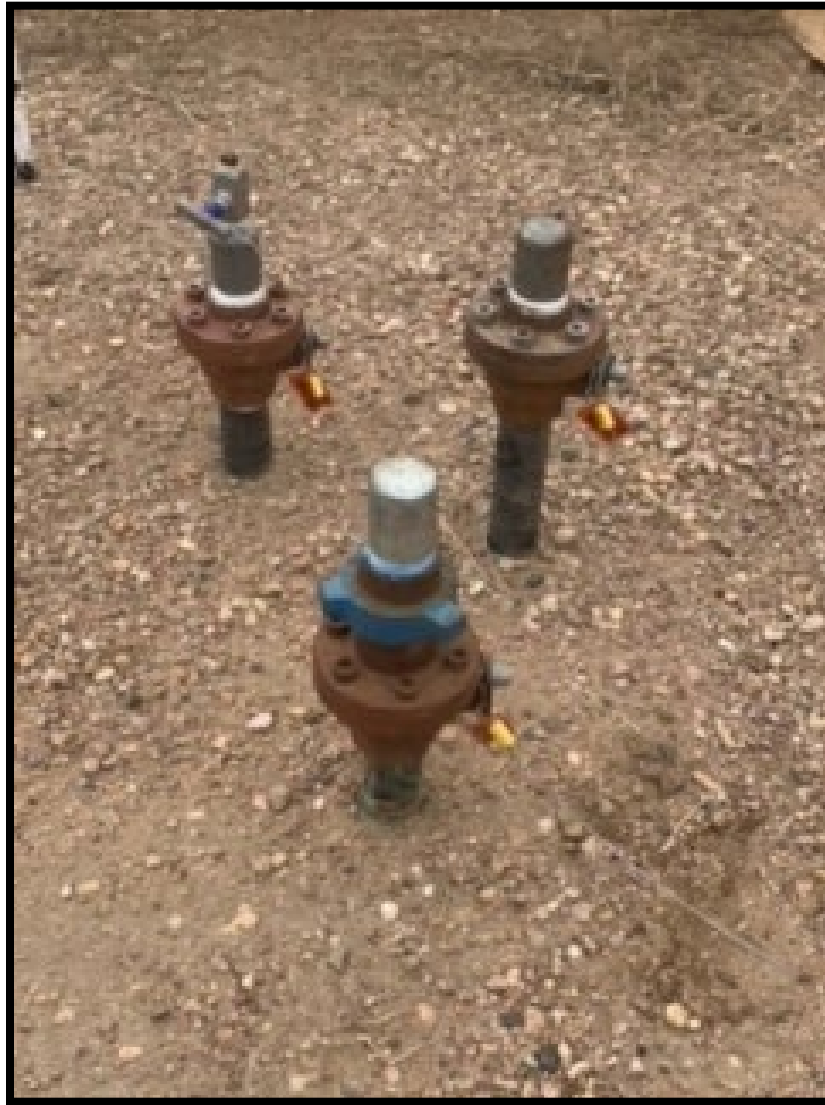
**CA:** Unmarked Risers at Antelope 31-34-15HNB Separator Site; see photos. Upon removing a flowline or crude oil transfer line from use with the intent to abandon, an operator must immediately apply OOSLAT to the risers. OOSLAT must stay in place at all times during the process of abandoning the flowline or crude oil transfer line until the operator removes the riser. Comply with Rule 1105.b.

**CA Resolution:** Operator has reported that identified risers have been appropriately marked to comply with Rule 1105.b.

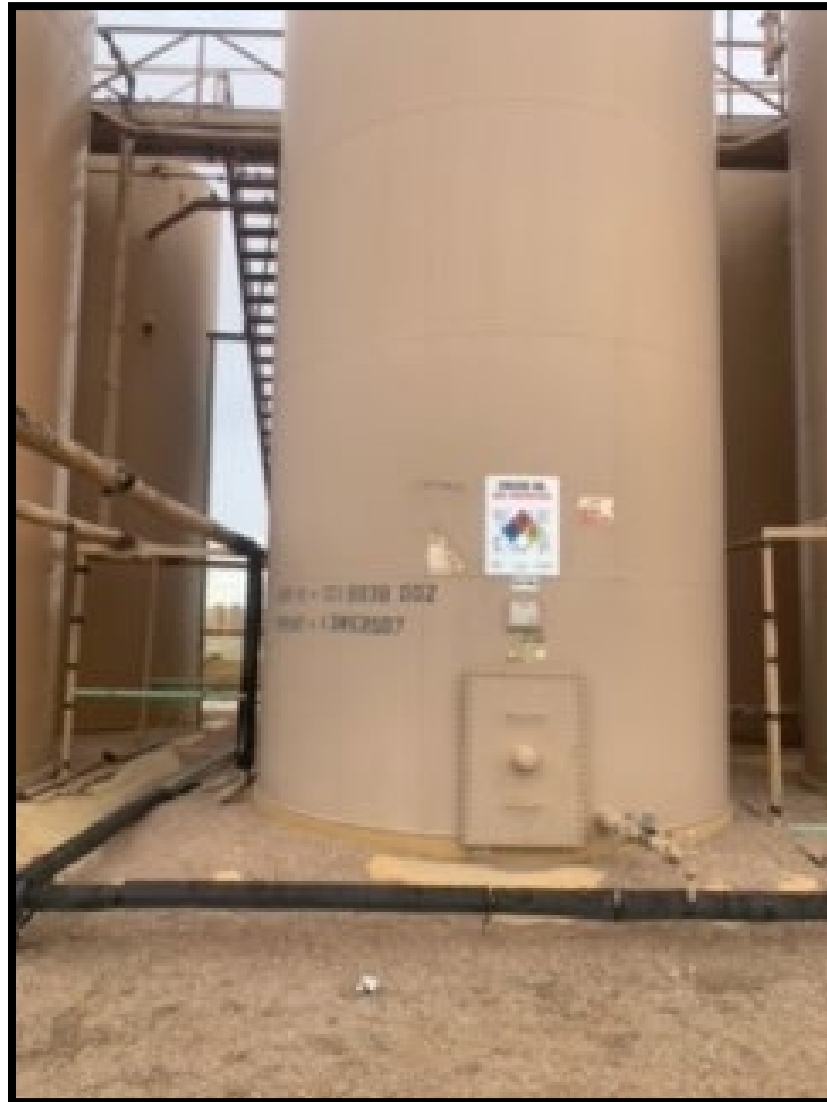
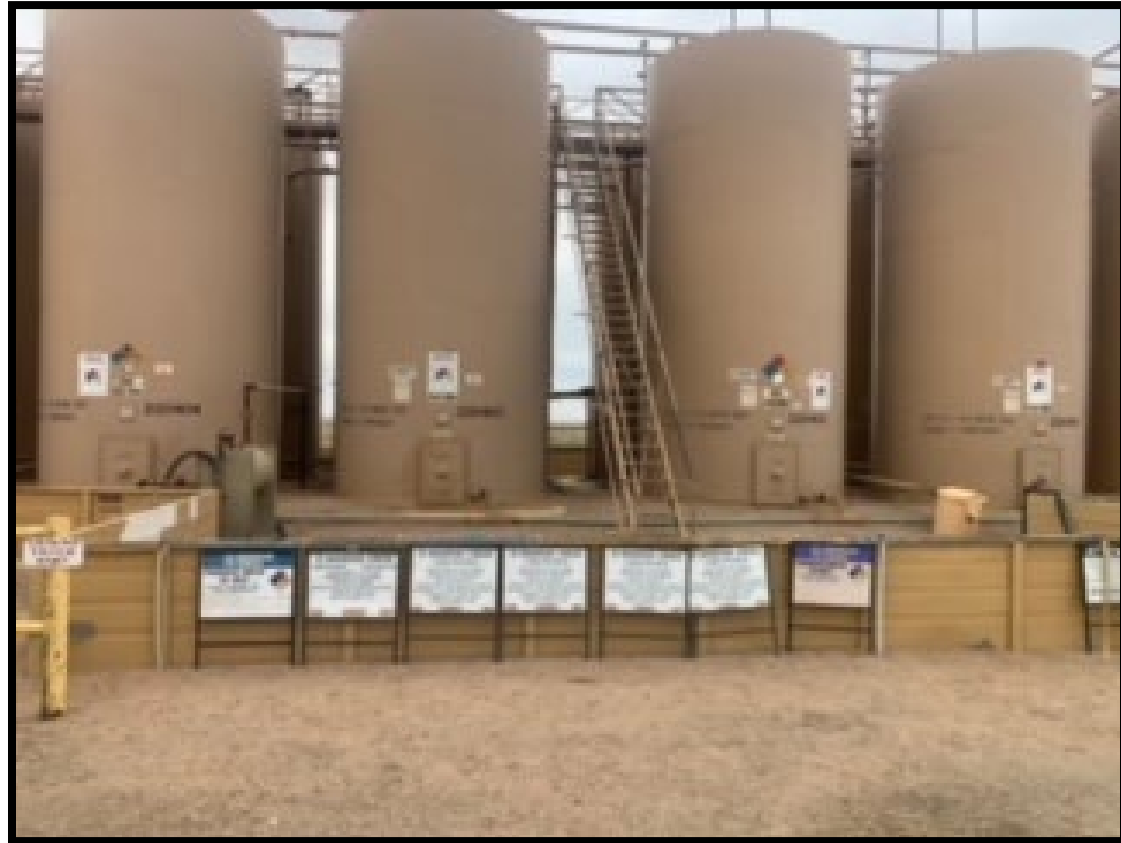
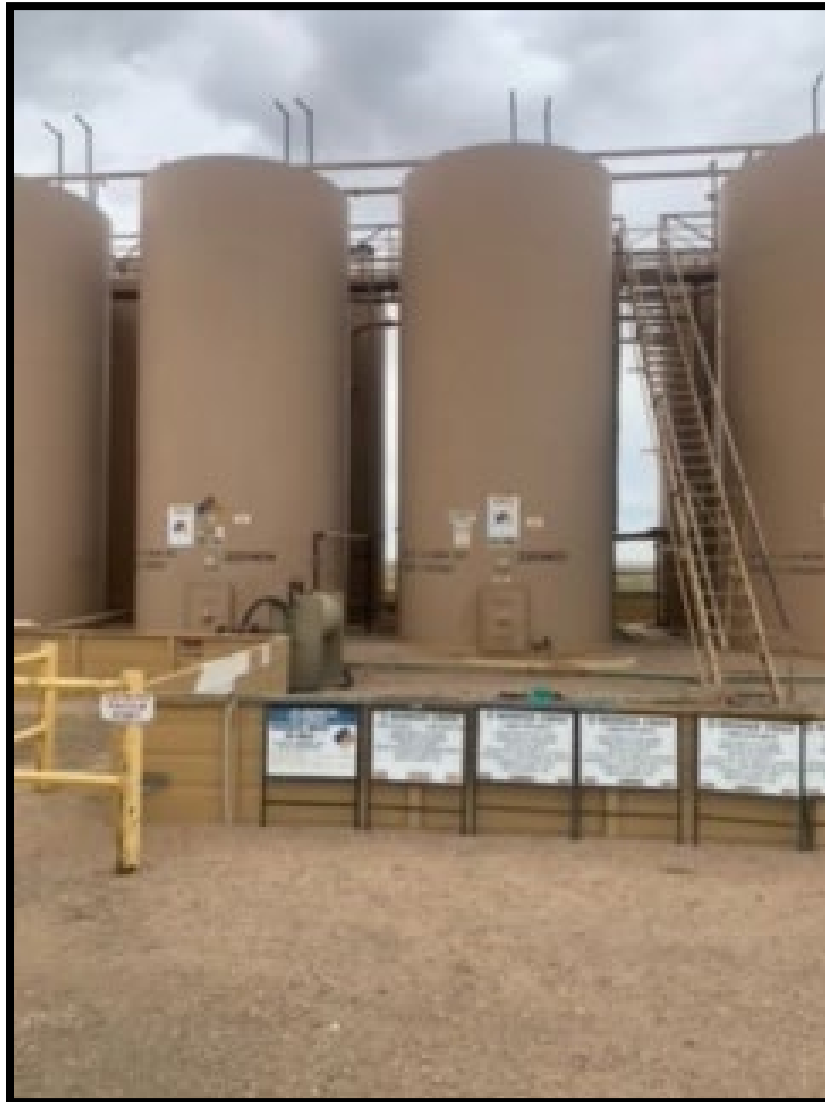
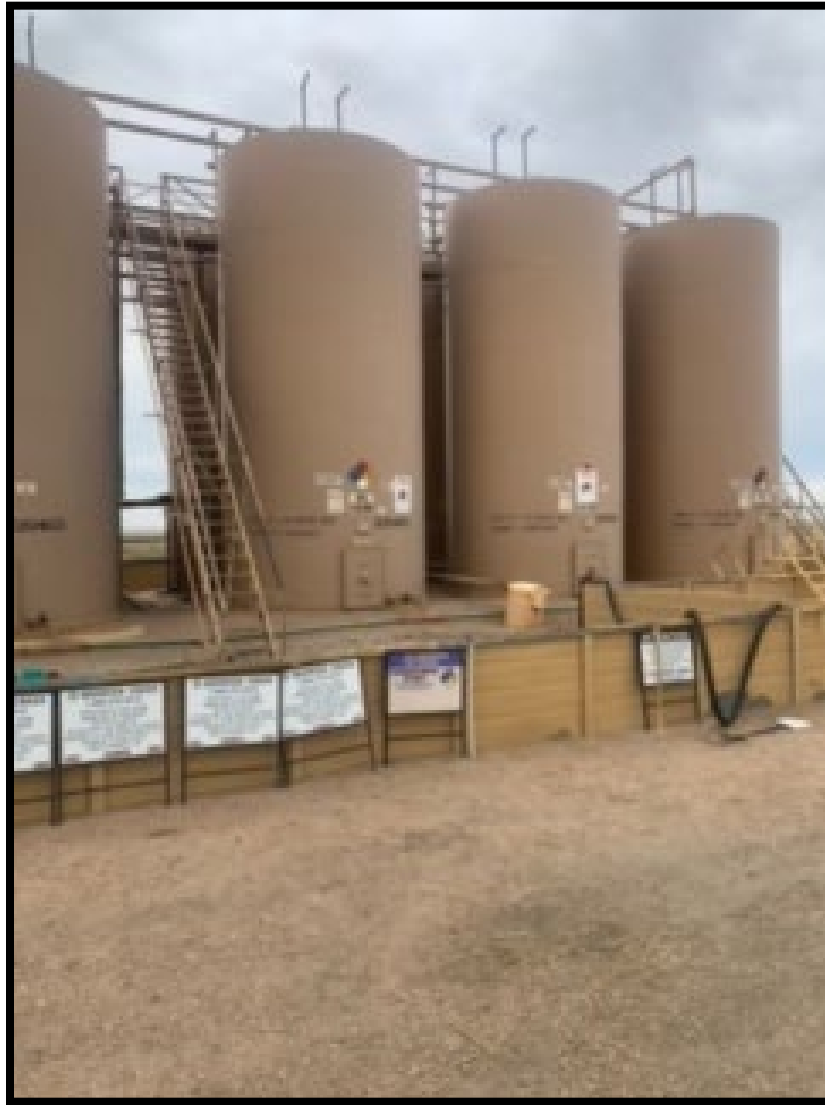
**CA:** Tank Labels STILL remain unaddressed - EAST TANK BATTERY LABELS - #1336 - NFPA and Content. #220404 - Content, Capacity and NFPA. #220403 - NFPA. #220402 - Capacity and Content. #220401 -NFPA. East side of East Tanks - far North Tank -Capacity. Far South Tank - Content, Capacity and NFPA. See photos. Same Corrective Action Date remains the same. Install sign to comply with Rule 605.h.

**CA Resolution:** Operator has reported that appropriate labels have now been installed to comply with Rule 605.h.
