Inspection Photos

Operator: Epic Energy LLC - 10684

Location ID: 325125

Inspection Photos
Location Name: Martinez 1
Location ID: 325125

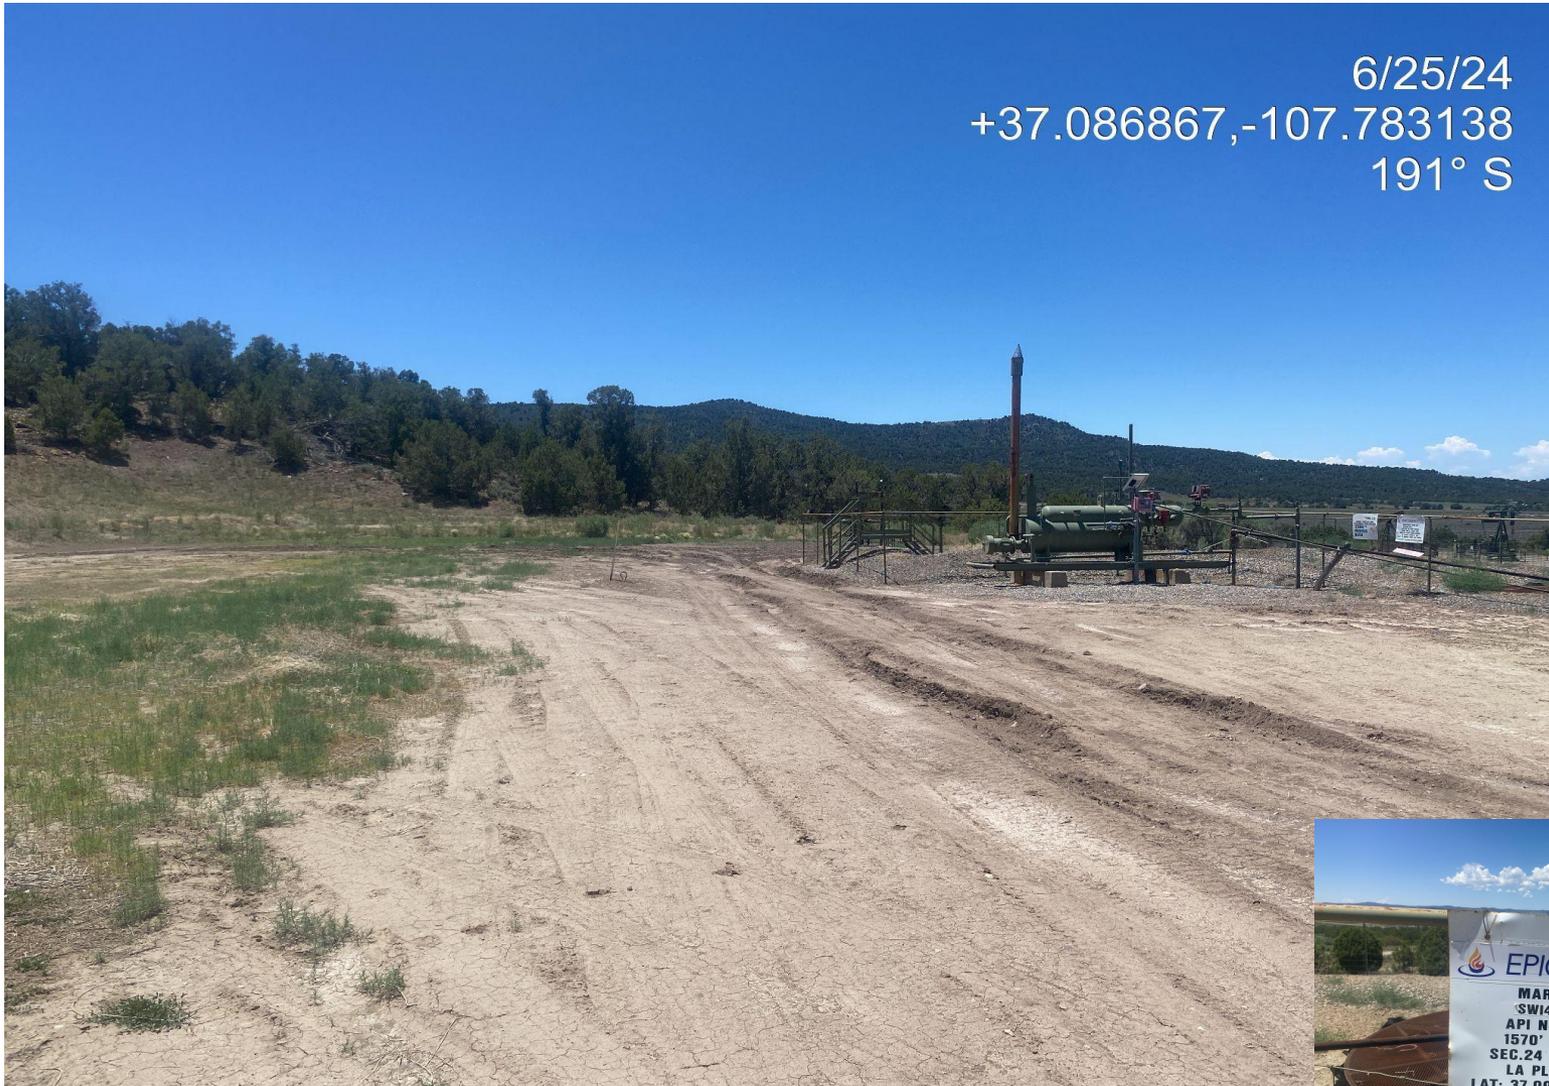
Photo 1. View of the well disturbance taken from the access point facing center.

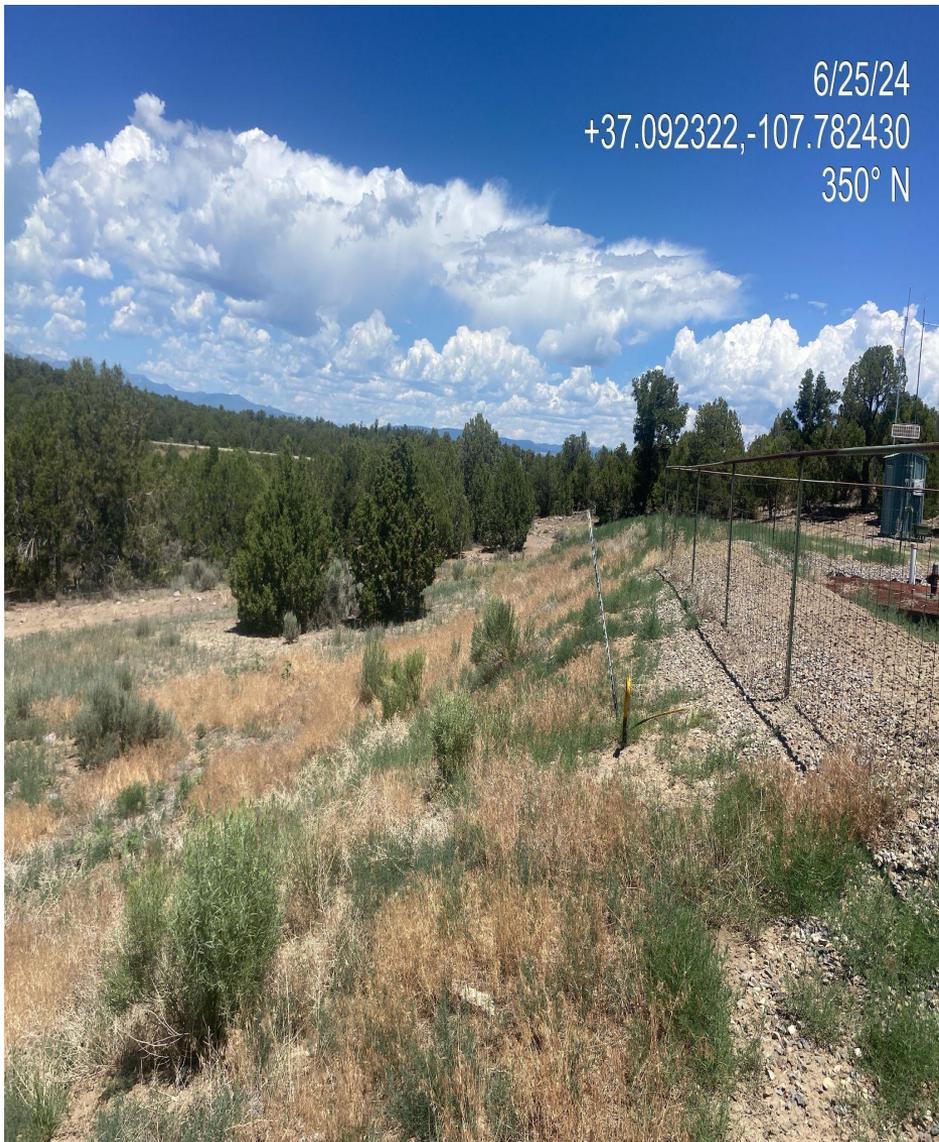
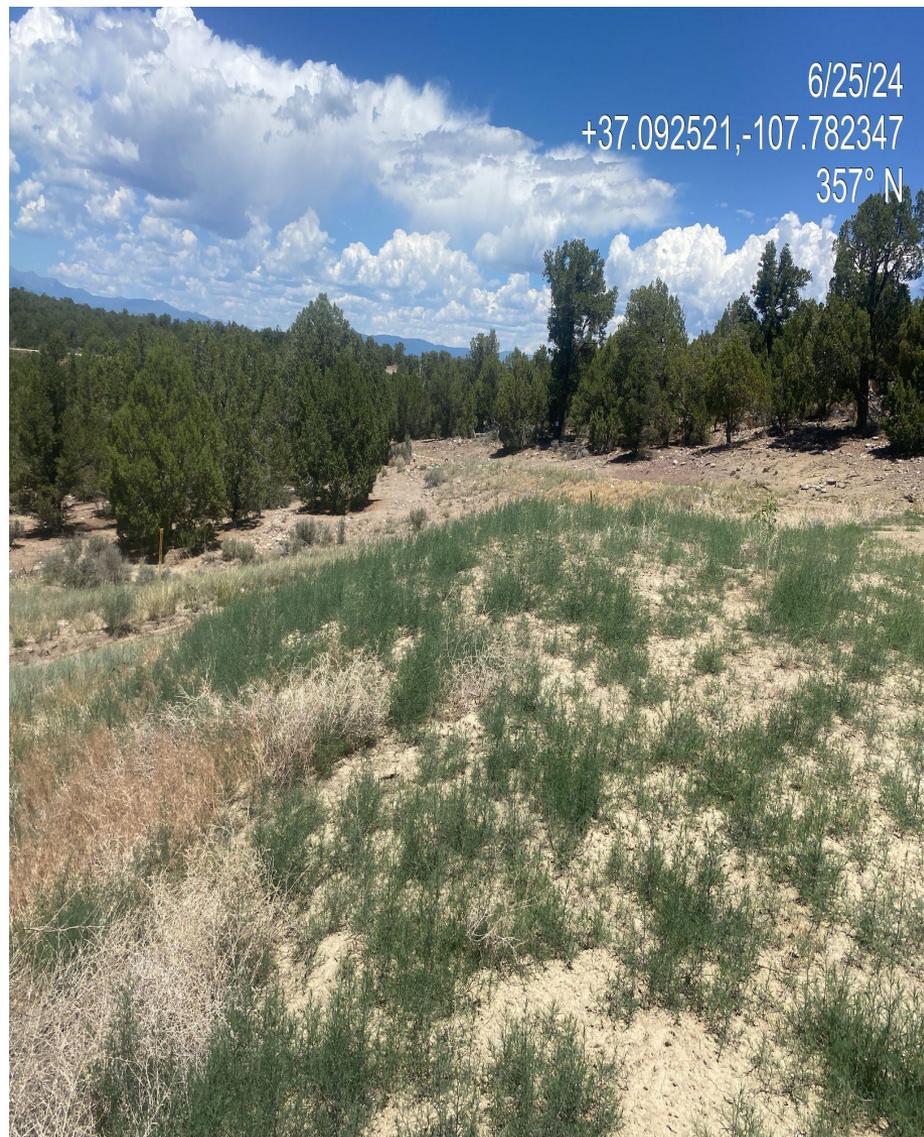
Photo 2. Western and Northwestern interim reclamation areas dominated by annual weeds including Cheatgrass and Russian thistle.

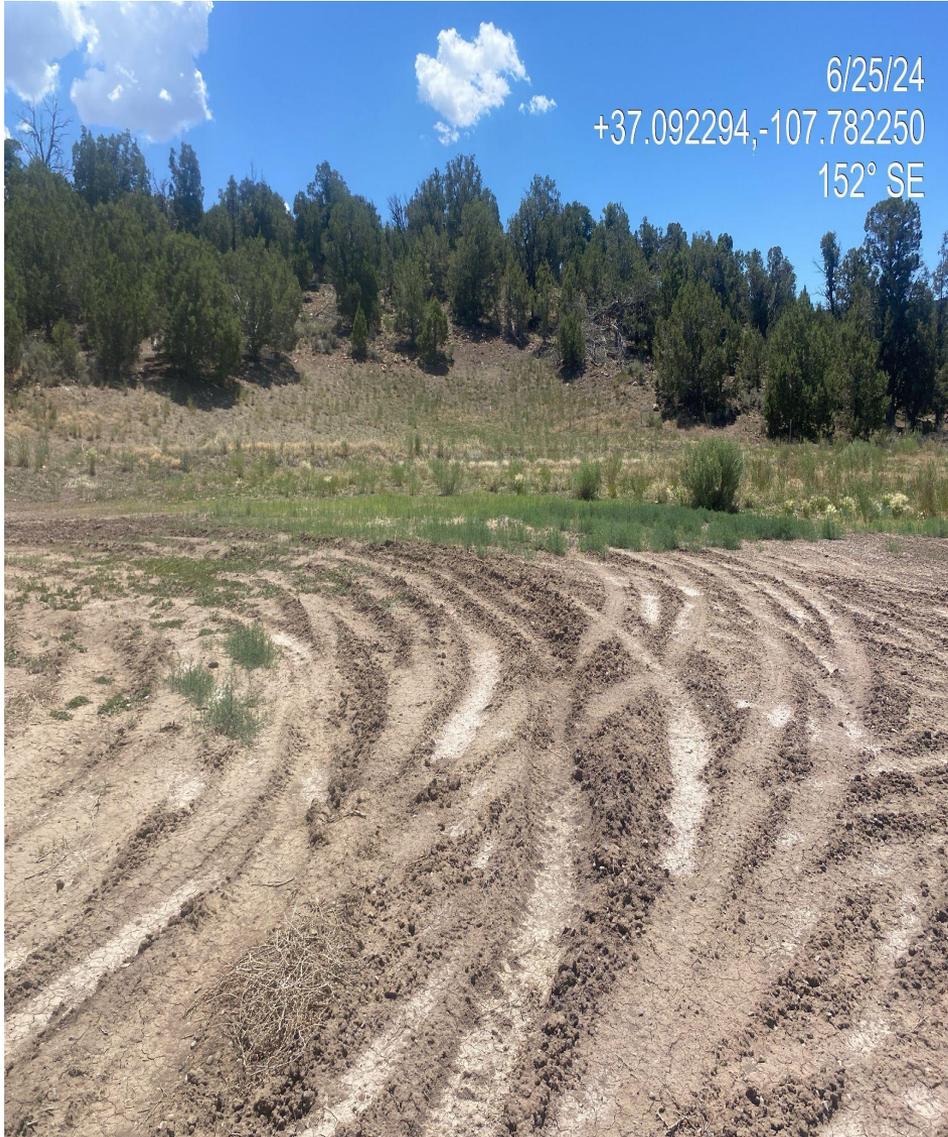
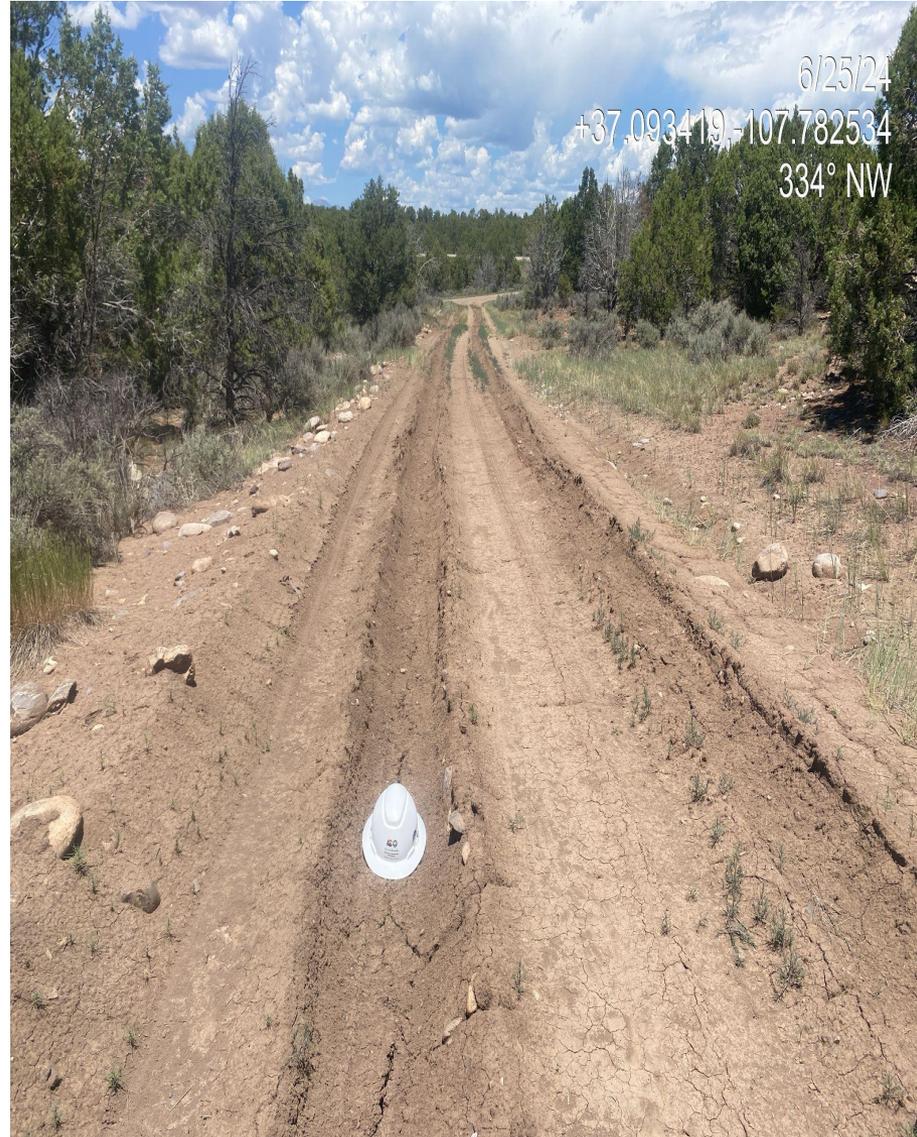
Photo 3. Rutting observed in the southeast corner of the active pad and along the access road. Additional stabilization/grading is needed to minimize degradation of the active pad/access road.

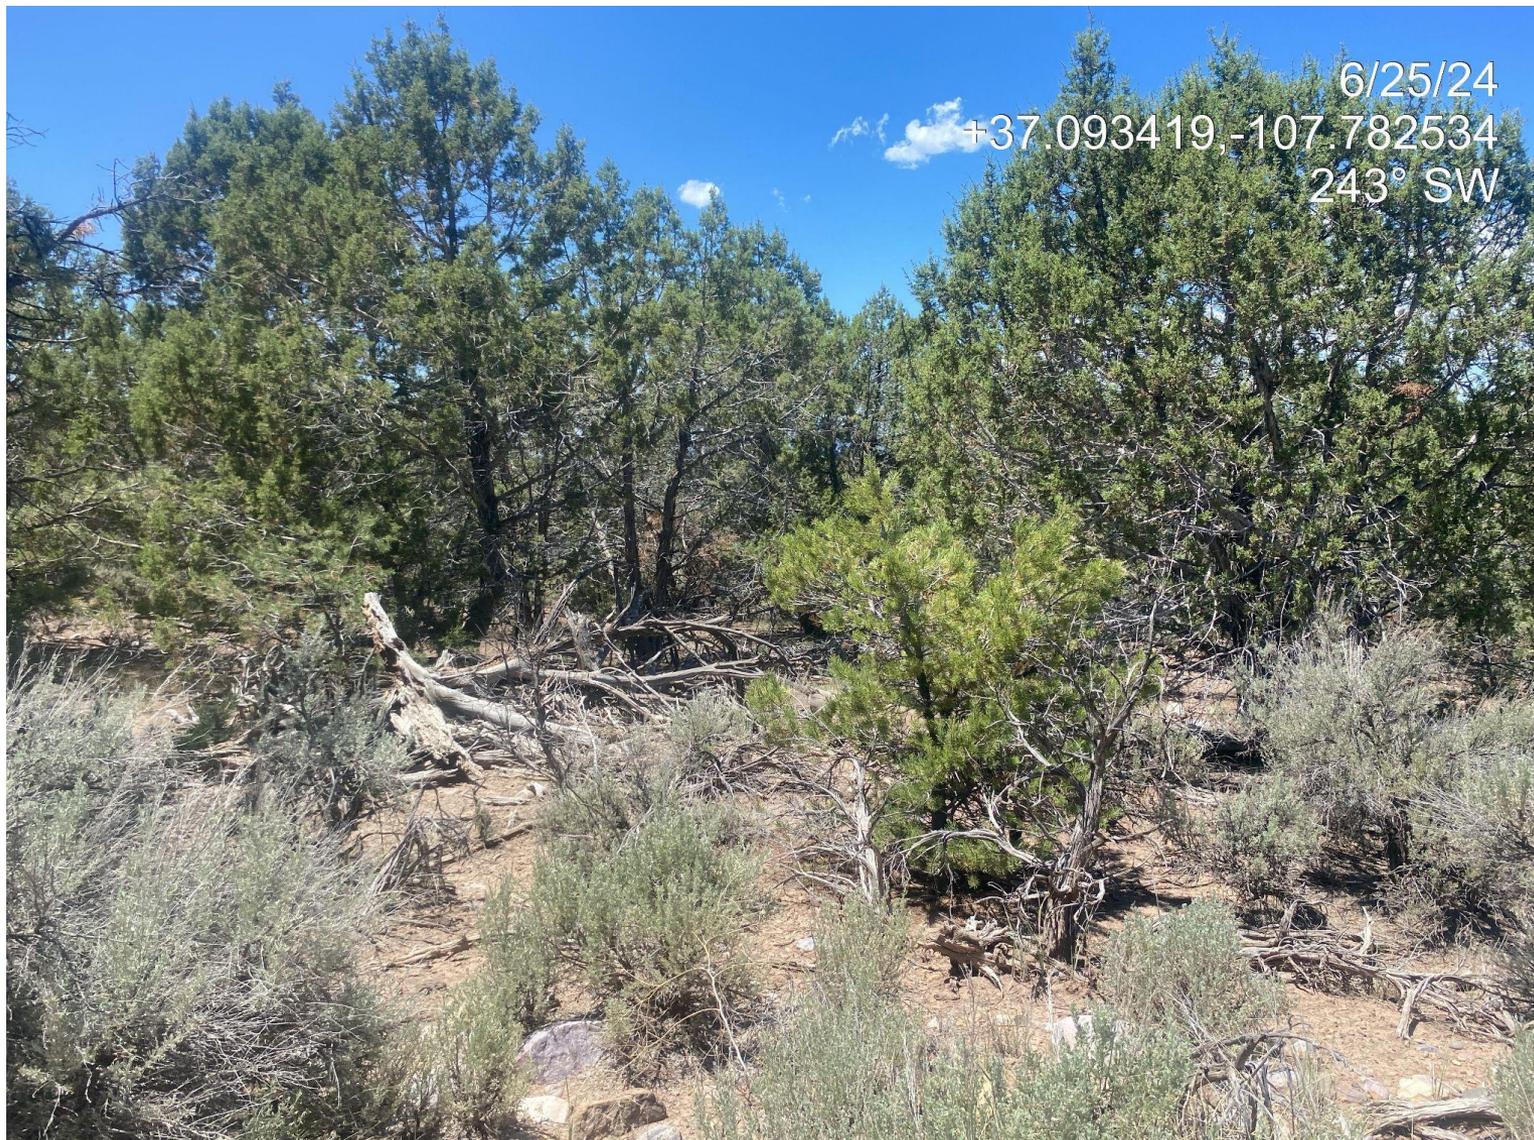
Photo 4. View of reference area comprised of sage brush and juniper.
