# Inspection Photos

**Operator:** ROBERT L BAYLESS PRODUCER LLC  
#6720

**Location ID:** 316762

Routt County, CO

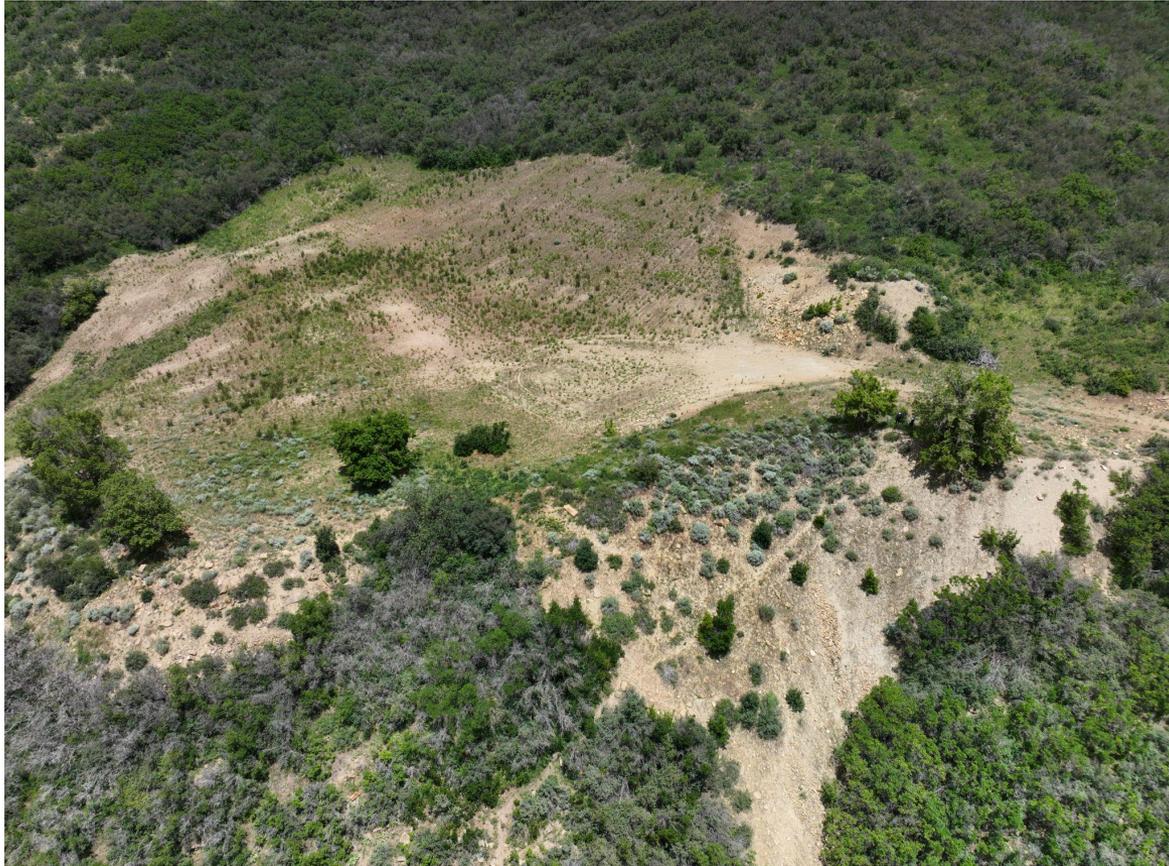
**Photo 1:** Photo taken with use of a sUAS. Photo taken from the southwest of the Location, facing northeast; photo provides an overview of the Location.

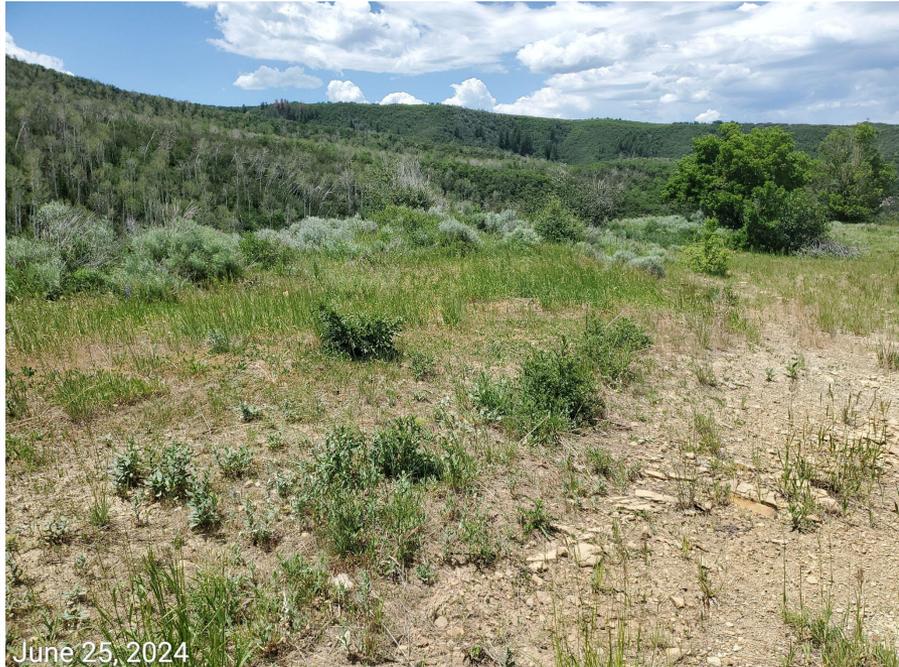
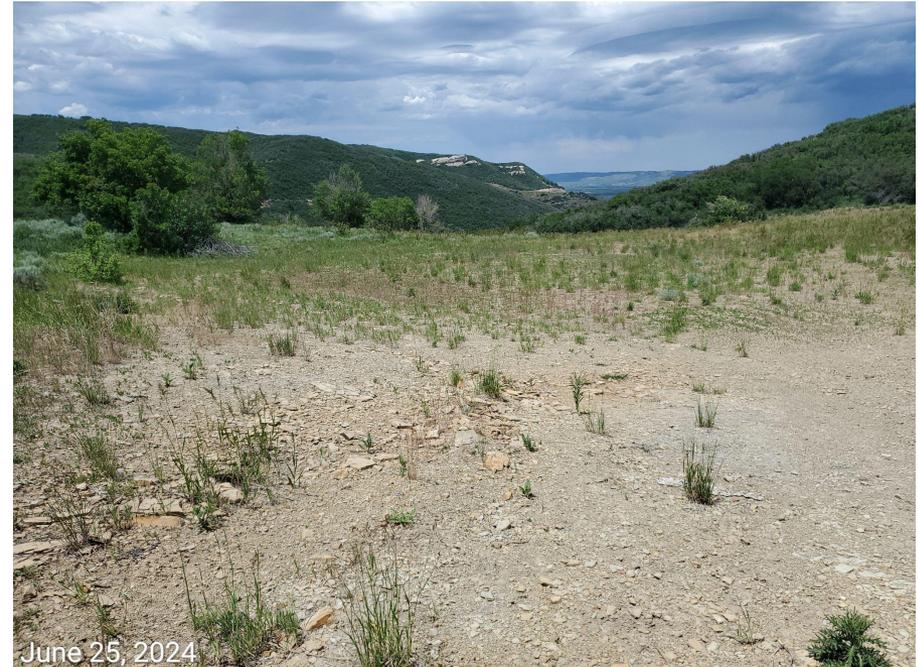
**Photo 2:** Photos 2-3 taken from the Location entrance on the east end of the site. Photos provide an overview from southwest, west north to northeast. Photos show Location has not been reclaimed in accordance with 1004 rules. Locations is predominantly Undesirable Plant Species or bare/exposed soils. Unable to find evidence that topsoil has been replaced, or exists on the Location.

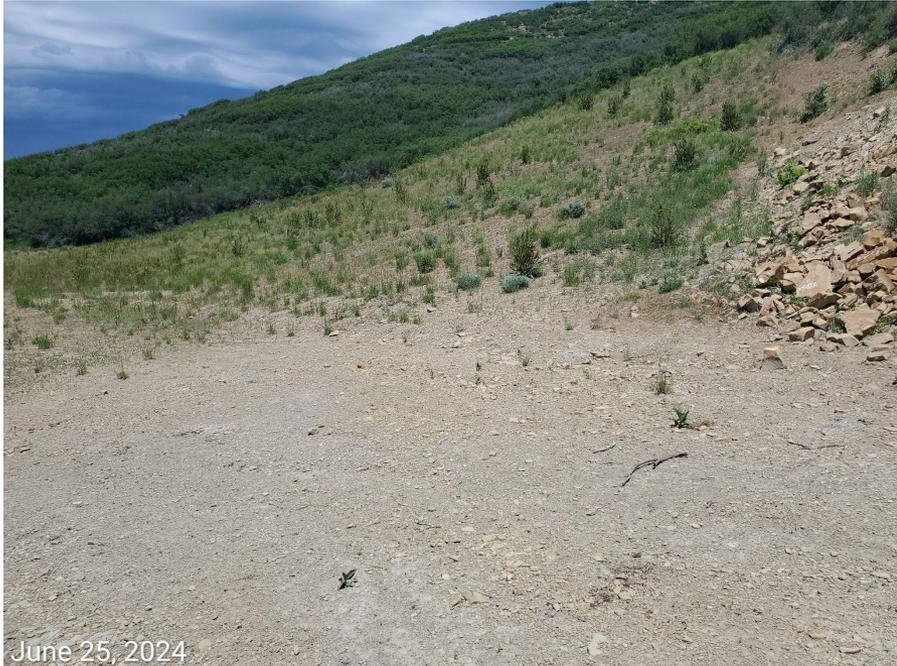
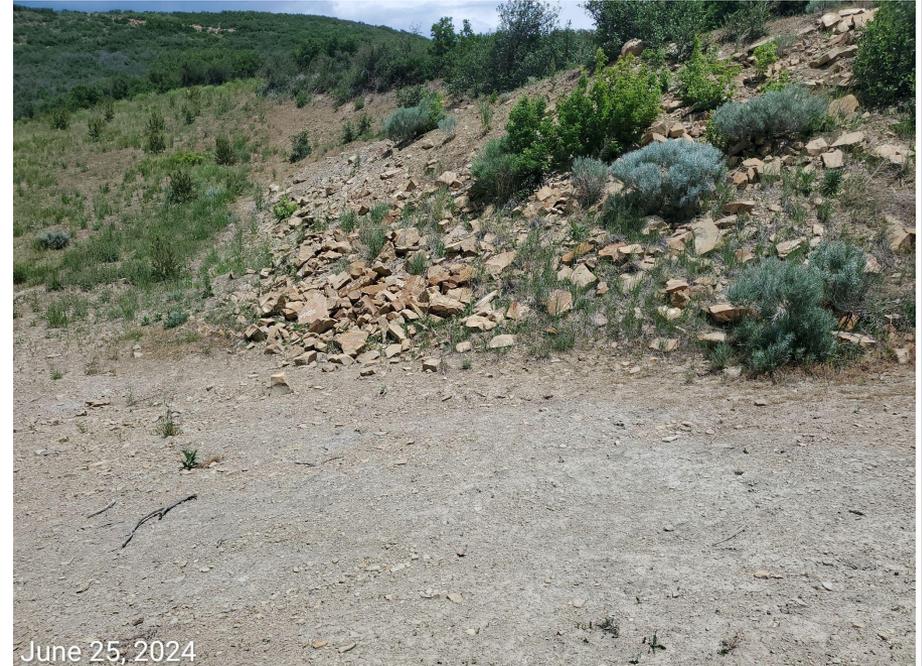
**Photo 3:** See comments under photo 2.

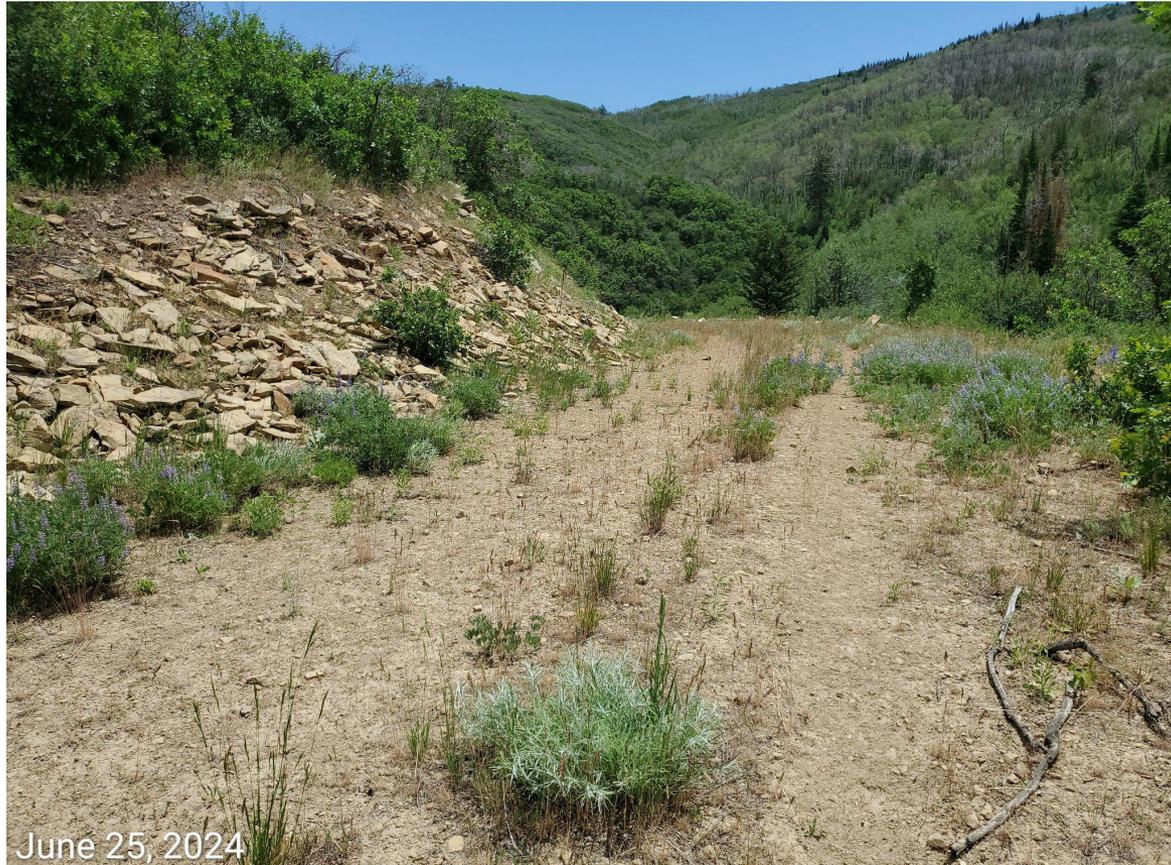
**Photo 4:** Photo example showing access road has not been recontoured/regraded and reclaimed in accordance with 1004 Rules.

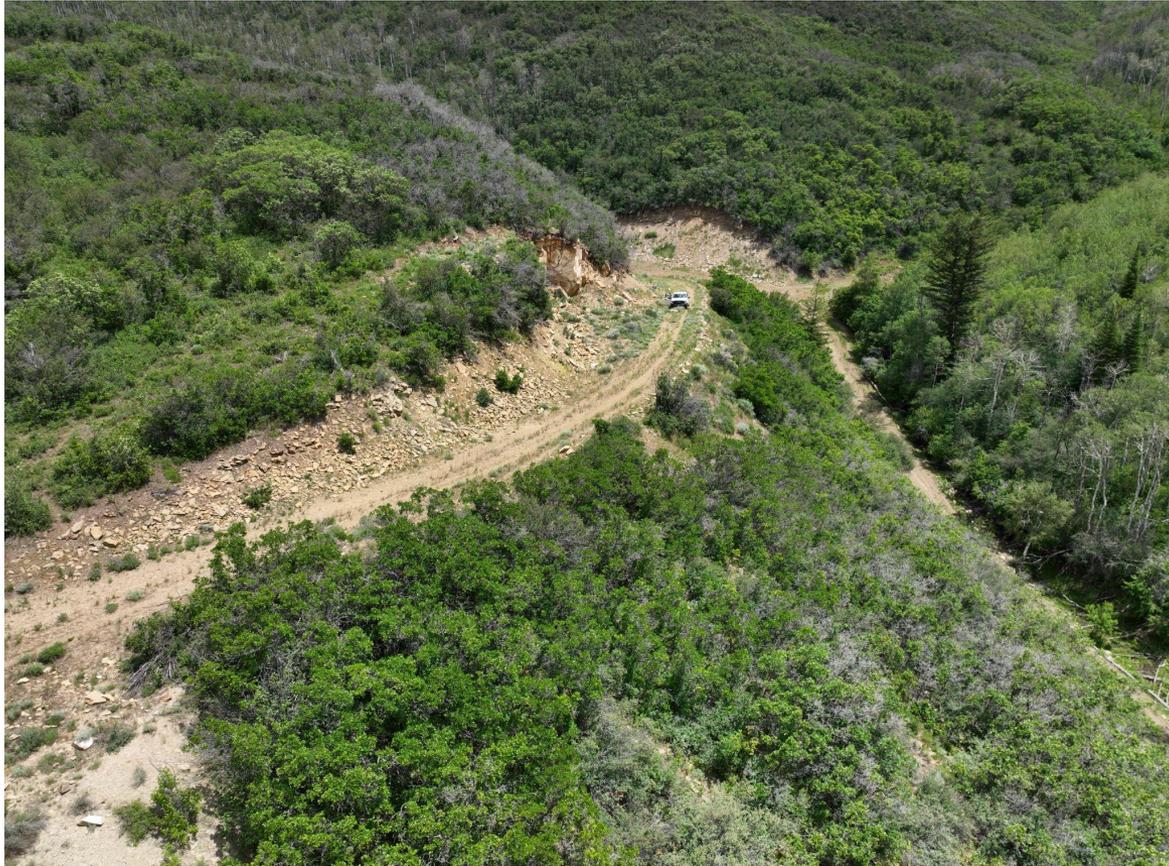
**Photo 5:** Continued from photo 4. Aerial image showing access road has not been recontoured/regraded and reclaimed in accordance with 1004 Rules.

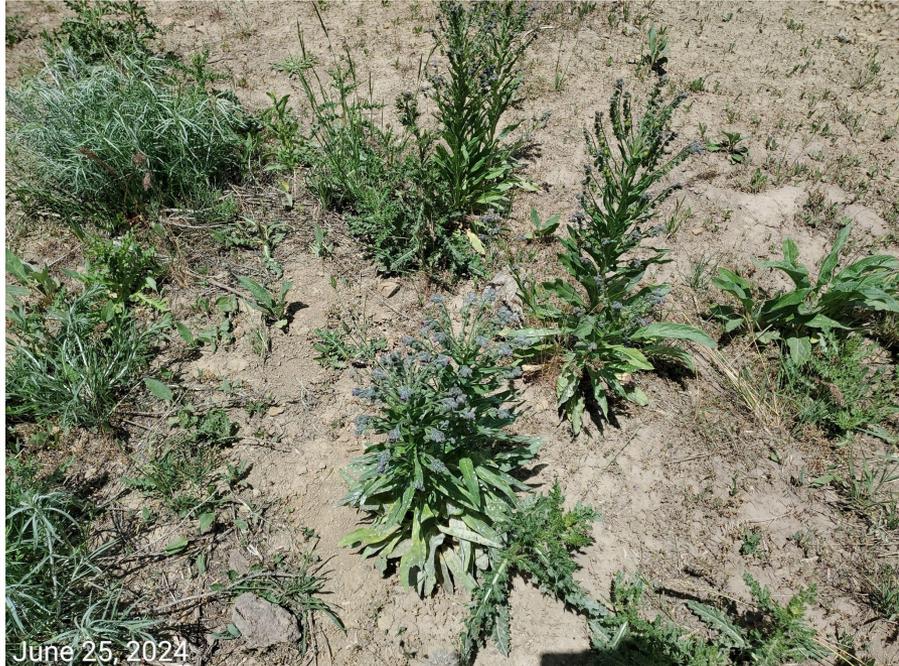
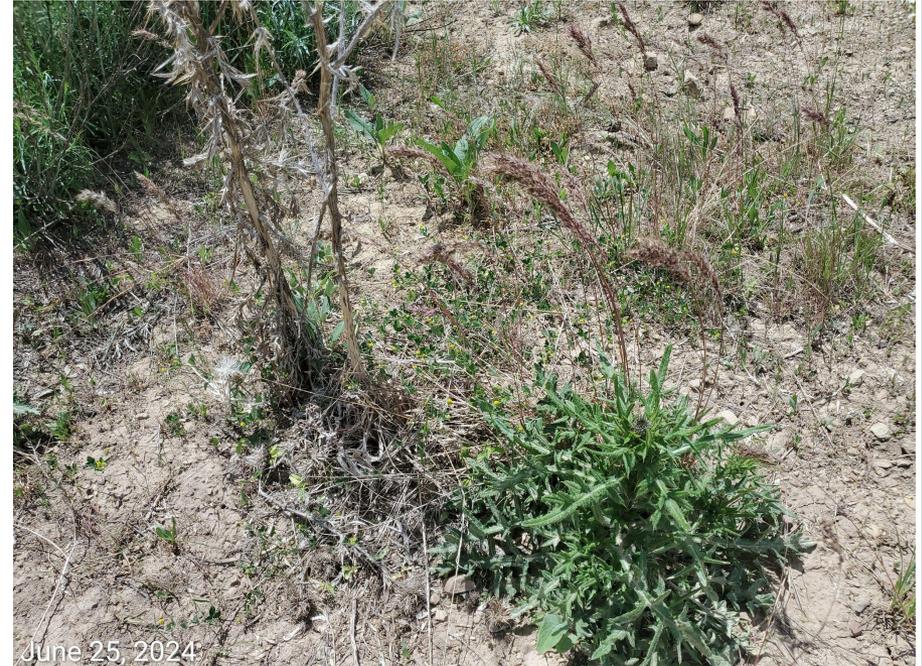
**Photo 6:** Photos 6-7 examples showing noxious weed establishment on the Location. Weeds observed include Houndstongue, Canada thistle, Bulbous Bluegrass, Bull thistle and Field Bindweed.

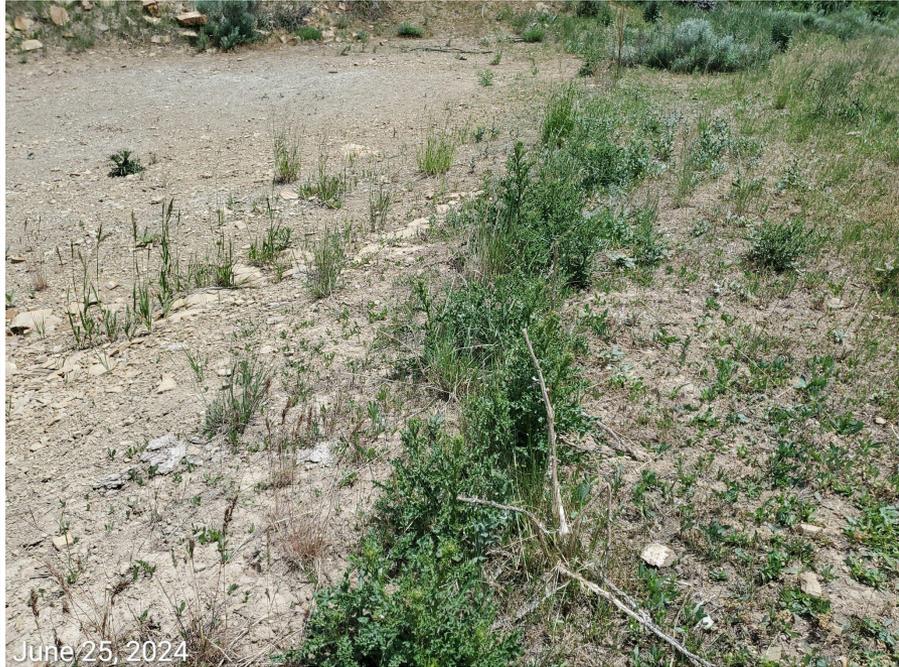
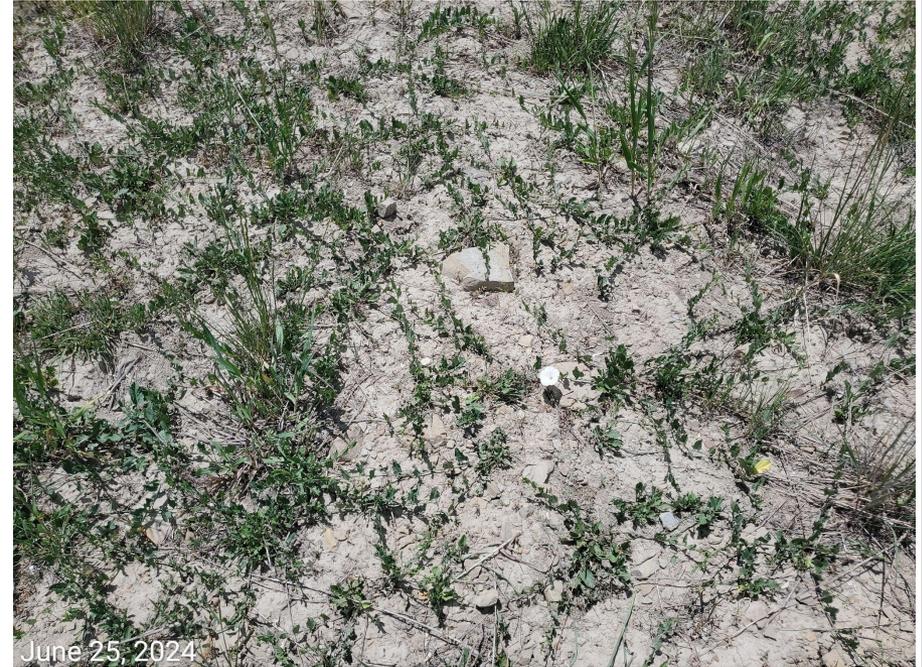
**Photo 7:** See comments under photo 6.

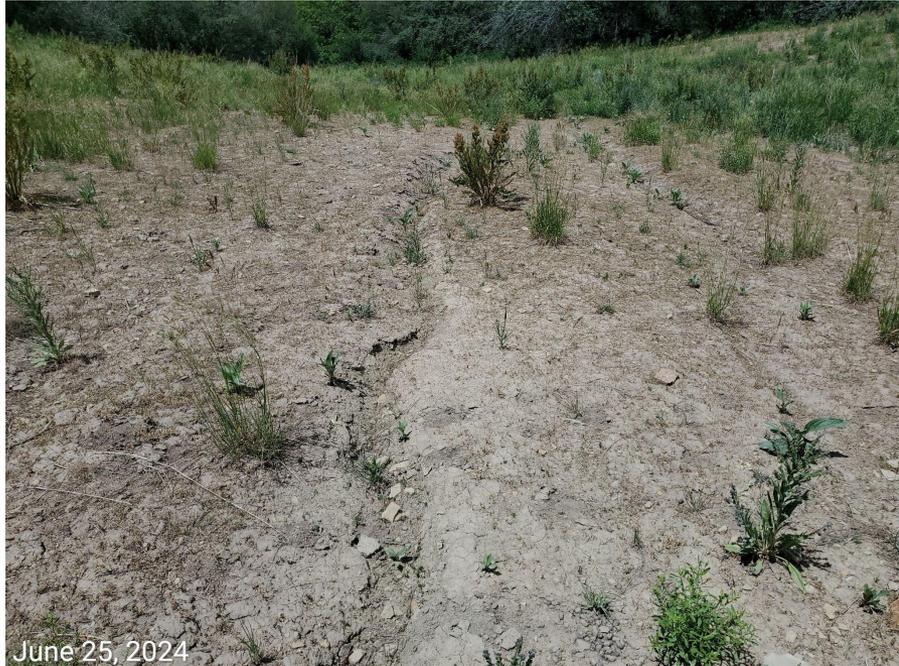
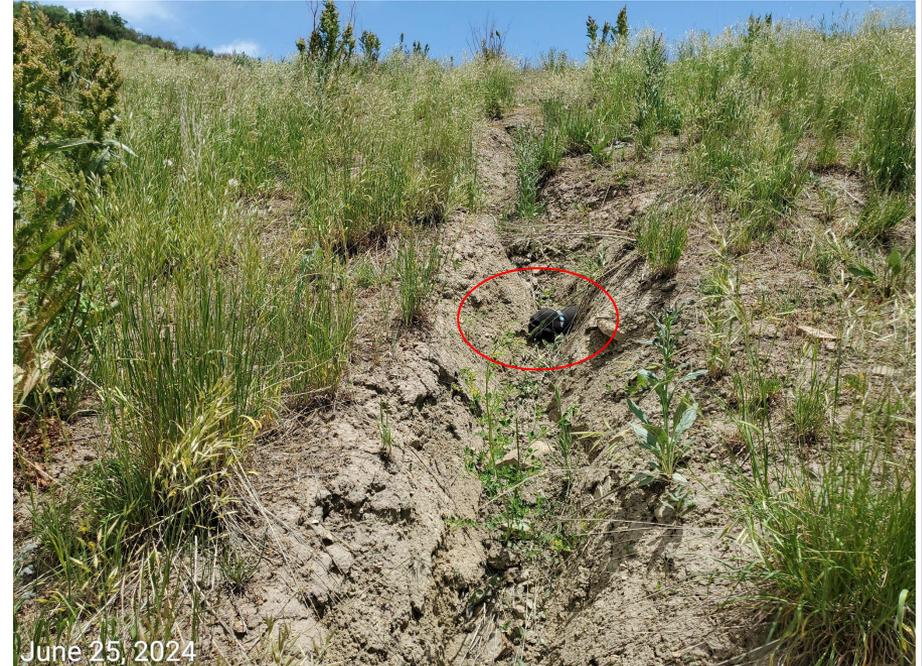
**Photo 8:** Photos taken from the western areas of the Location. Photos examples showing stormwater and erosion control monitoring and management also does appear to be occurring; BMPs to manage runoff in a manner that minimizes erosion, degradation and sediment transport was not observed. Gully erosion observed; hat in photo right for reference.

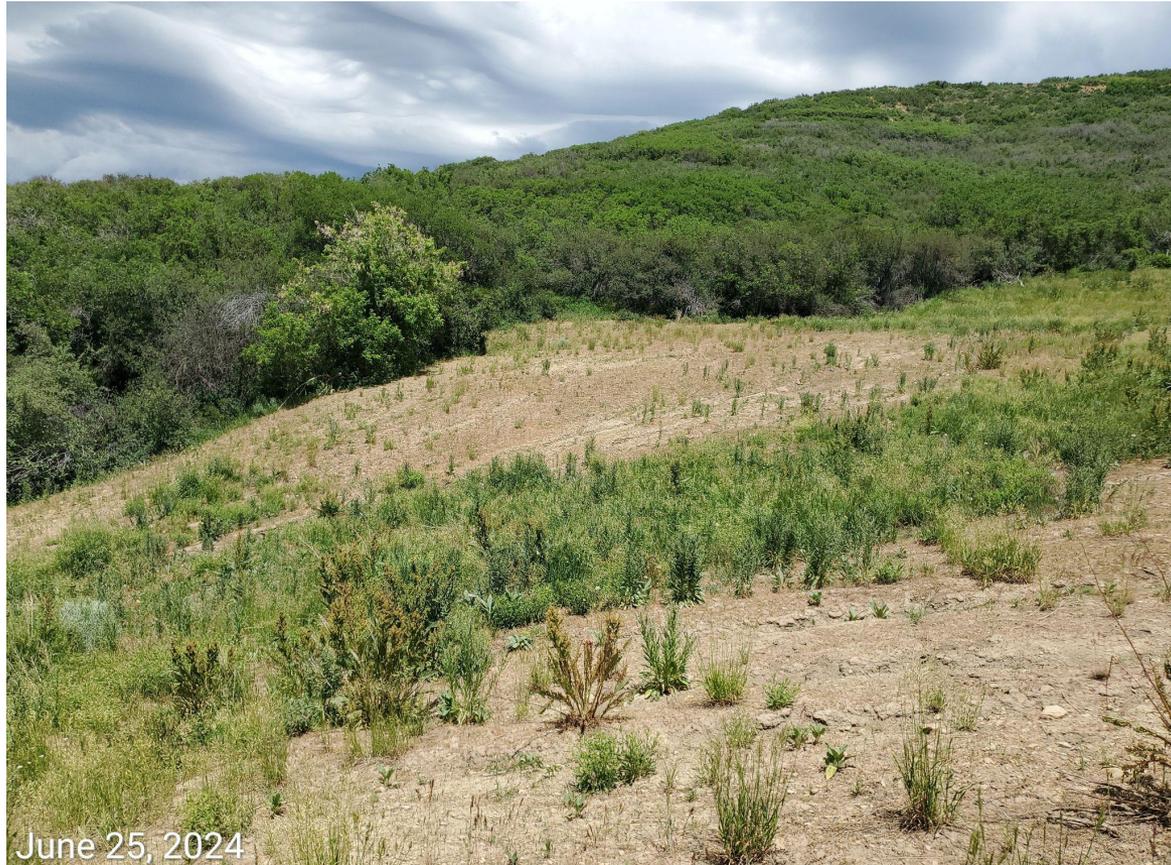
**Photo 9:** Photo showing areas on the west end of the Location where stormwater issues were observed.

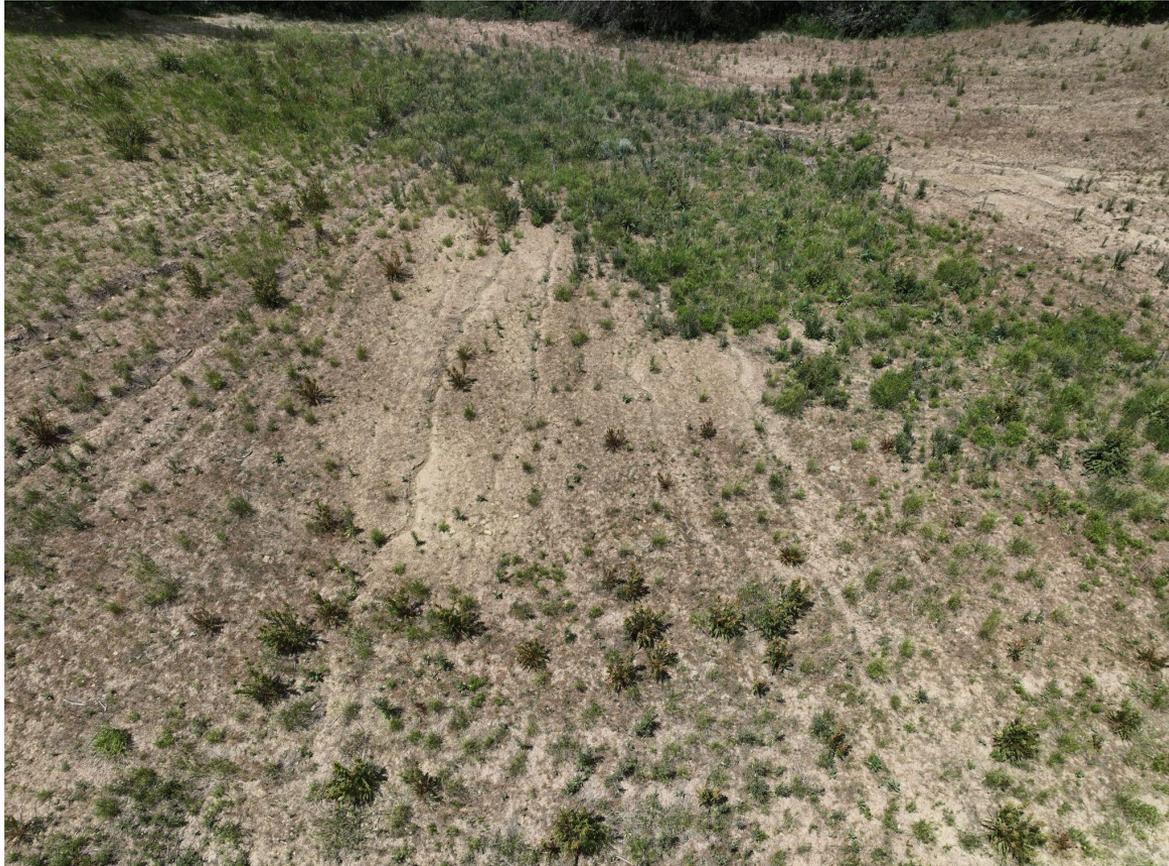
**Photo 10:** Aerial image showing areas on the west end of the Location where stormwater issues were observed. Erosion degradation observed throughout the slopes of the Location.

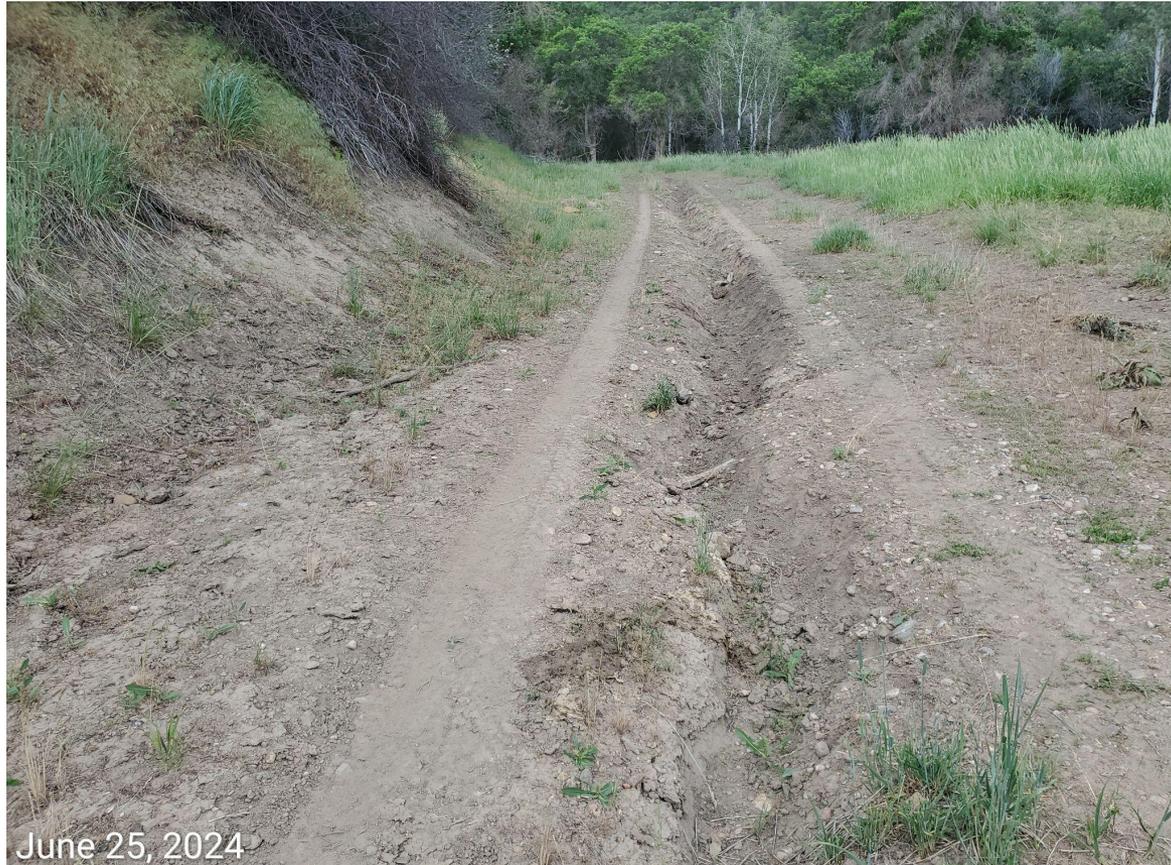
**Photo 11:** Photo taken from the access road. Photo examples showing erosion degradation issues observed on the road.
