# Inspection Photos

**Operator:** ROBERT L BAYLESS PRODUCER LLC -  
6720

**Location ID:** 316765

**Inspection Doc:** 696205940

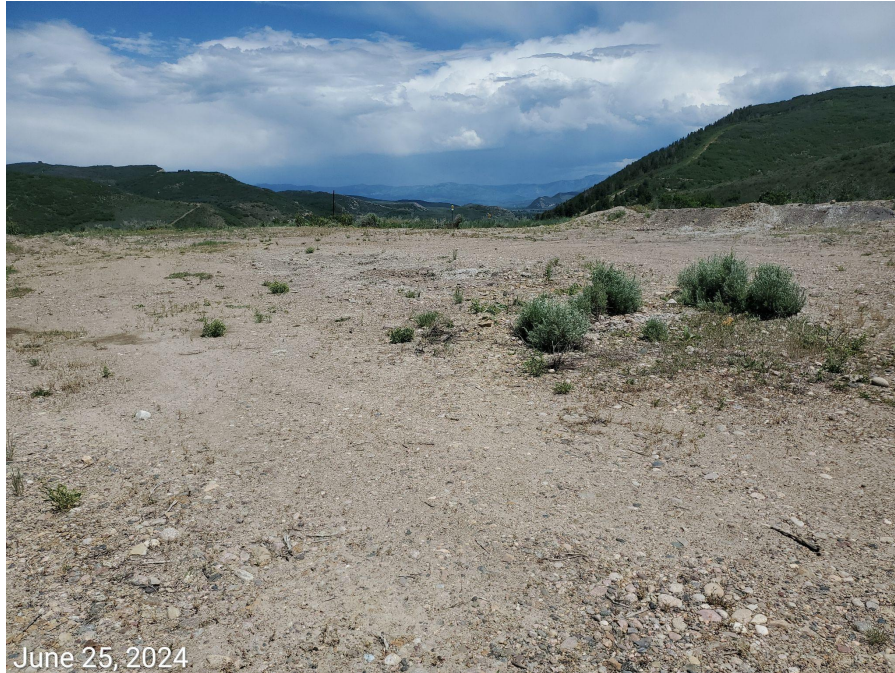
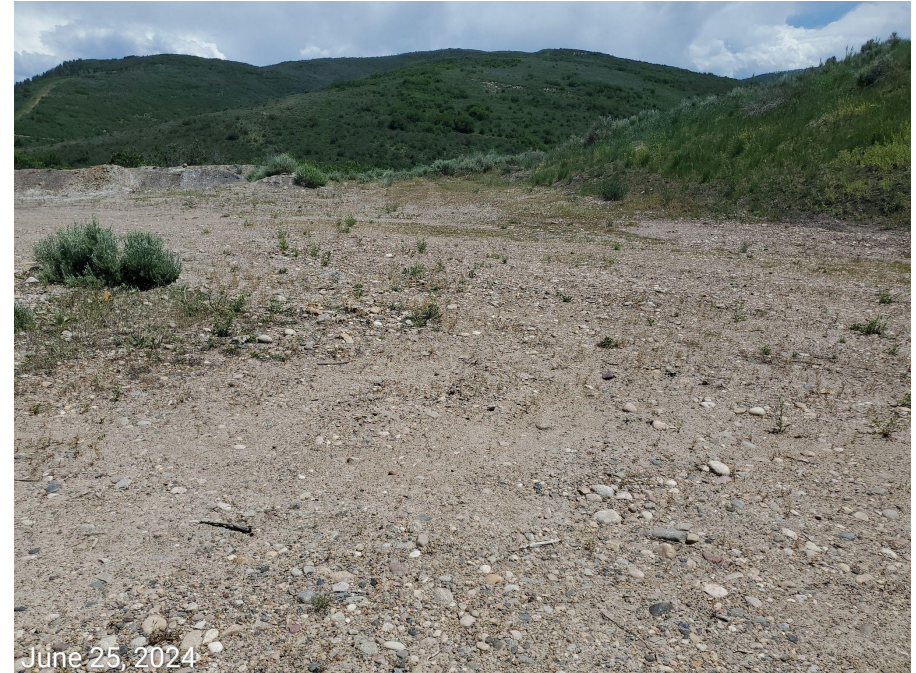
**Photo 1:** Photos taken from the Location entrance on the southwest end of the Location. Photos provide an overview of the Location from north and east

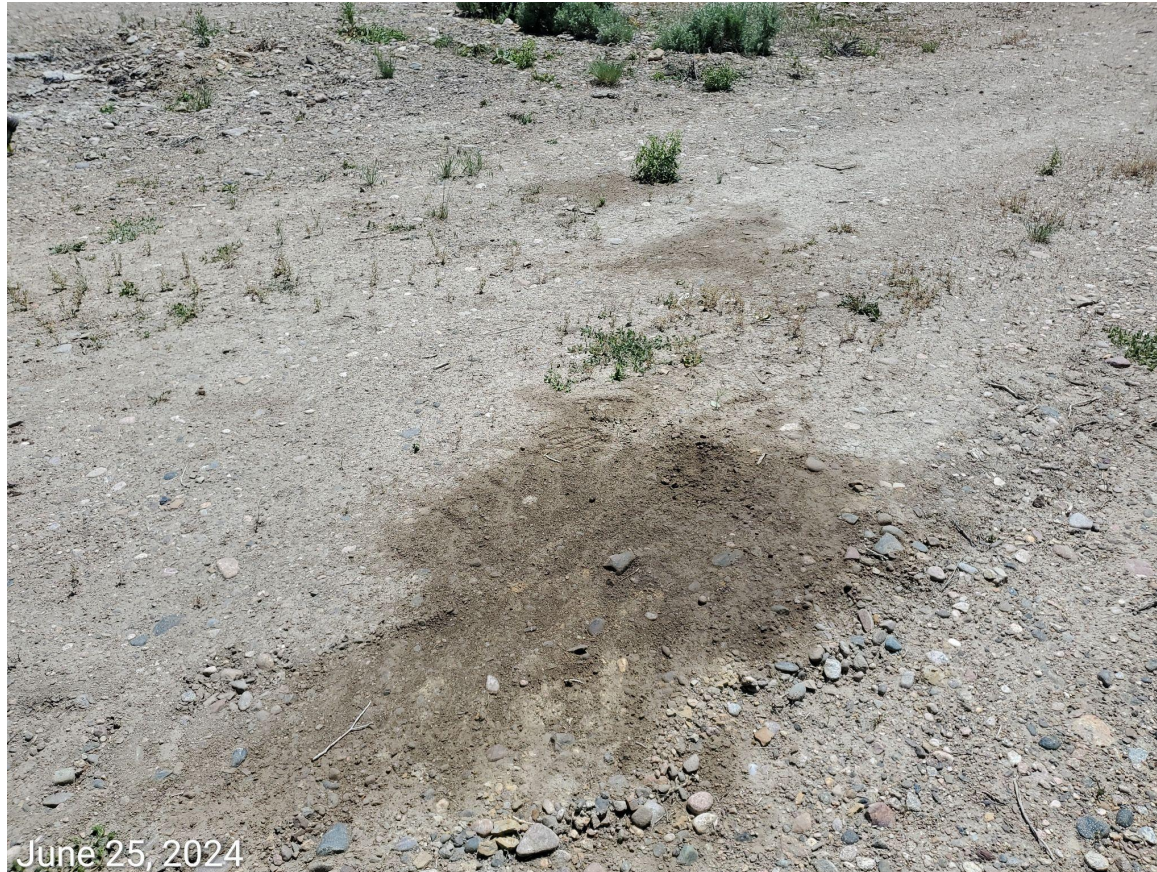
**Photo 2:** Stained soils observed on the west end of the location.

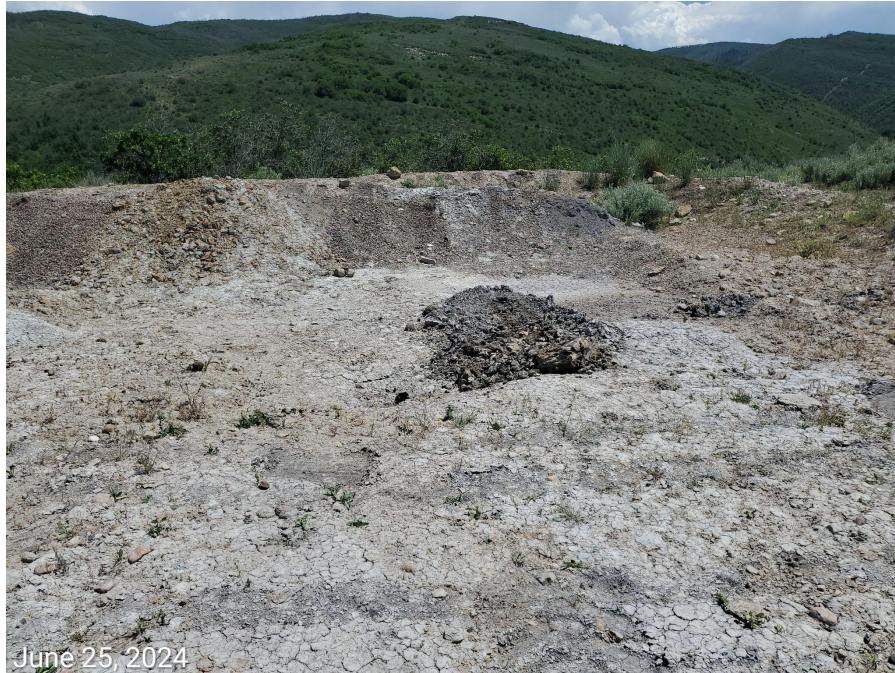
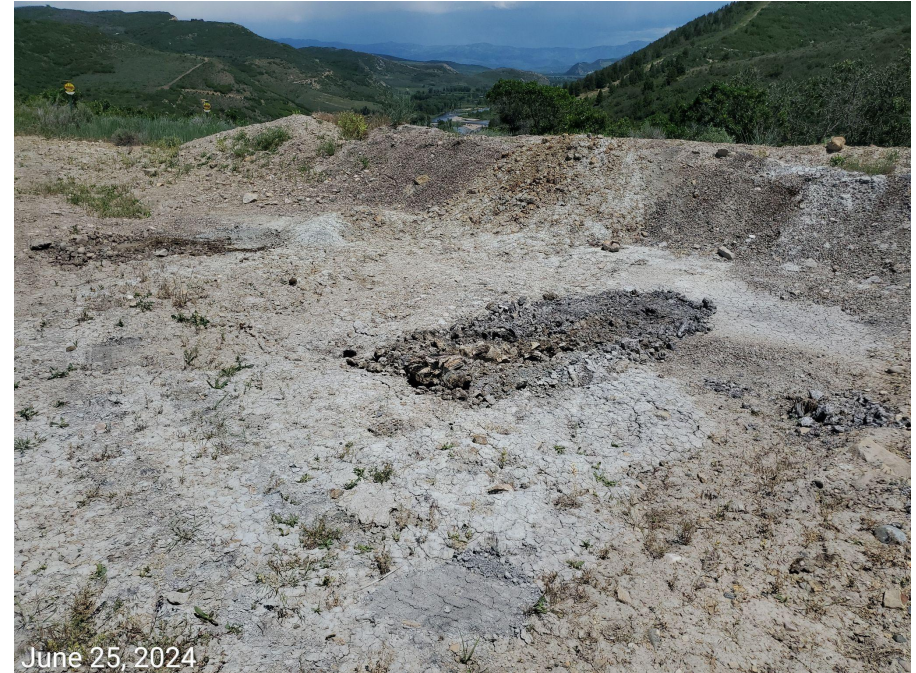
**Photo 3:** Photo shows former battery facility location on the east end of the site. Remediation for facility closure is in process.

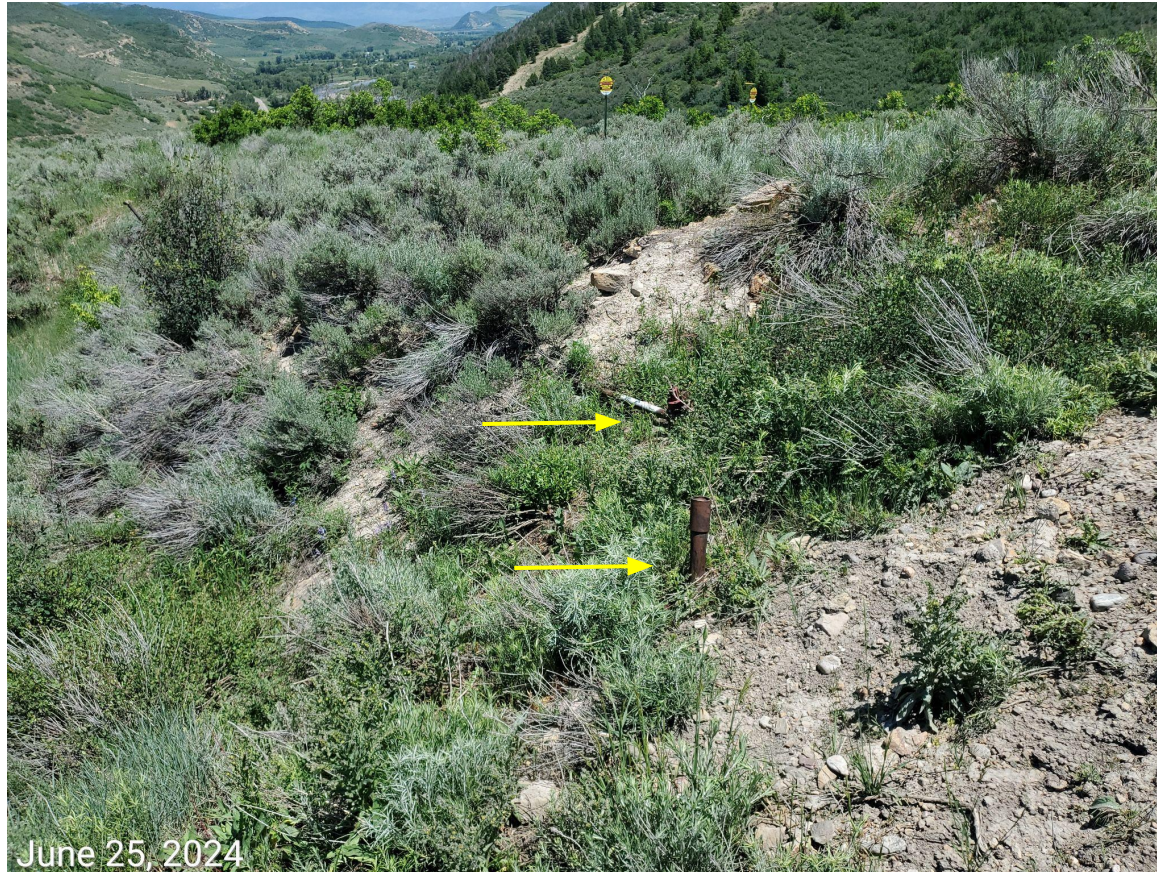
**Photo 4:** Photo taken from the northwest end of the Location. Photo shows remaining pipe riser equipment. Equipment requires removal.

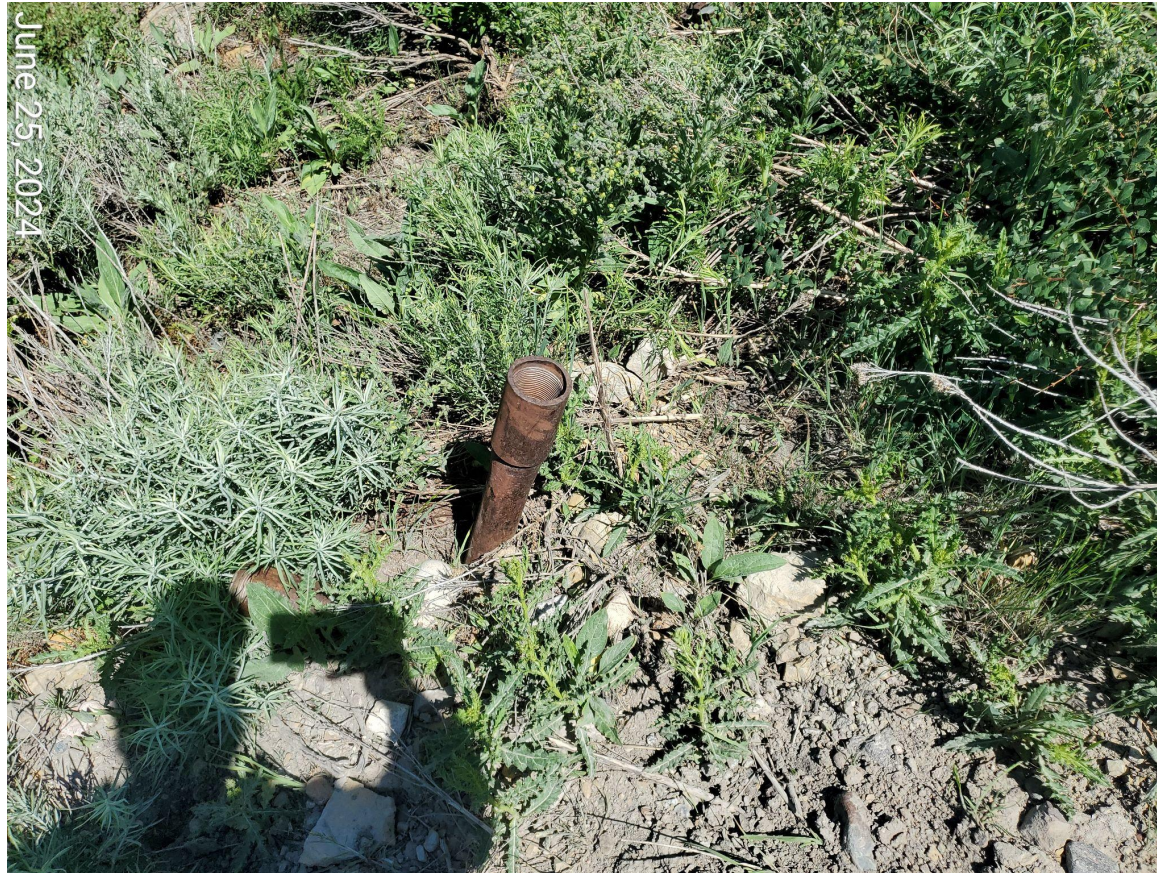
**Photo 5:** Continued from photo 4. Pipe has not been capped. BMPs to prevent access by wildlife, including bats/birds required.

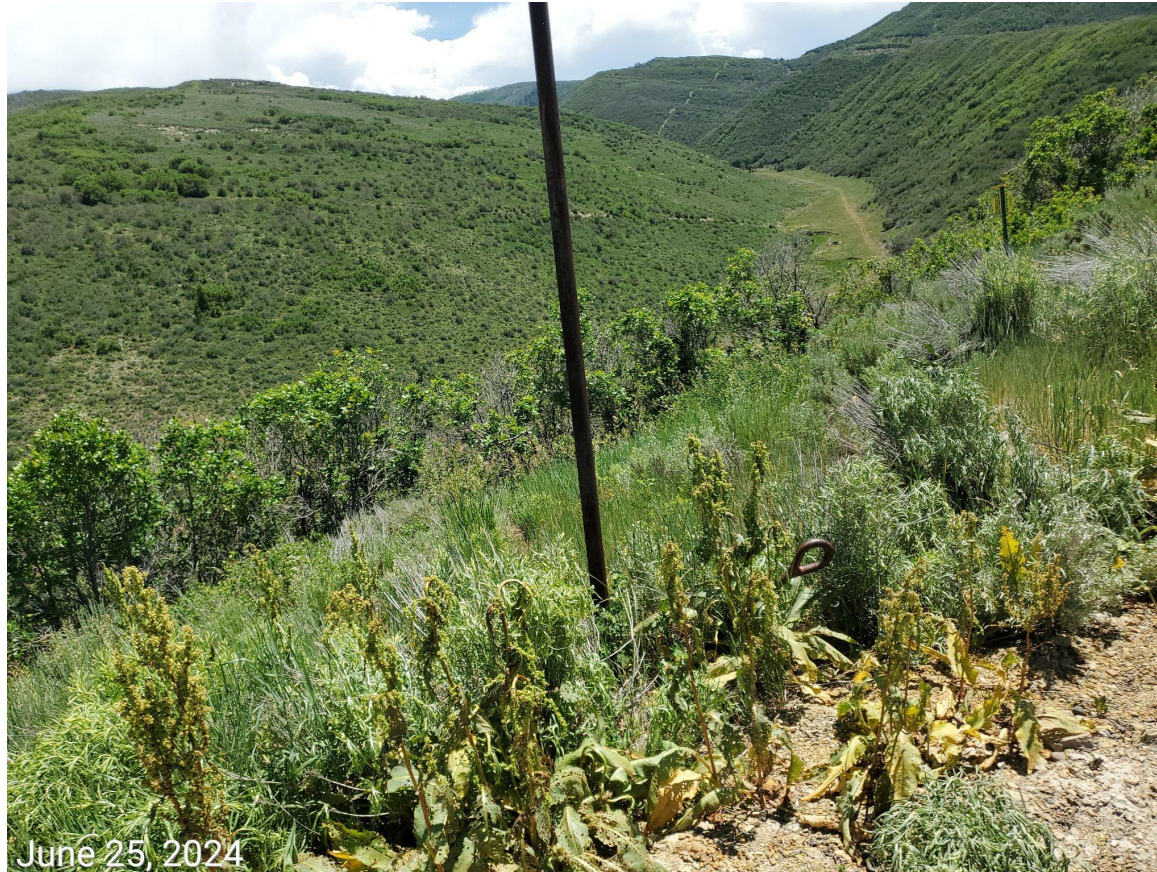
**Photo 6:** Photo shows anchor equipment remaining on the east end of the Location.

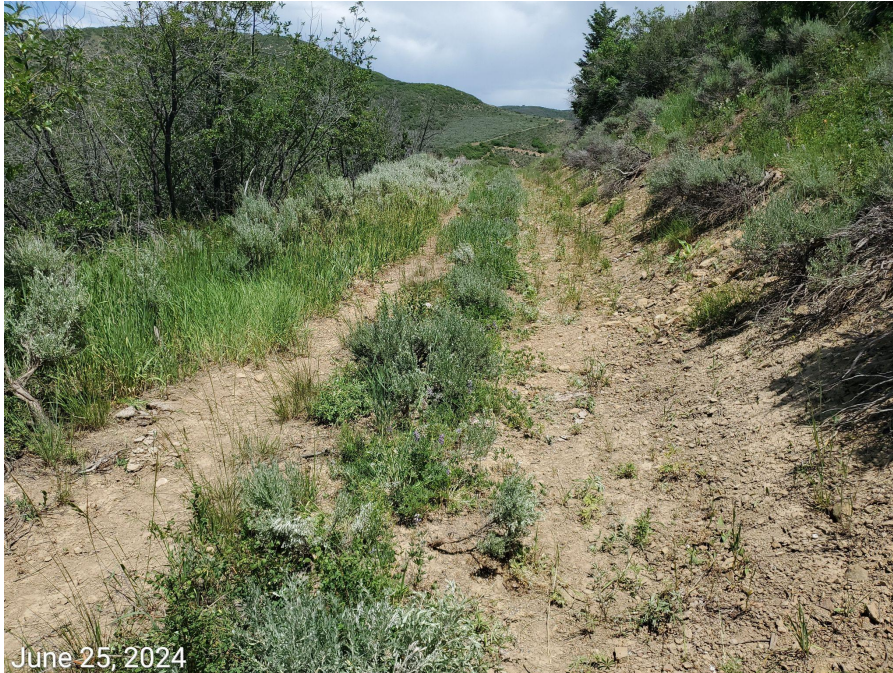
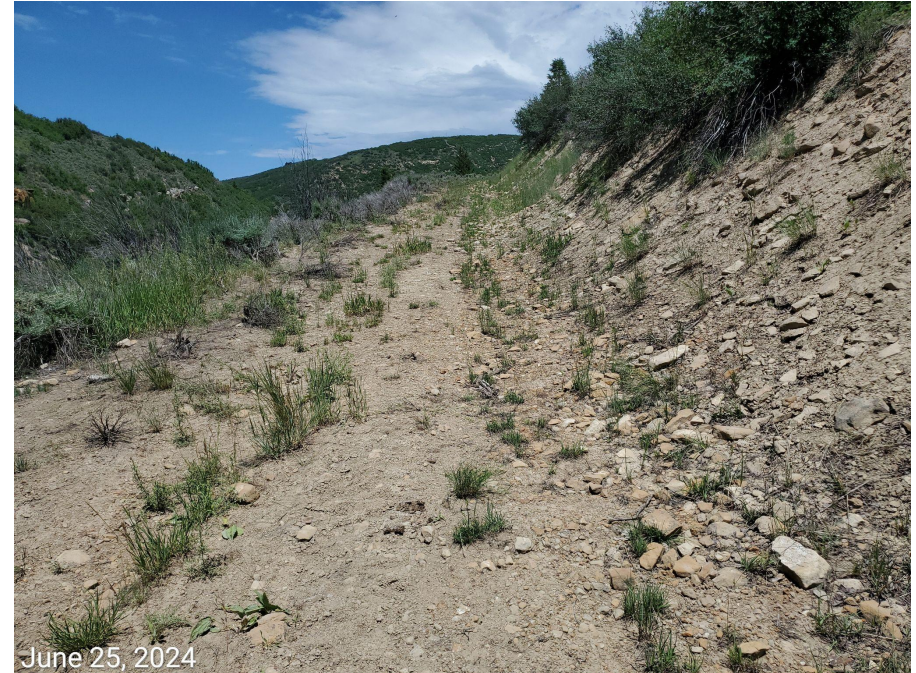
**Photo 5:** Photos examples showing the access road has not been recontoured/regraded and reclaimed.
