Stormwater Inspection

Operator: Noble Energy Inc - 100322

Location ID: 329434

Location Name: Smith-64N64W 9SWNW

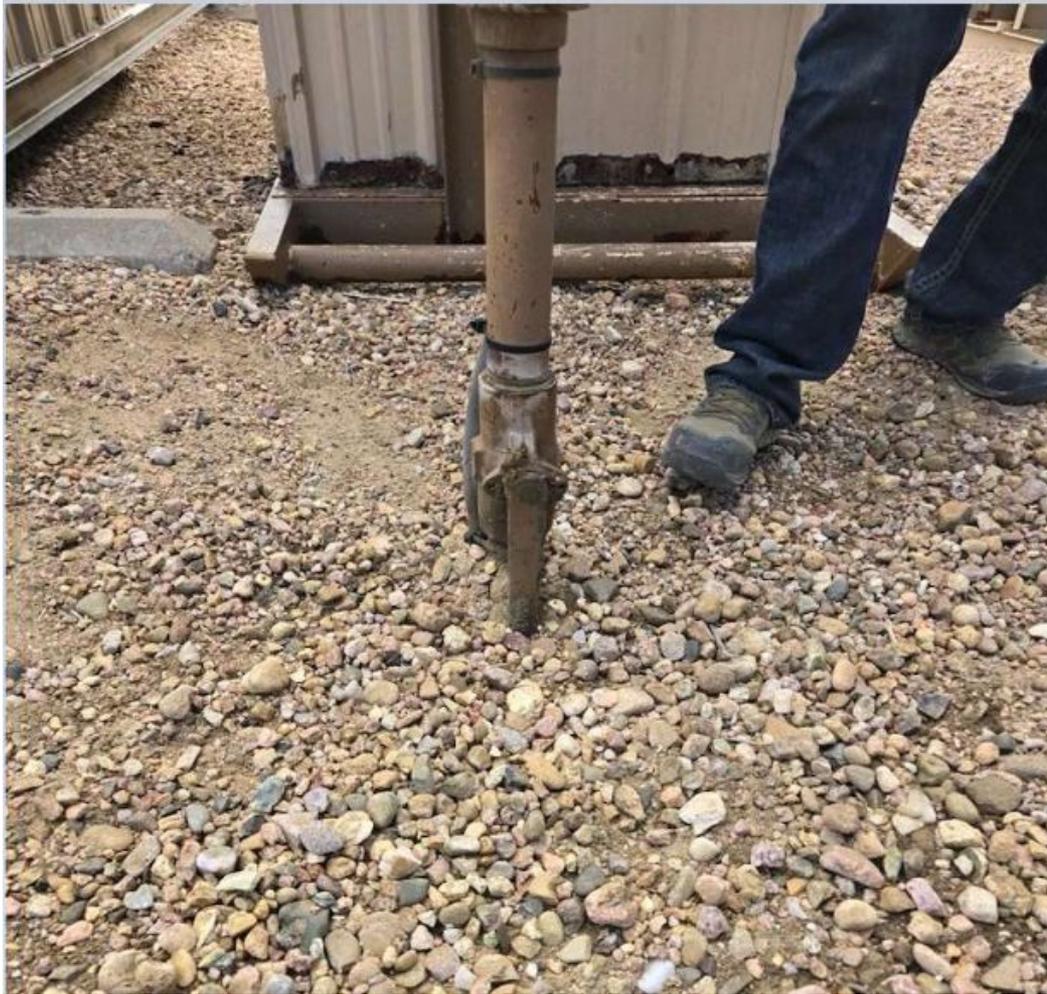
Photo 1. The photo is an Operator photo from FIRR #403835323 demonstrating soil staining clean-up has been completed at the tank battery location.

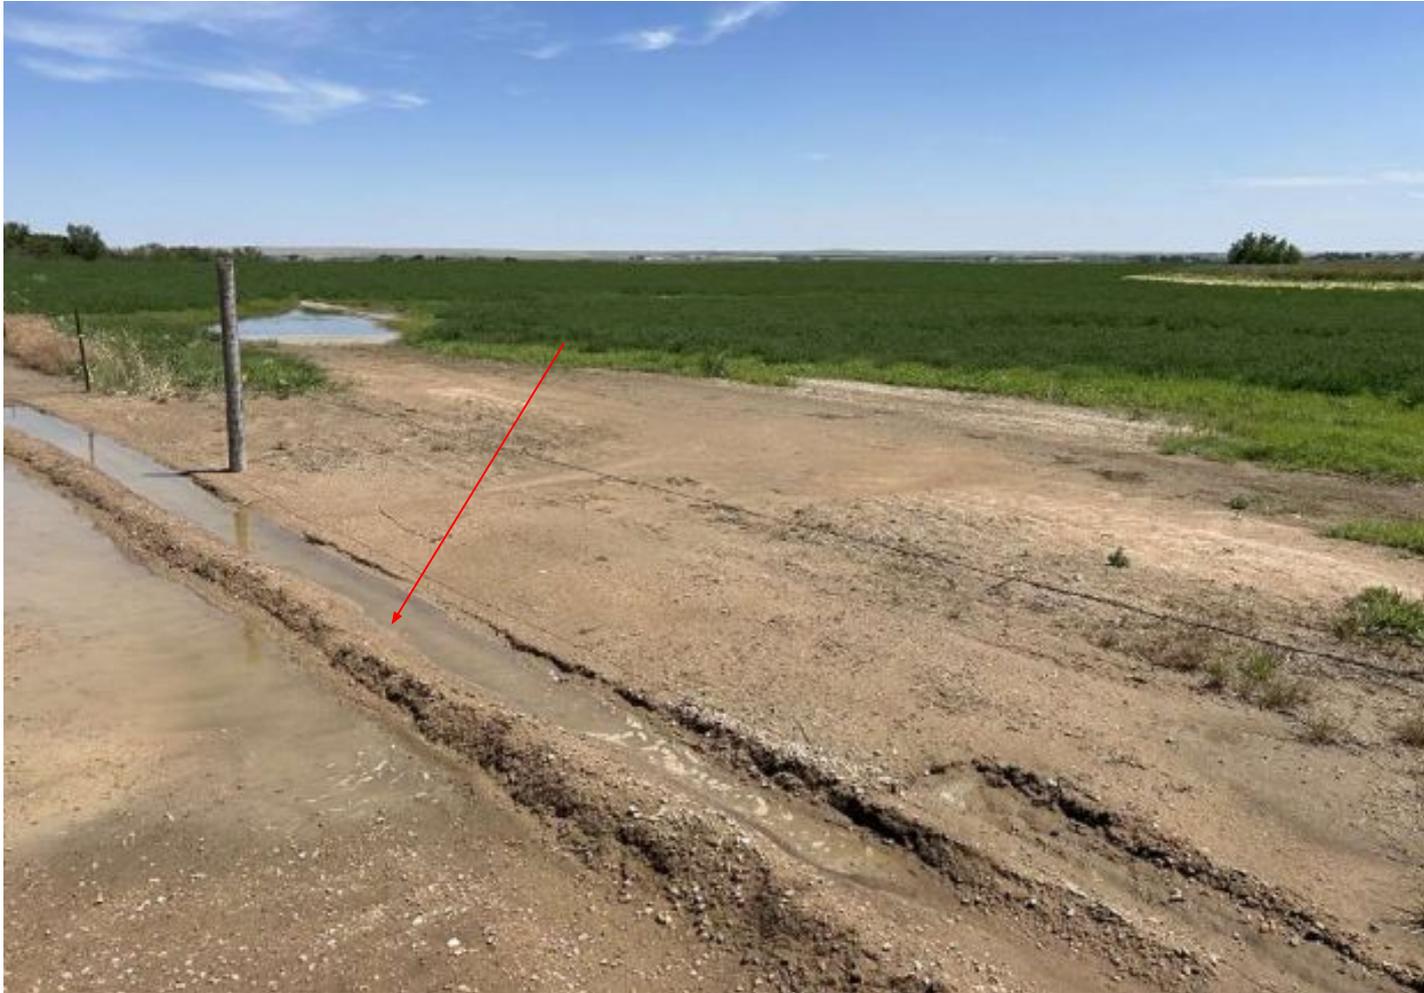
Photo 2. The photo is an Operator photo from FIRR #403838786 demonstrating the Operator has attempted to slow erosion on the tank battery location with a small berm.

Note - Erosion has yet to be repaired off location in the alfalfa field.

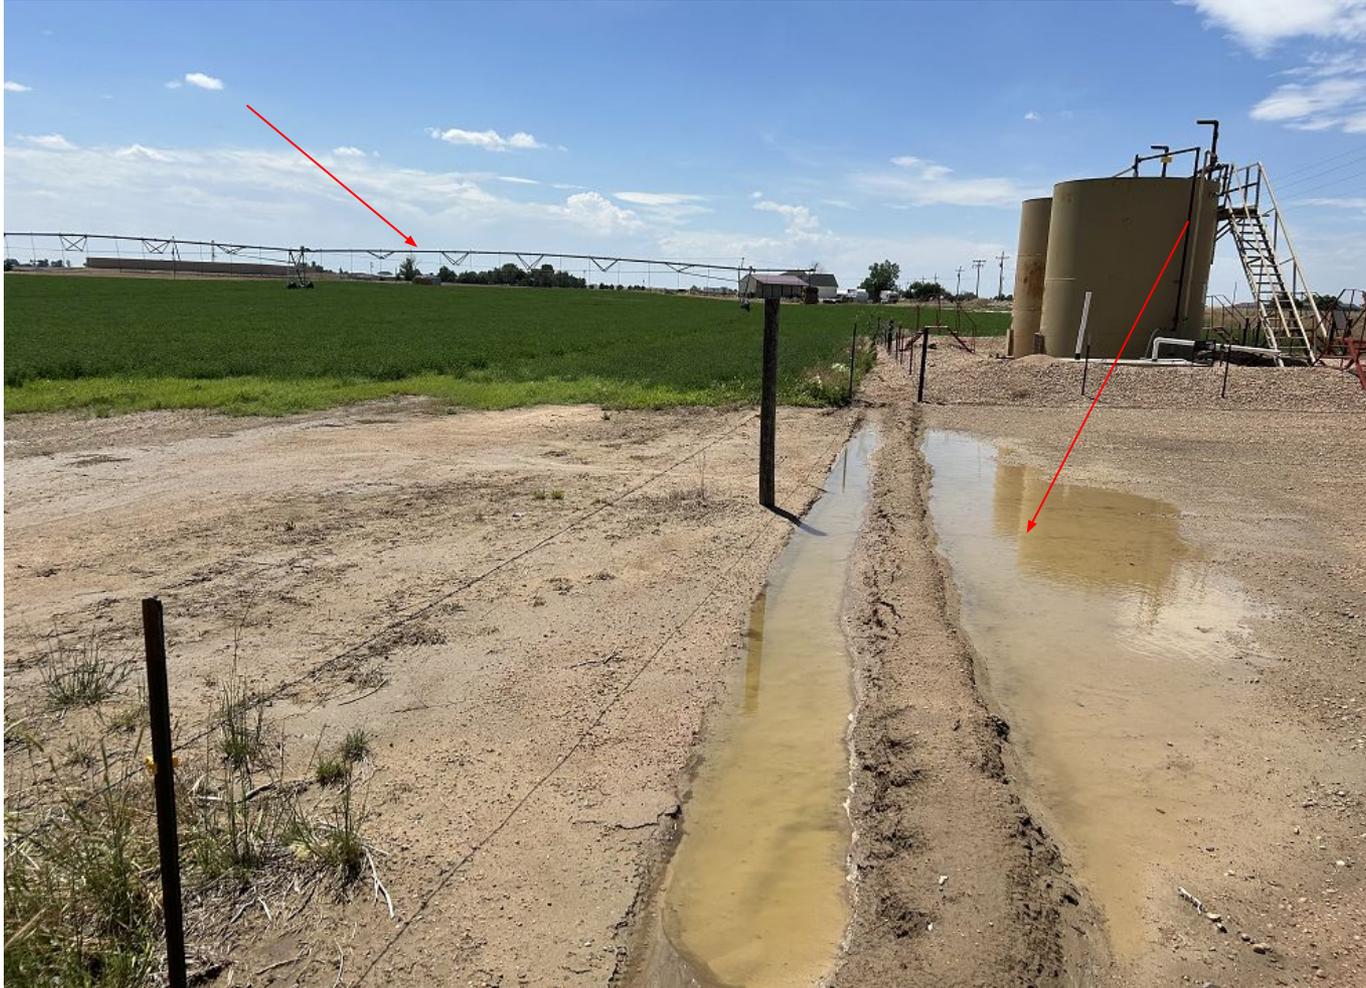
Photo 3. The photo is an Operator provided photo demonstrating the Operator has attempted to slow erosion on the tank battery location with a small berm. However the pivot seen in the background is causing ponding on the tank battery due to installed BMP's.
