Inspection Photos

Operator: PUCKETT LAND COMPANY #10341

Location ID: 316610

Inspection Doc: 696205958

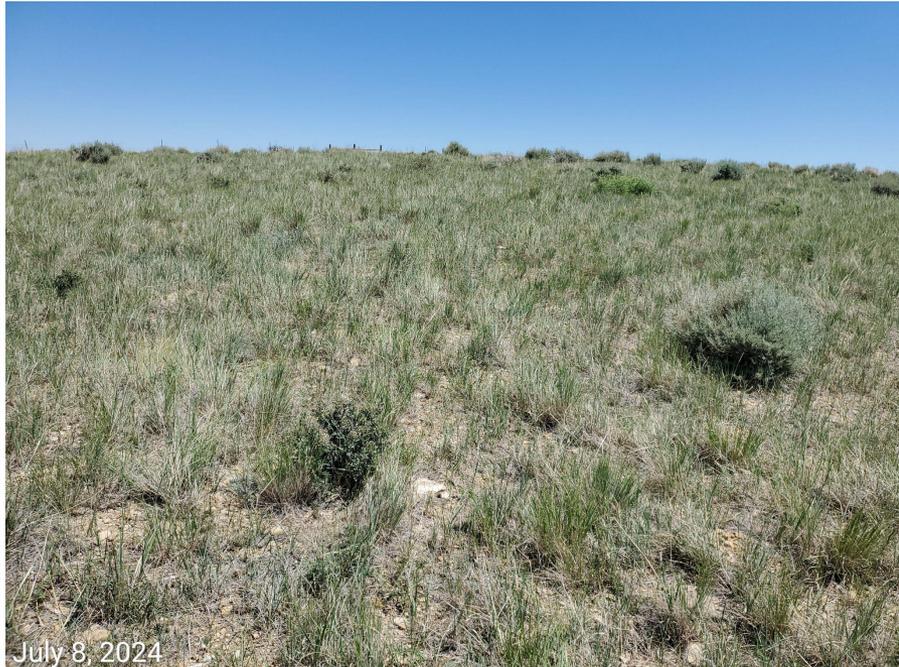
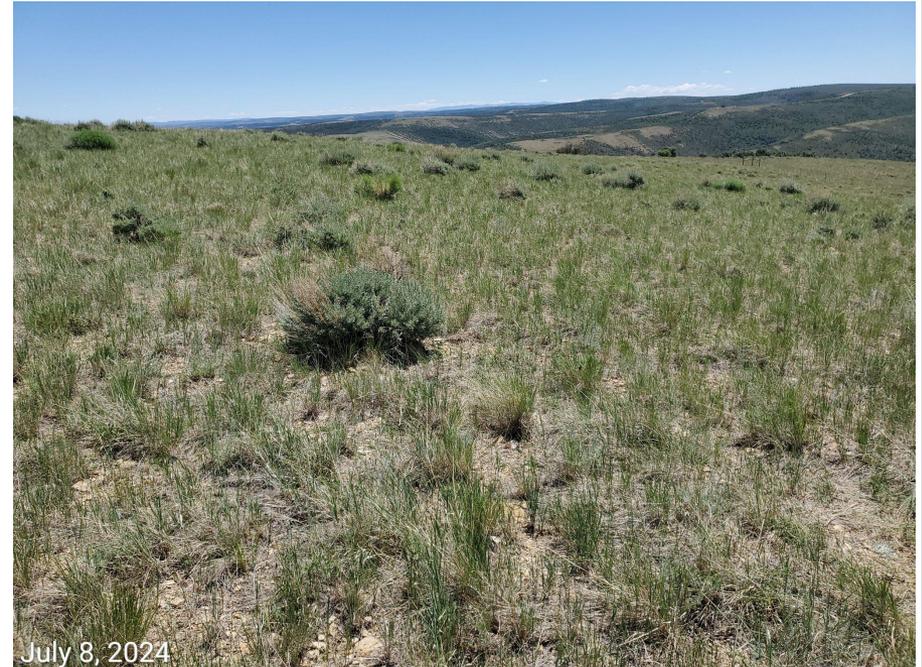
Photo 1: Photos 1-2 taken from central areas of the Location. Photos provide an overview from north, east, south to west. Location has met 1004 revegetation requirements.

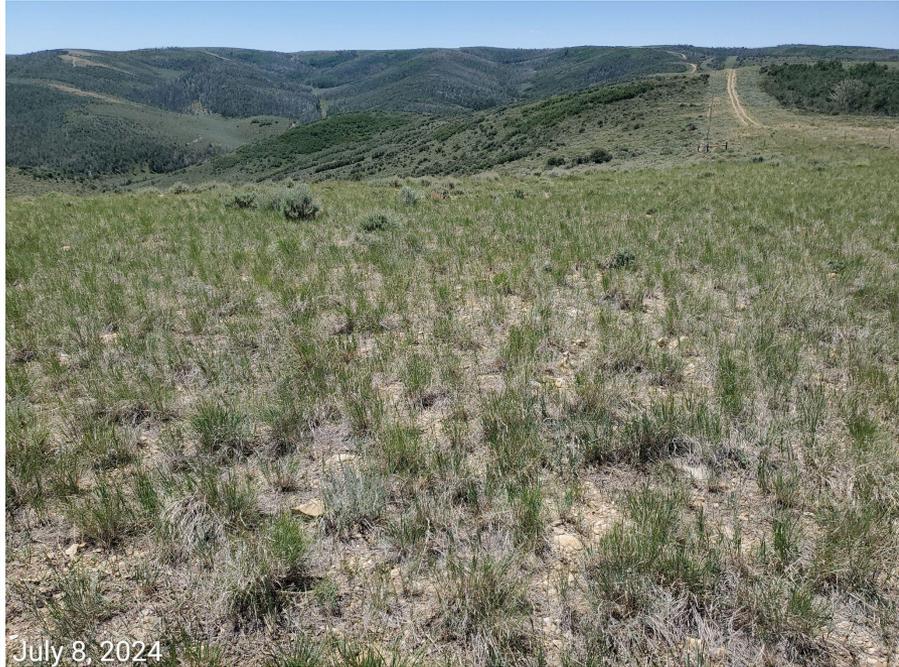
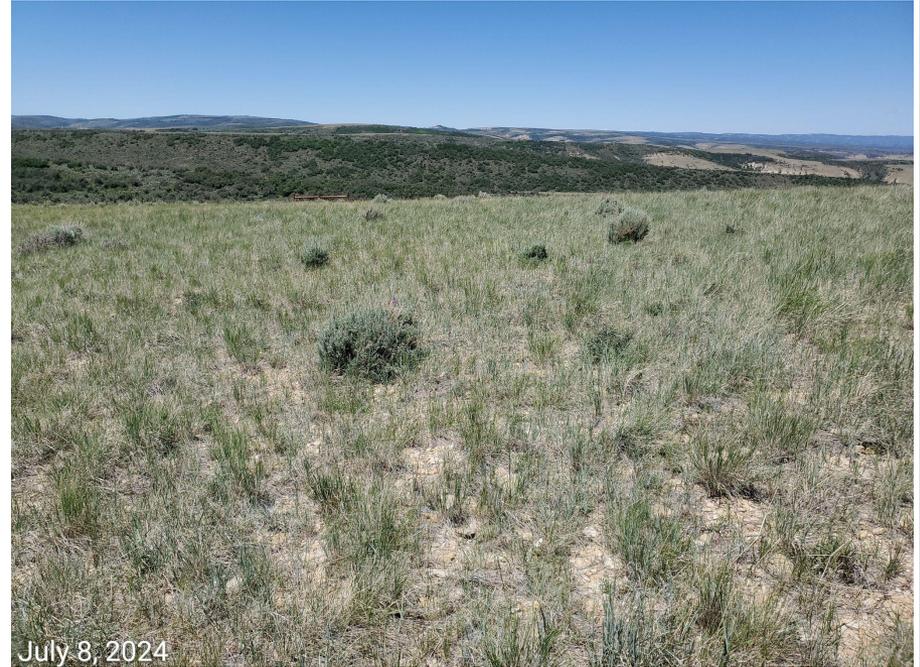
Photo 2: See comments under photo 1.

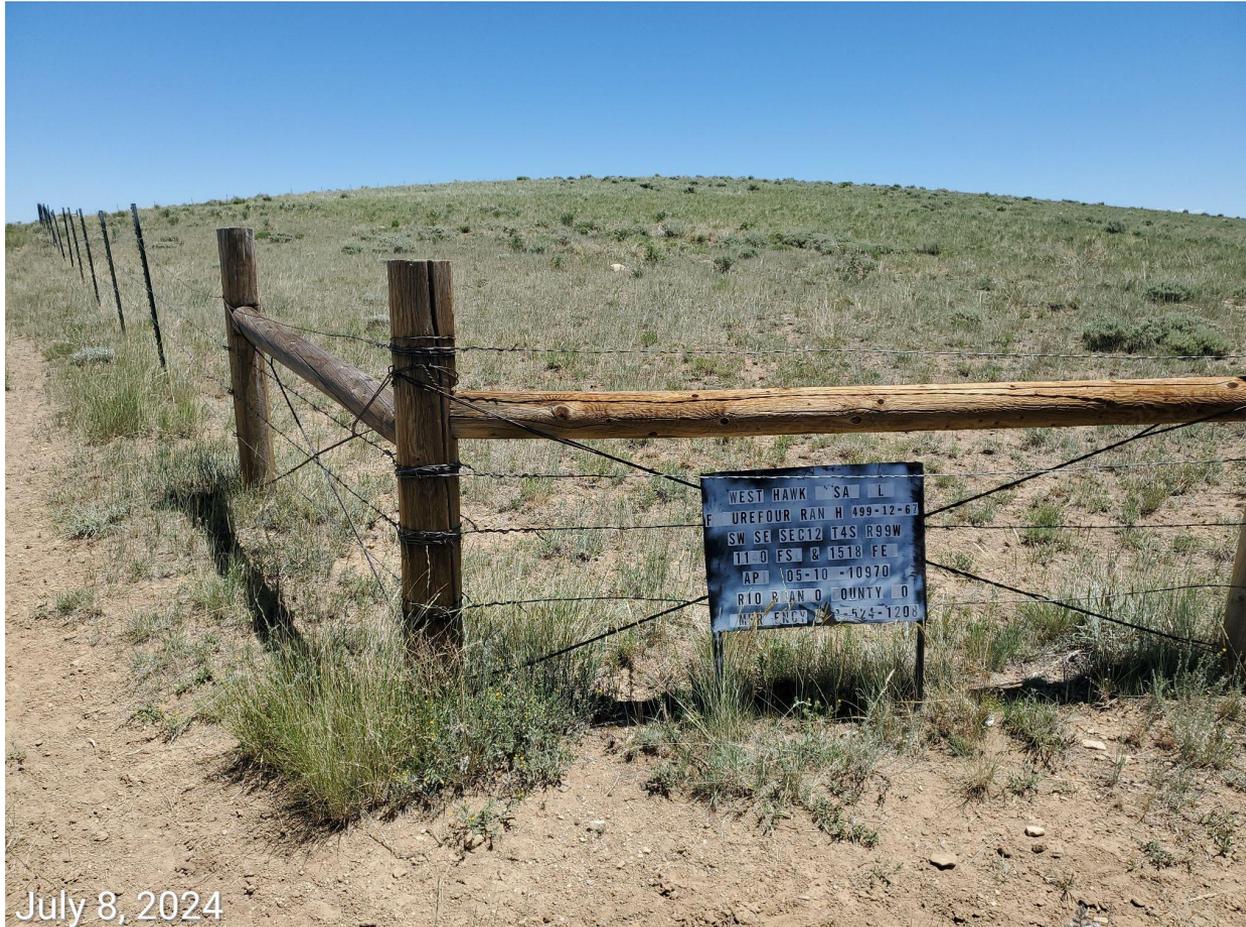
Photo 3: Signage remaining at Locations entrance. Signage requires removal.

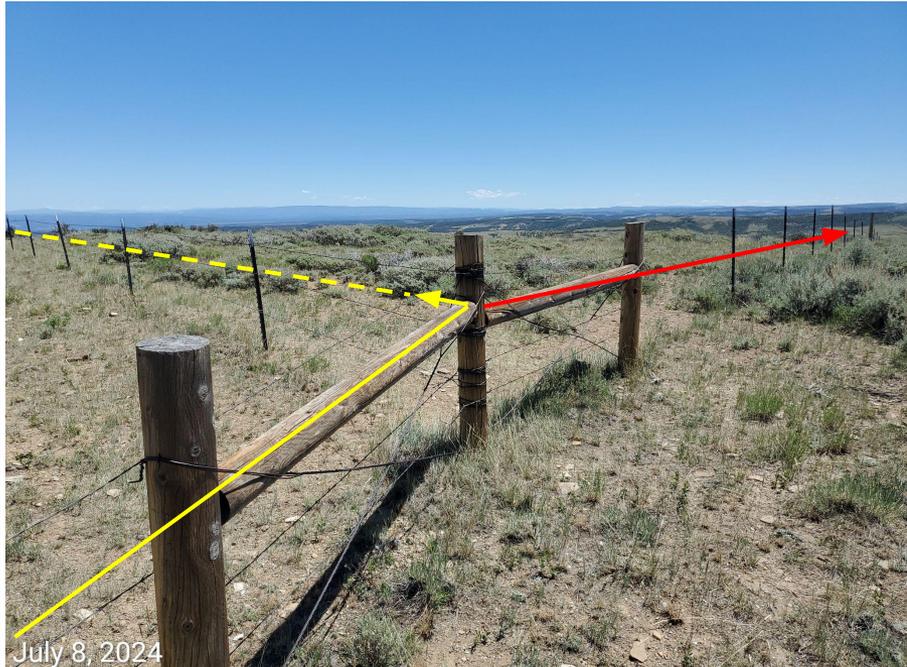
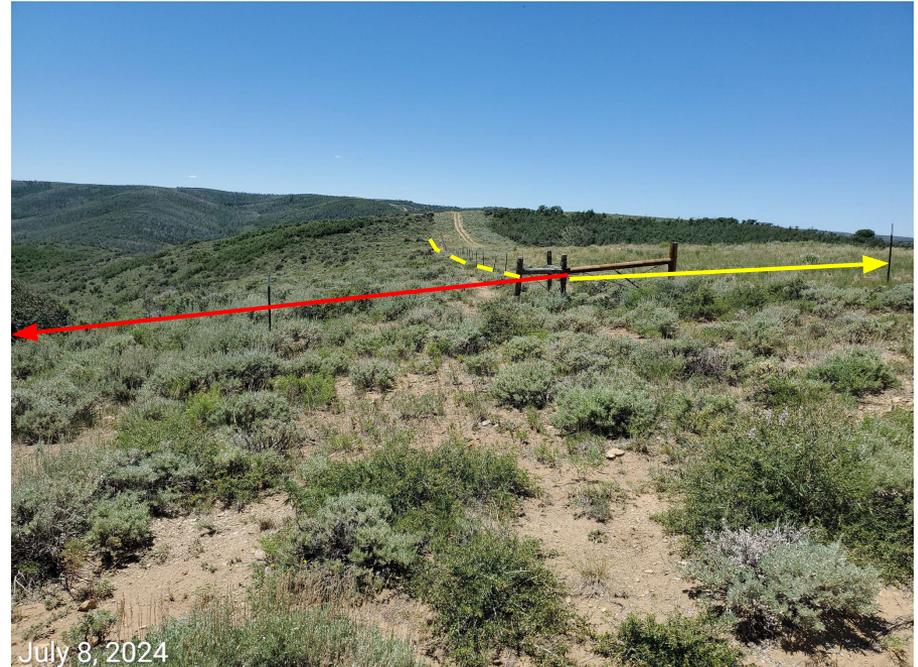
Photo 4: Photos examples showing Fence remaining along the perimeter of the Location; specifically, where the perimeter fence ties into the Surface Owner's pasture fence (dotted yellow line). Fence along the eastern perimeter of the Location (red) will require removal; fence to remain for the Surface Owner (yellow arrow) will need to be maintained.

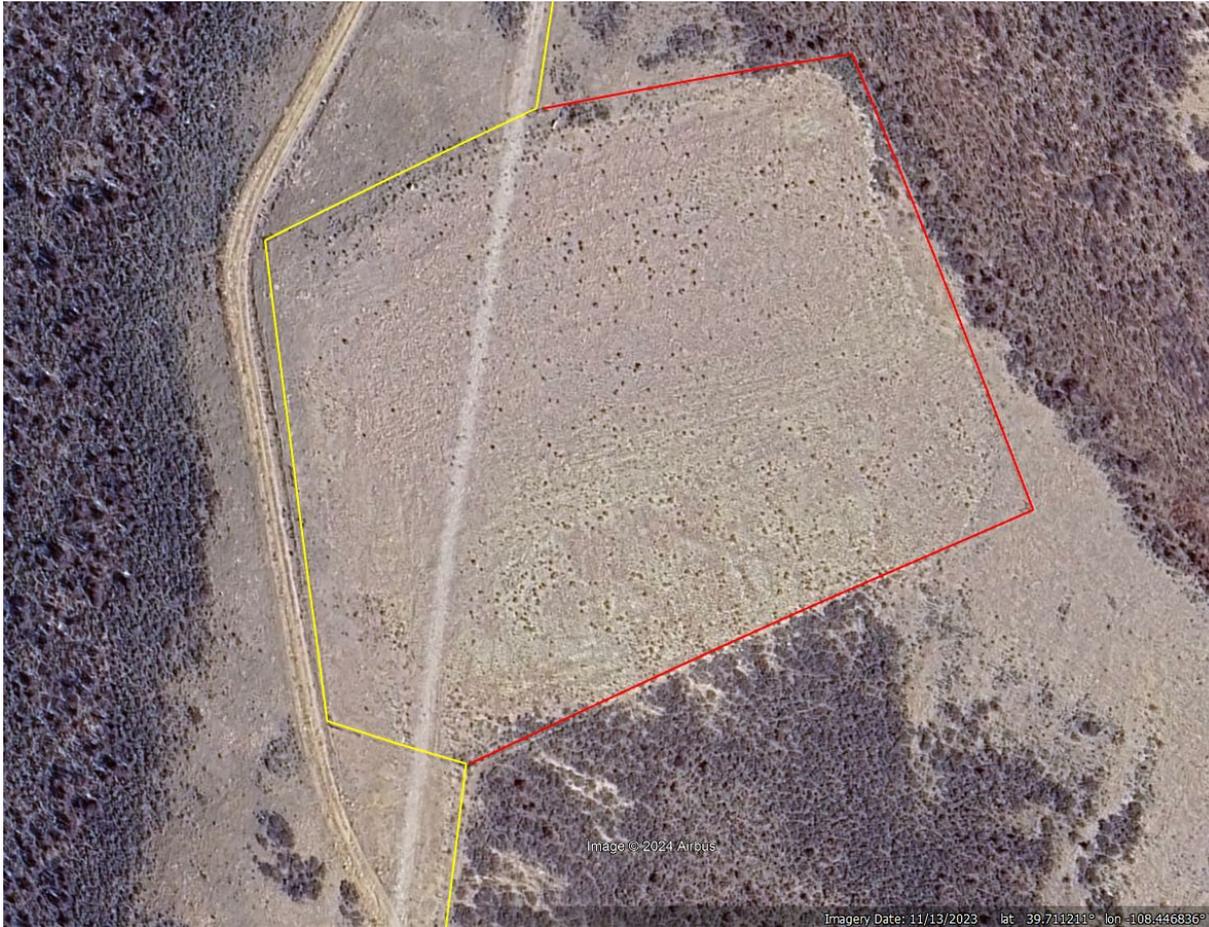
Photo 5: Continued from photo 4. Photo 2023 Google Earth aerial imagery showing the Location's perimeter fence remaining. Fence outlined in red will require removal.
