Final Reclamation and Stormwater Inspection

Operator: PDC Energy Inc - 69175

Location ID: 332807

Inspection Photos
Location Name: Dutton HD Pad 22-30D
Location ID: 332807

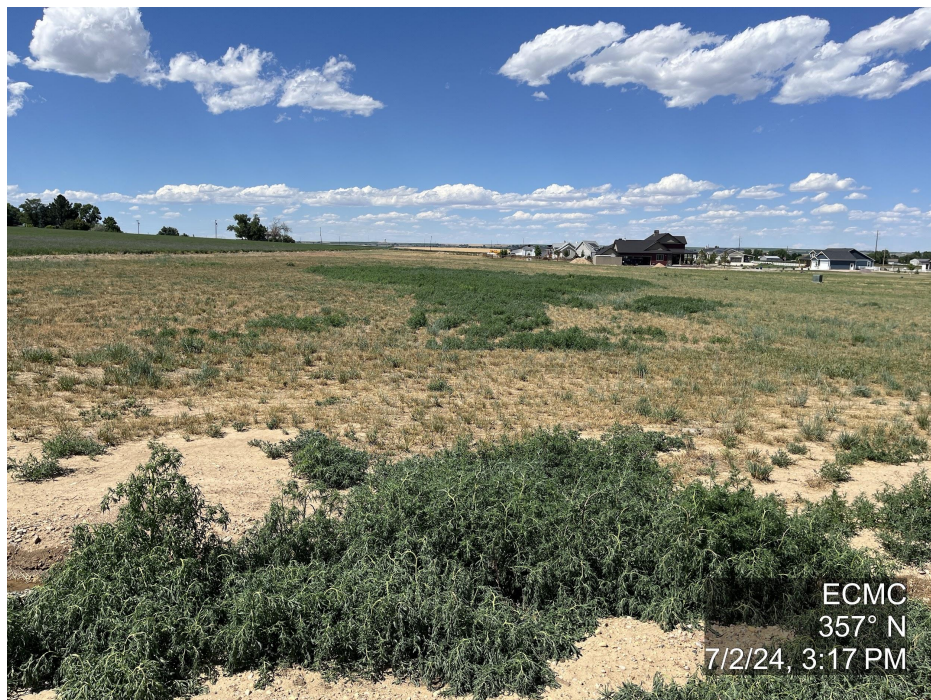
Photo 1. The photo was taken at the entrance to the well location facing North. The photo illustrates the outline of disturbance is apparent on the landscape with dominance of Kochia.

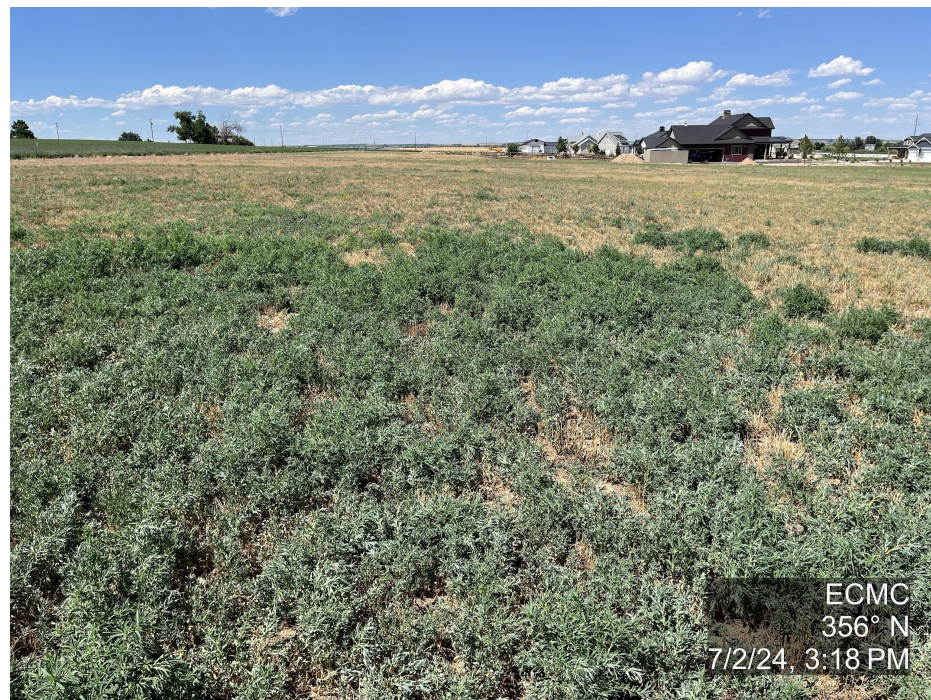
Photo 2. The photo was taken at the well location facing North. The photo illustrates the boundary and dominance of Kochia.

Note - The well location is in a fallow field at the time inspection.

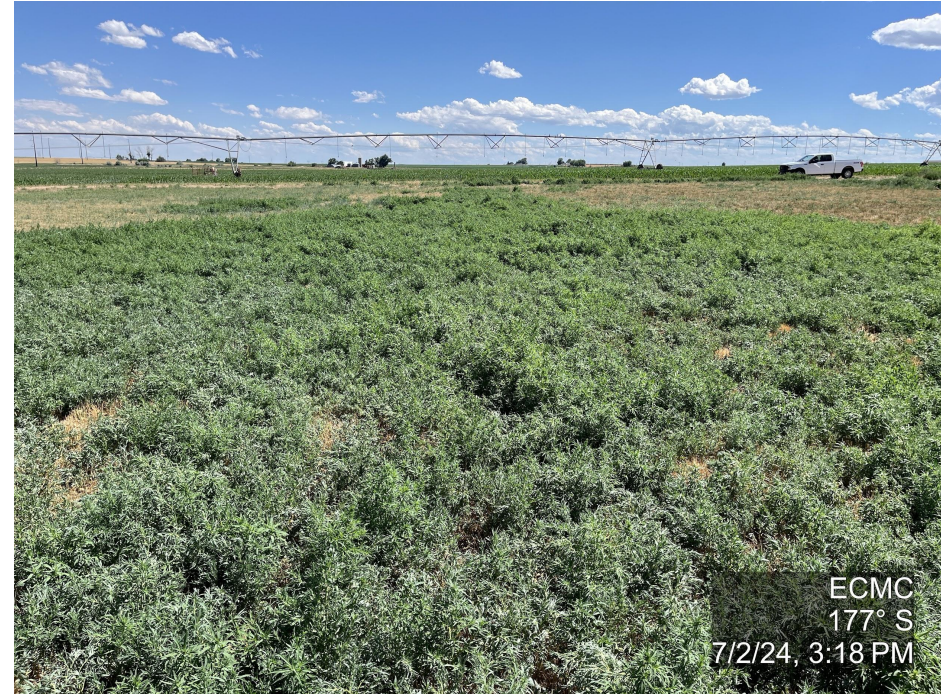
Photo 4. The photo was taken at the well location facing South.
Refer to the comment for photo 2.

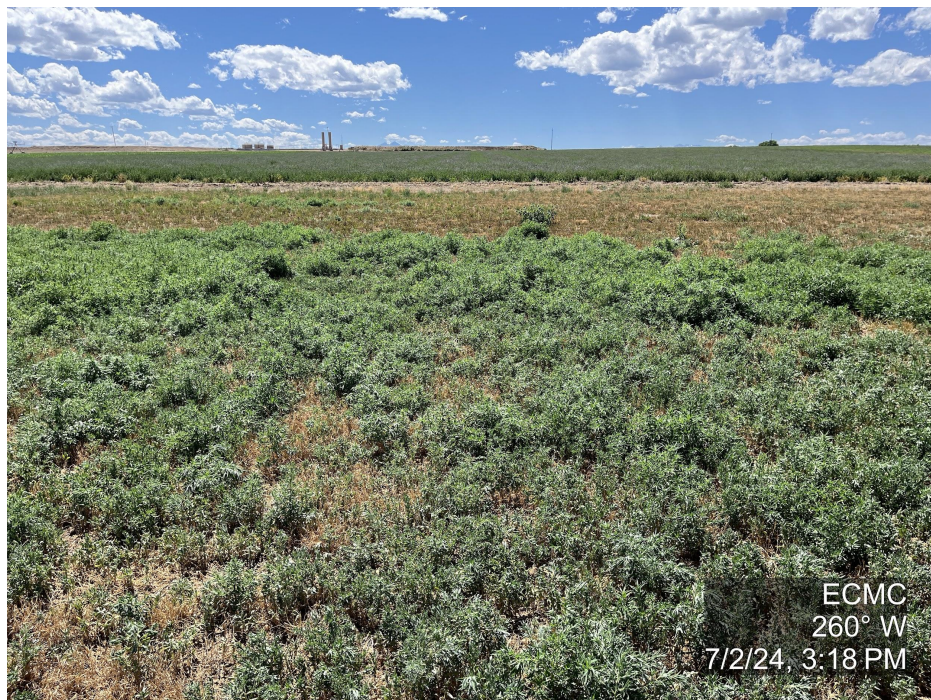
Photo 5. The photo was taken at the well location facing West. Refer to the comment for photo 2.

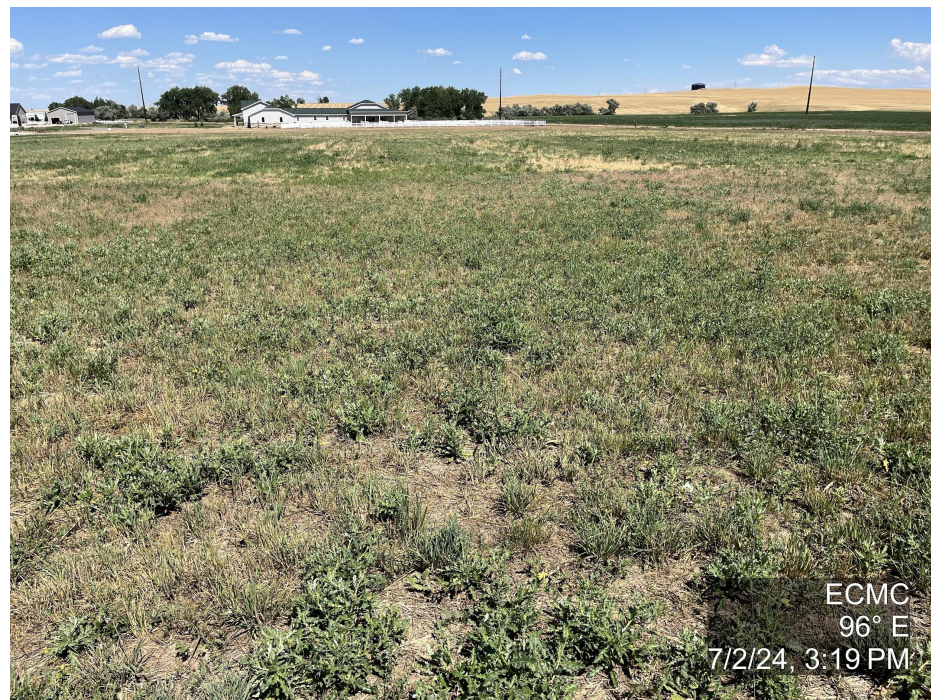
Photo 6. The reference photo was taken near the well East of the well location facing East. The photo illustrates the field is currently fallow.

Note - Though fallow the field appeared to be dominated by Bluebunch wheatgrass.

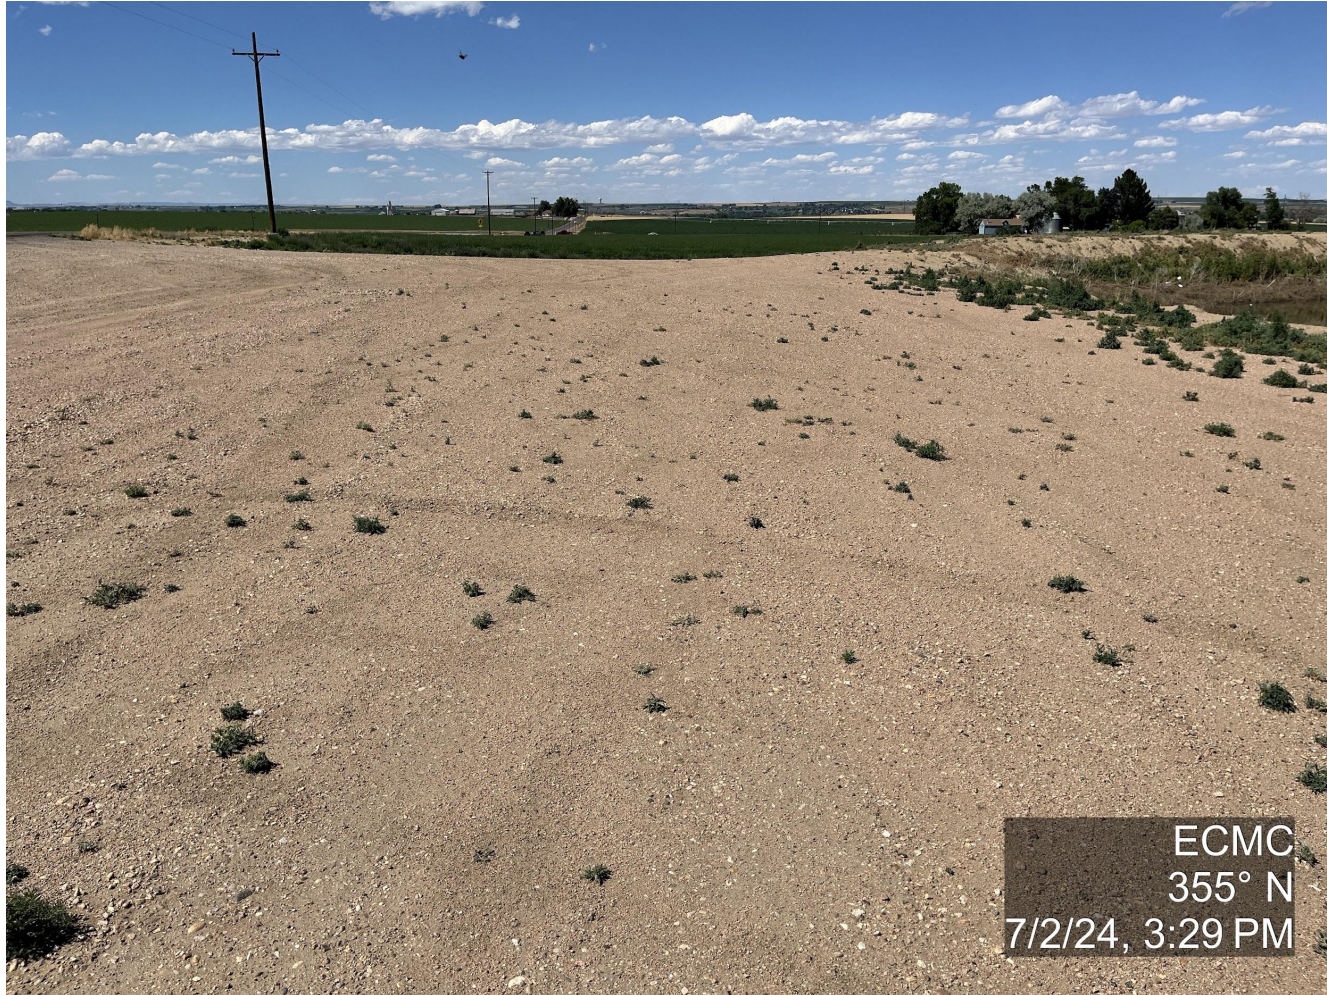
Photo 7. The photo was taken at the tank battery location. The photo illustrates the former tank battery location is stabilized with compact road base.
