Interim Reclamation and Stormwater Inspection

Operator: KP Kauffman Company Inc - 46290

Location ID: 318294

Inspection Document #: 713900770

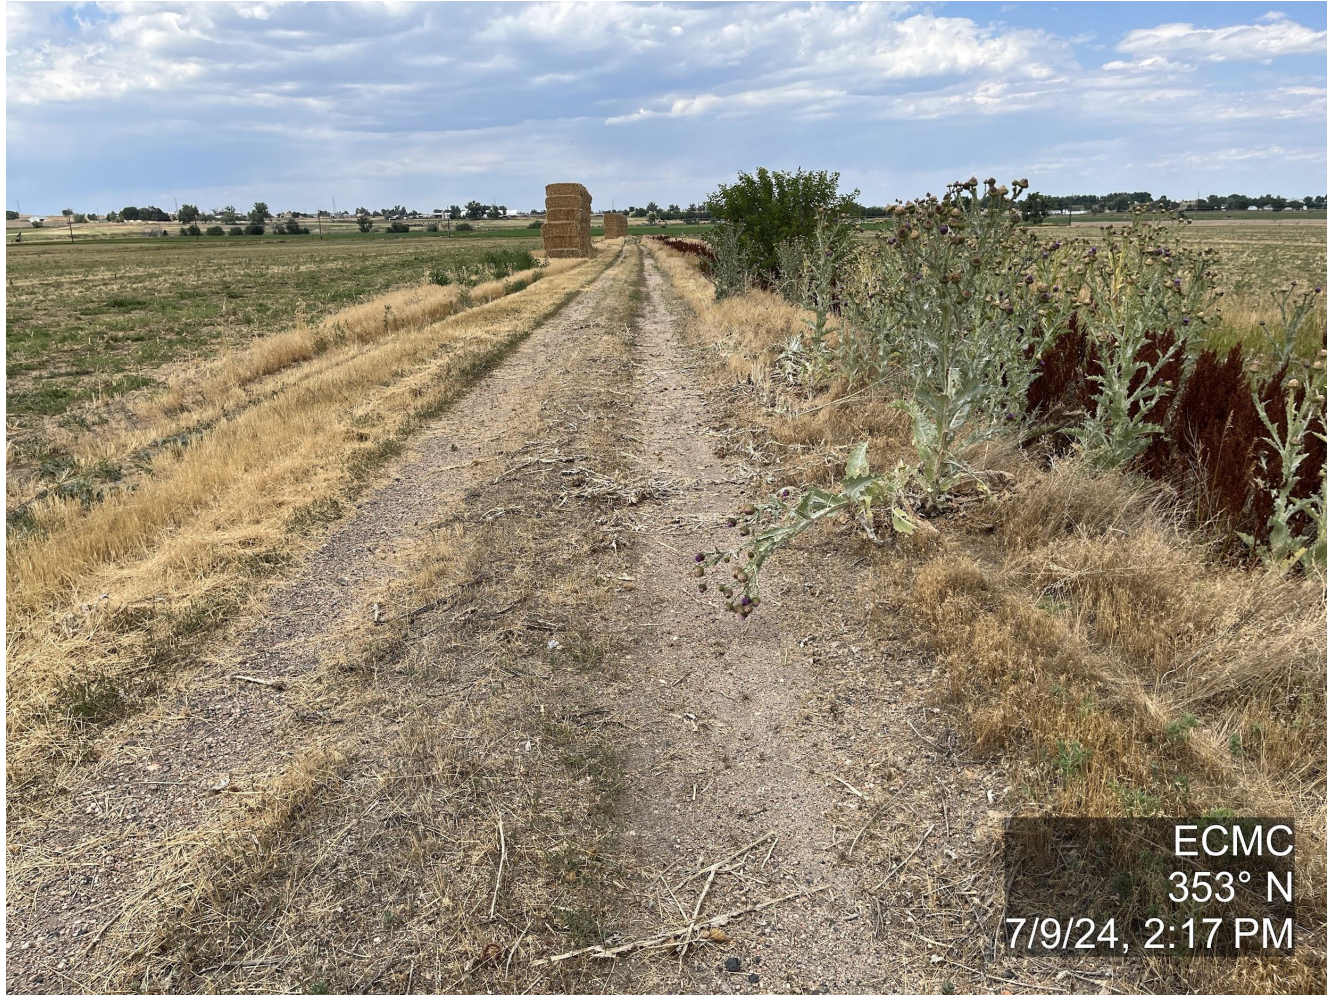
Photo 1. The photo was taken along the access road to the well location facing North. The photo illustrates the access road has been mowed since the complaint was submitted however Scotch thistle still remains along the access road right of way.

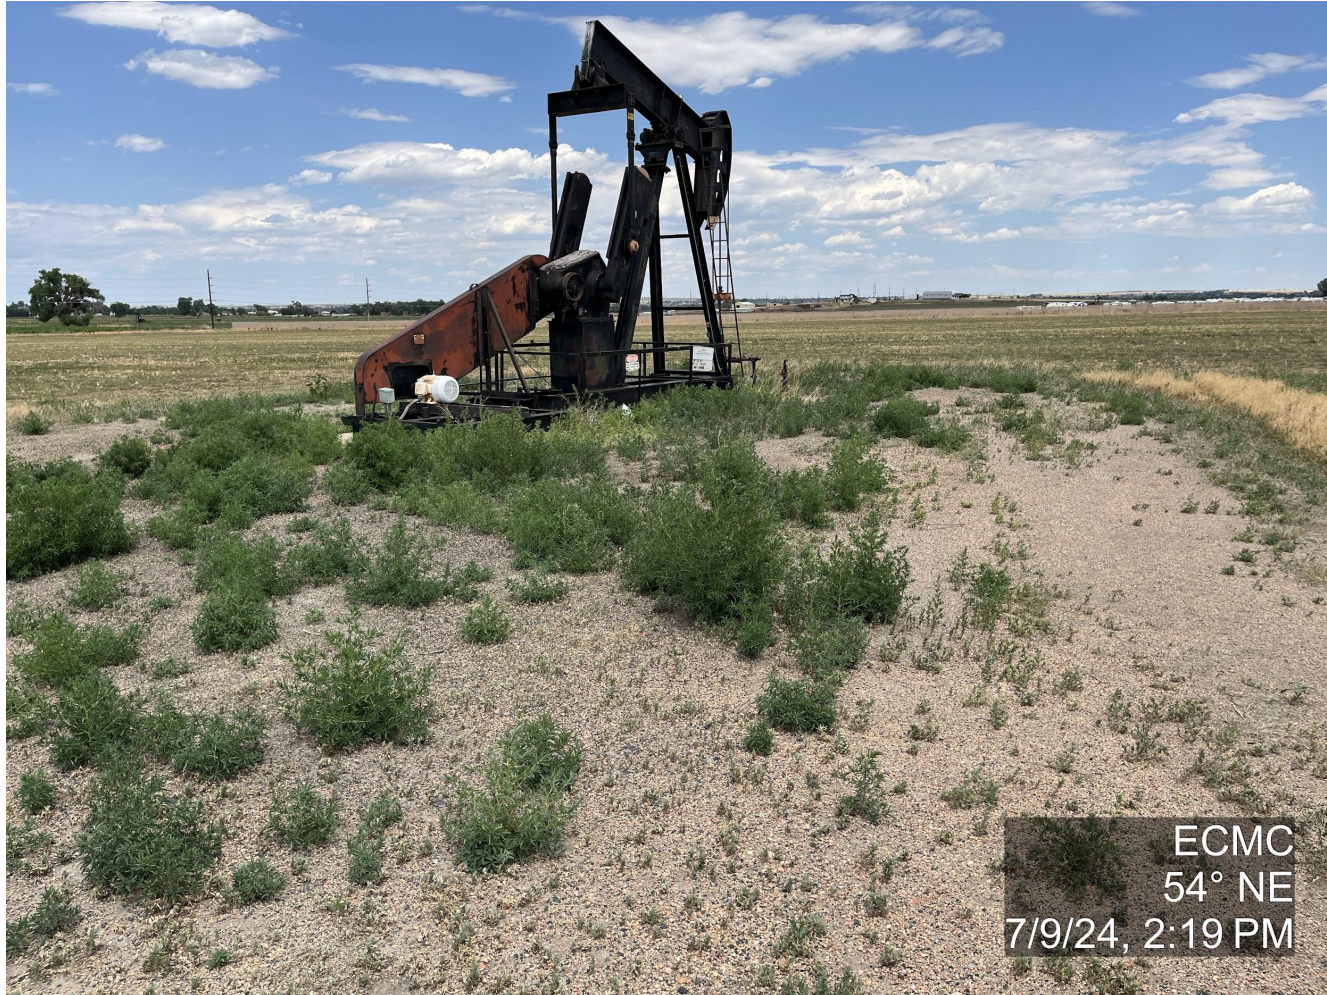
Photo 2. The photo was taken at the well location facing Northeast. The photo illustrates Kochia growing unmanaged across the well location and around equipment.

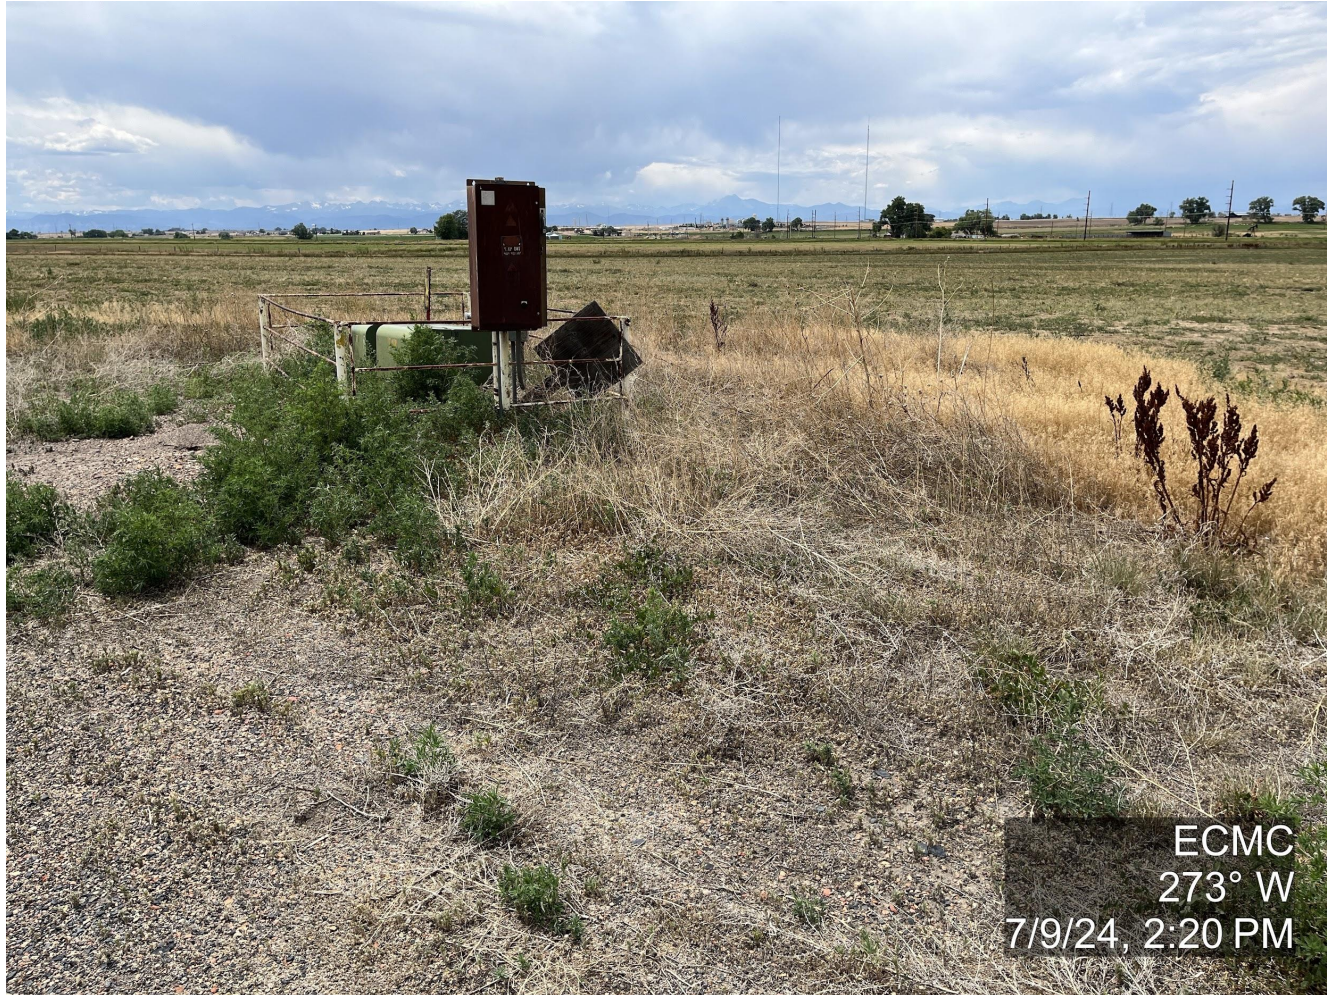
Photo 3. The photo was taken at the well location facing West. The photo illustrates Kochia, Curly dock and Cheatgrass growing unmanaged across the well location and around equipment.
