Operator: BCEI
Location Name: Antelope F-18
Loc ID: 429686
Inspection: 696306503

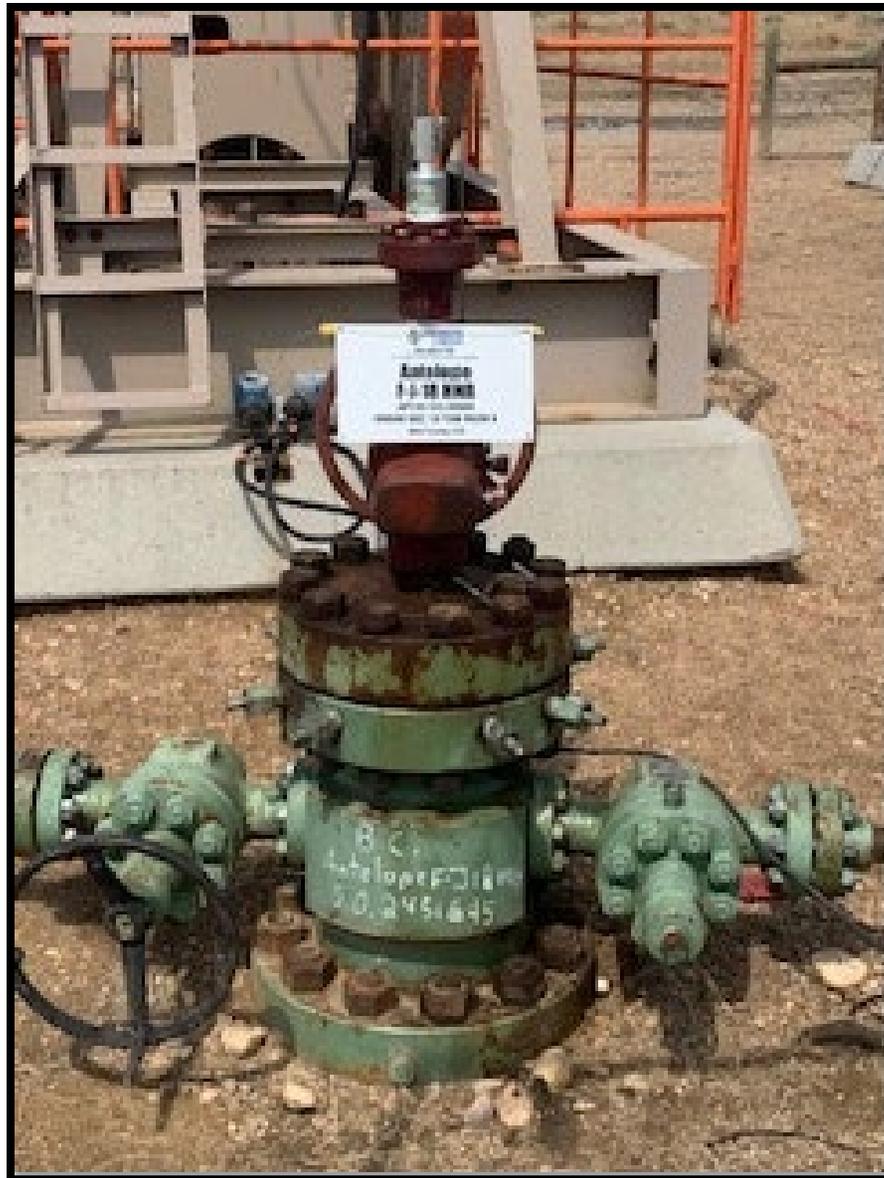
Exhibit A

CA: F-J-18HNB Well Sign has faded no longer visible; see photos Install sign to comply with Rule 605.d.

CA Resolution: Operator has reported that the signage has been updated and appropriately installed to comply with Rule 605.d.
