Operator: XOG

Location Name: Arellano 10-L Facility

Loc ID: 440776

Inspection: 708201213

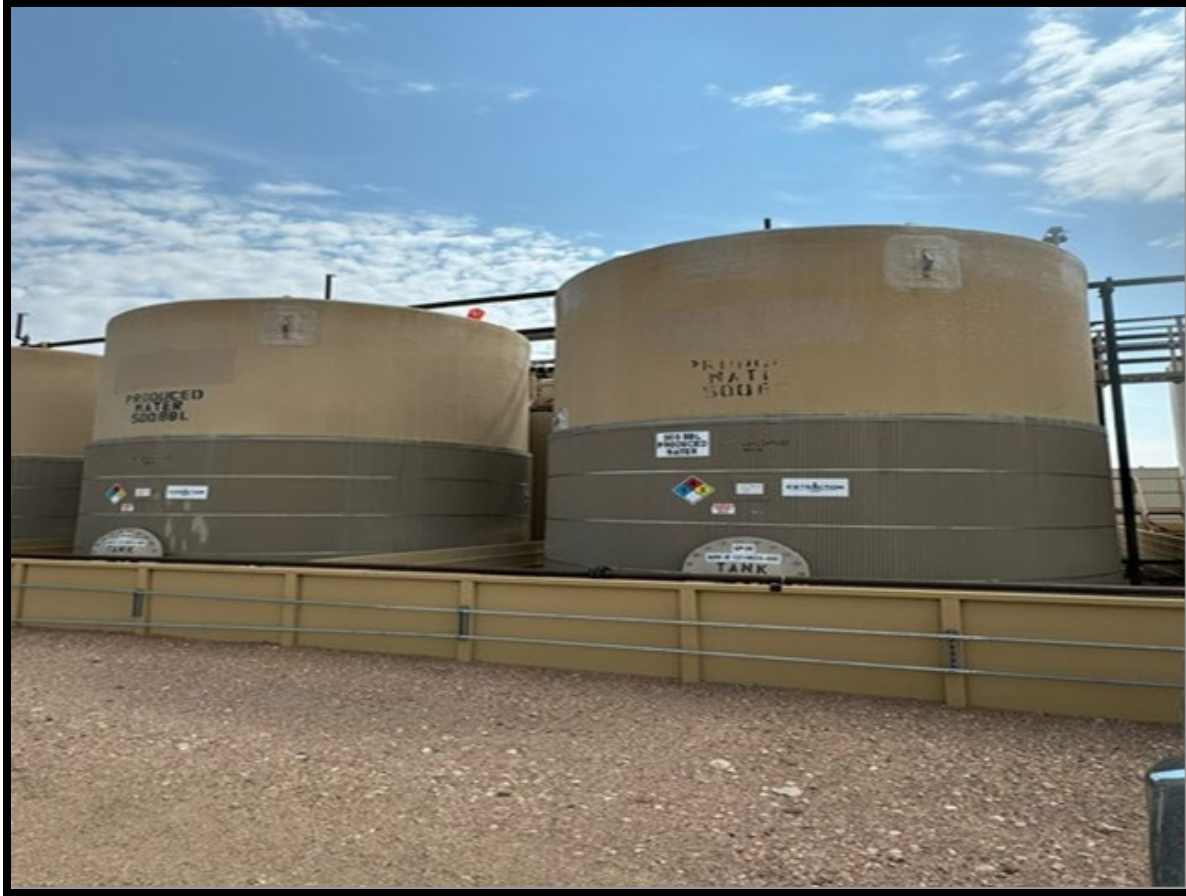
Exhibit A

CA: Tank labels and signs are faded, peeling, cracked. Refer to attached inspection photos for examples. Install sign to comply with Rule 605.g.

CA Resolution: Operator has reported that the labels have been replaced and installed appropriately to comply with Rule 605.g.
