Inspection Photos

Operator: WINDSOR ENERGY GROUP LLC

Location ID: 397591

Inspection Doc: 696206001

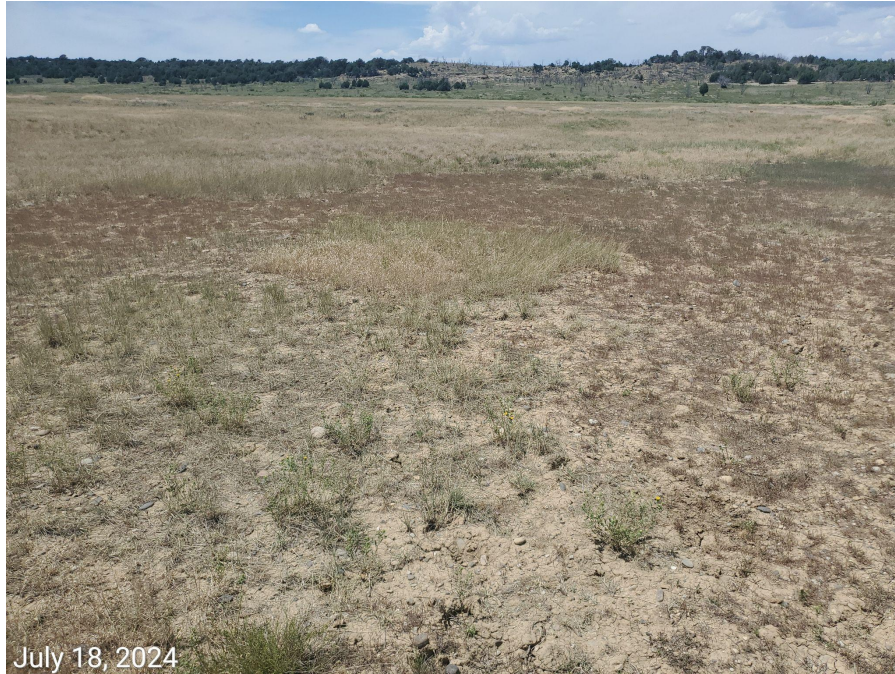
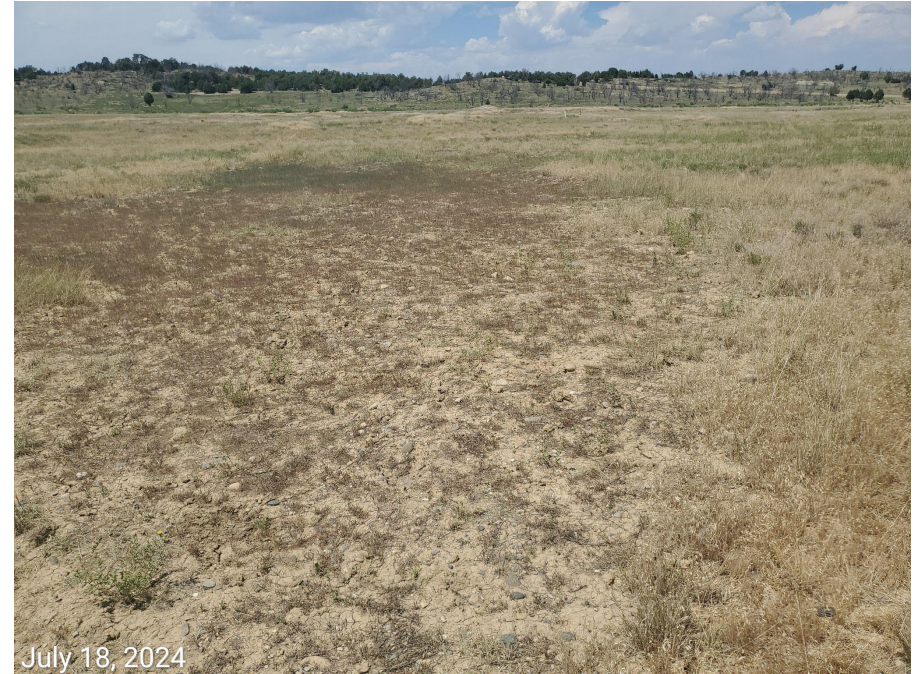
Photo 1: Photos taken from the east end of the Location, facing southwest and northwest. Location is not progressing towards 1004 uniform, perennial vegetative requirements; vegetation is predominantly undesirable plant species.

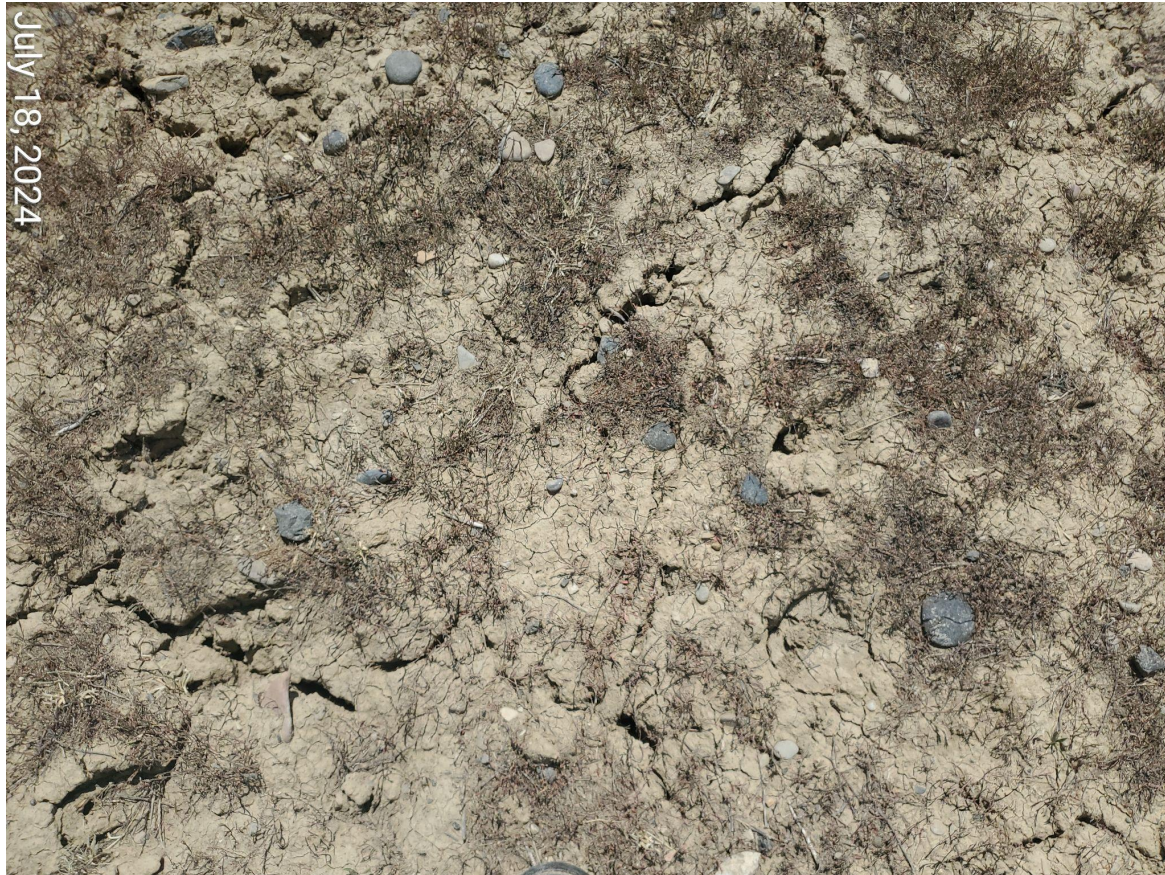
Photo 2: See comments under photo 1.

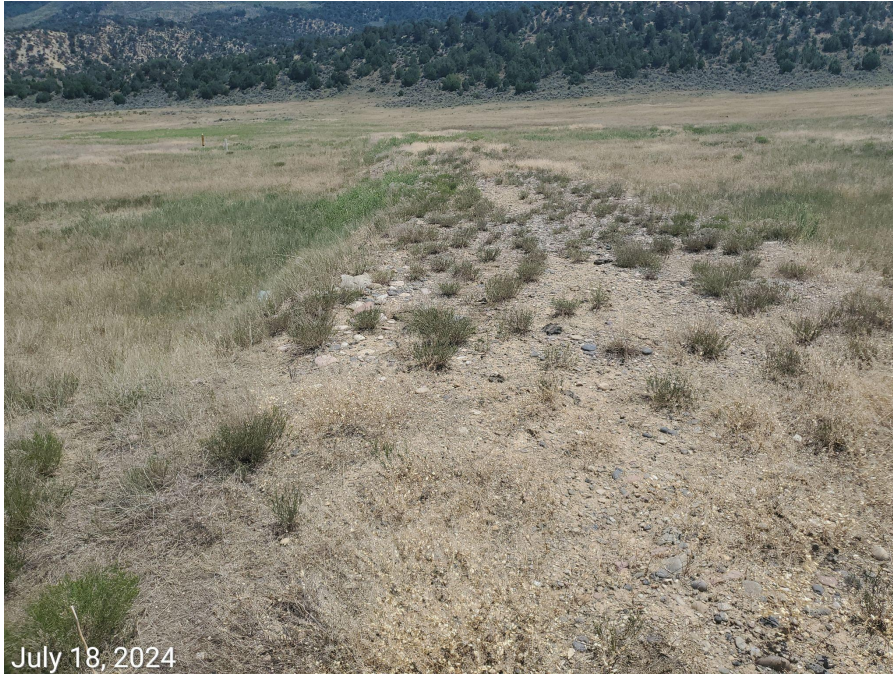
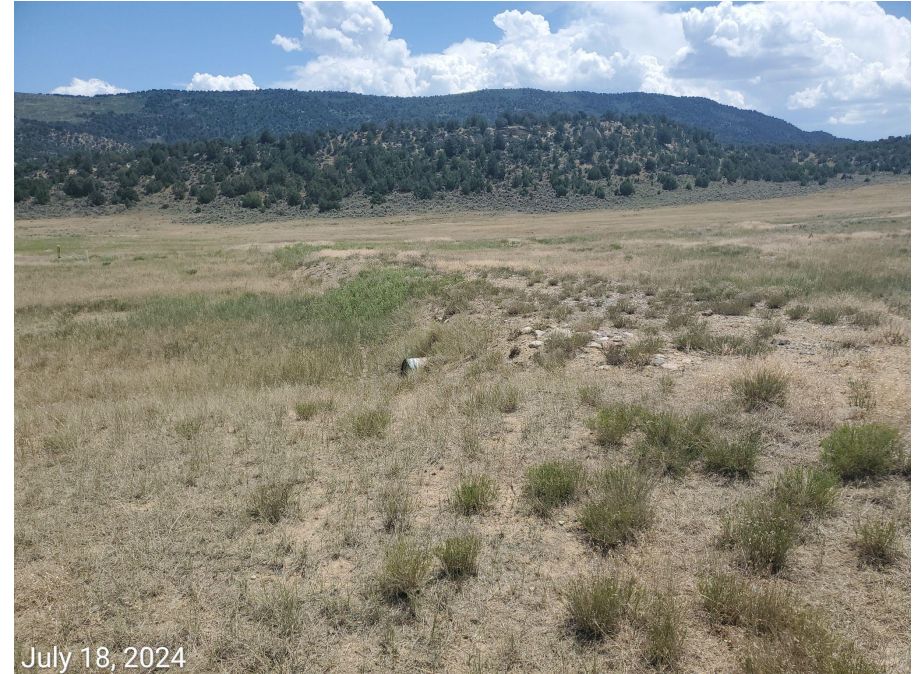
Photo 3: Photo shows reclamation work including, but not limited to, removal of culvert/gravel, compaction alleviation, recontouring/regrading and revegetation activities have not been performed at the access road.
