Operator: BCEI
Location Name: Antelope 18C
Loc ID: 418098
Inspection: 696306501

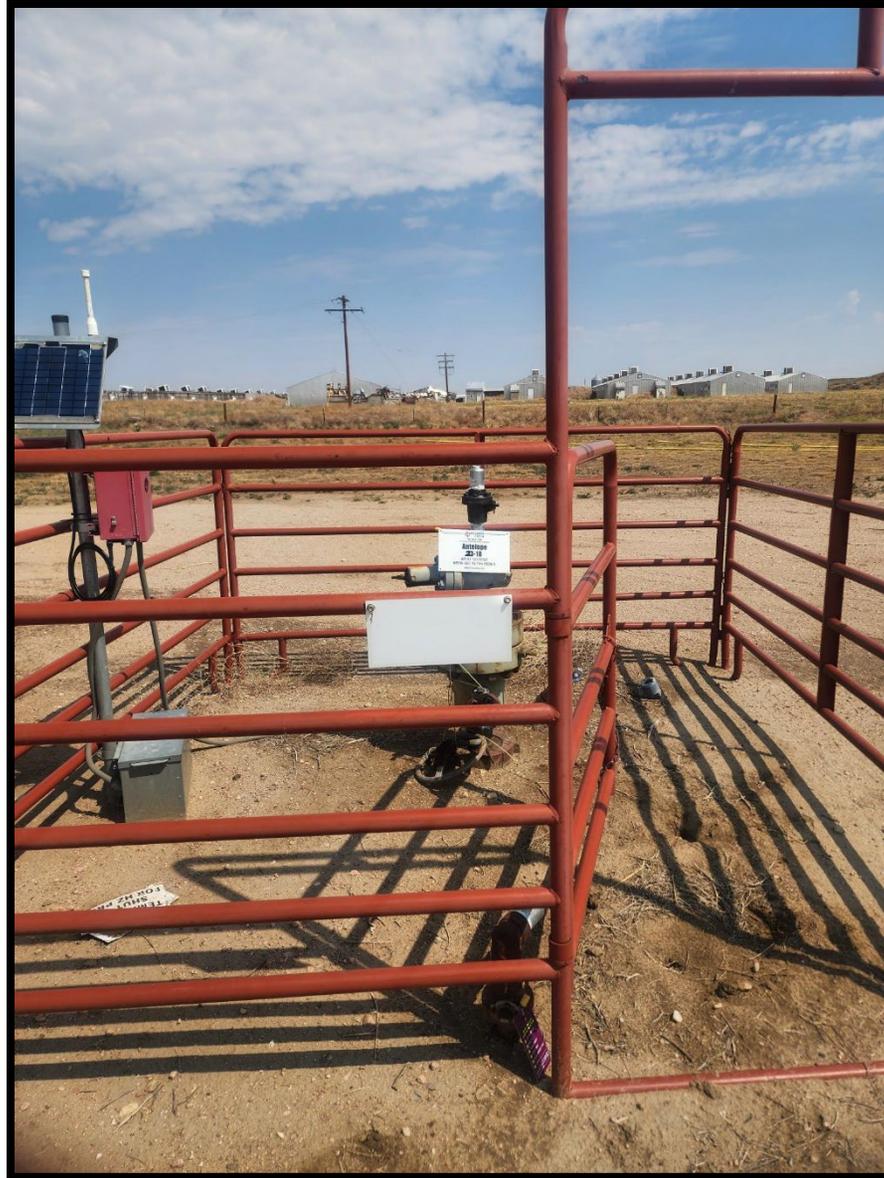
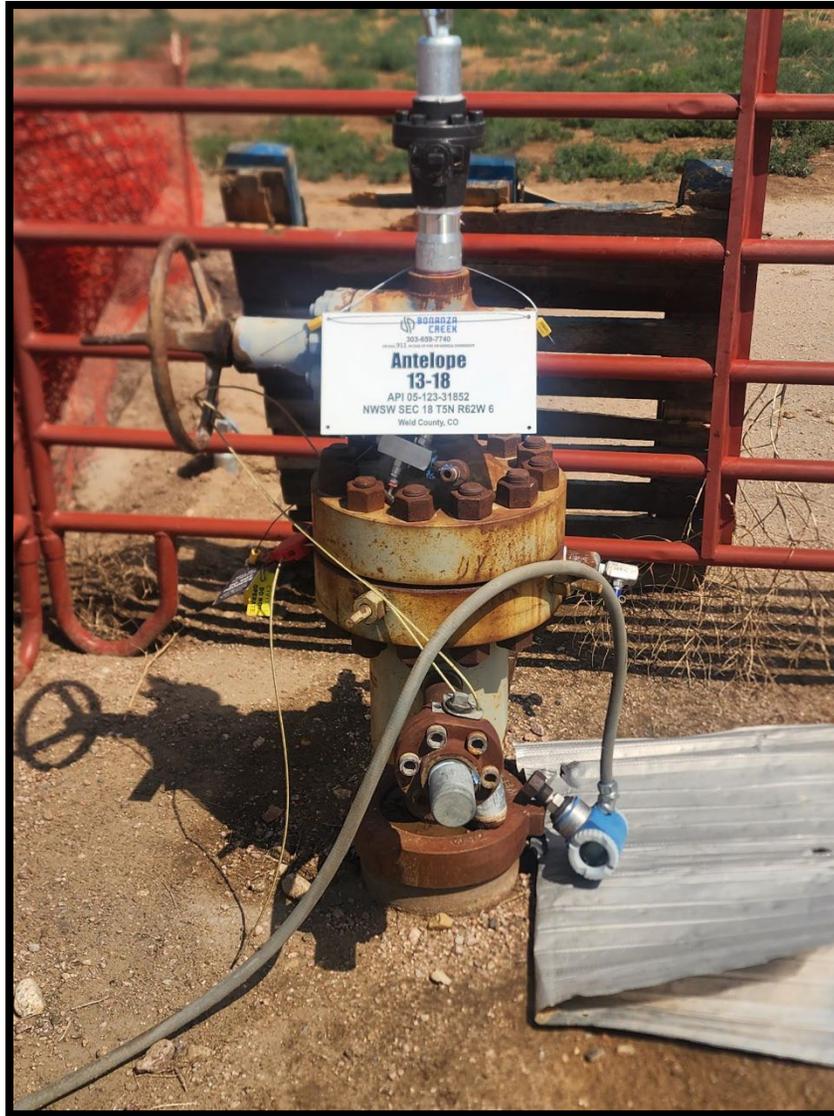
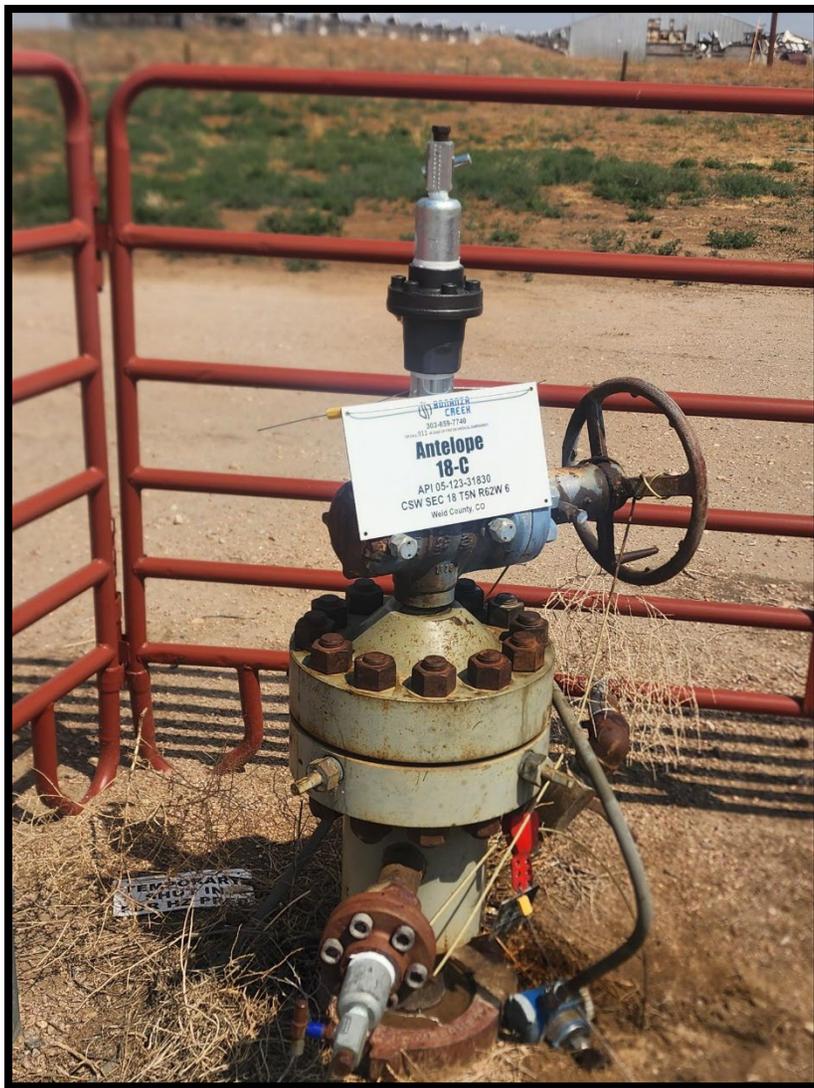
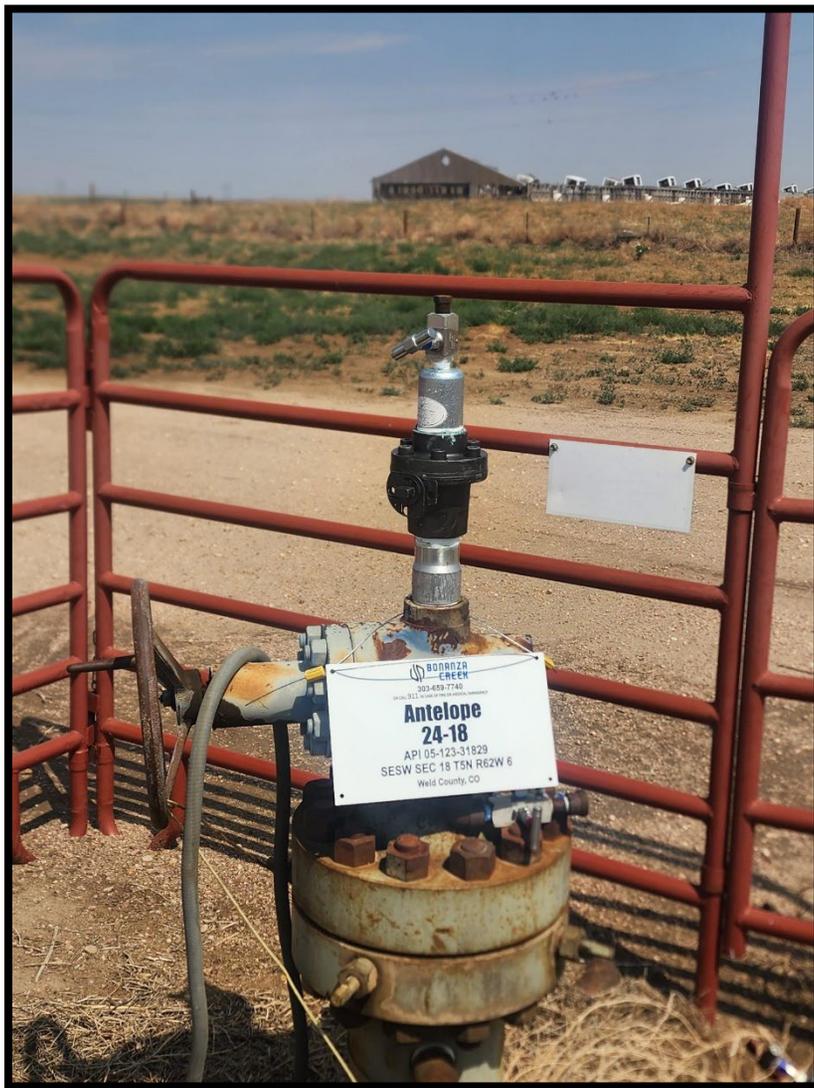
CA: All 4 remaining Wellhead Signs have faded no longer visible; see photos. Install sign to comply with Rule 605.d

CA Resolution: Operator has reported that the identified Wellhead signs have now been appropriately replaced/installed to comply with Rule 605.d.
