## MIGRATORY BIRD / RAPTOR SURVEY REPORT

**WELBA PEAK UNIT  
DUNCAN FACILITY (ECMC LOCATION ID: 485573)  
Moffat County, Colorado**

**July 26, 2024**

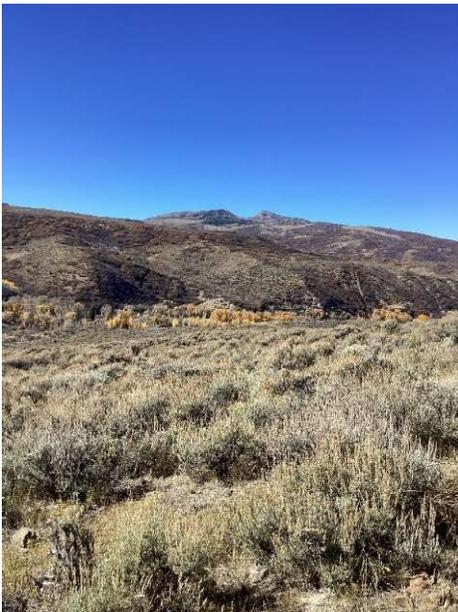
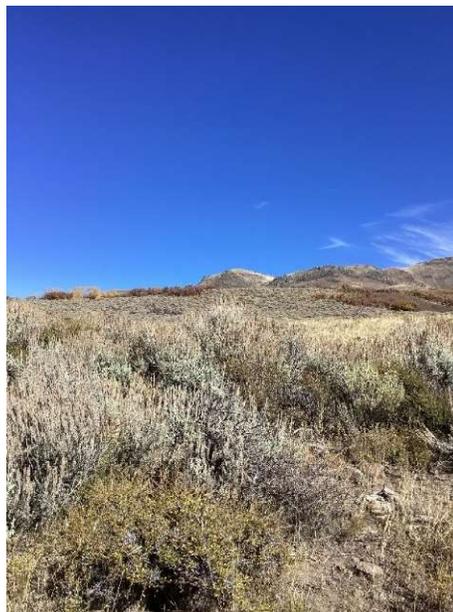
### REPRESENTATIVE PHOTOGRAPHS

**Observer:** Sarah Brady  
**Date of Observation:** 05/23/2023  
**Land Ownership:** Private  
**Description of Nest:** Small cup like nest; Unoccupied  
**Nest Substrate:** Gamble Oak (live)  
**Height of Substrate (ft):** 8  
**Nest Ht. Above Ground (ft):** 6  
**Active**  **Inactive**   
**Number of Eggs:** NA  
**Number of Young:** NA  
**Exposure of Nest:** NW  
**Vegetation Type:** Rangeland  
**Condition of Nest:** Good  
**Quad Name:** Fly Creek

**Nest Number:** N/A  
**Species:** Unknown MBTA  
**T 11N, R 89W, Sec 14**  
**GIS File Name:** Welba Peak  
**Remarks, Physical Relationship to Other Nests, Etc.:** Nest is small-medium MBTA stick built nest located 8' up in a gamble oak in the disturbance area; it is inactive-unoccupied but in good condition for use, could be black-billed magpie. No other MBTA nest within disturbance area. No raptor nests within 0.5 miles.

**Observer:** Chris Cooper  
**Date of Observation:** 07/24/2023  
**Land Ownership:** Private  
**Description of Nest:** Could not locate  
**Nest Substrate:** Gamble Oak  
**Height of Substrate (ft):** 8  
**Nest Ht. Above Ground (ft):** 6  
**Active**  **Inactive**   
**Number of Eggs:** NA  
**Number of Young:** NA  
**Exposure of Nest:** NA  
**Vegetation Type:** Rangeland  
**Condition of Nest:** NA  
**Quad Name:** Fly Creek

**Nest Number:** NA  
**Species:** Red-Tailed Hawk (RTHA)  
**T 11N, R 89W, Sec 14**  
**GIS File Name:** Welba Peak  
**Remarks, Physical Relationship to Other Nests, Etc.:** Nest is small-medium MBTA stick built nest located 8' up in a gamble oak in the disturbance area; it is inactive-unoccupied but in good condition for use, could be black-billed magpie. No other MBTA nest within disturbance area. No raptor nests within 0.5 miles.
