**Operator: HPR**

**Location Name: Garden Creek 06-11H**

**Loc ID: 415772**

**Inspection: 693700441**

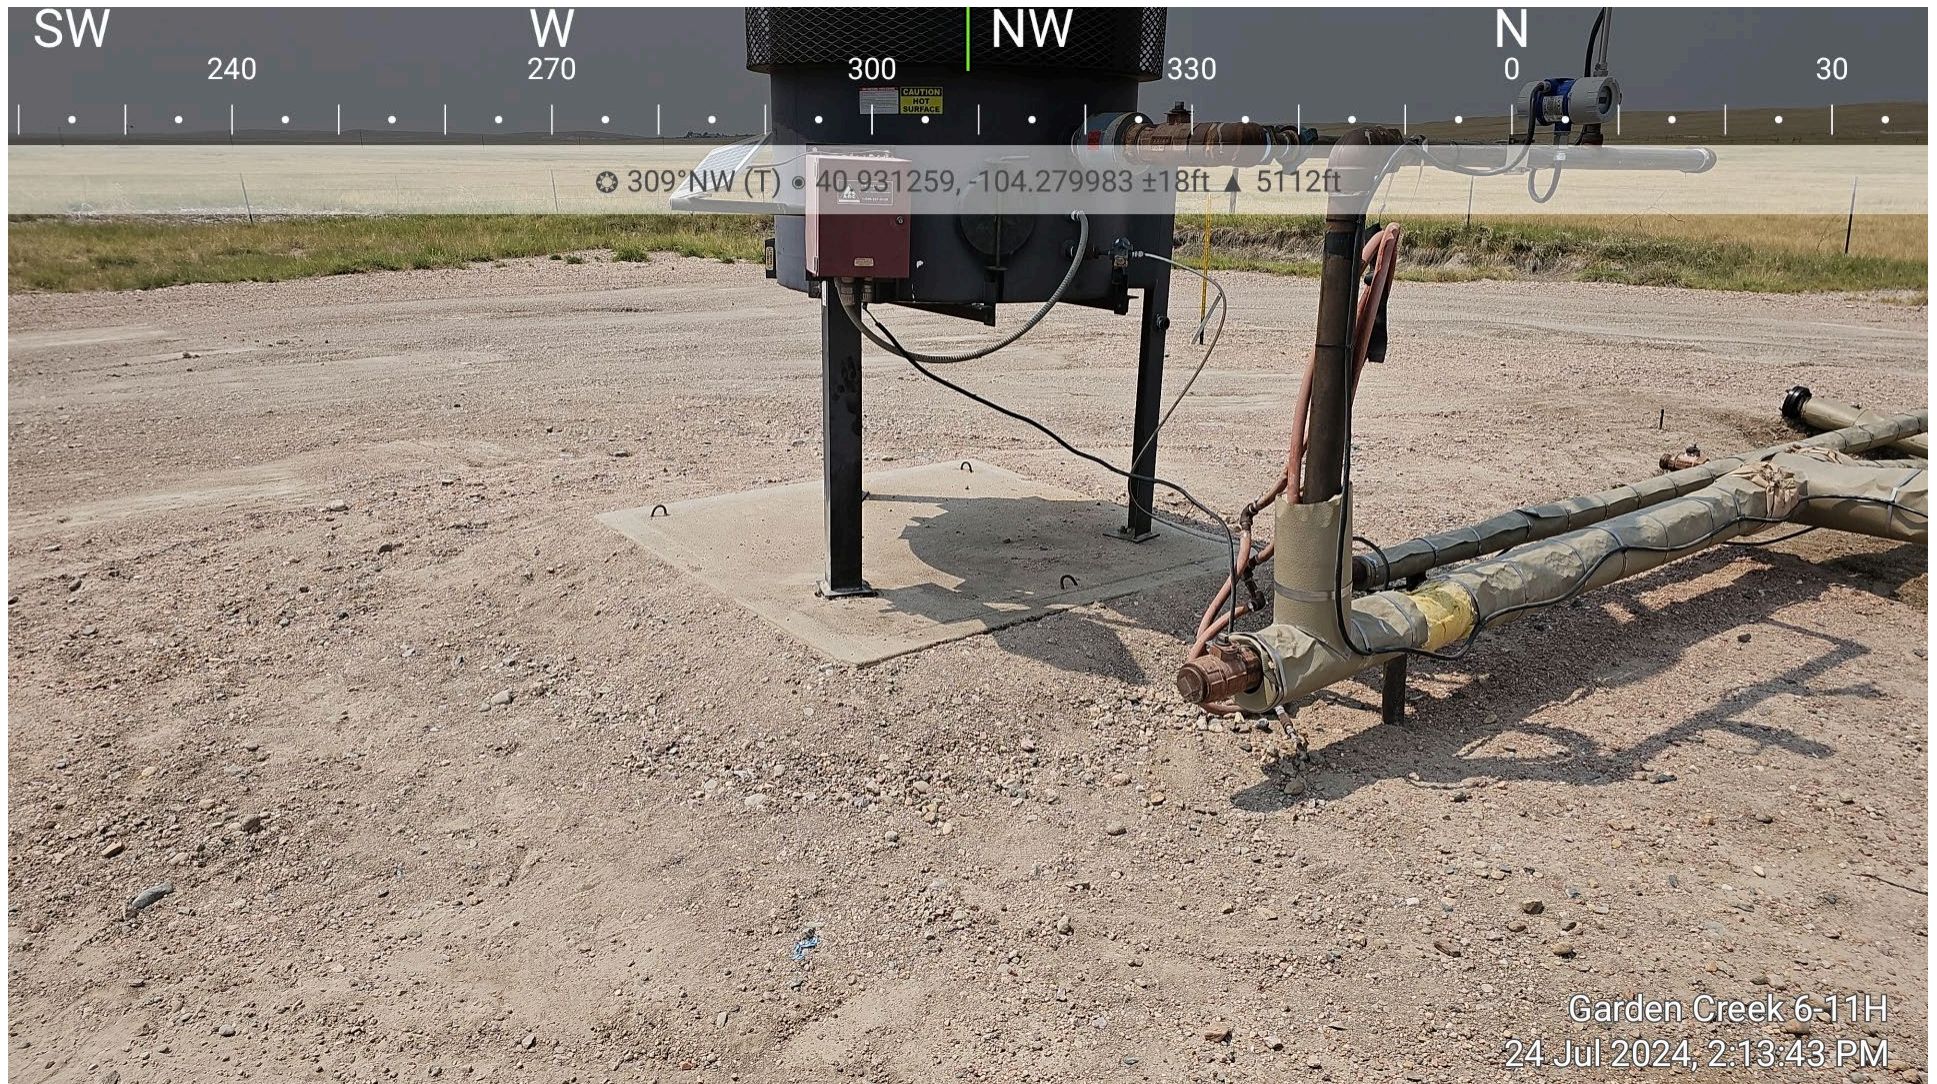
**CA:** Small spill localized beneath ECD. Cleanup spill and identify cause of release ECD and repair.

**CA Resolution:** Operator has provided follow-up to show that noted spill has been appropriately addressed to comply with the 900 series.
