## Inspection Photos

Location Name: Dry Creek

Federal 1-14

REM #19966

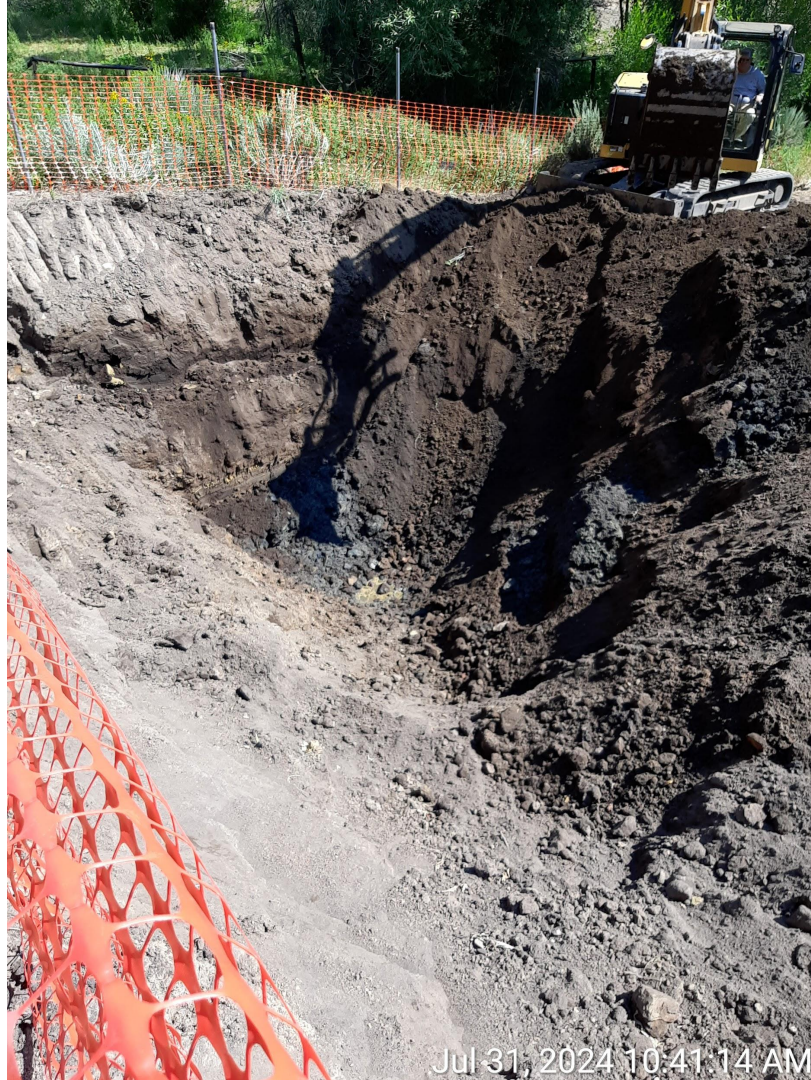
Jul 31, 2024 10:41:14 AM

Looking mostly north, downstream. Area of former Flare pit. Vegetation in the background of picture is sage creek. The Creek is approximately 90 feet away. Water was present in Sage Creek.

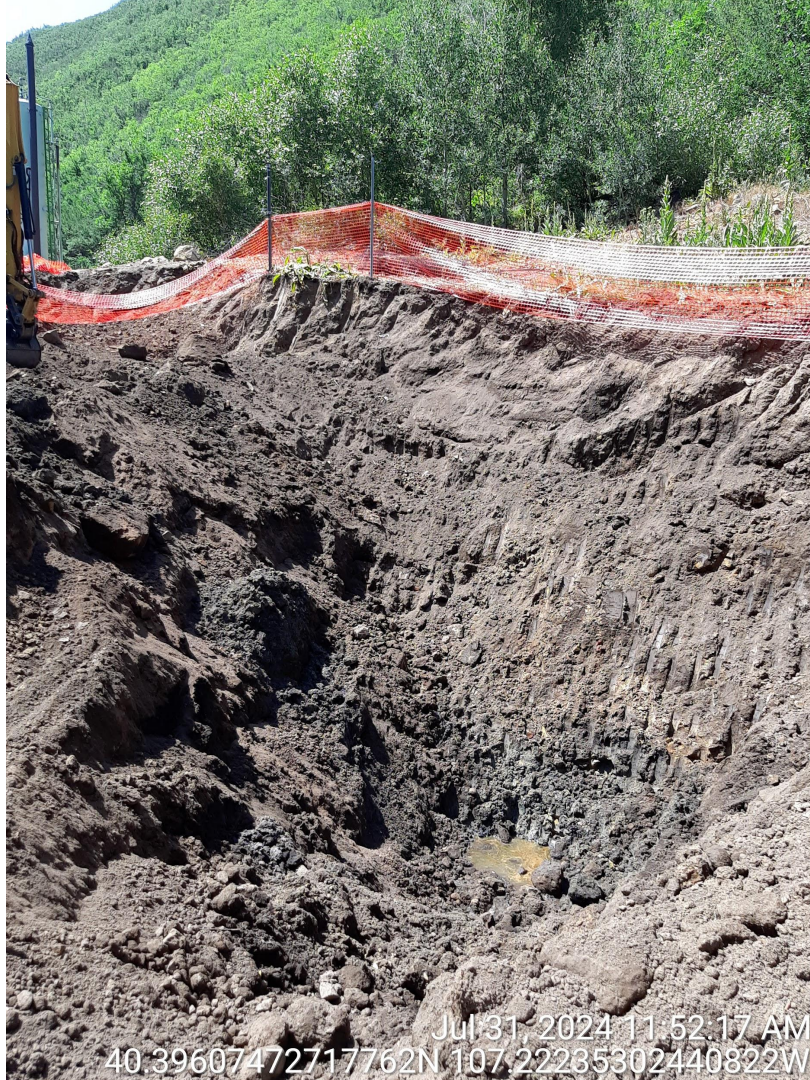
Jul 31, 2024 11:52:17 AM  
40.39607472717762N 107.22235302440822W

Photo taken looking mostly south. During excavation activities, groundwater was discovered. A sample of groundwater was collected by HRL consulting.

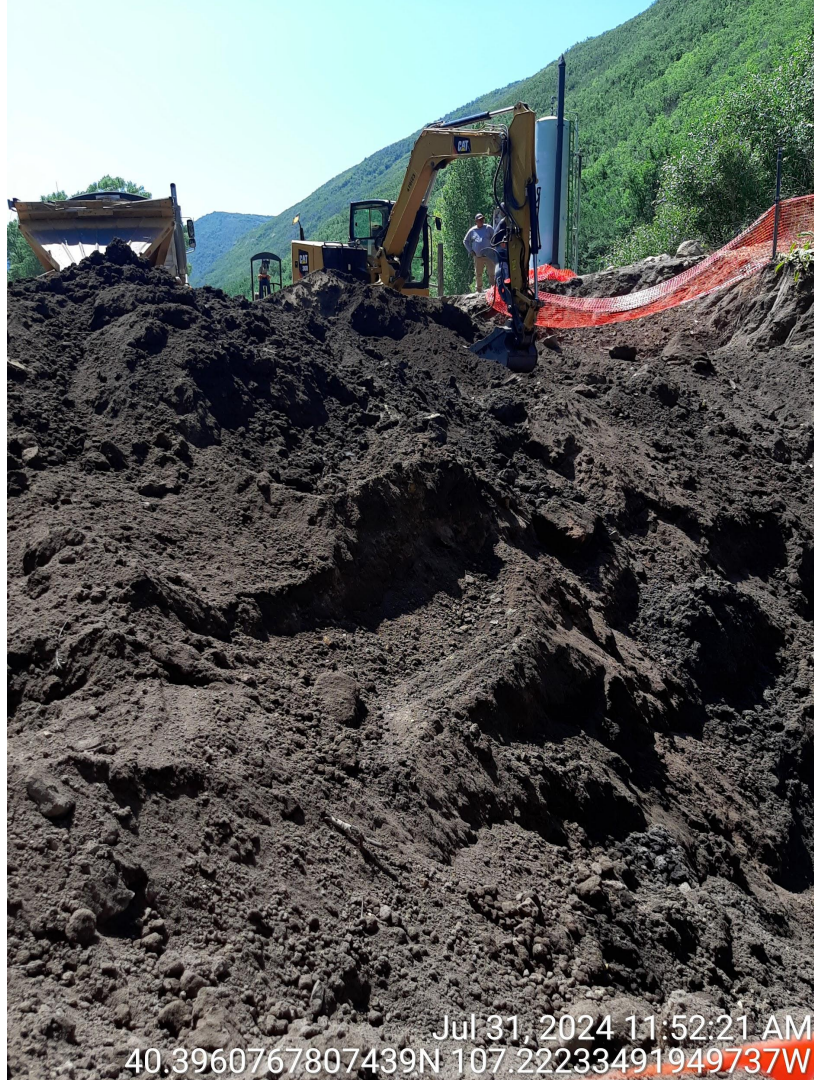
Jul 31, 2024 11:52:21 AM  
40.3960767807439N 107.22233491949737W

Photo of excavation of  
flare pit.

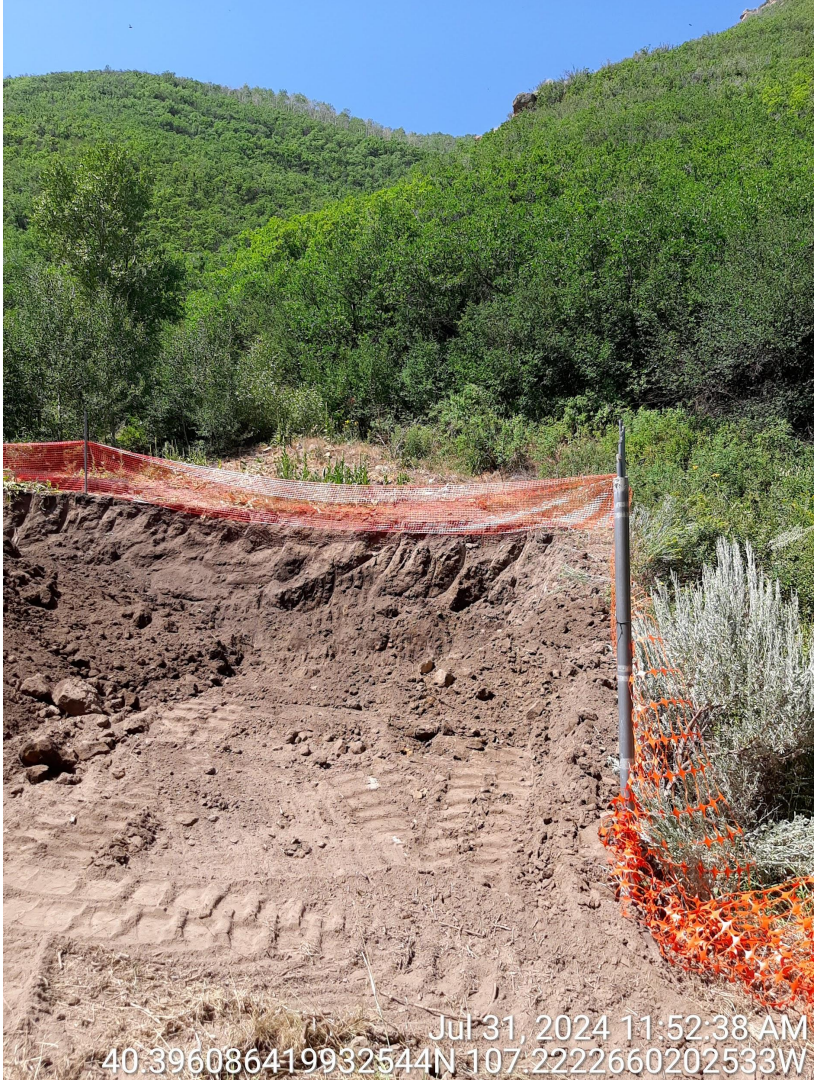
Jul 31, 2024 11:52:38 AM  
40.396086419932544N 107.2222660202533W

Photo taken looking north  
on the east side of flare  
pit.

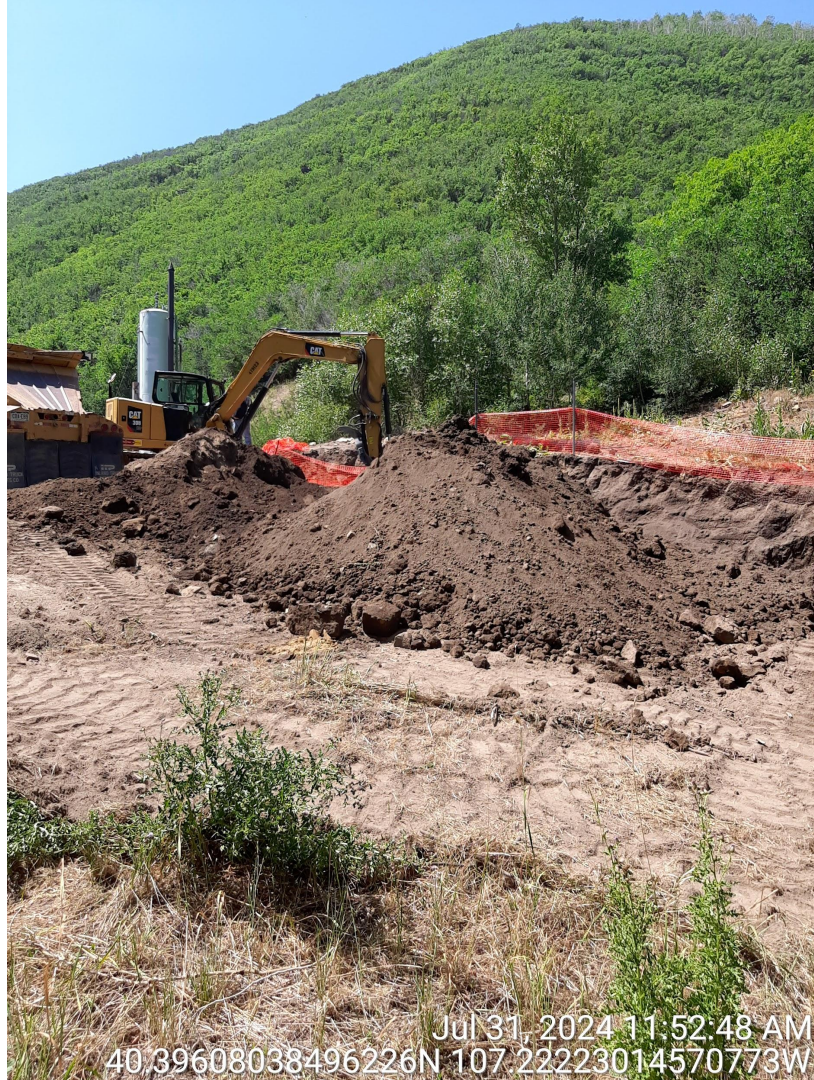
Jul 31, 2024 11:52:48 AM  
40.39608038496226N 107.22223014570773W

Photo taken from the east side of former pit, looking west.

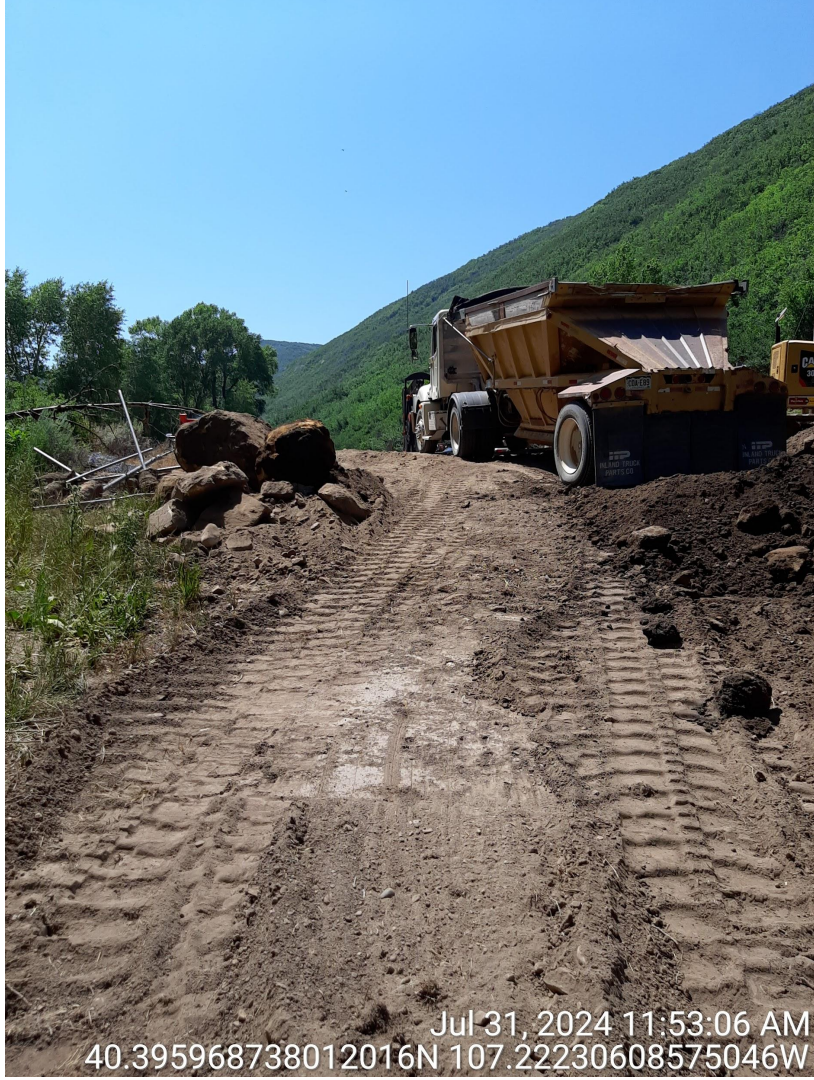
Jul 31, 2024 11:53:06 AM  
40.395968738012016N 107.22230608575046W

Photo taken looking  
south at access road on  
the east side of pit.

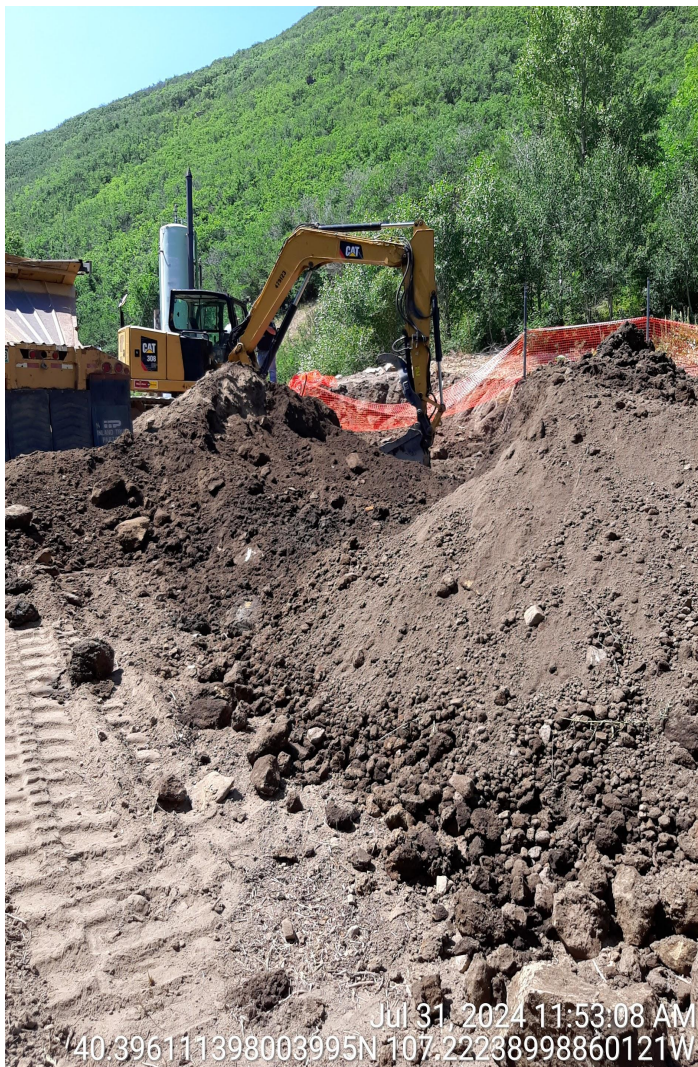
Looking southwest  
across flare pit.
