Operator: HPR

Location Name: Randall Creek 13-27H

Loc ID: 424282

Inspection: 696300679

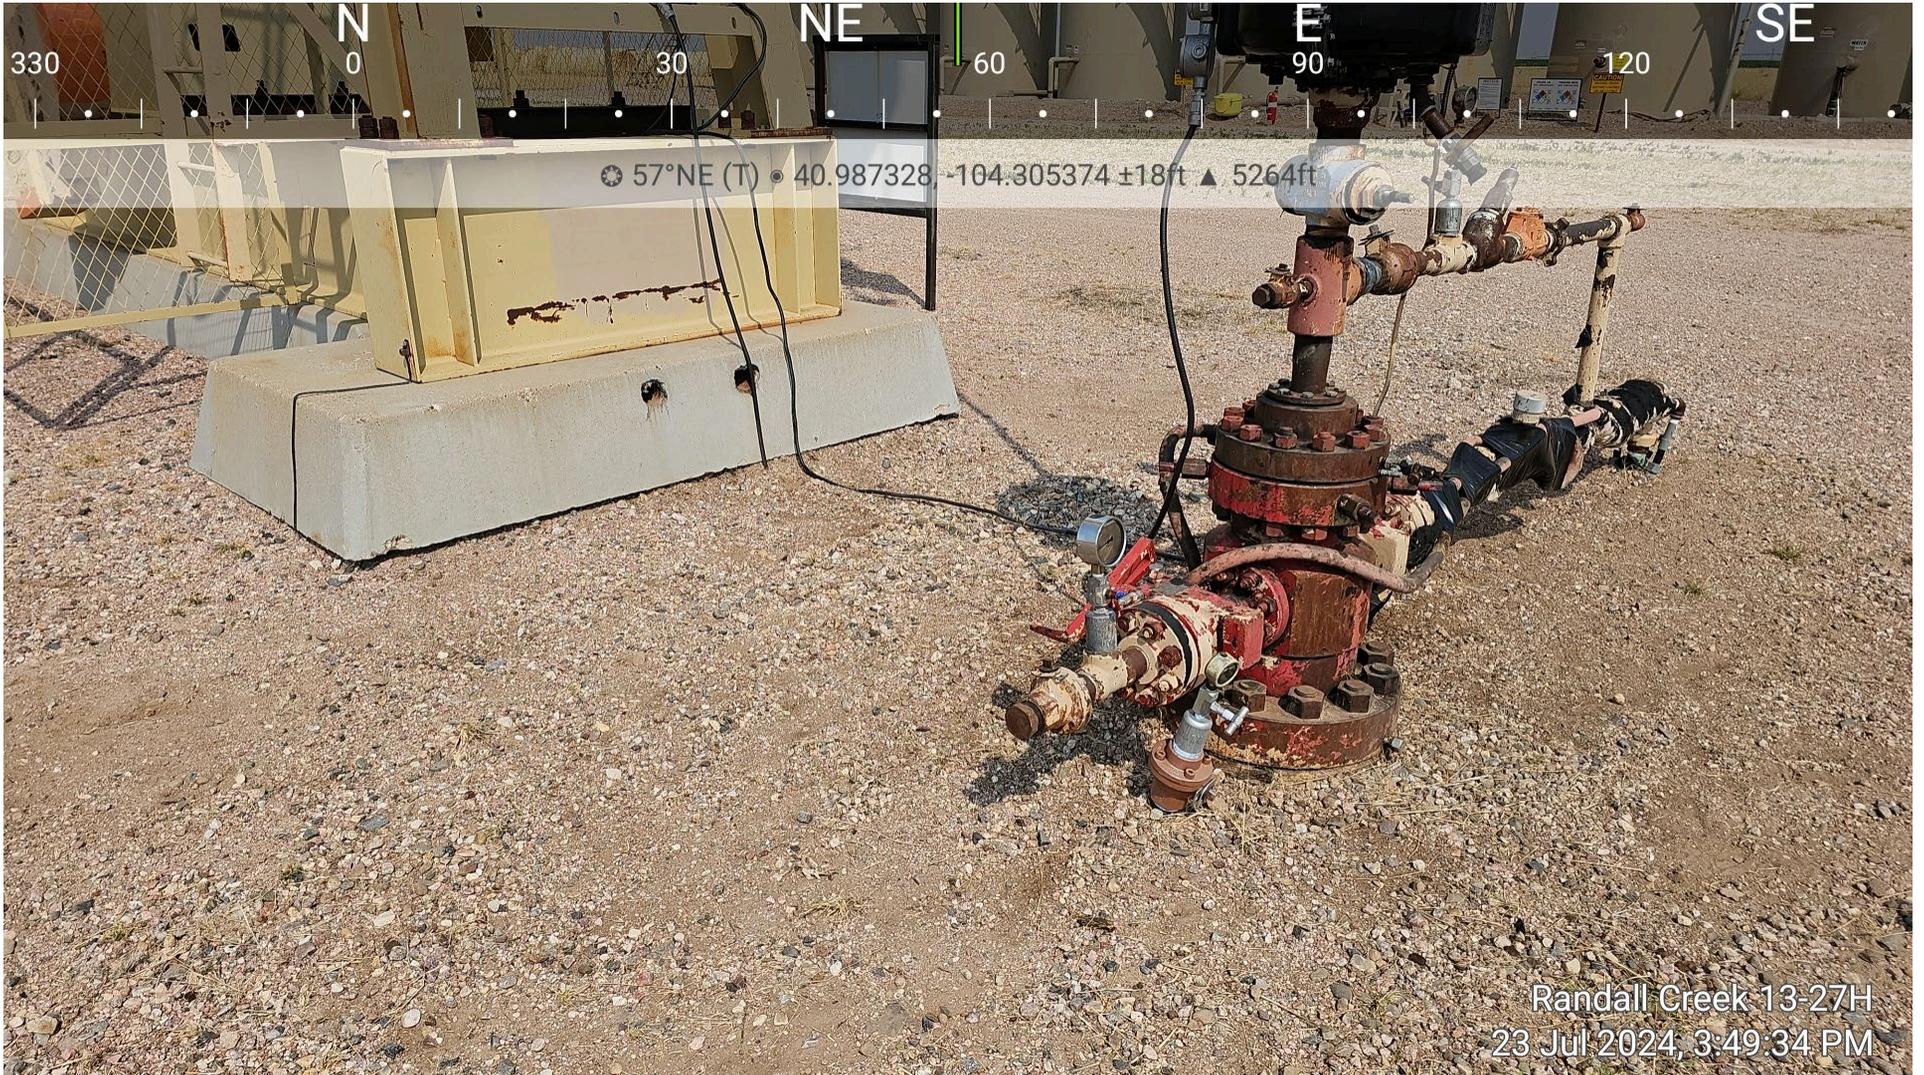
Randall Creek 13-27H
23 Jul 2024, 3:49:34 PM

CA: Stained soil at Wellhead, see photo 3. Corrective Action: Comply with Rule 907.e

CA Resolution: Operator has provided photo evidence to show that the stained soil has been appropriately removed/cleared and mechanical issues leading to the leak have also been addressed.

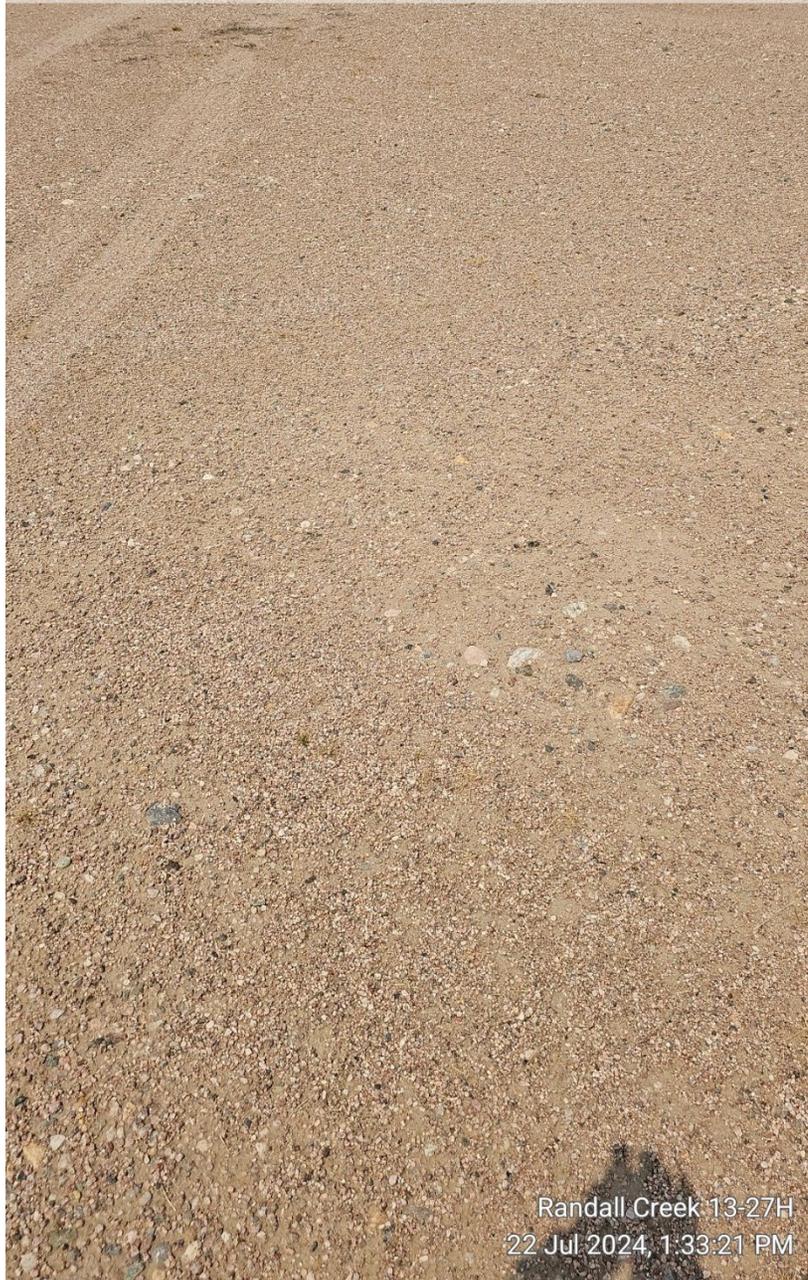
Randall Creek 13-27H
22 Jul 2024, 1:33:21 PM

CA: Northeast Deadman Anchor is not marked, see photo 4. Corrective Action: Mark guy line anchors per Rule 604.c.(2)Q.

CA Resolution: Operator has provided follow-up to show that identified deadman has removed.
