ENSOLUM

August 8, 2024

Subject: Soil Sampling Summary
Caerus Piceance, LLC
Remediation Project Number: Not Assigned
RNPU 196-19B
Rio Blanco County, Colorado

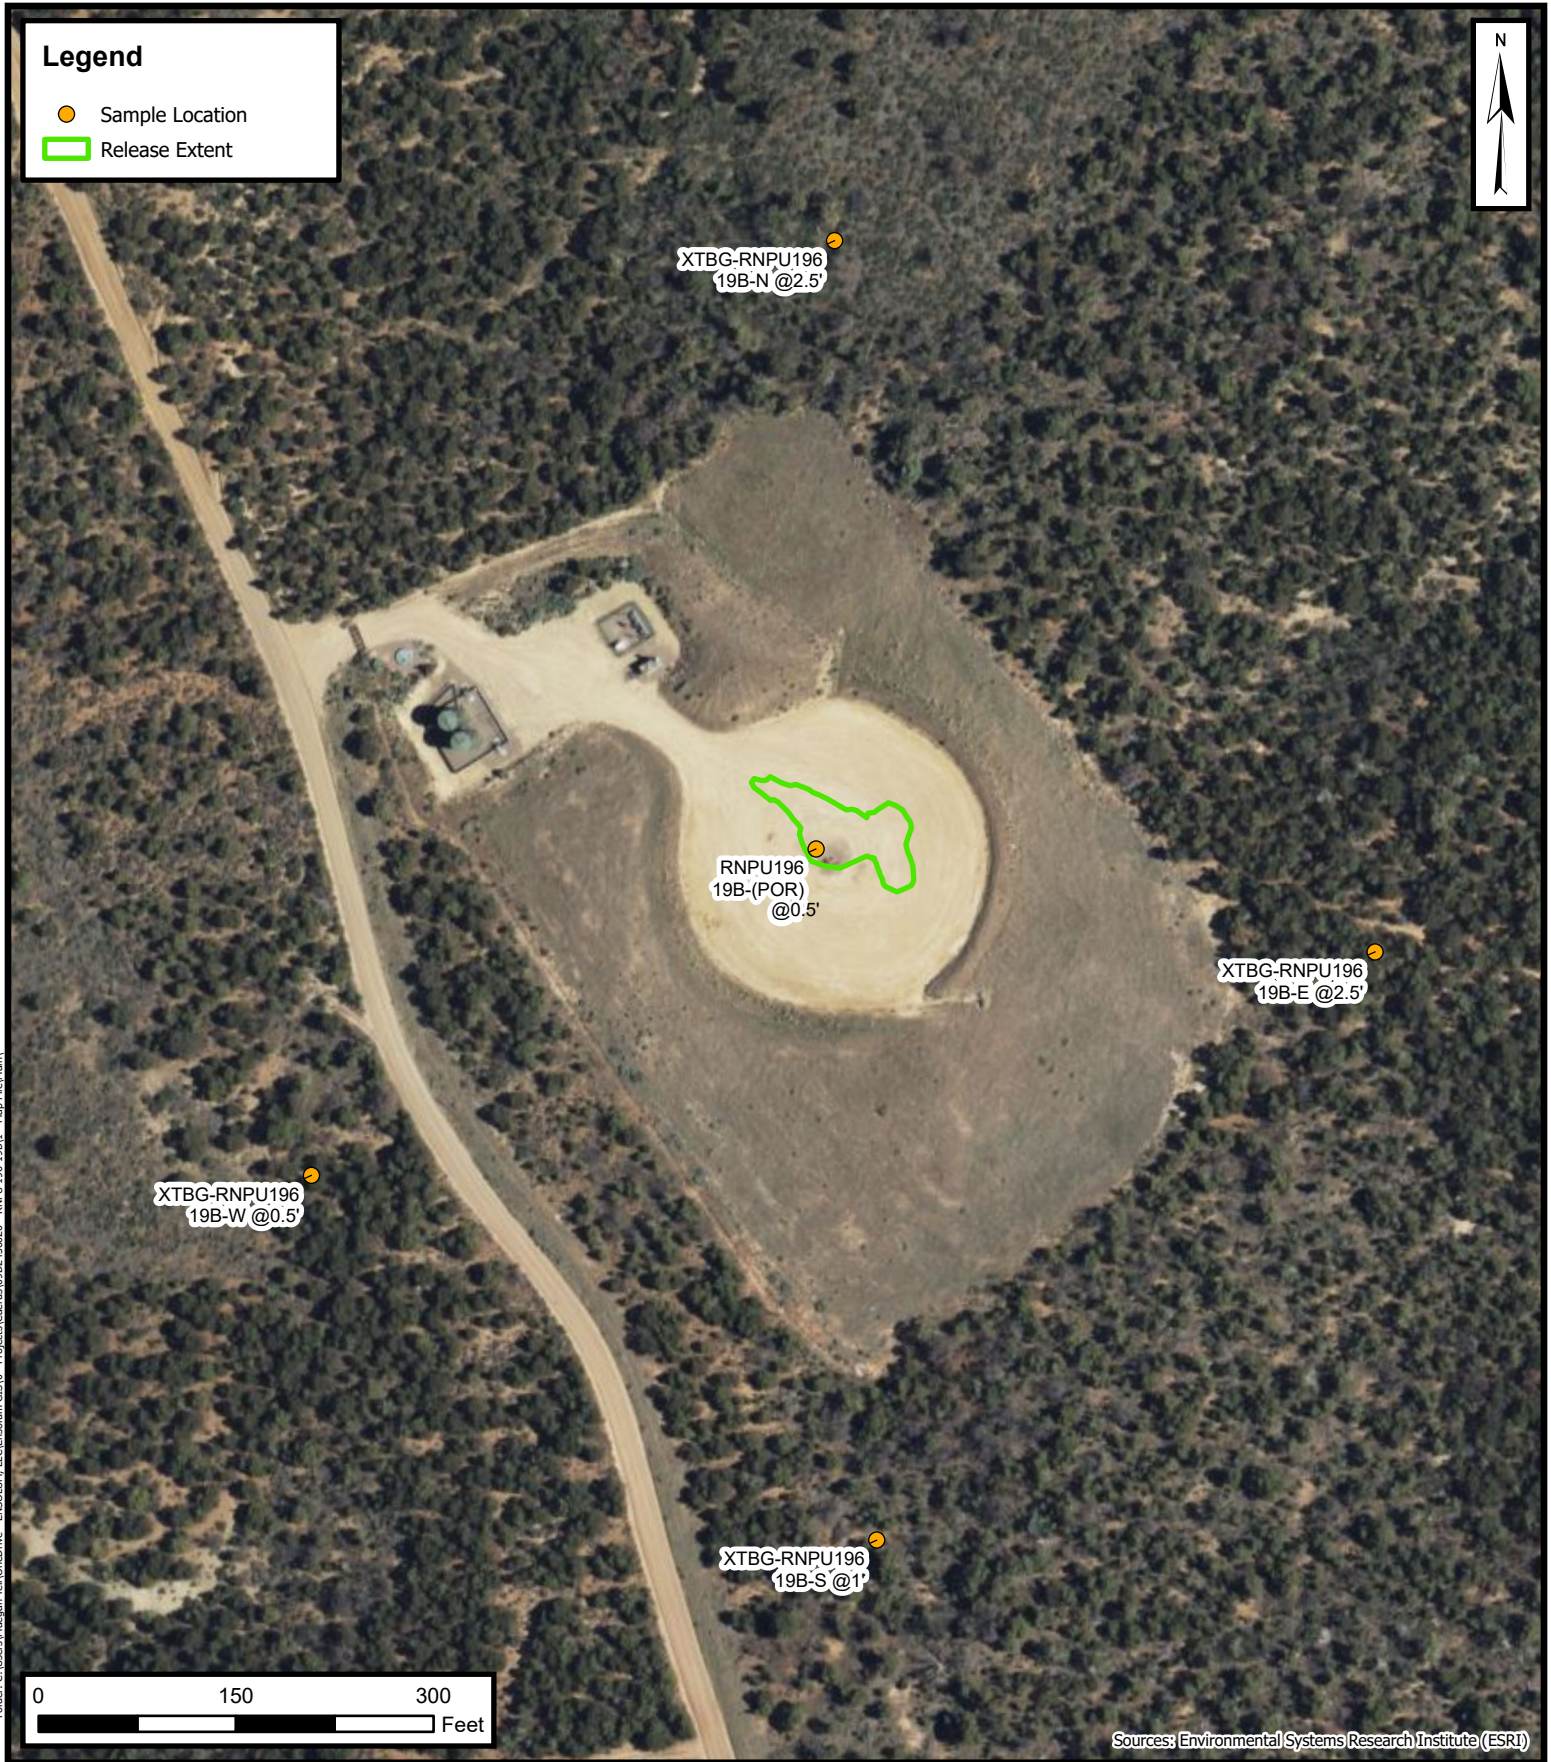
Soil Sample Location Map

RNP 196-19B
Caerus Piceance, LLC
39.9550091, -108.2012763

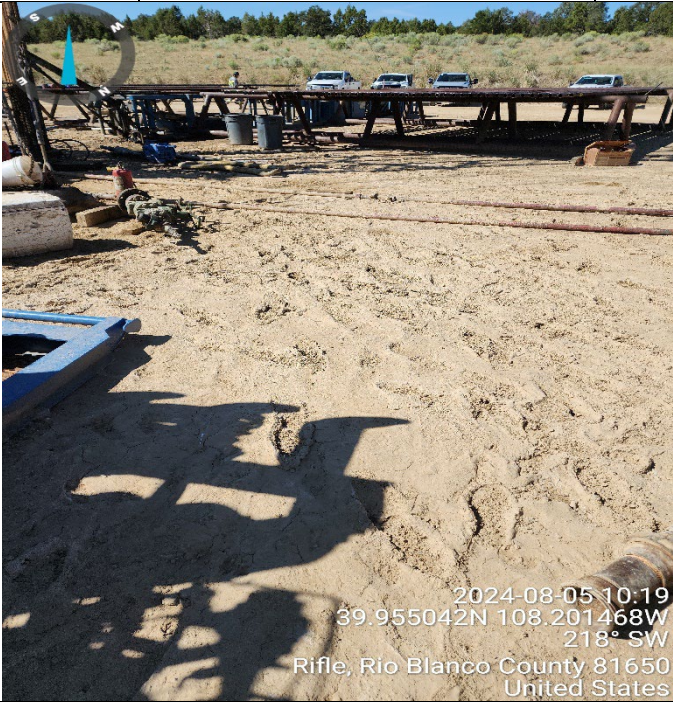
PHOTOGRAPHIC LOG		
Caerus Piceance, LLC	RNPU 196 19B Rio Blanco County, Colorado	Sample ID: RNPU 196-19B-(POR)@0.5
Date: 8/5/2024	Photo No. 1 – POR	Coordinates Lat/Long: 39.954938, -108.201445

<p>2024-08-05 10:19 39.955042N 108.201468W 218° SW Rifle, Rio Blanco County 81650 United States</p>		
View facing south at POR.

On August 5, 2024, initial soil sampling activities were conducted at the **RNPU 196-19B** location. One (1) soil sample was collected, (RNPU 196-19B-(POR)@0.5), at the point of release (POR) at a depth of approximately 0.5 feet below ground surface (bgs). The soil sample was field screened for volatile organic compound (VOC) concentrations using a photoionization detector (PID) and exhibited a reading of 37.0 ppm. The sample was submitted to Pace for analysis of the full Table 915-1 analytical suite with a standard turnaround request.

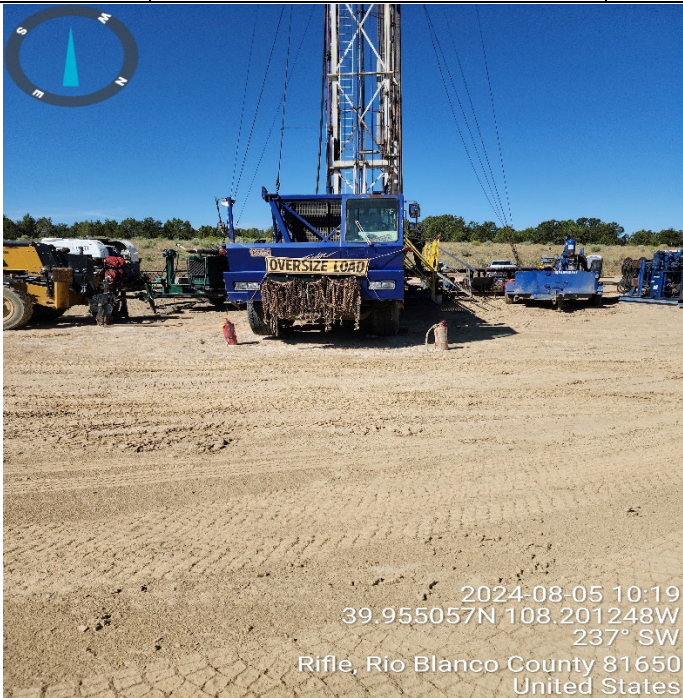
PHOTOGRAPHIC LOG		
Caerus Piceance, LLC	RNPU 196 19B Rio Blanco County, Colorado	Sample ID: NA
Date: 8/5/2024	Photo No. 2 – Release area	Coordinates Lat/Long: 39.954938, -108.201445

<p>2024-08-05 10:19 39.955057N 108.201248W 237° SW Rifle, Rio Blanco County 81650 United States</p>		
View facing south at the release area.

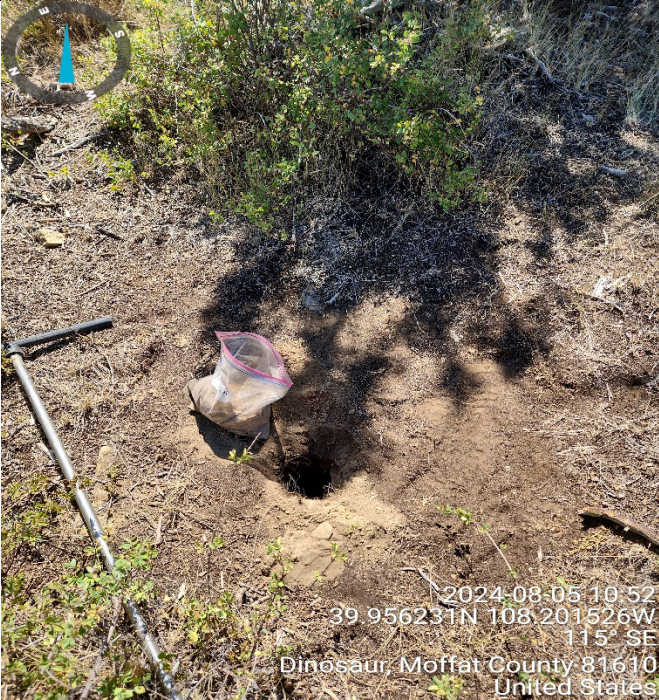
PHOTOGRAPHIC LOG		
Caerus Piceance, LLC	RNPU 196 19B Rio Blanco County, Colorado	Sample ID: XTBG-RNPU 196-19B-N@2.5
Date: 8/5/2024	Photo No. 3 – XTBG-N	Coordinates Lat/Long: 39.954938, -108.201445

View facing east of XTBG-N.

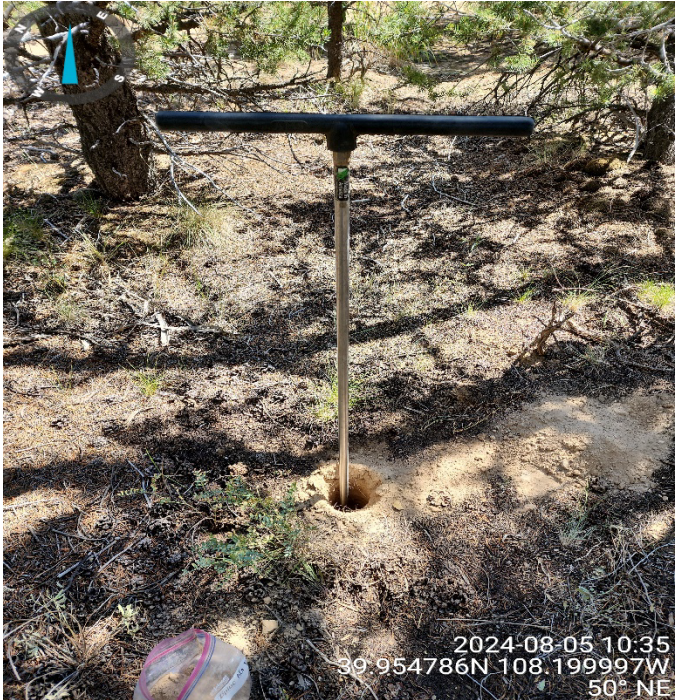
PHOTOGRAPHIC LOG		
Caerus Piceance, LLC	RNPU 196 19B Rio Blanco County, Colorado	Sample ID: XTBG-RNPU 196-19B-E@2.5
Date: 8/5/2024	Photo No. 4 – XTBG-E	Coordinates Lat/Long: 39.954938, -108.201445

View facing west of XTBG-E.

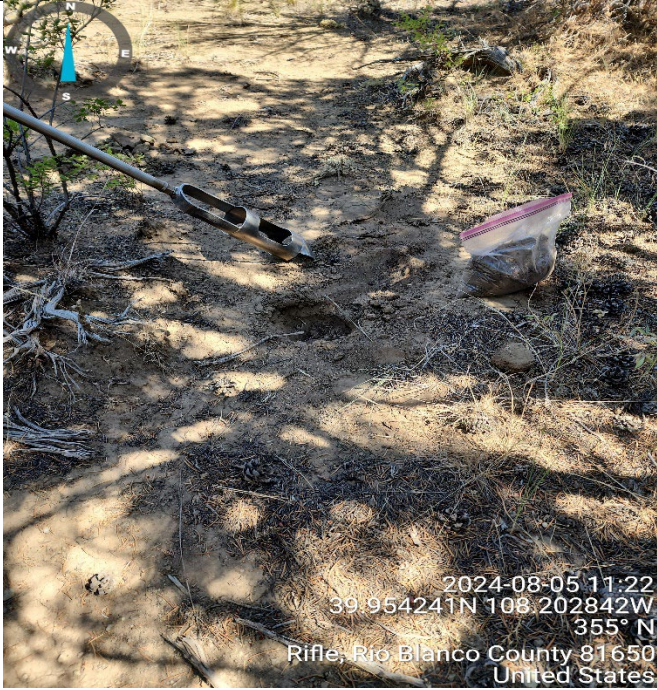
PHOTOGRAPHIC LOG		
Caerus Piceance, LLC	RNPU 196 19B Rio Blanco County, Colorado	Sample ID: XTBG-RNPU 196-19B-W@0.5
Date: 8/5/2024	Photo No. 5 – XTBG-W	Coordinates Lat/Long: 39.954938, -108.201445

View facing north at XTBG-W.

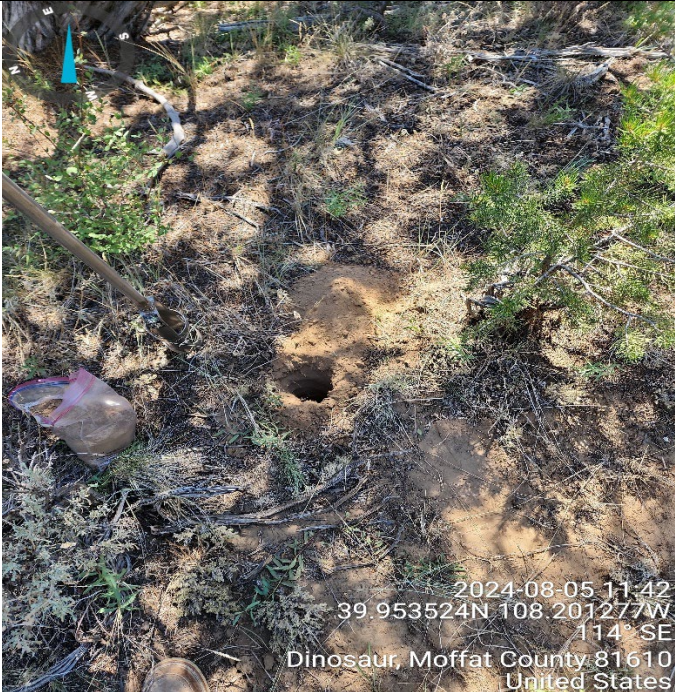
PHOTOGRAPHIC LOG		
Caerus Piceance, LLC	RNPU 196 19B Rio Blanco County, Colorado	Sample ID: XTBG-RNPU 196-19B-S@1.5
Date: 8/5/2024	Photo No. 6 – XTBG-S	Coordinates Lat/Long: 39.954938, -108.201445

View facing east of XTBG-S.
