Final Reclamation and Stormwater Inspection

Operator: PDC ENERGY INC- 69175

Location ID: 302303

Inspection Photos
Location Name: Rothe 29BU
Location ID: 302303

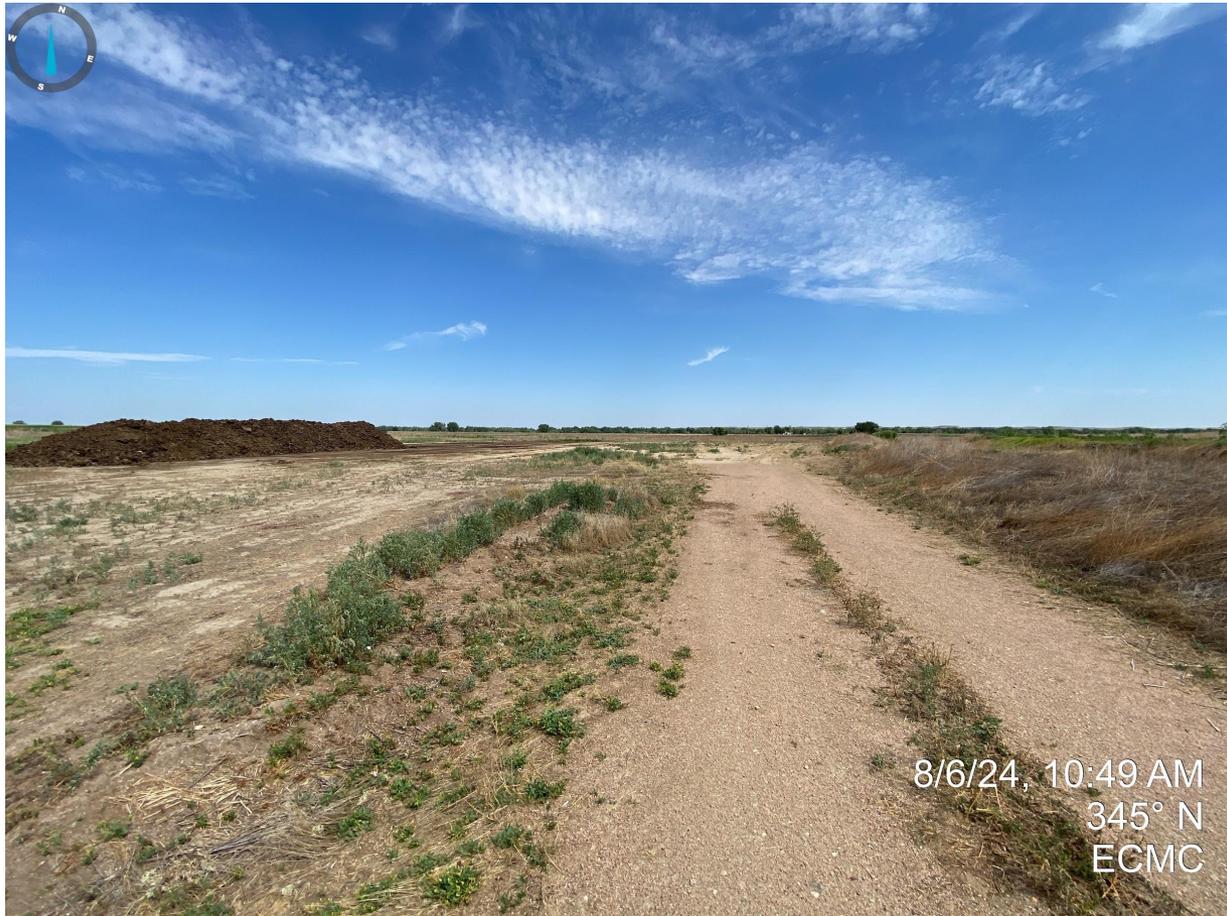
Photo 1. Taken south of the former tank battery and well location. Photo illustrates the access road does not appear to have been reclaimed with road base still present.

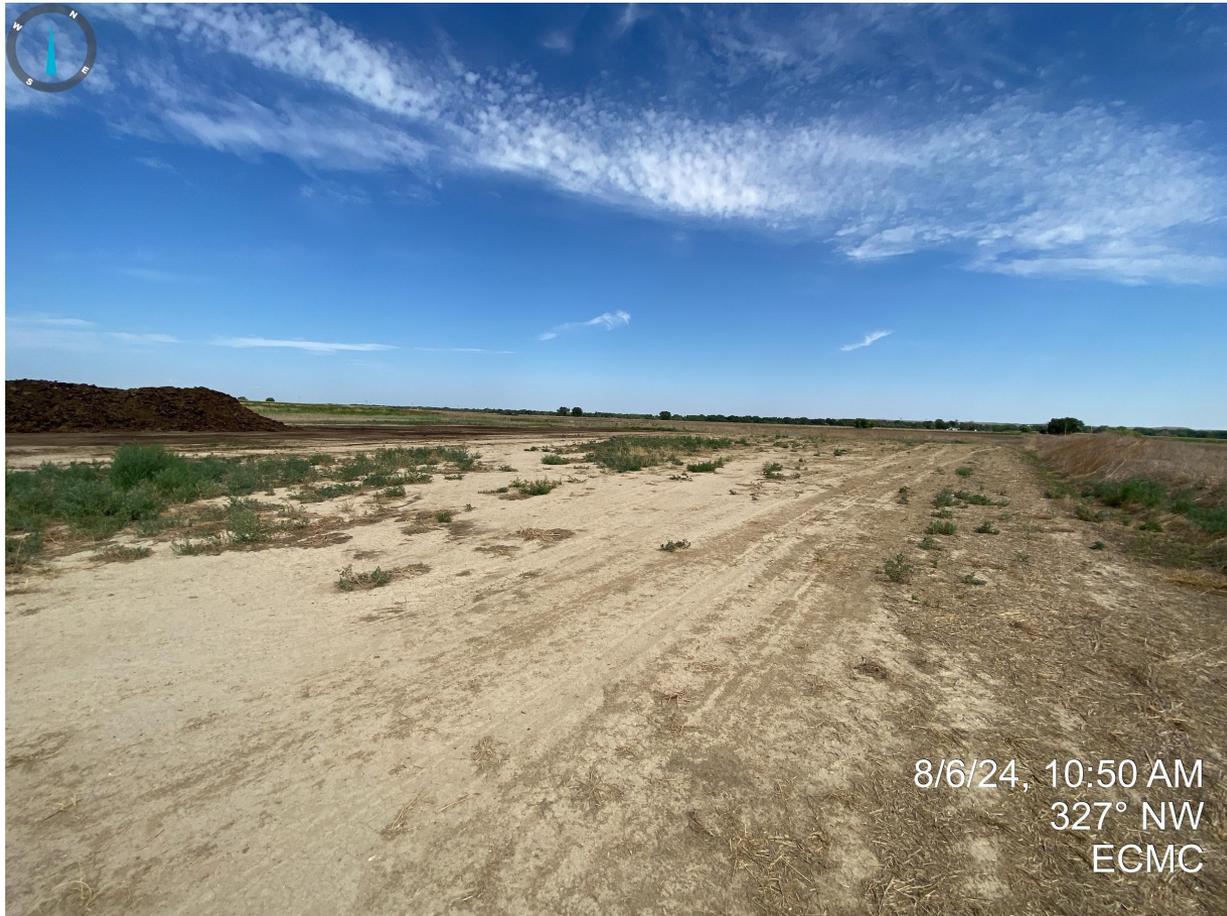
Photo 2. Southeast corner of the former tank battery location. The location does not appear to be progressing towards reclamation standards and regulations with the presence of bare soil and undesirable vegetation (e.g. kochia) observed.

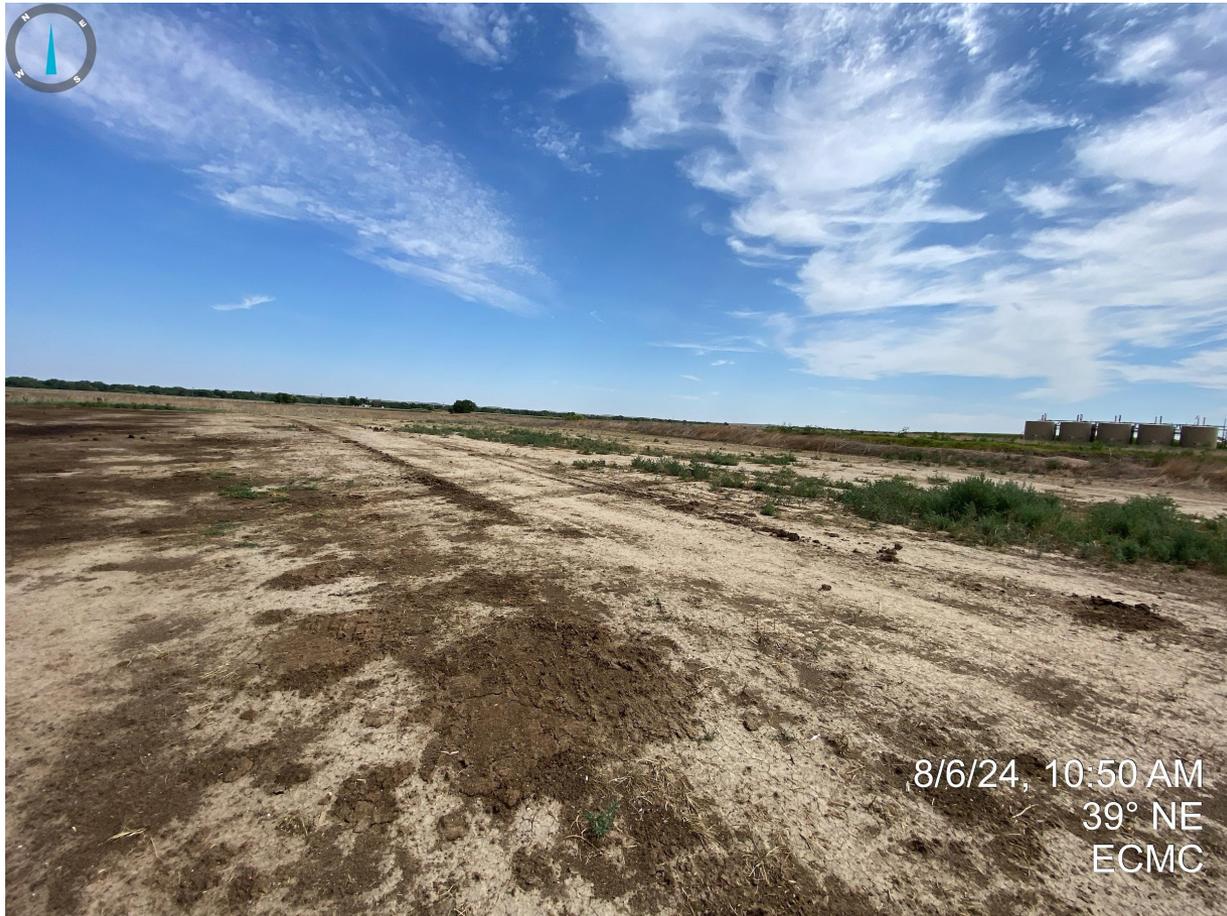
Photo 3. Southwest corner of the former tank battery; see comments in Photo 2.

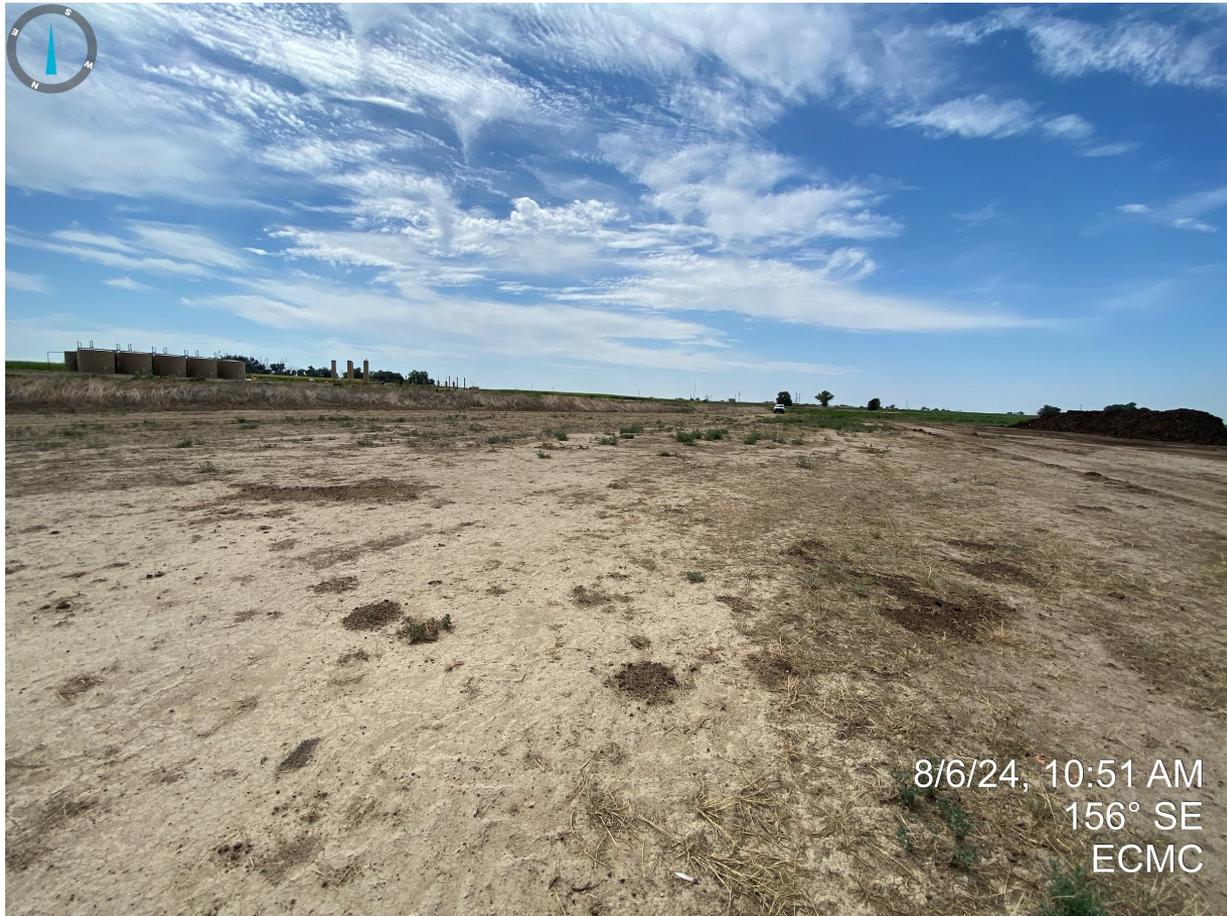
Photo 4. Northwest corner of the former tank battery; see comments in Photo 2.

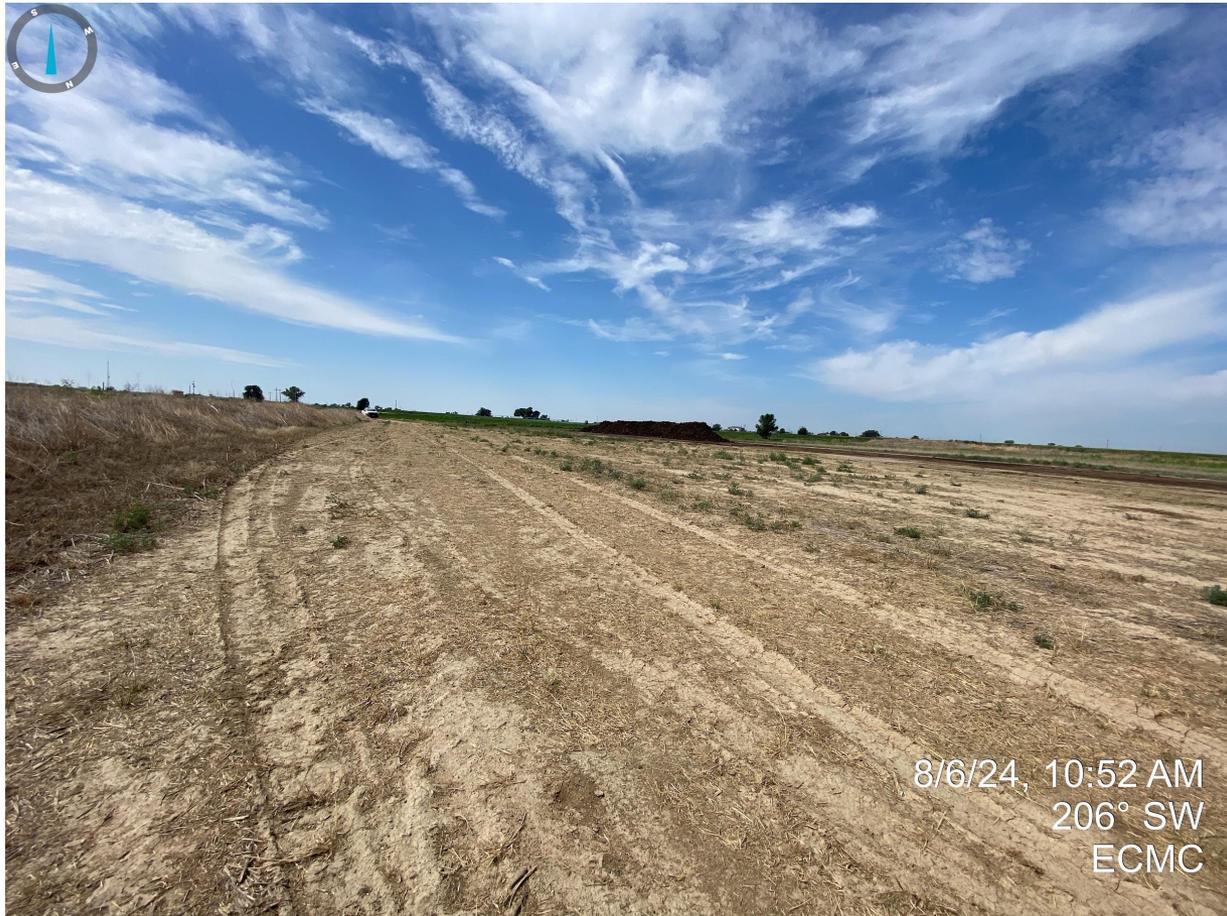
Photo 5. Northeast corner of the former tank battery; see comments in Photo 2.

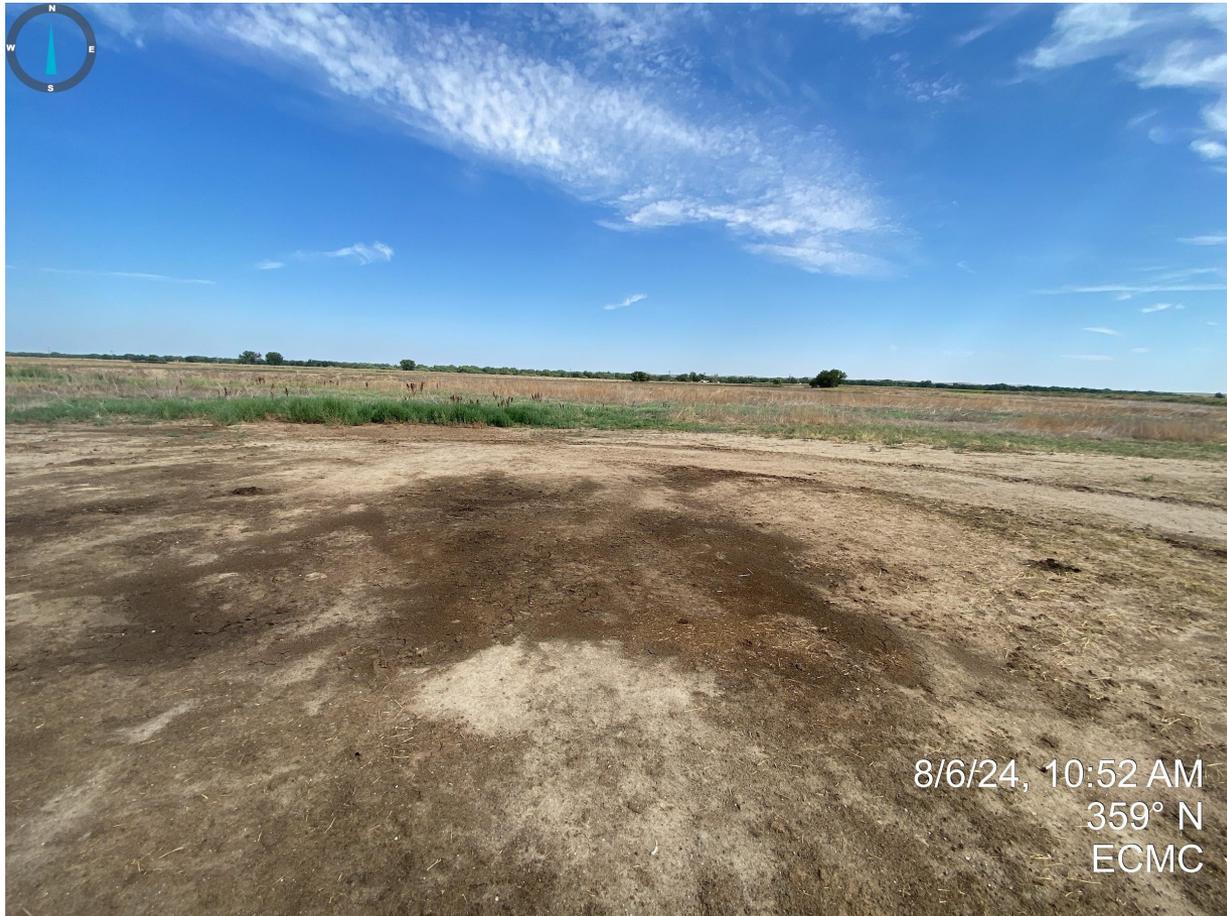
Photo 6. Facing north at the former well location. Additional reclamation activities are required to comply with Rule 1004.
