Inspection Photos

Operator: Hilcorp Energy Company - 10133

Location ID: 325480

Inspection Document #: 714001066

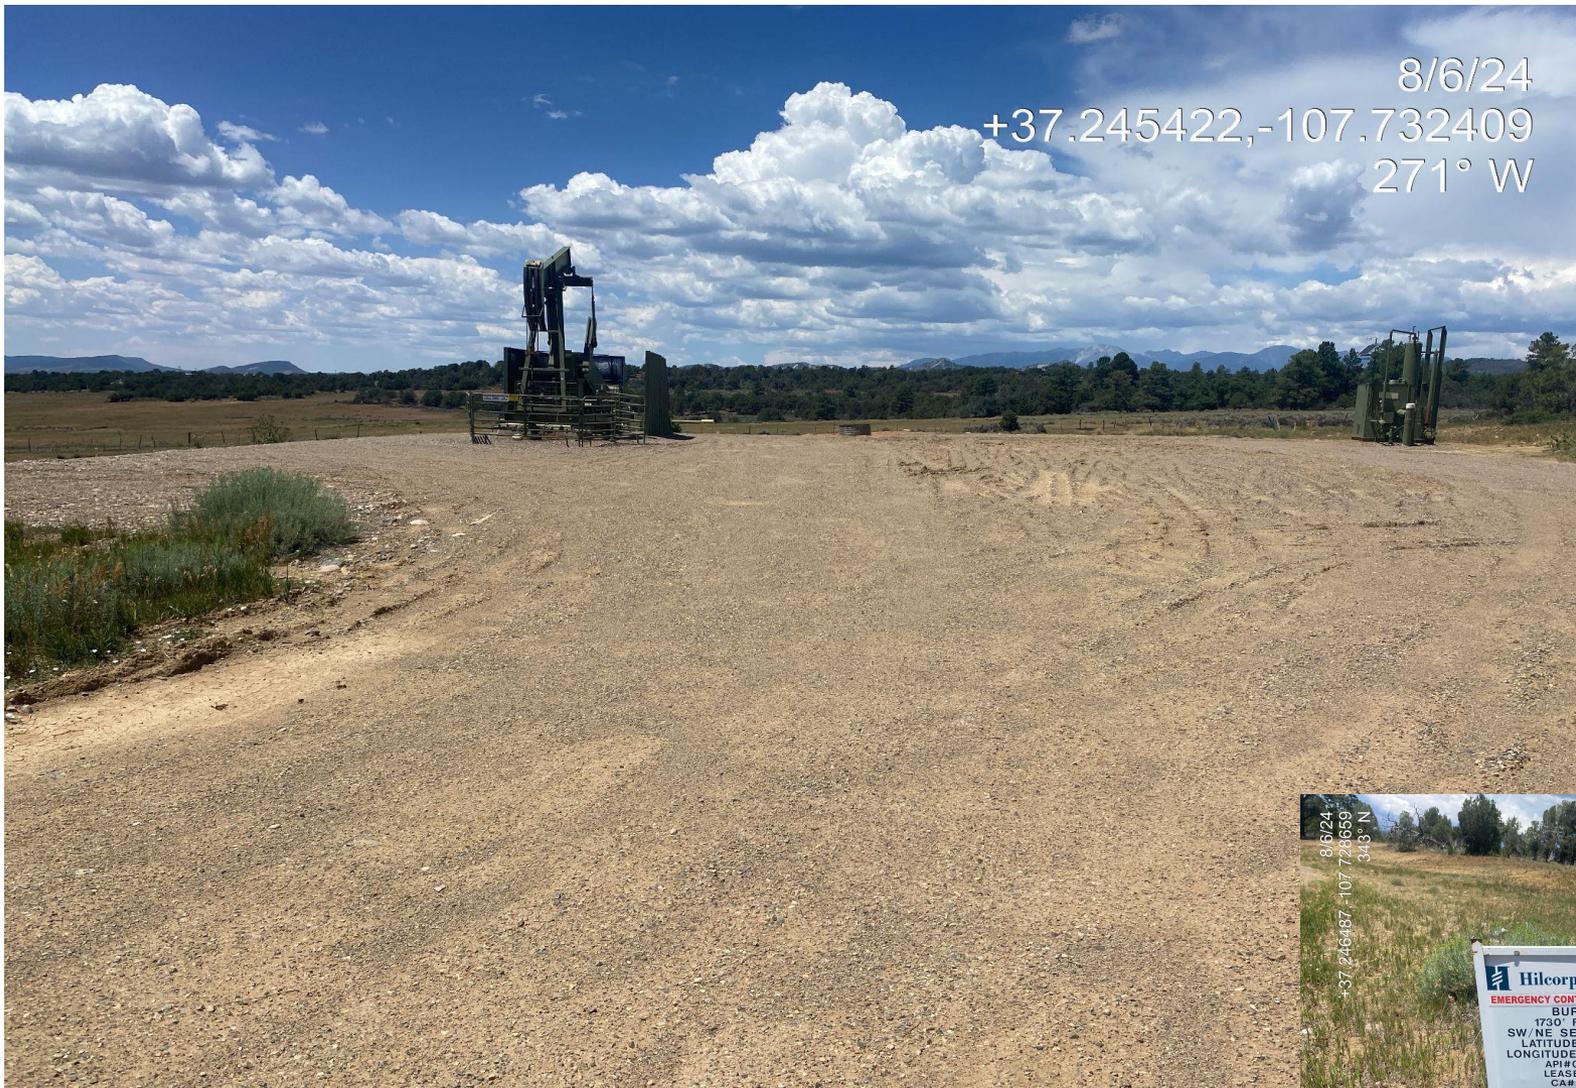
Photo 1. View of the location taken from the access point facing center.

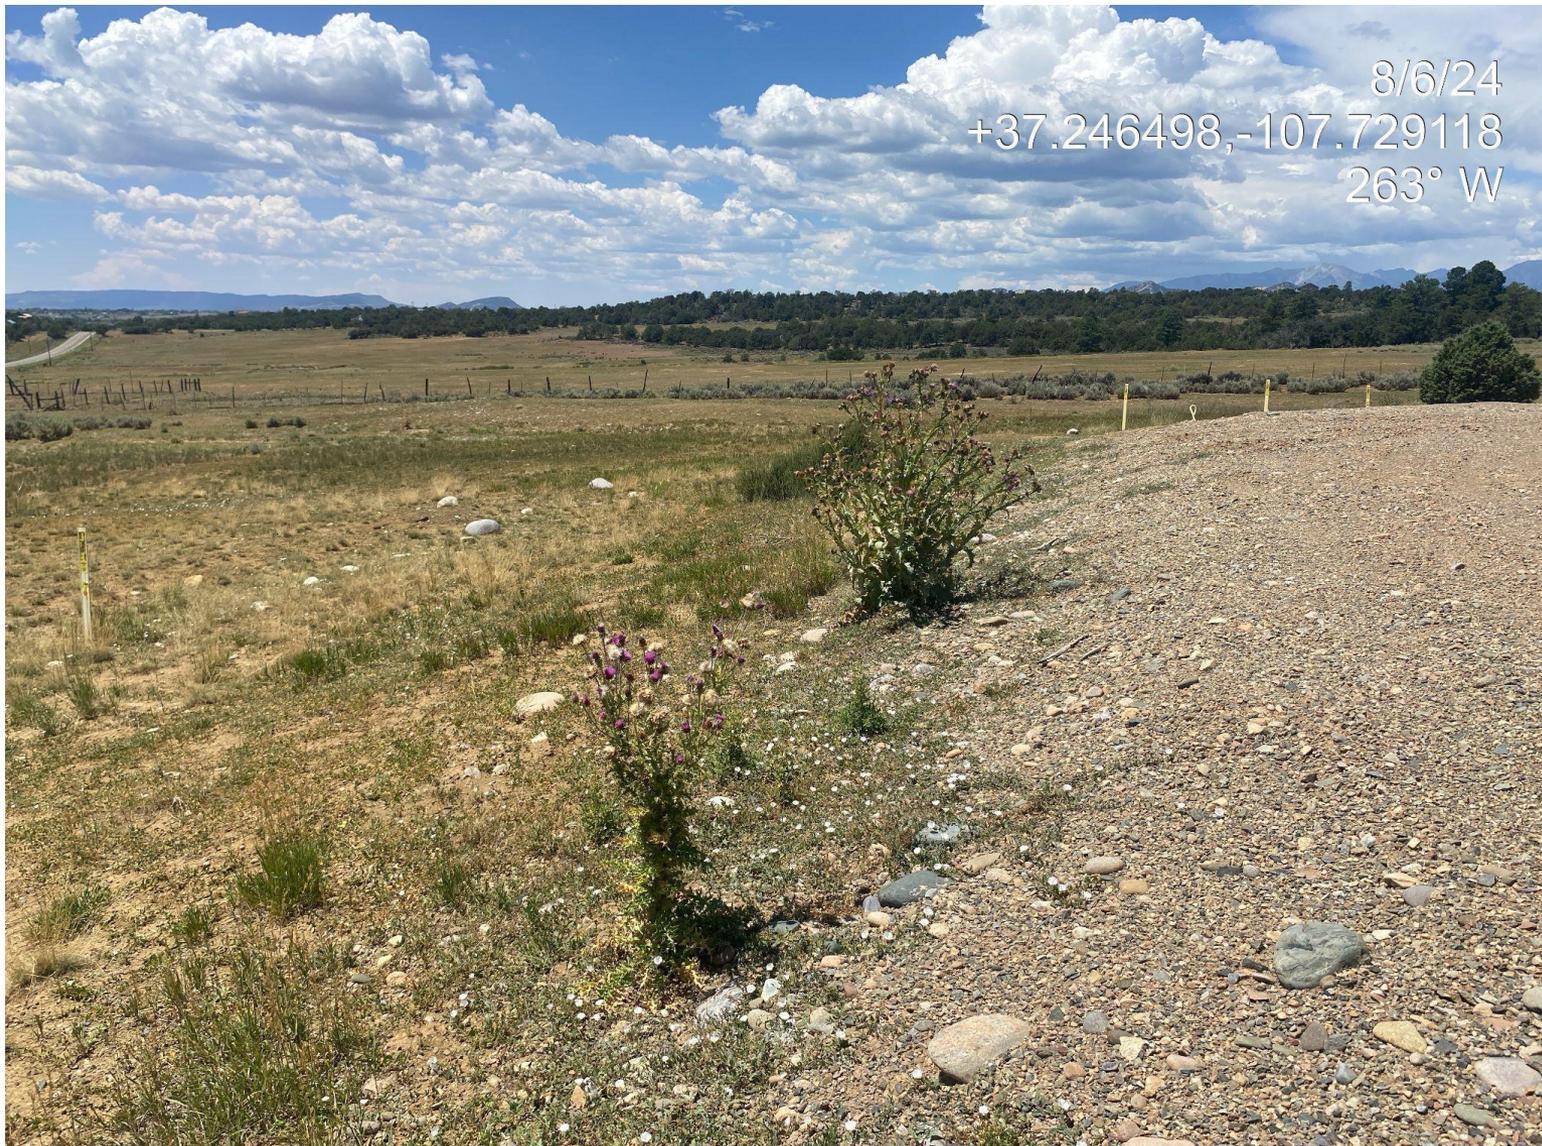
8/6/24
+37.246498,-107.729118
263° W

Photo 2. Patches of flowering Musk thistle observed in the southern portion of the disturbance.

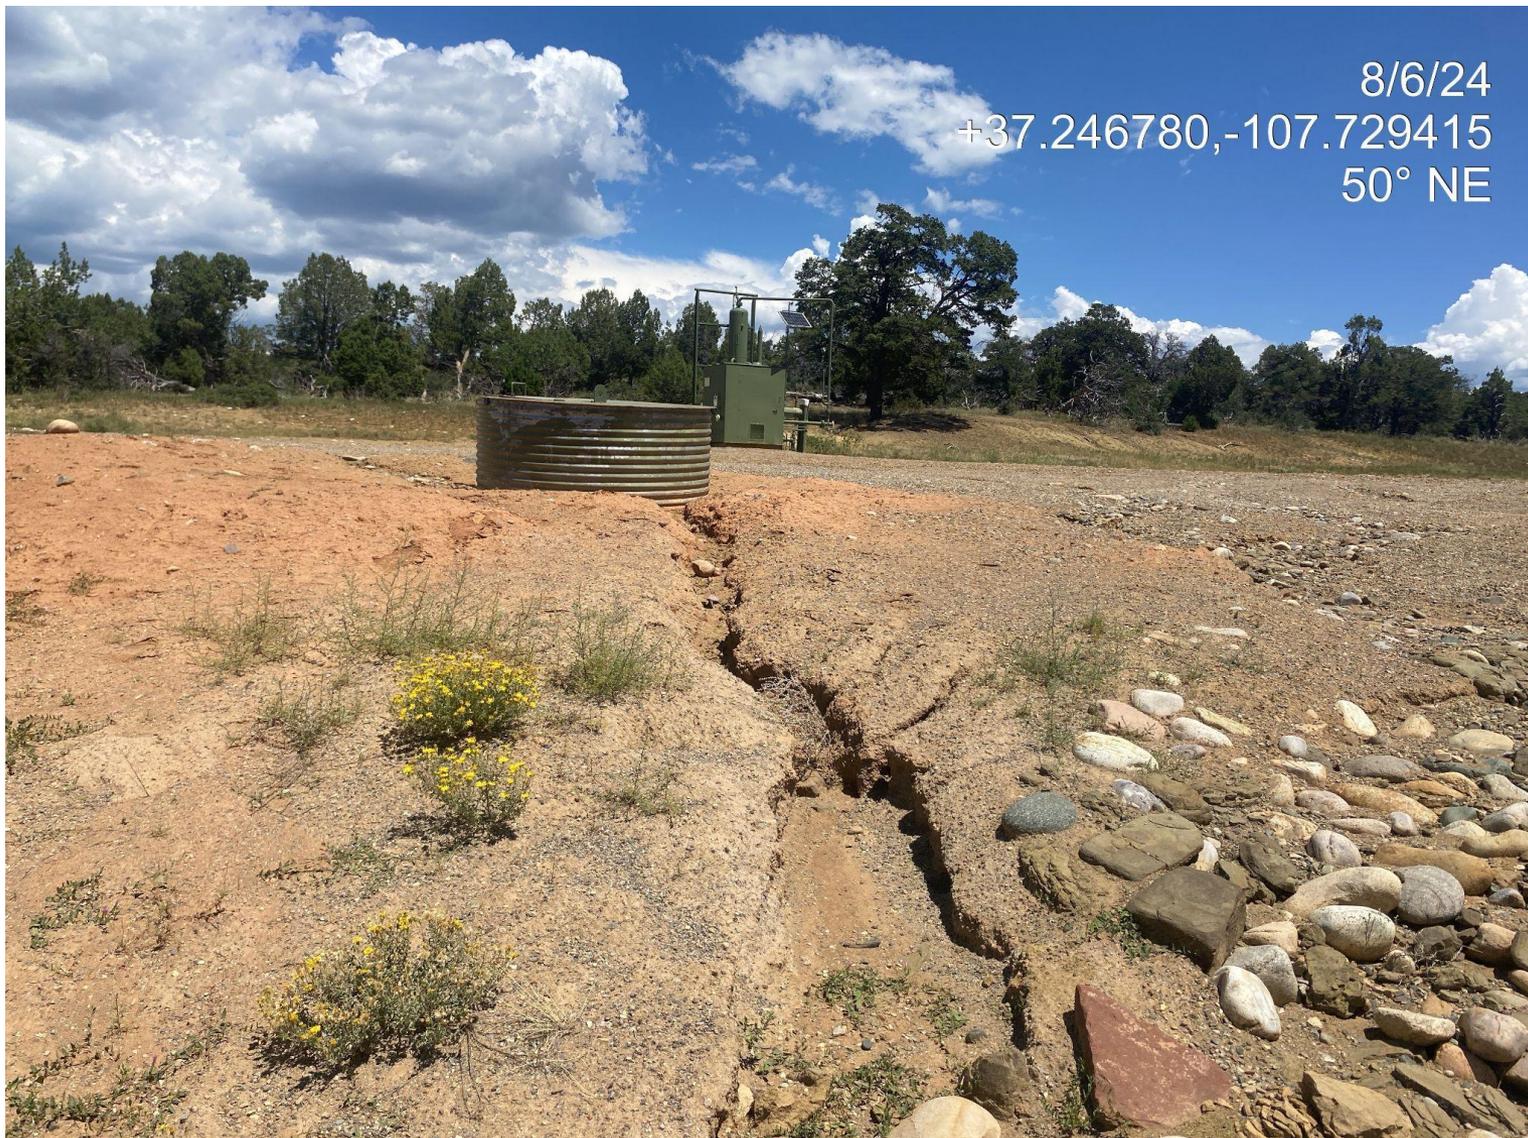
8/6/24
+37.246780,-107.729415
50° NE

Photo 3. View of rill/gully erosion forming in the southwest corner of the disturbance. Storm water BMPs/controls are needed in this area.

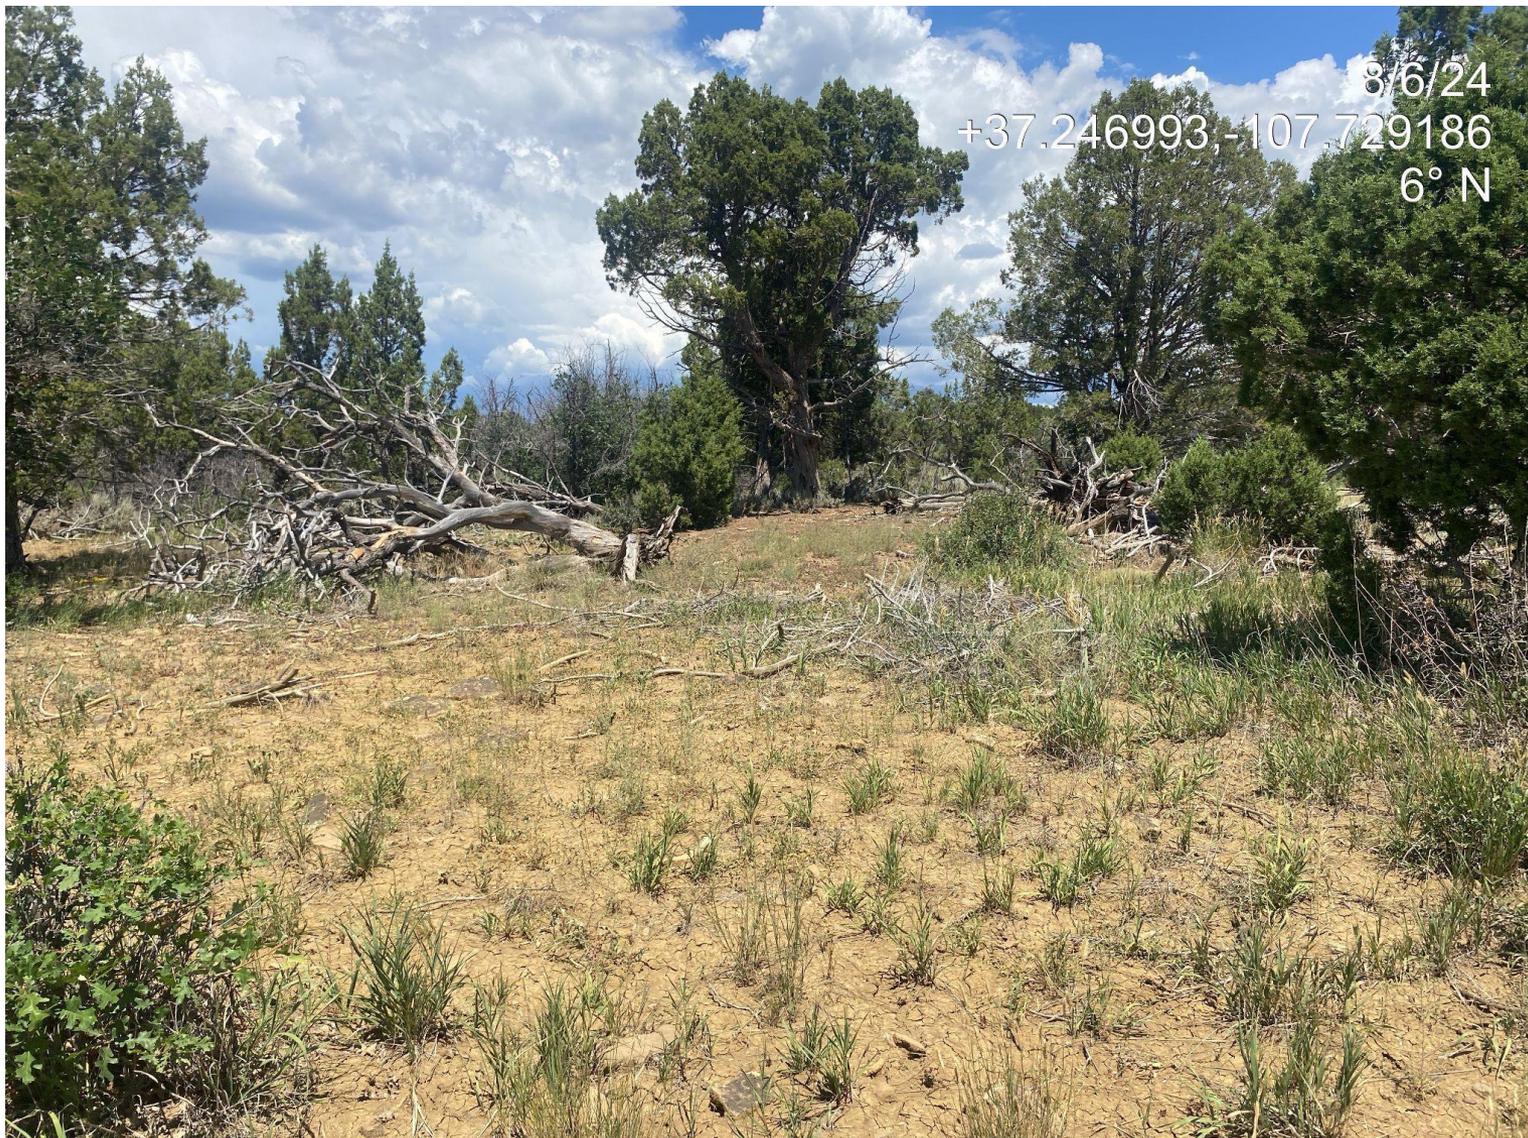
Photo 4. Reference area comprised of Juniper, Antelope bitterbrush and Smooth brome.
