Inspection Photos

Operator: TEP ROCKY MOUNTAIN LLC #96850

Location ID: 335294

Inspection Doc: 696206108

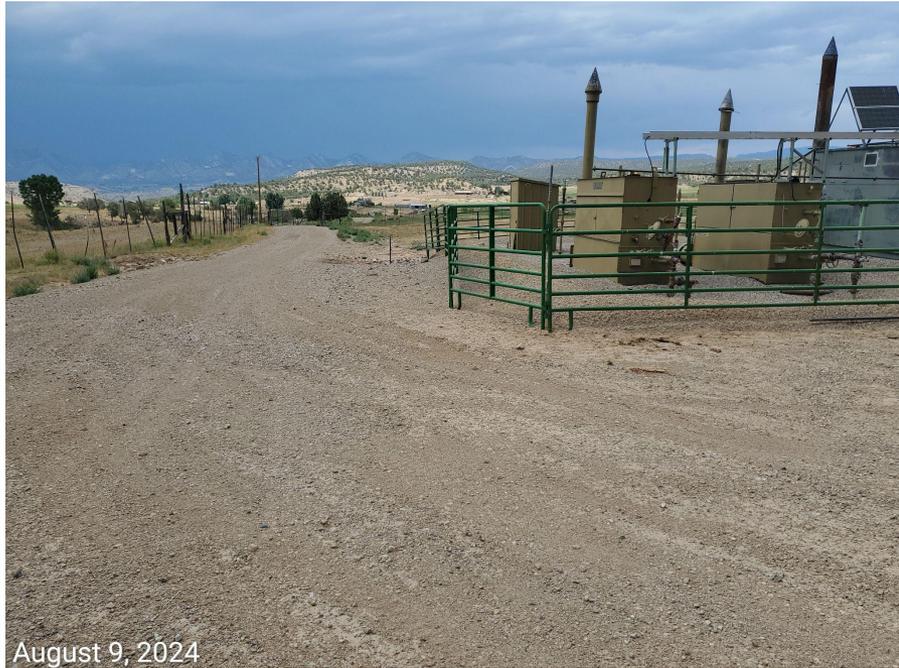
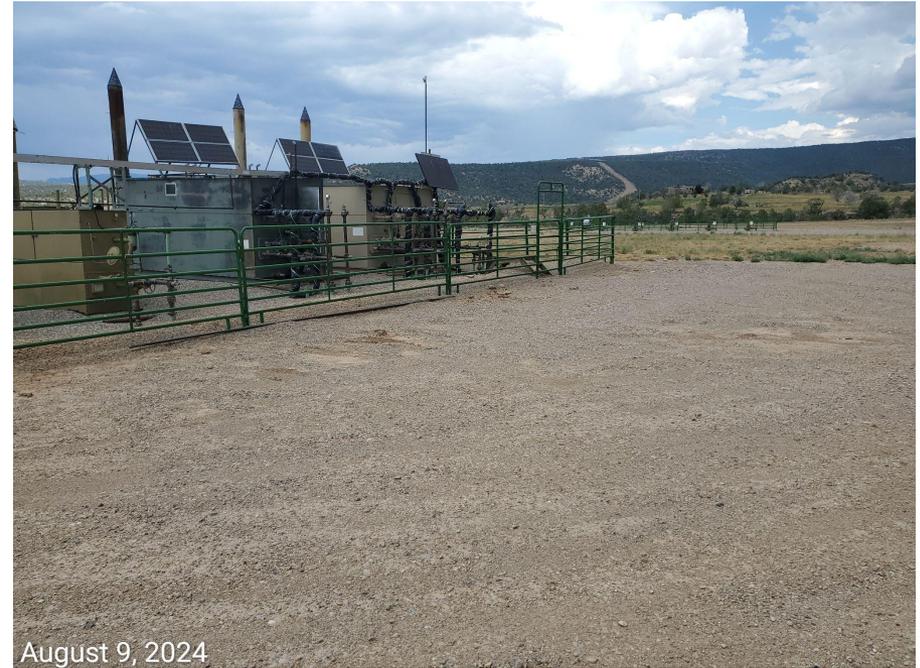
Photo 1: Photos 1-2 taken from the west end of the Location. Photos provide an overview of the Location from north, northeast, southeast to south.

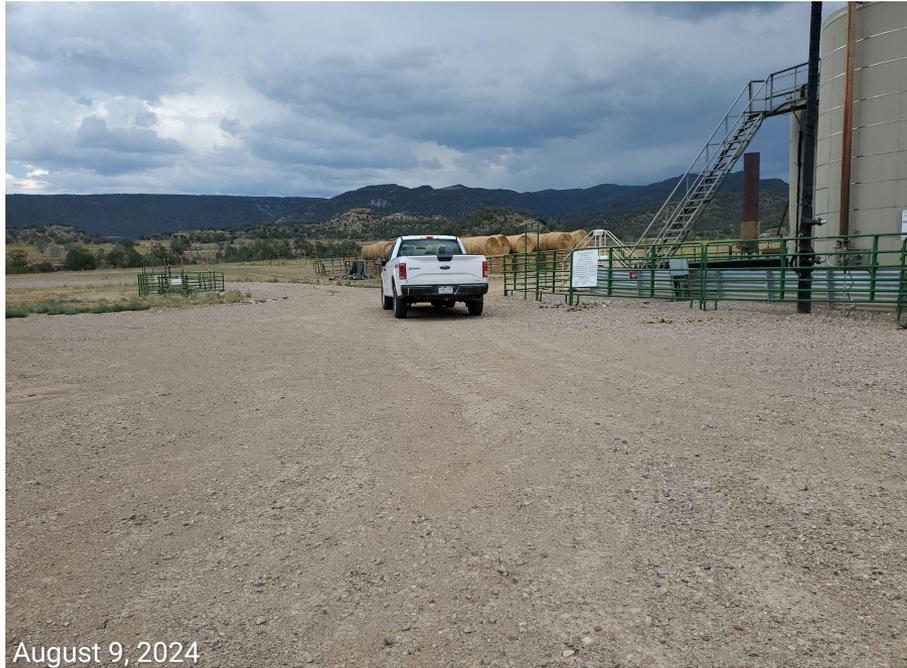
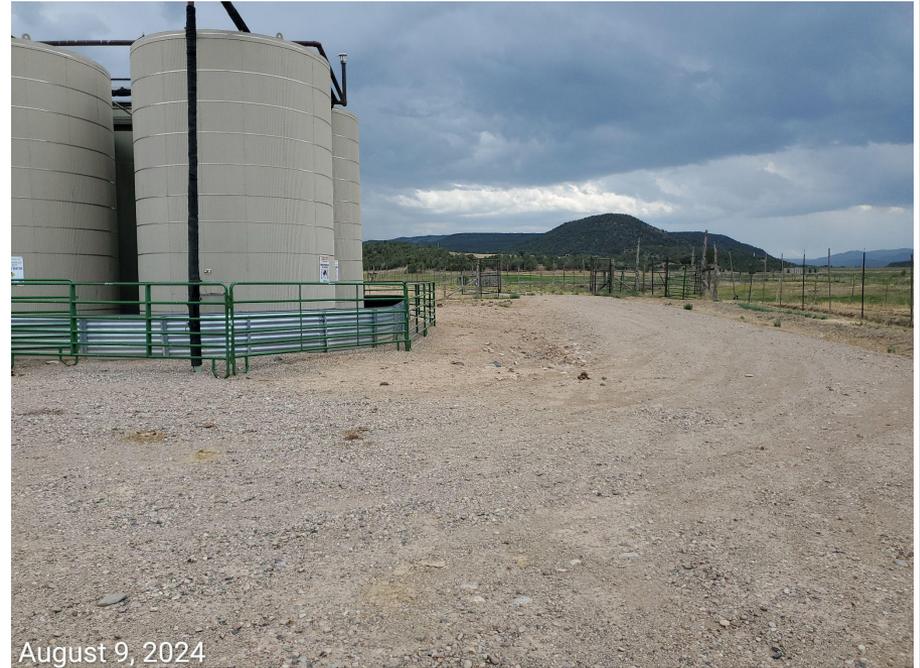
Photo 2: See comments under photo 1.

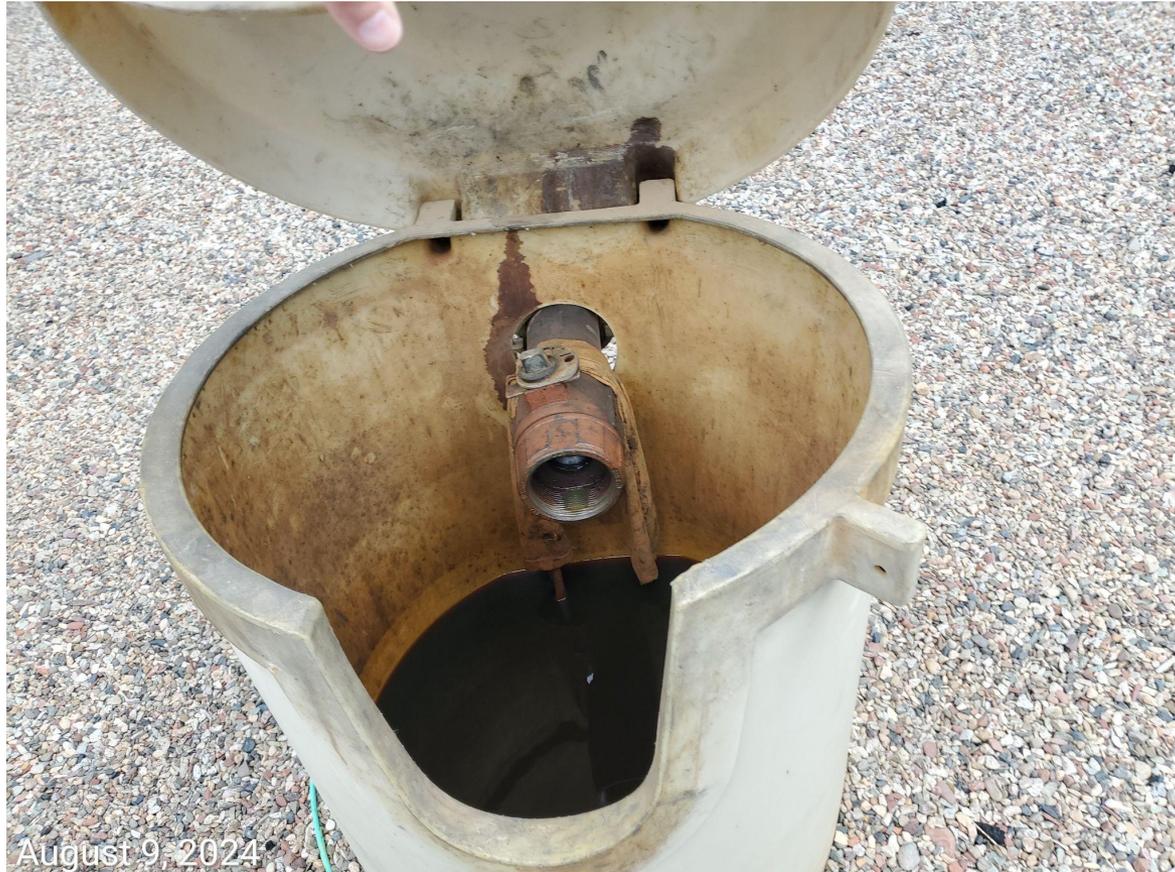
Photo 3: Lines at tank missing cap/plug. Produced fluids within containment.

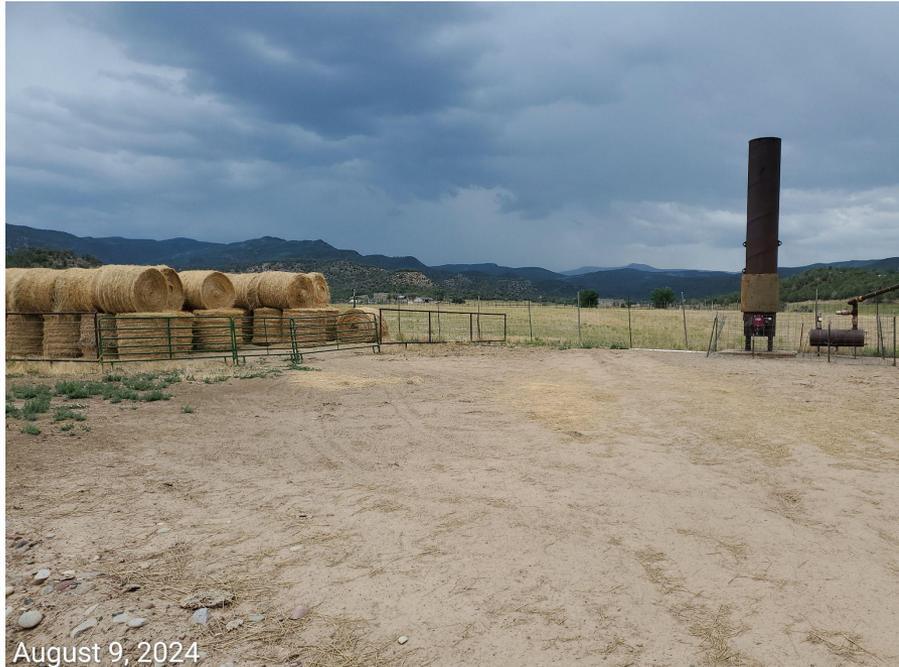
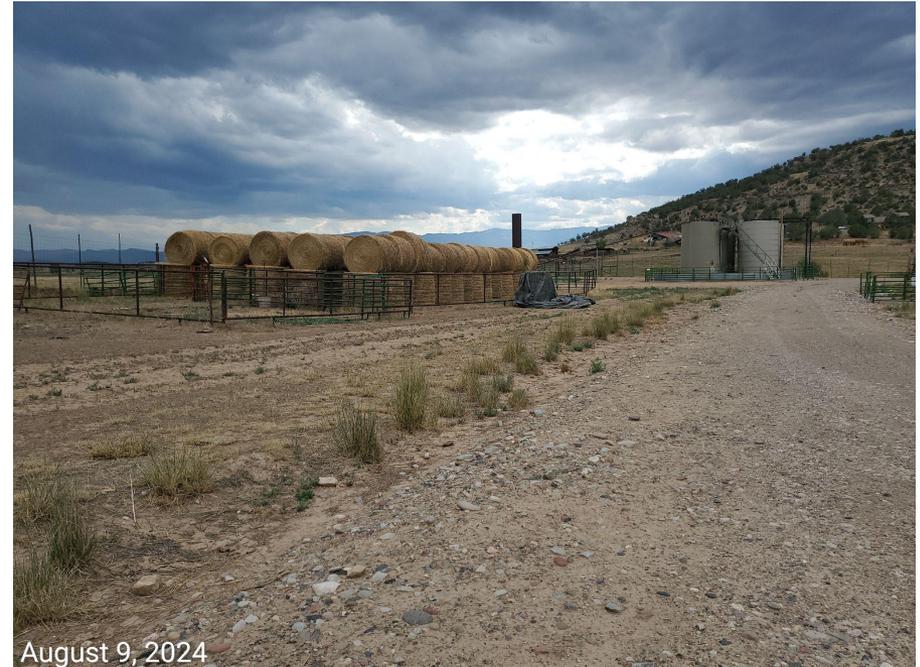
Photo 4: Photos taken from the south end of the Location. Photos show hay storage in close proximity of production equipment on the Location.

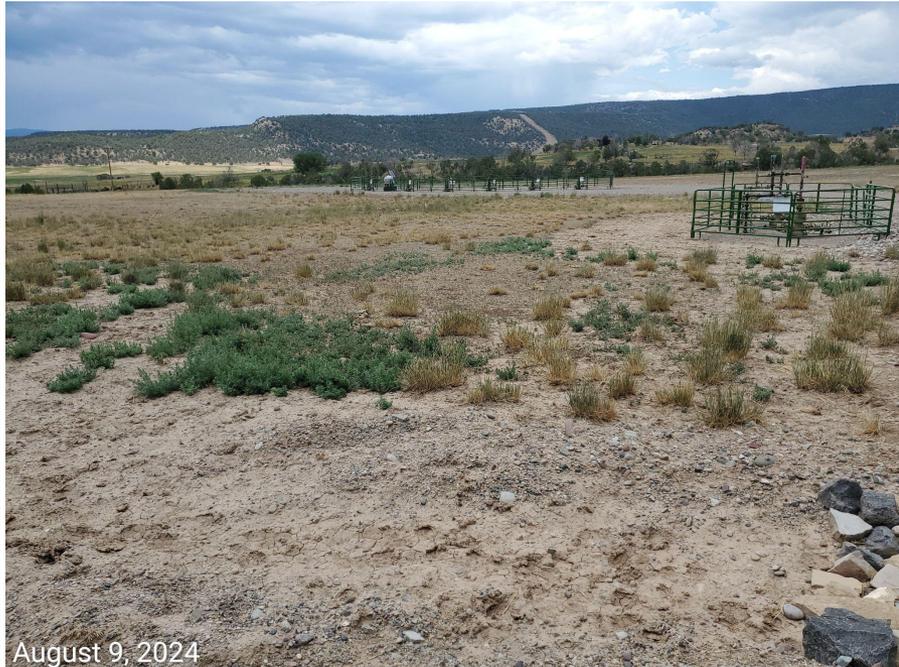
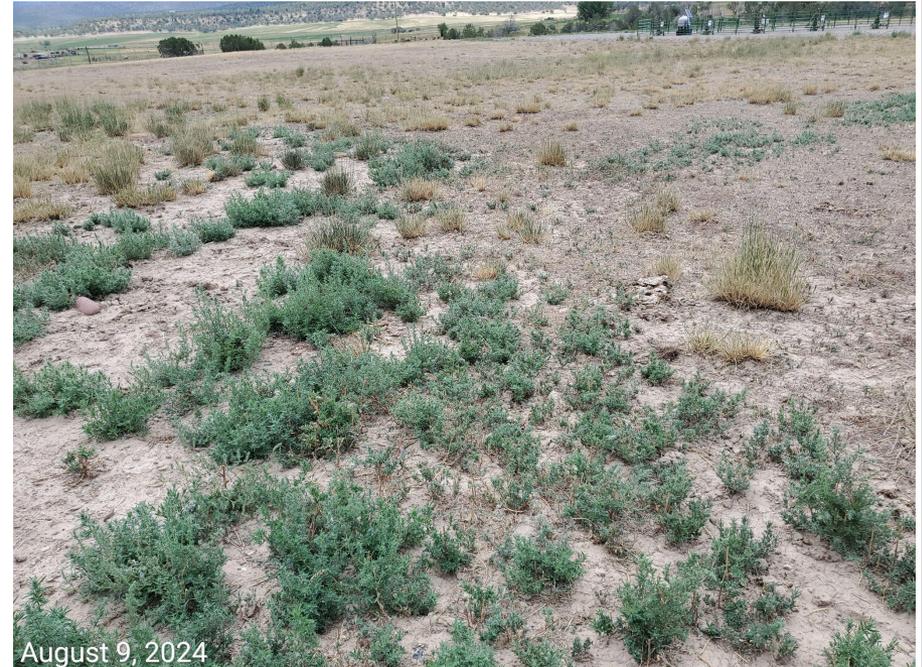
Photo 5: Photos 5-8 taken from the interim areas of the Location. Photos show that interim reclamation is not progressing towards ECMC 1003 Reclamation requirements; interim areas are predominantly bare, or vegetated by Undesirable Plant Species. Perennial establishment that was observed was sparse.

Noxious weed establishment, including Jointed Goatgrass and Field Bindweed observed throughout interim areas of the Location.

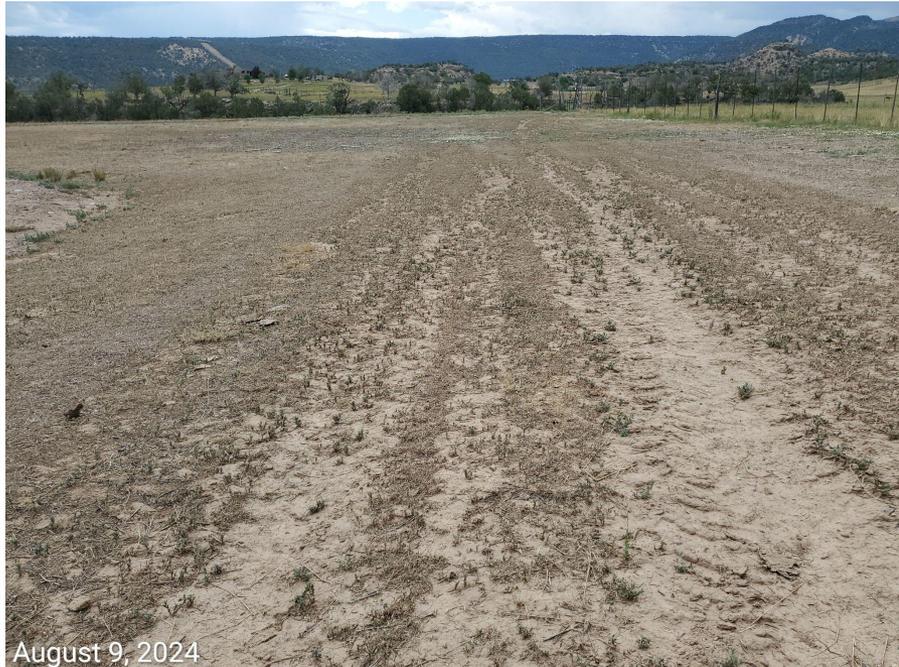
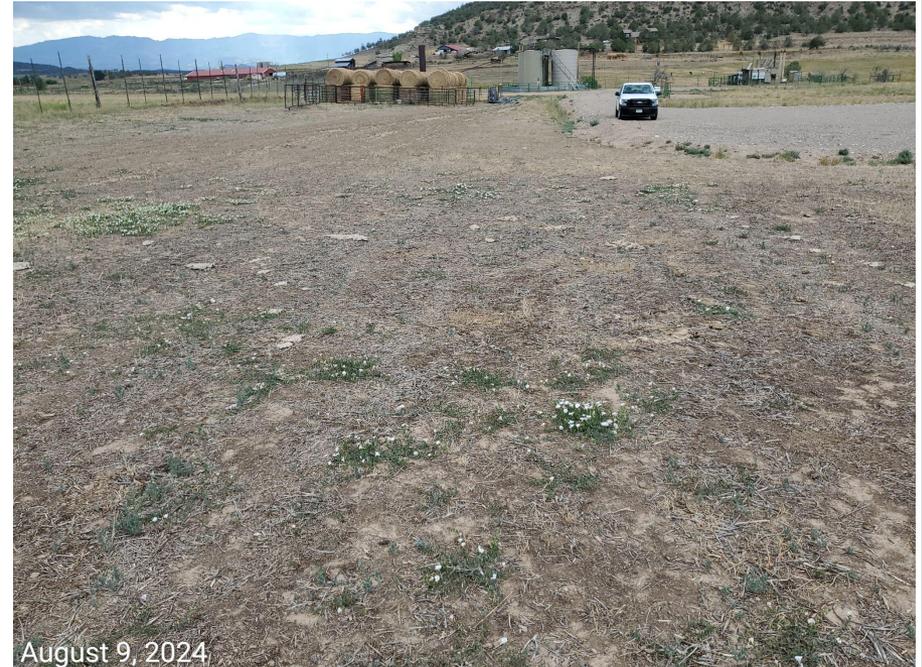
Photo 6: See comments under photo 5.

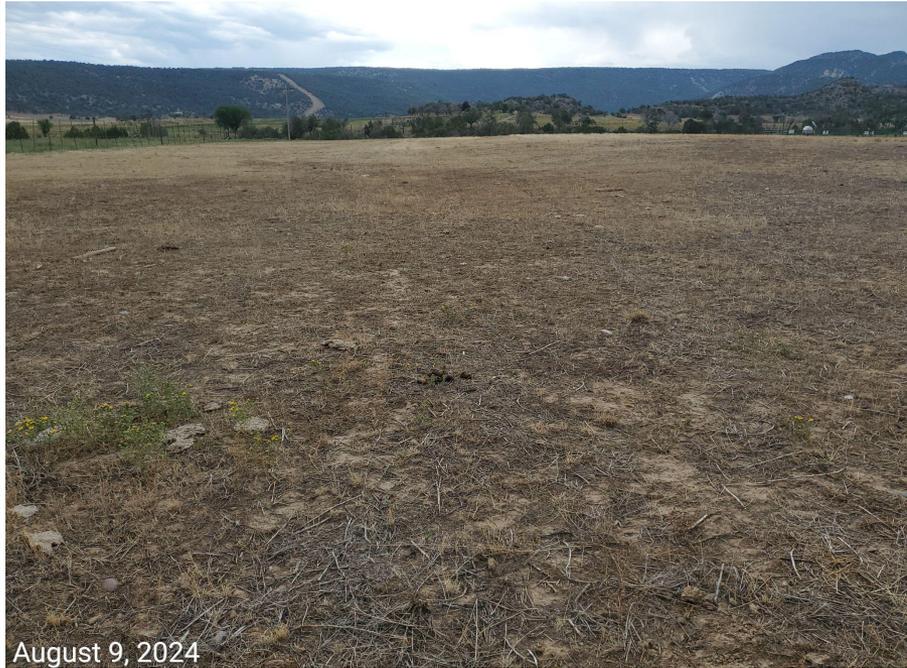
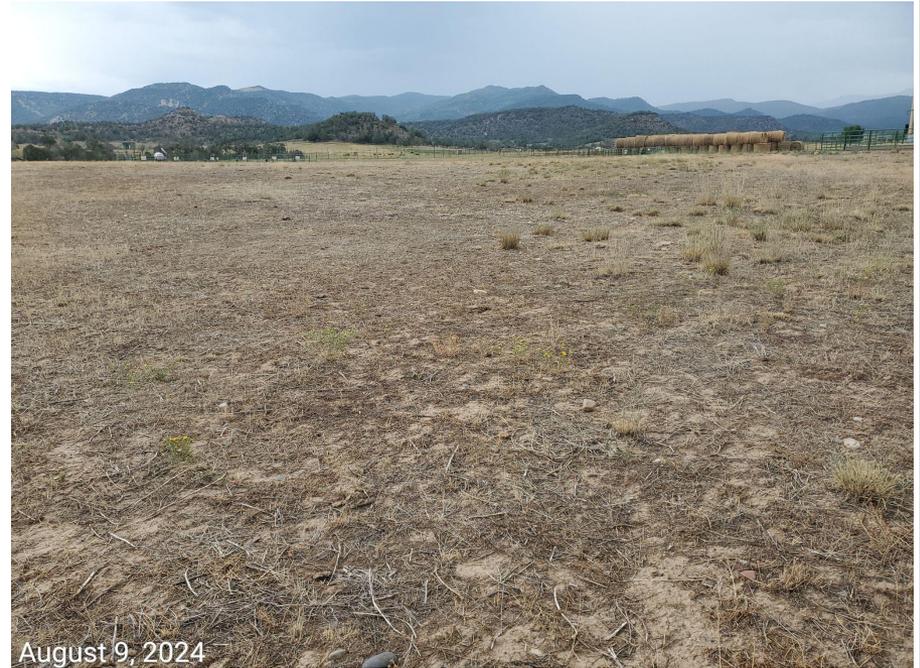
Photo 7: See comments under photo 5.

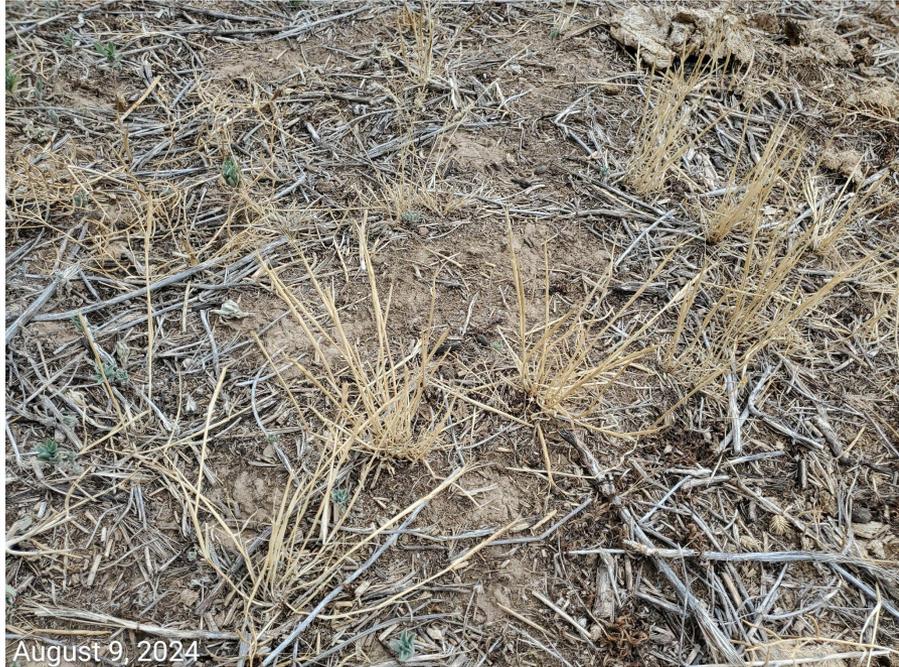
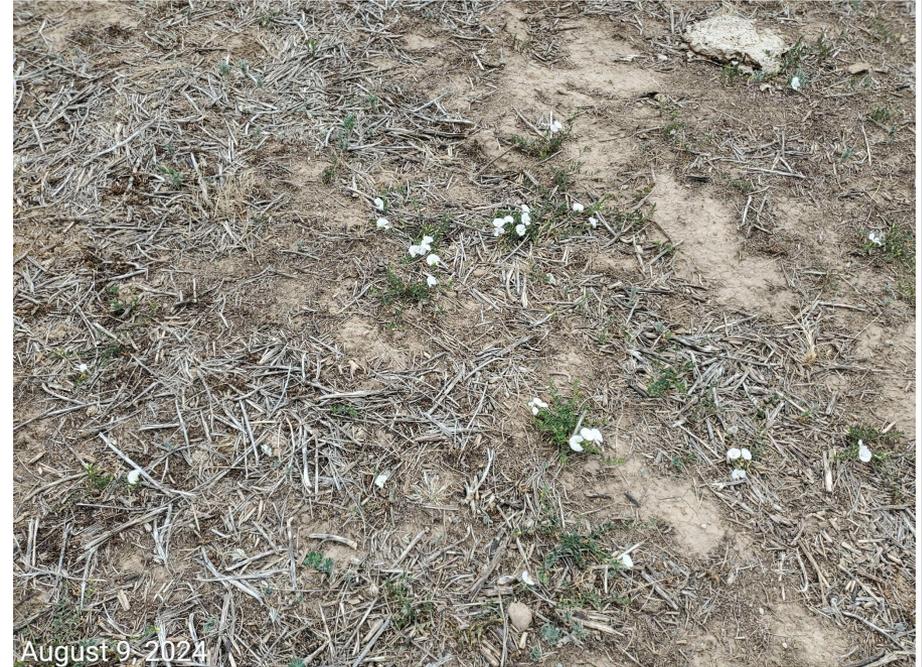
Photo 8: See comments under photo 5. Photo left example showing Jointed Goatgrass establishment on the interim areas; photo right example showing Field Bindweed.
