# Inspection Photos

**Operator:** TEP ROCKY MOUNTAIN LLC #96850

**Location ID:** 335053

**Inspection Doc:** 696206114

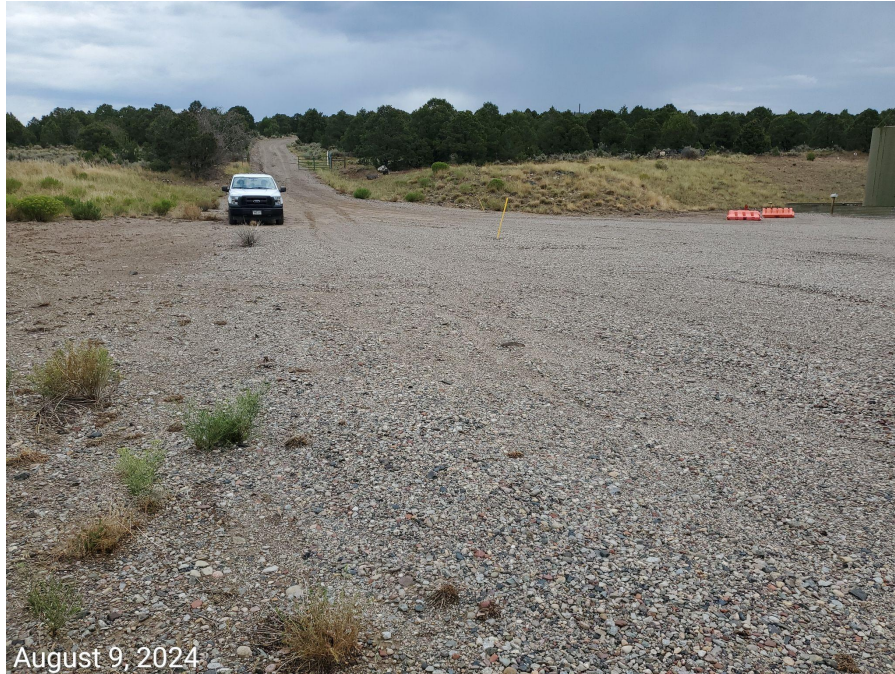
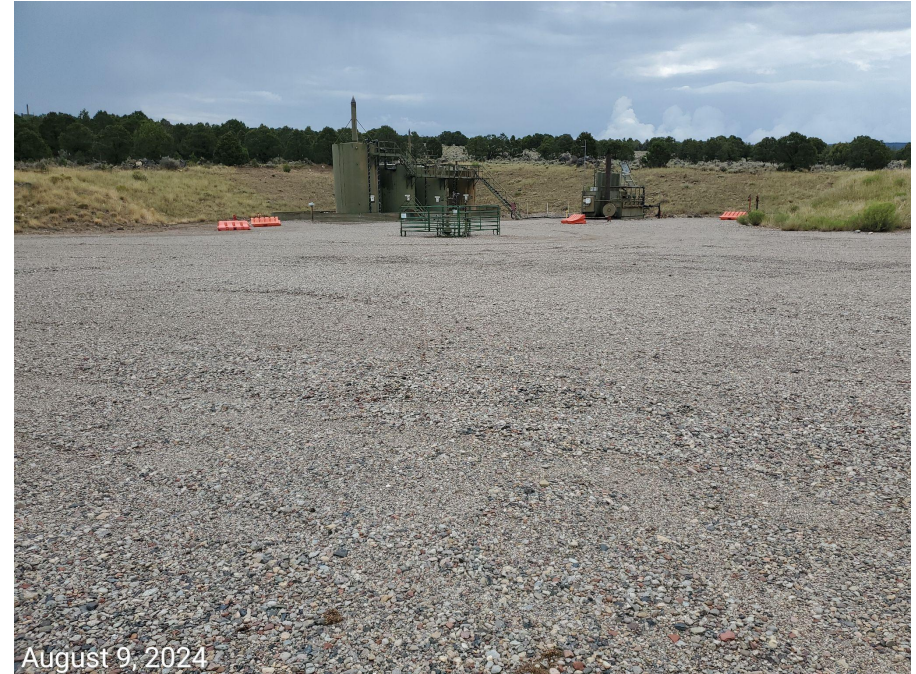
**Photo 1:** Photos 1-2 taken from the north end of the Location. Photos provide an overview from east, southeast, southwest to west. Photos also show areas on the west end of the Location are not necessary for production, and have not been reclaimed.

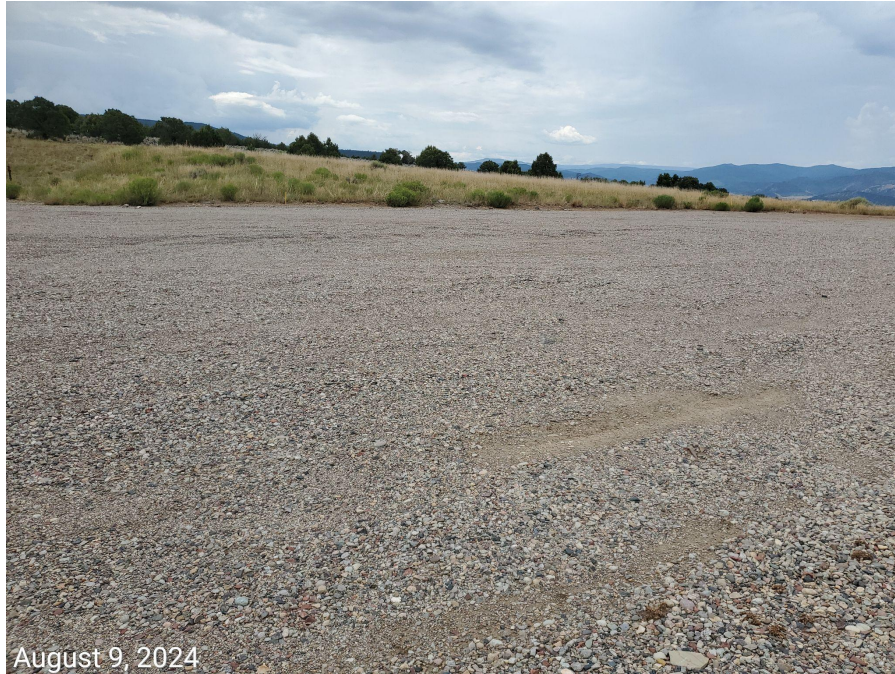
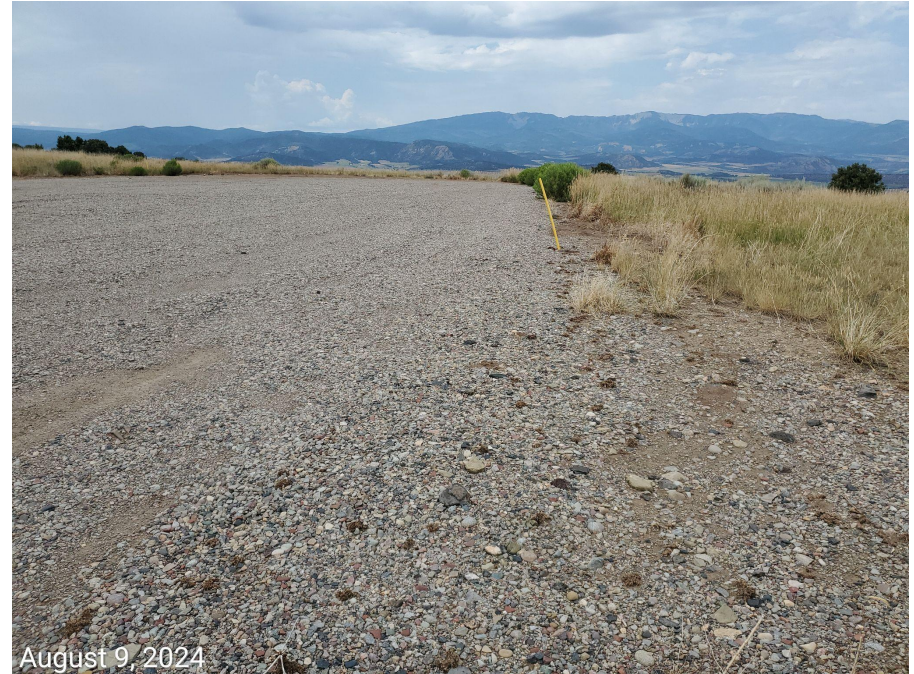
**Photo 2:** See comments under photo 1.

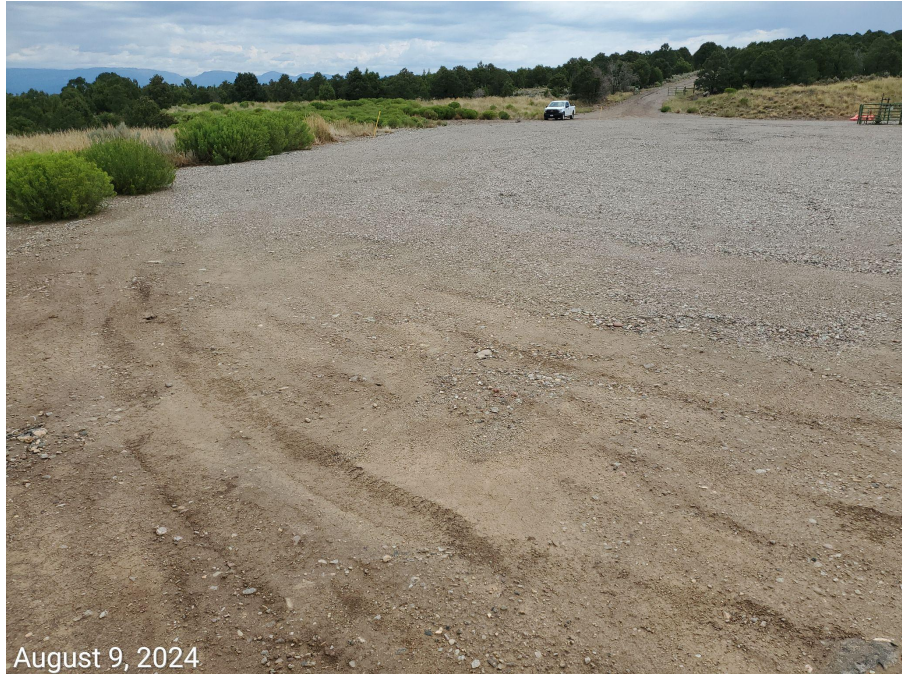
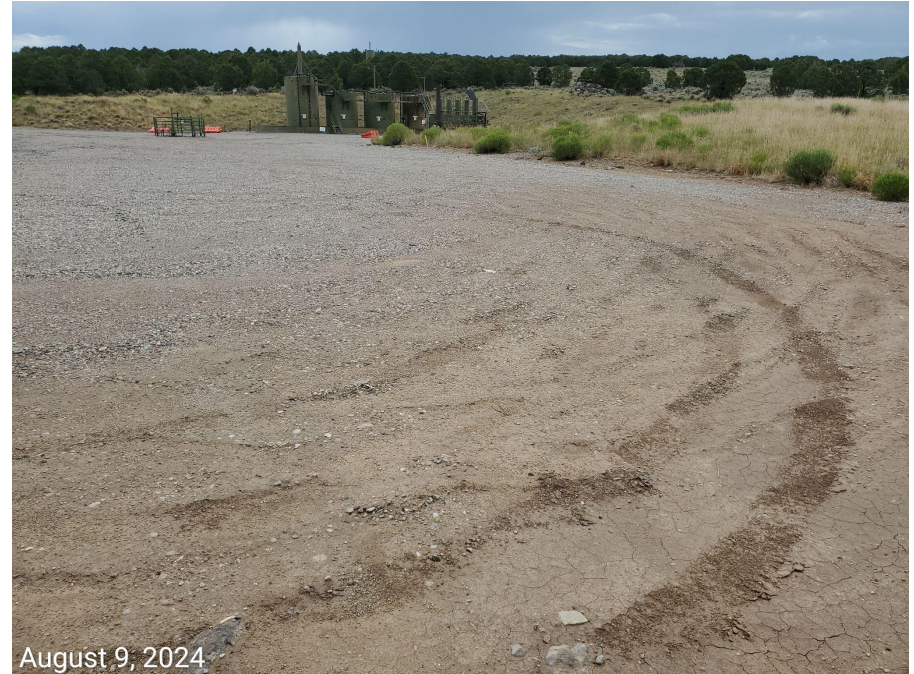
**Photo 3:** Photos taken from the west end of the Location, facing northeast and southeast. Photos show areas on the west end of the Location are not necessary for production, and have not been reclaimed.

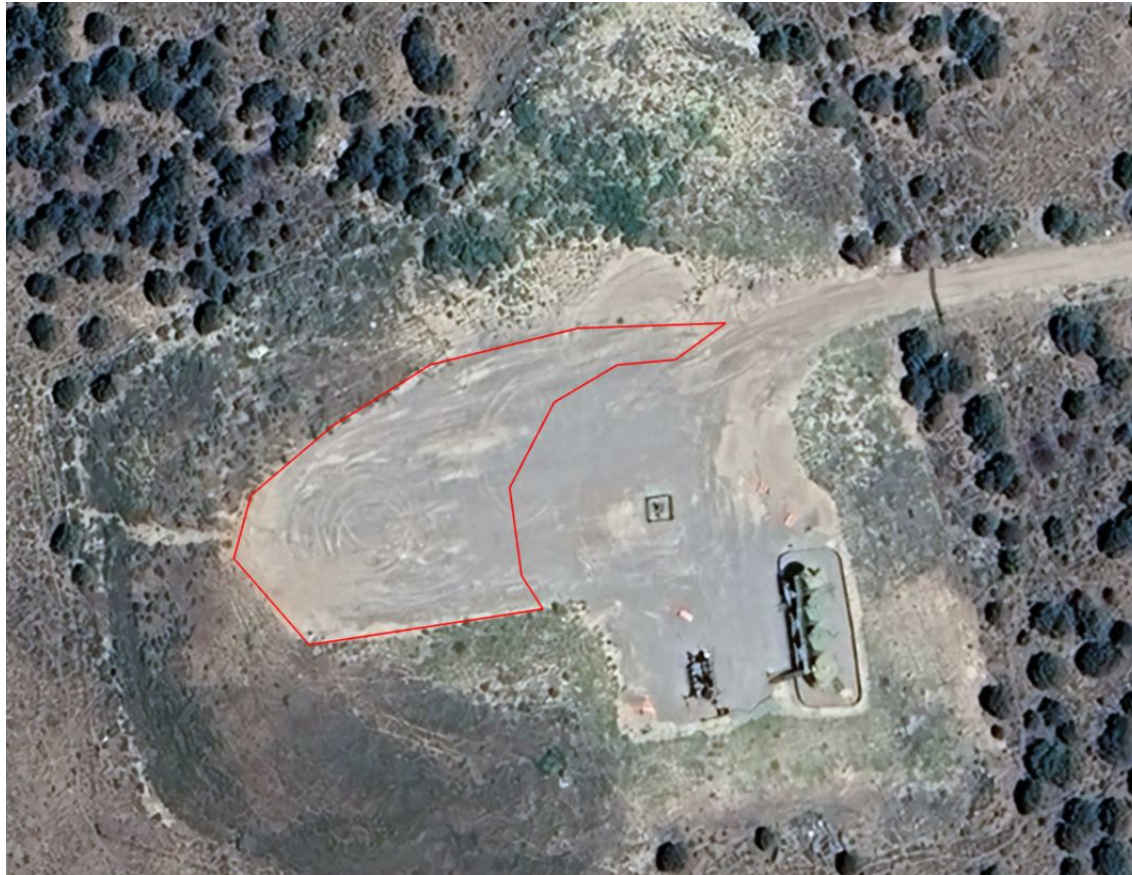
**Photo 4:** 2023 Google Earth aerial imagery. Photo provides overview of the Location. Red polygon represents approximate areas of the Location that are not reasonably needed for production.

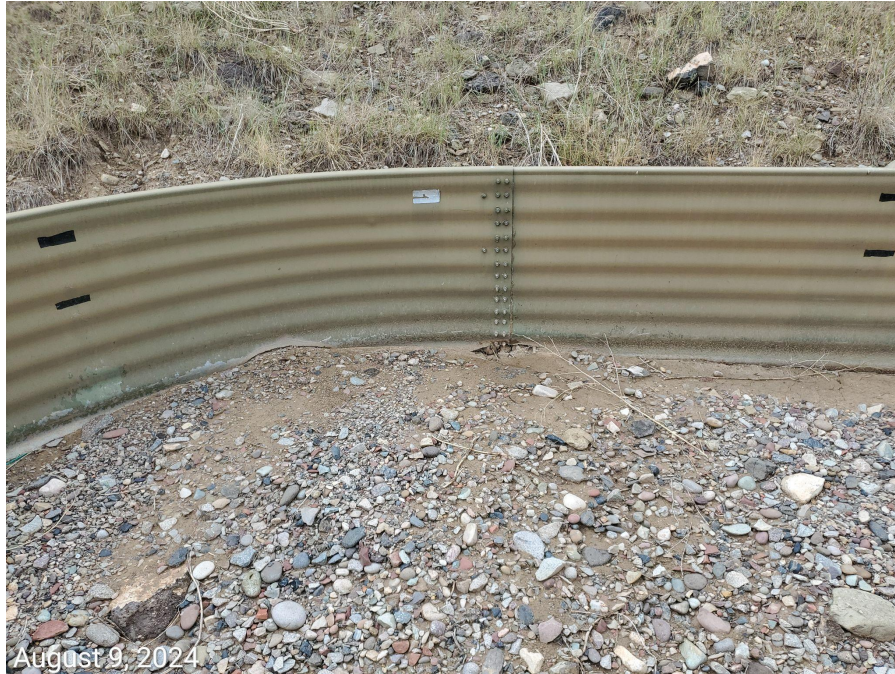
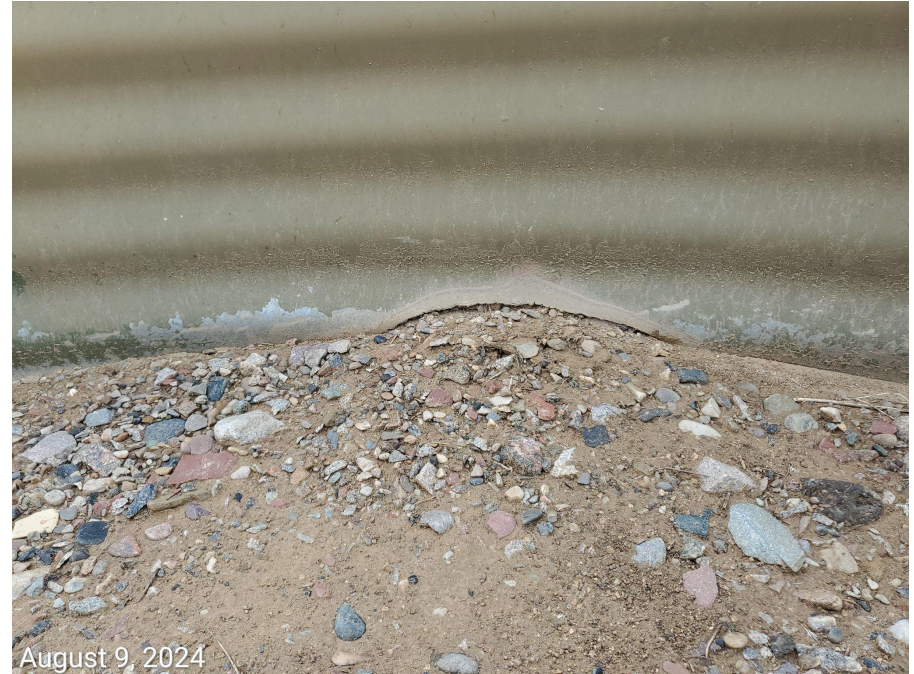
**Photo 5:** Photos 5-6 taken from the battery facility. Photo shows holes within the metal containment berm. Work to ensure BMP remains sufficiently impervious to contain a spill or release have not been taken.

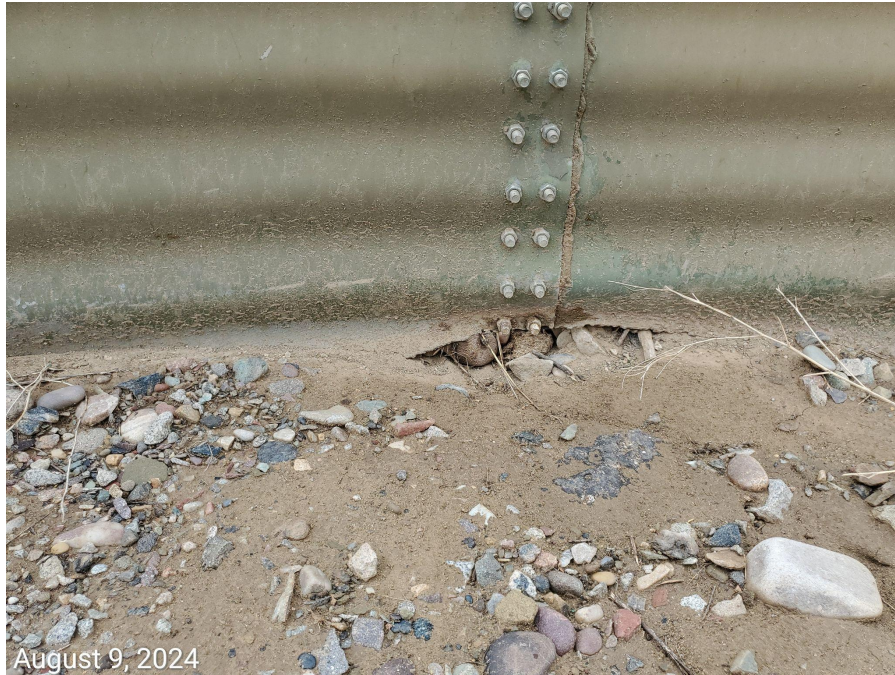
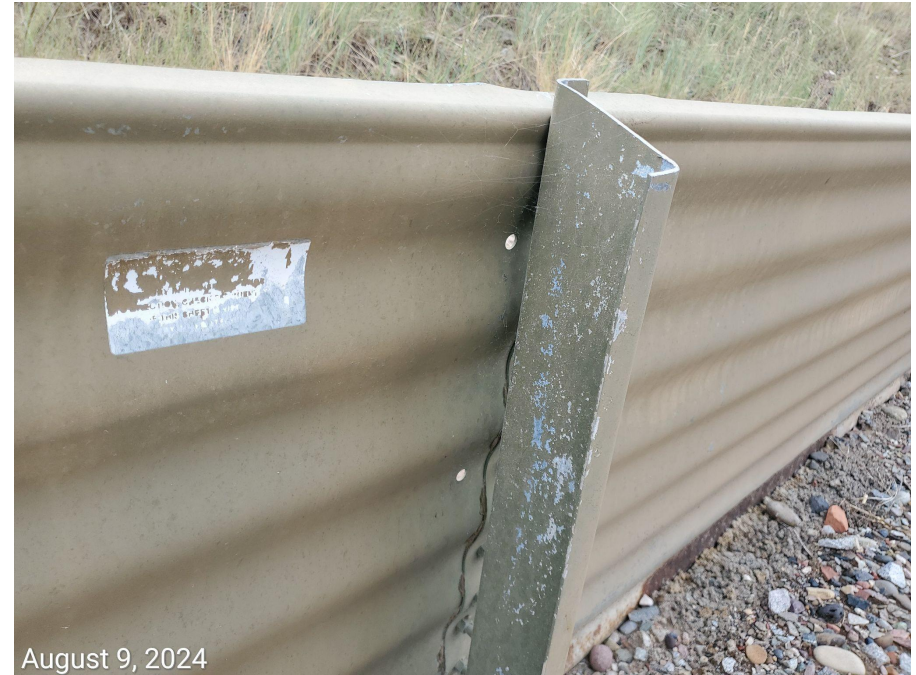
**Photo 6:** See comments under photo 5.
