Inspection Photos

API: 071-09356

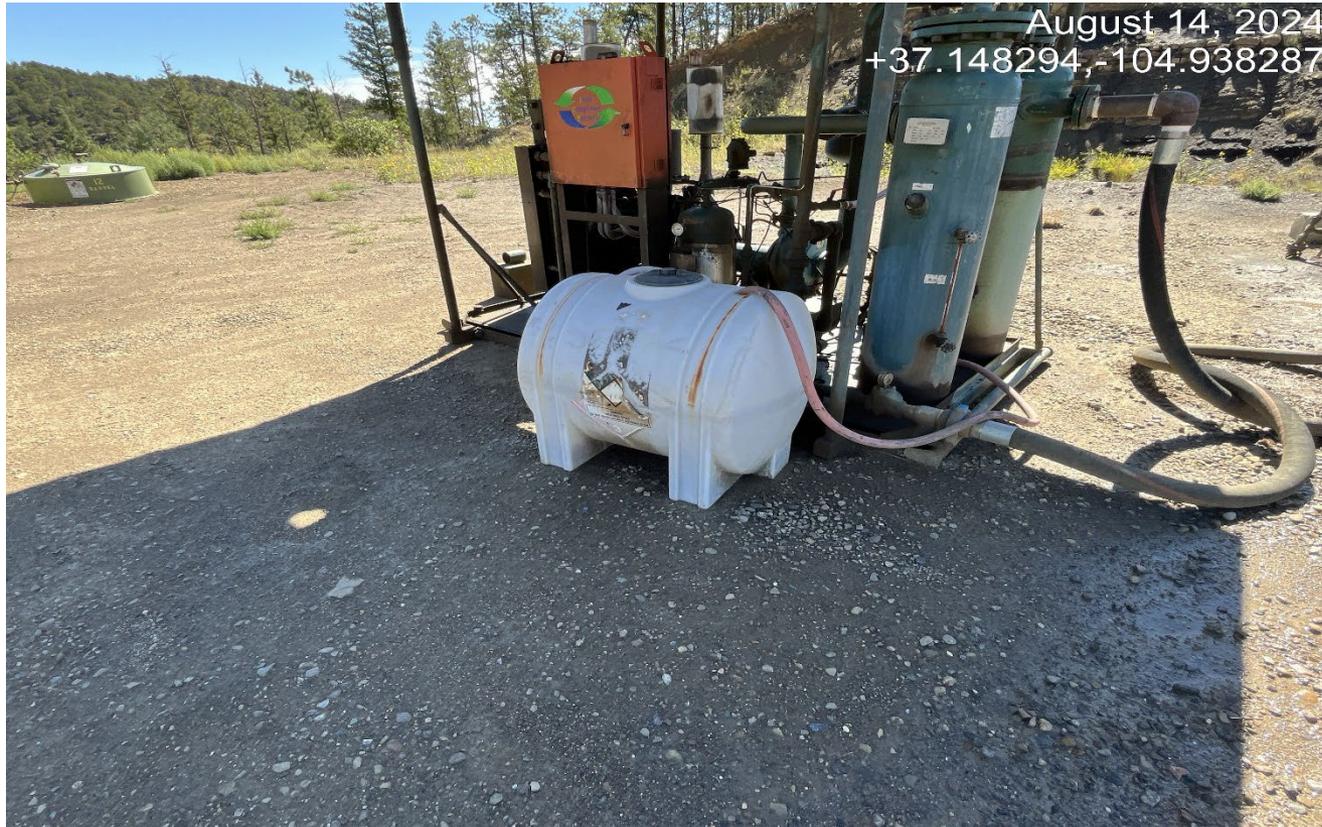
Photo 3. The labeling on this tank is degraded and needs to be replaced. This tank should also have secondary containment..
