# Inspection Photos

**Operator:** TEP ROCKY MOUNTAIN LLC #96850

**Location ID:** 323875

**Inspection Doc:** 696206124

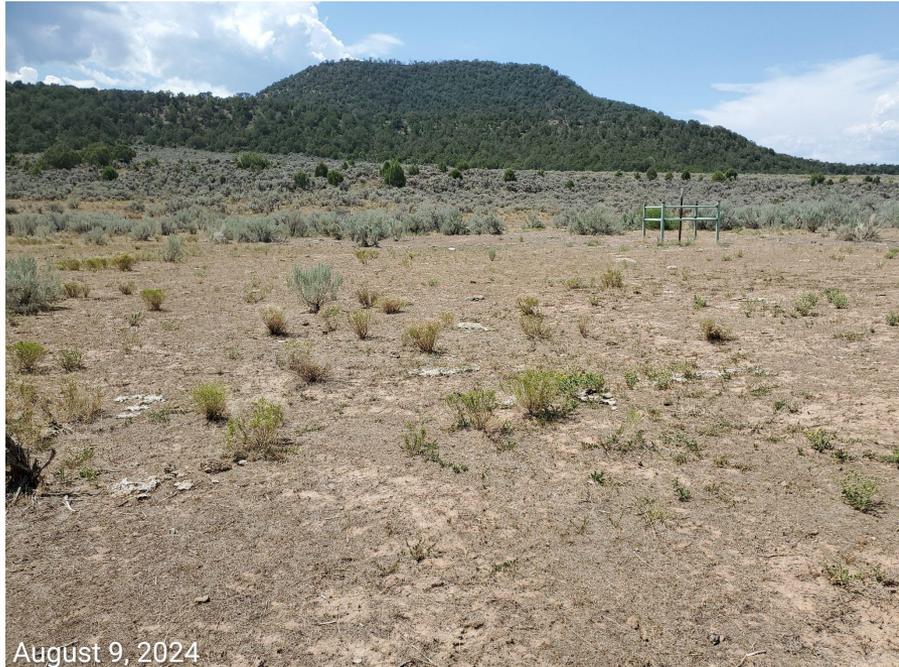
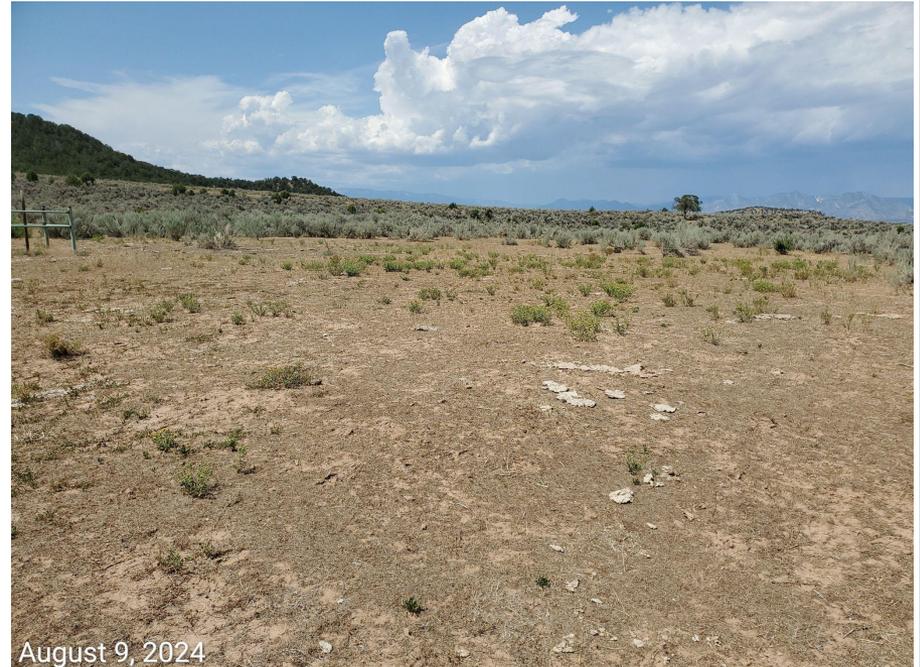
**Photo 1:** Photos taken from the east end of the Location. Photos provide an overview of the Location from southwest to northwest. Location is not progressing towards 1004 reclamation standards; perennial establishment is not uniform and location is predominantly bare, or vegetated by Undesirable Plant Species, including noxious weeds such as Jointed Goatgrass and Knapweed.

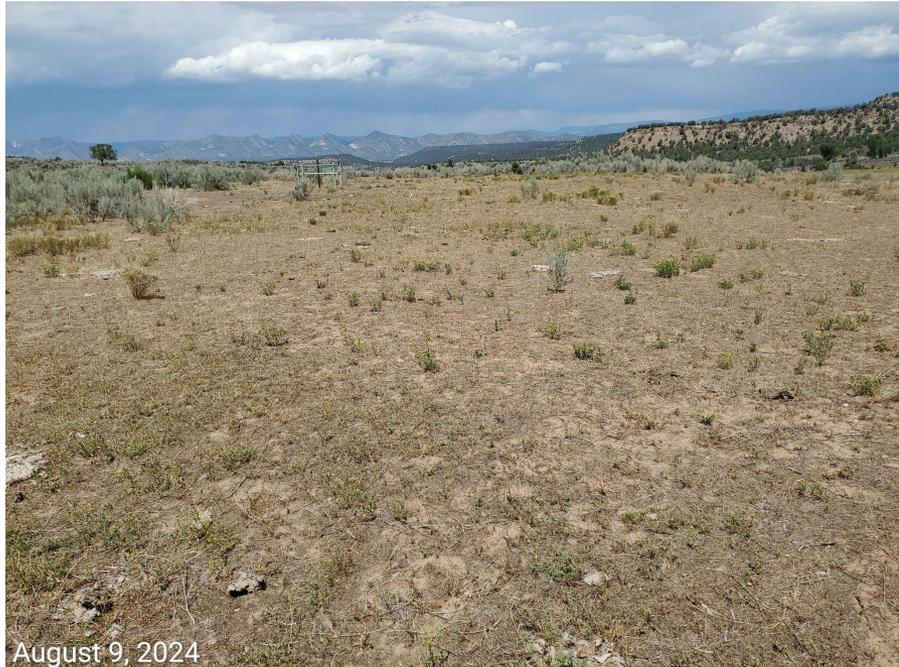
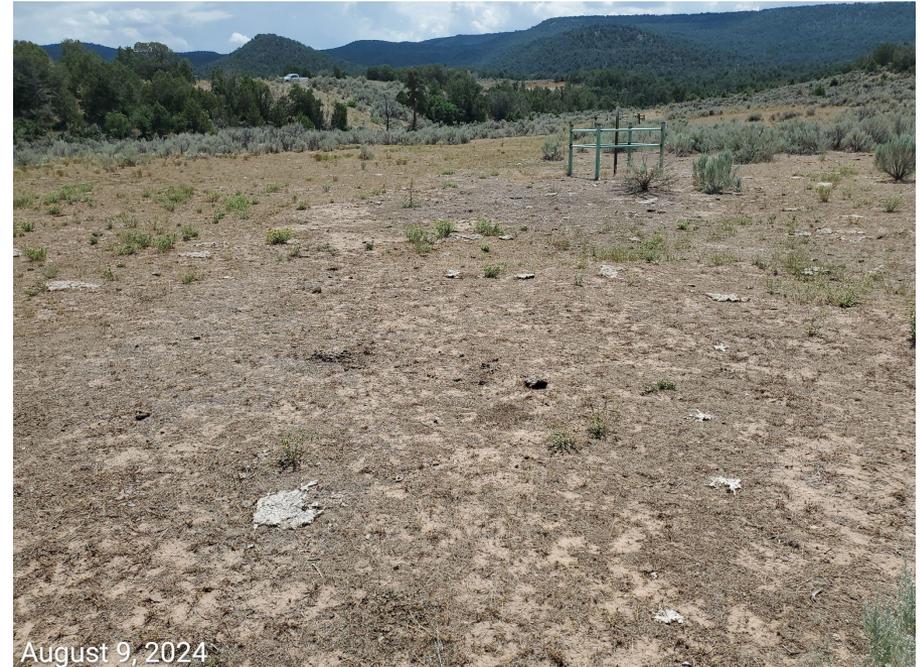
**Photo 2:** Photo left taken from the south end of the Location, facing north. Photo right taken from the north end of the Location, facing south. Location is not progressing towards 1004 reclamation standards; perennial establishment is not uniform and location is predominantly bare, or vegetated by Undesirable Plant Species, including noxious weeds such as Jointed Goatgrass and Knapweed.

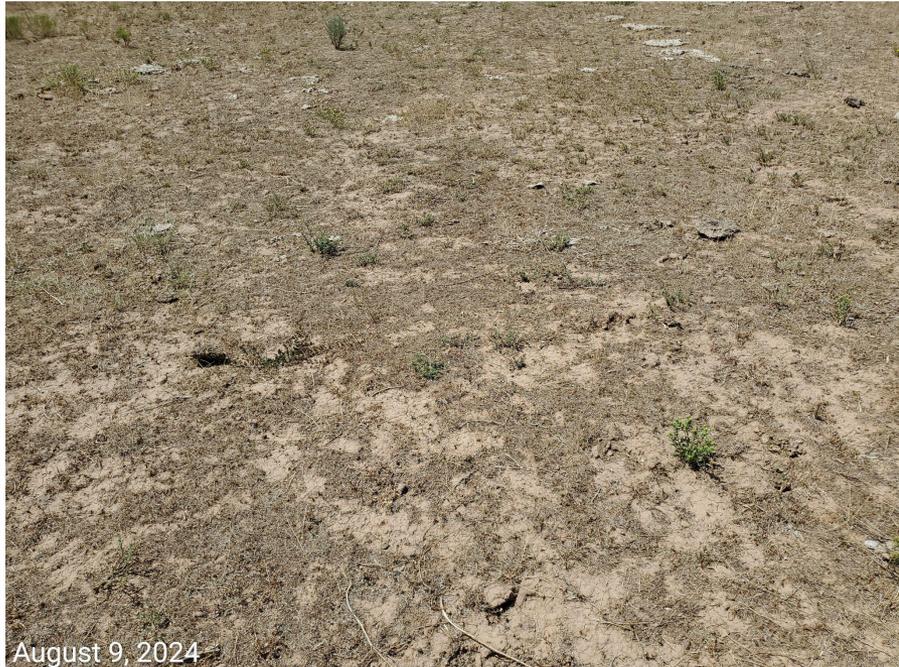
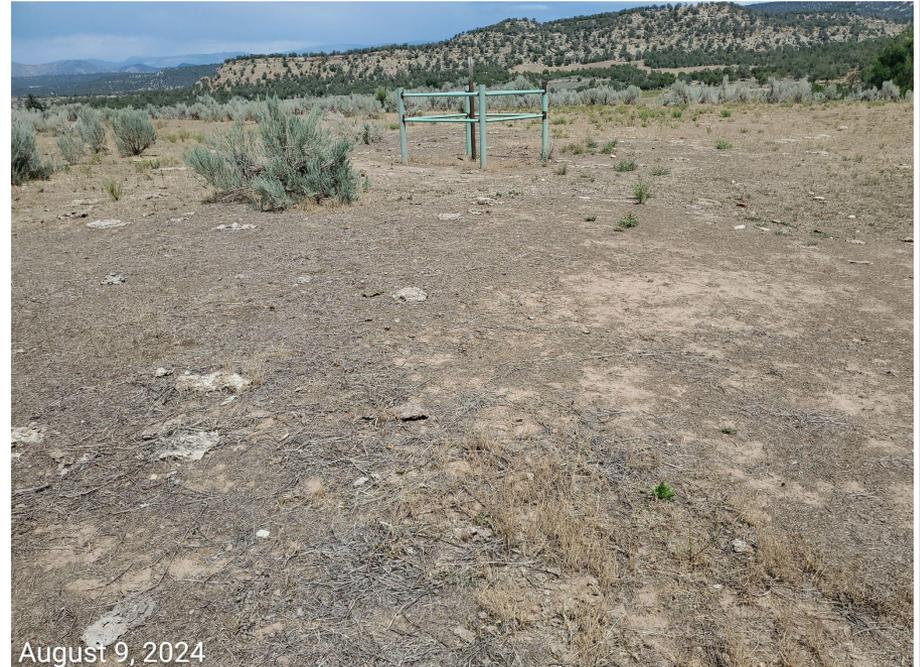
**Photo 3:** Photos examples showing perennial establishment is not uniform and location is predominantly bare, or vegetated by Undesirable Plant Species, including noxious weeds such as Jointed Goatgrass and Knapweed.

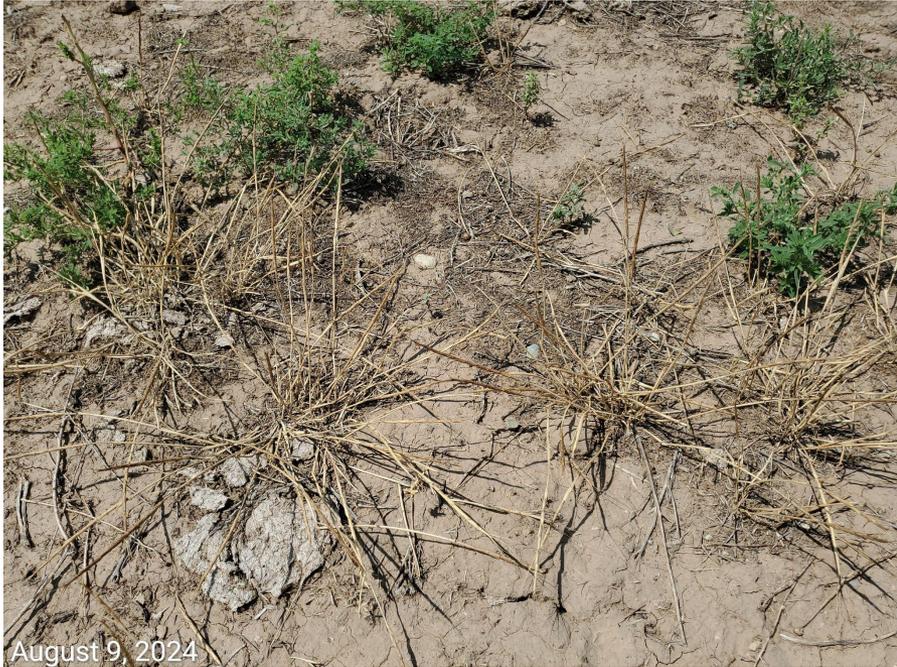
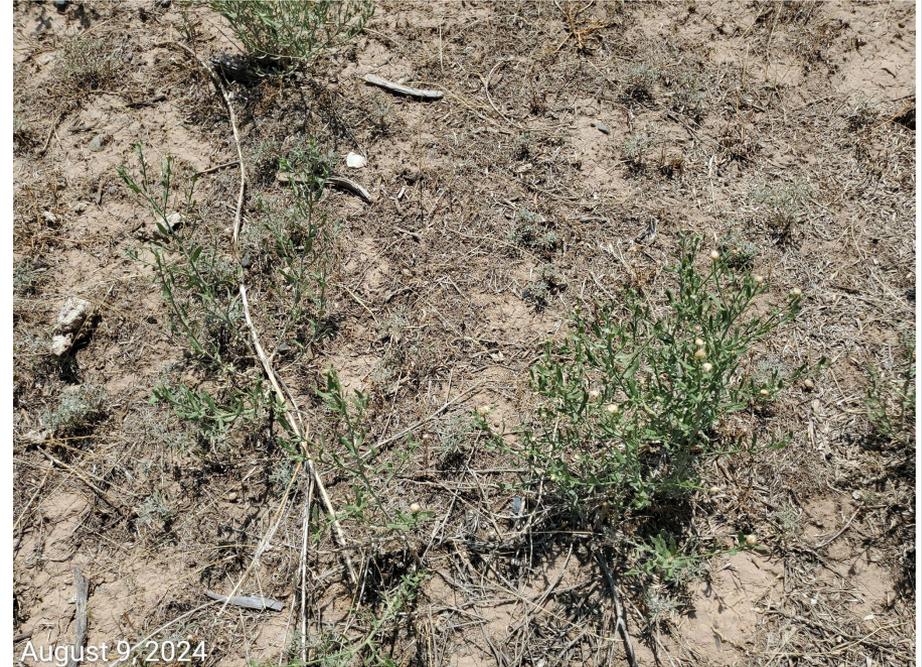
**Photo 5:** Photos examples showing Jointed Goatgrass and Knapweed establishment on the Location.

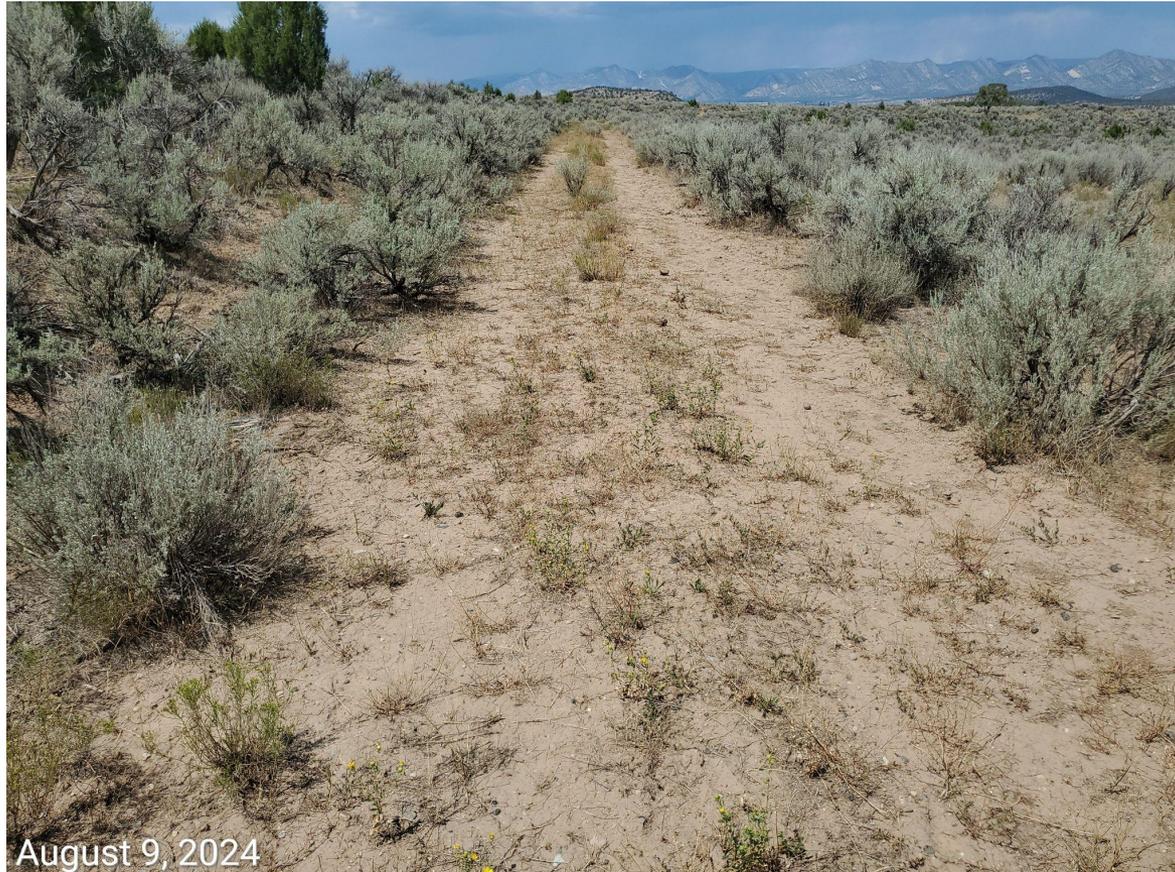
**Photo 1:** Photo taken from the access road facing north; O&G Access road to Location has not been reclaimed.

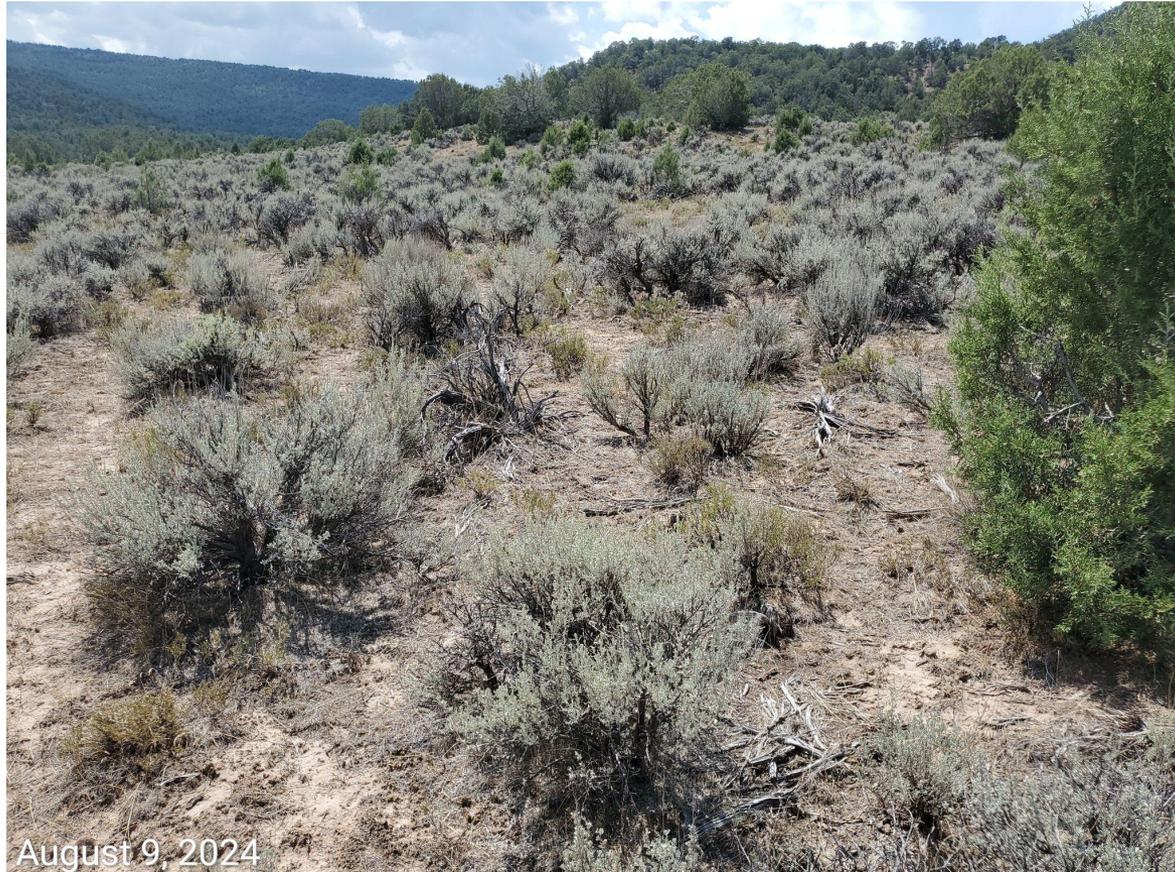
**Photo 4:** Photo taken from the adjacent reference area for comparison to establishment on the Location.
