Final Reclamation and Stormwater Inspection

Operator: CRESTONE PEAK RESOURCES OPERATING
LLC - 10633

Location ID/ Well API: 331608/ 123-20976

Inspection Photos
Location Name: Chapin 44-4
Location ID: 331608

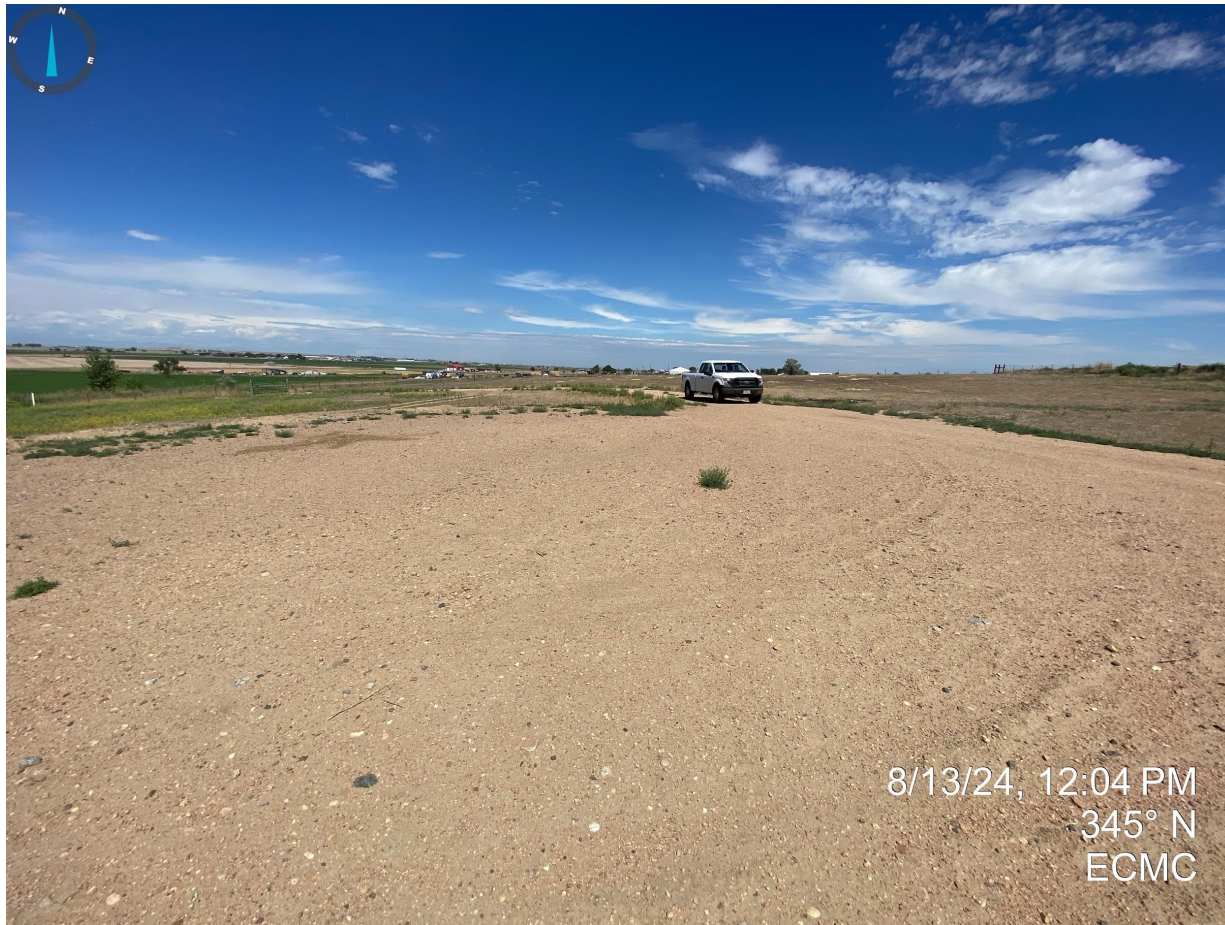
Photo 1. Facing north at the former well location. Well API 123-20976 was plugged and abandoned on 04/09/2018. It does not appear that final reclamation activities have been performed since the well was plugged.

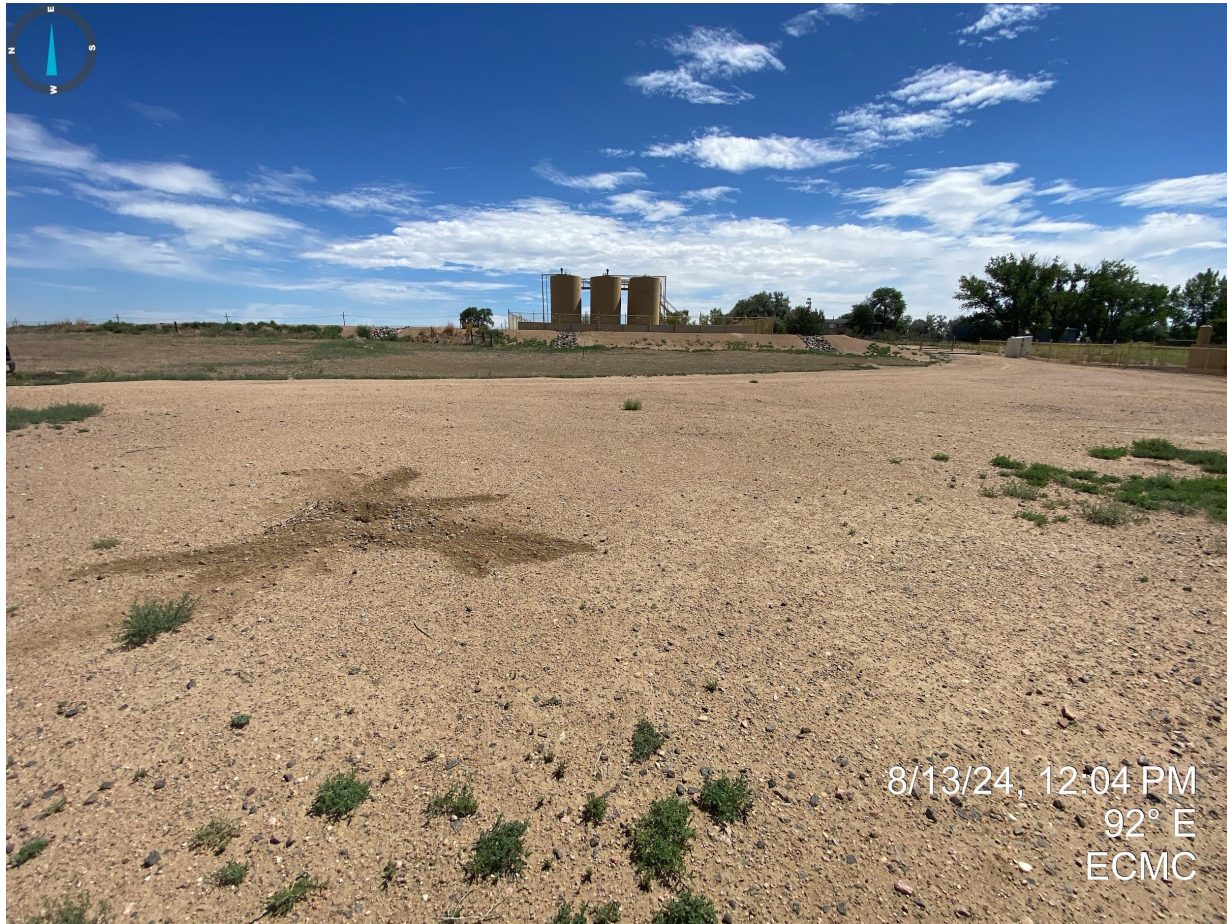
Photo 2. Facing east; see comments in Photo 1.

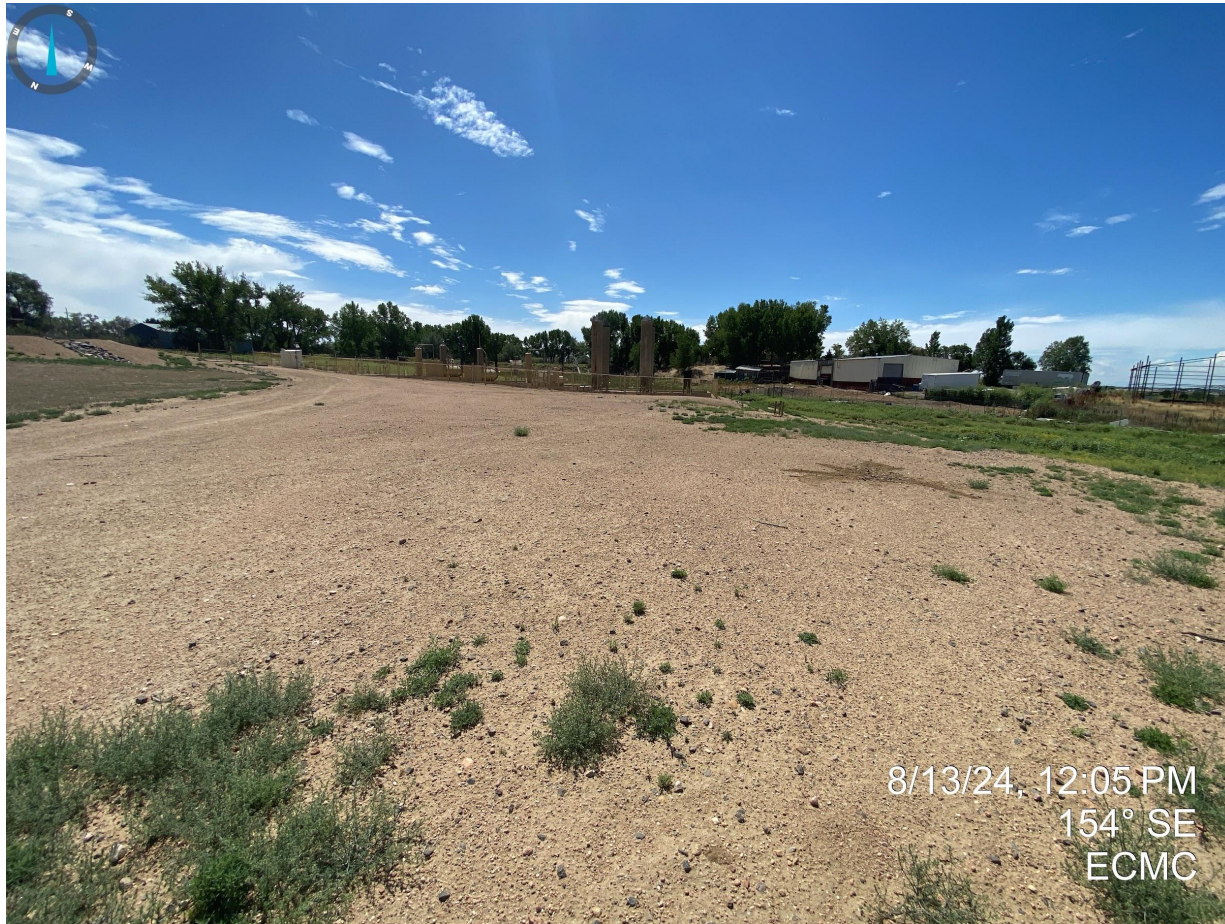
Photo 3. Facing southeast; see comments in Photo 1.

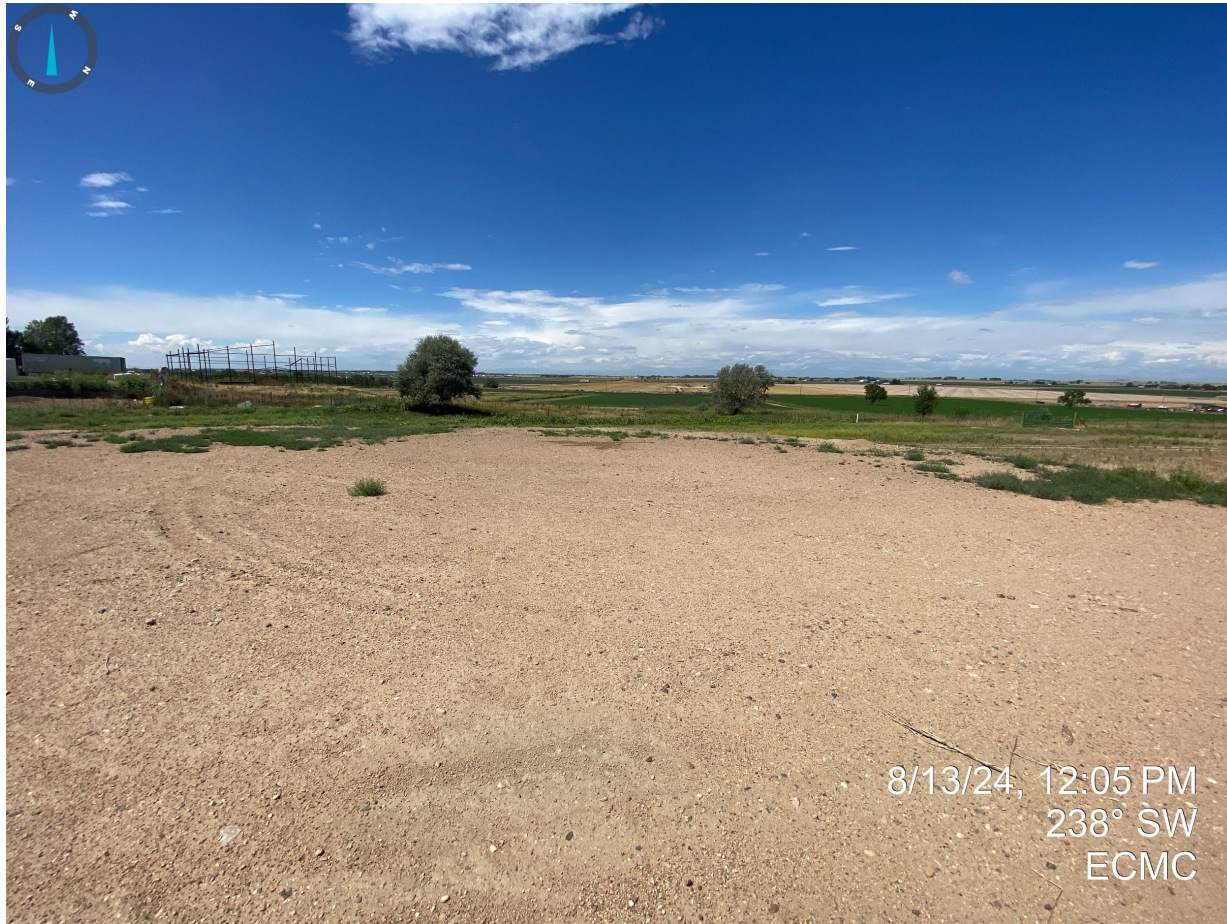
Photo 4. Facing southwest; see comments in Photo 1.

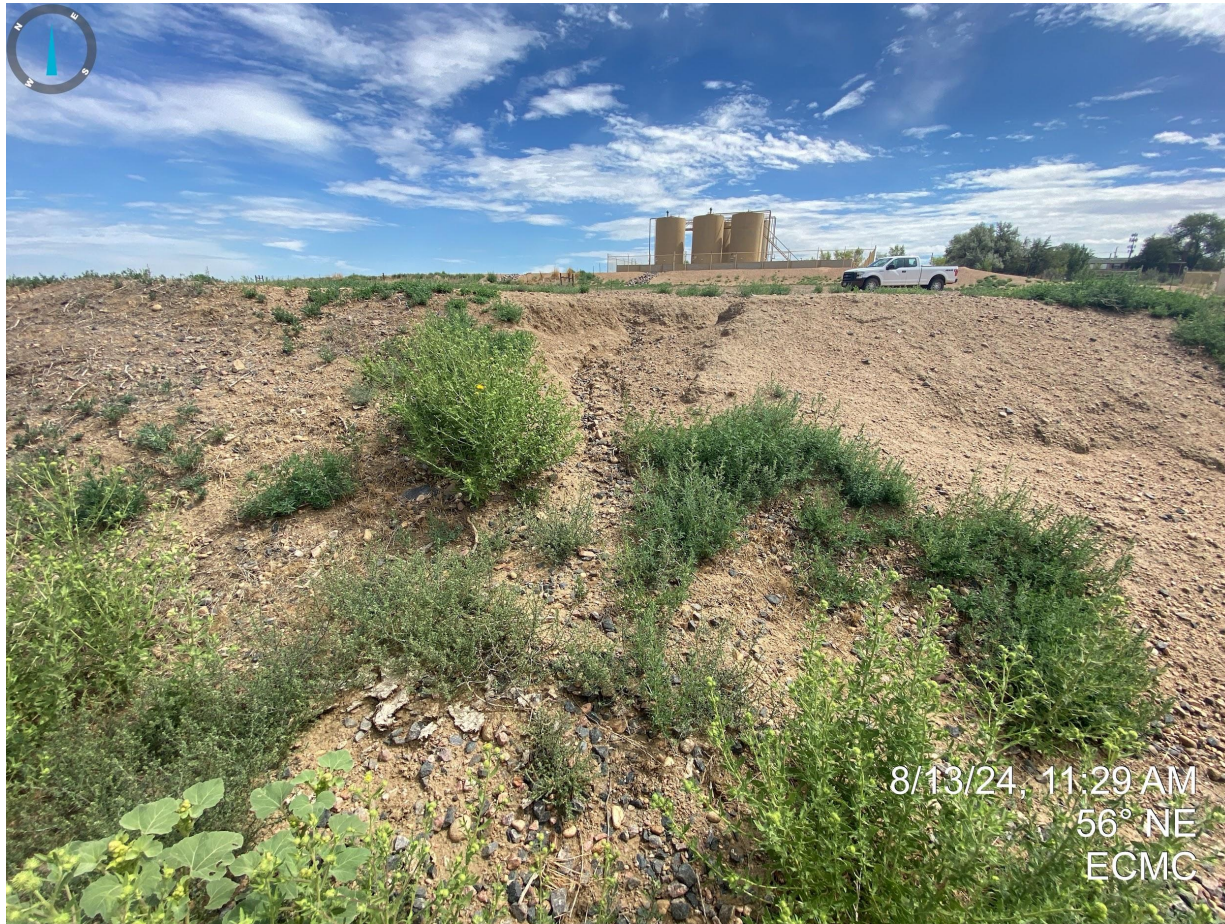
Photo 5. Taken near the southwestern portion of the expanded pad for Well API 123-20976. Photo illustrates erosion degradation (e.g gullying) originating from the pad with evidence of off location sediment deposition onto adjacent lands (Photo 6).

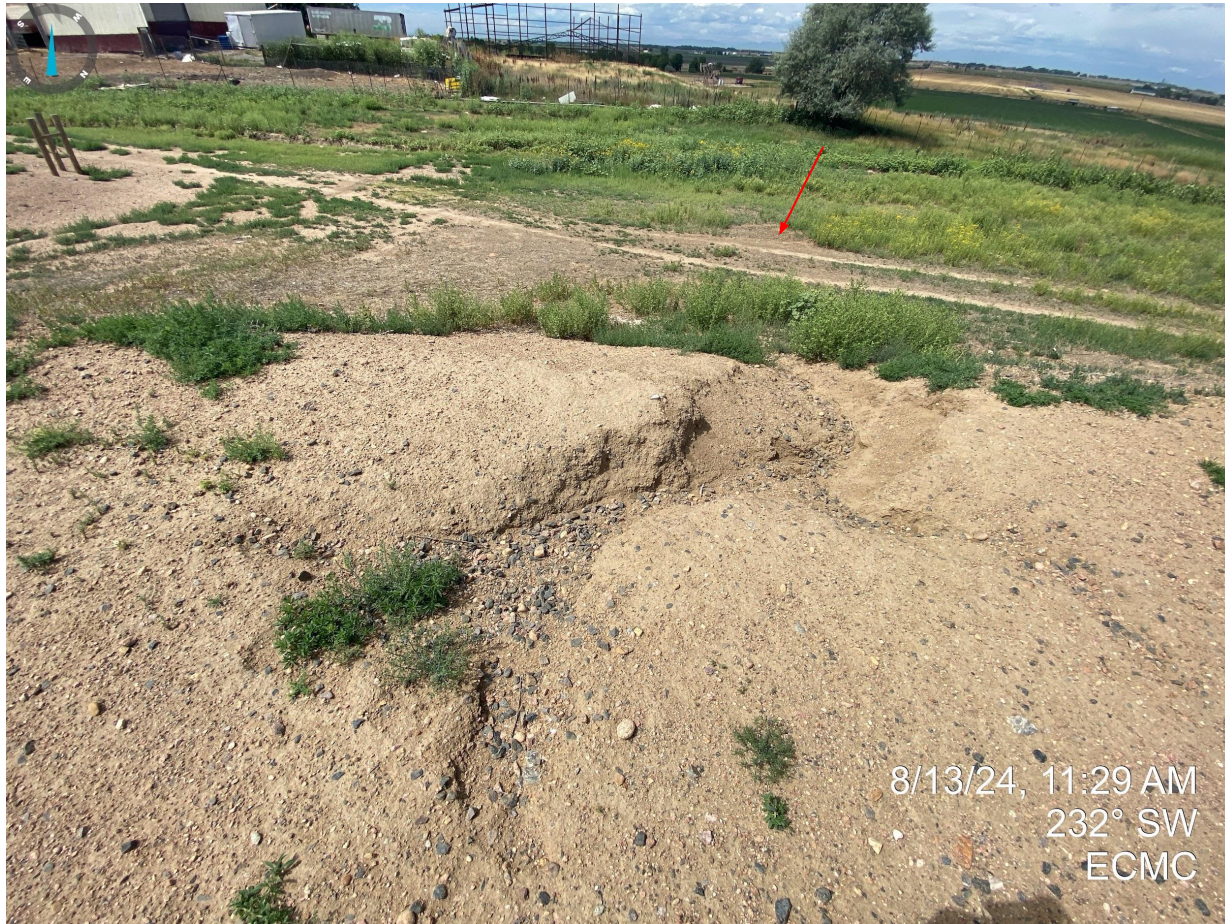
Photo 6. Continued from Photo 5; facing southwest. Photo illustrates erosion degradation (e.g. gullying) and sediment deposition off location (indicated by red arrow).

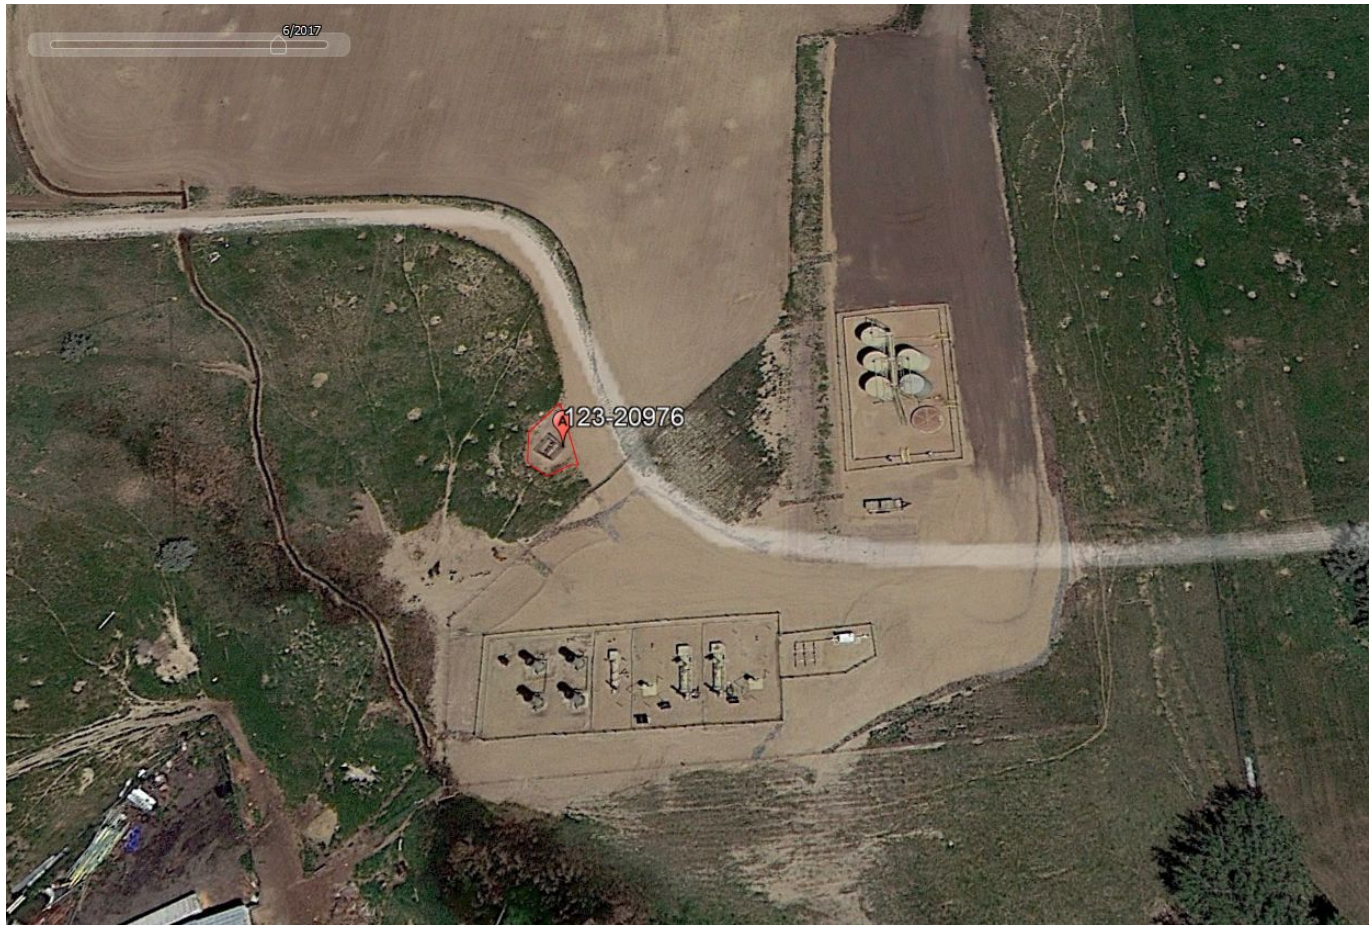
Photo 7. Google Earth aerial imagery taken circa (06/2017) prior to plugging and abandonment of Well API 123-20976. Red polygon illustrates approximate well footprint, not including access road to nearby well.

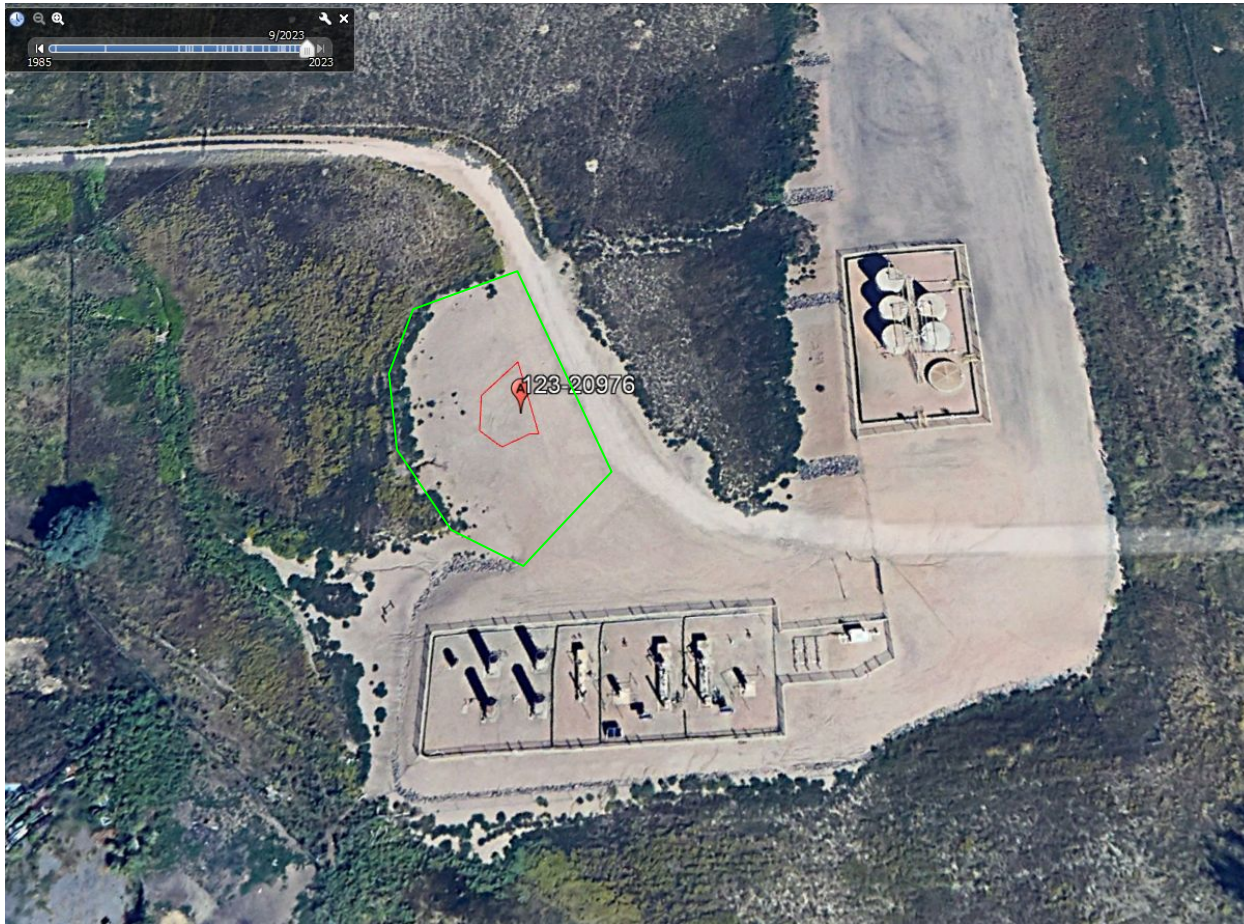
Photo 8. Google Earth aerial imagery taken circa (09/2023) after Well API 123-20976 was plugged and abandoned. Red polygon illustrates approximate footprint of the well before P&A operations and the green polygon illustrates the pad expansion likely used for P&A operations that was not reclaimed per Rule 1004.
