# Inspection Photos

API: 017-06625

Operator: **WILLIFORD ENERGY COMPANY**

Inspection Date: 8/19/2024

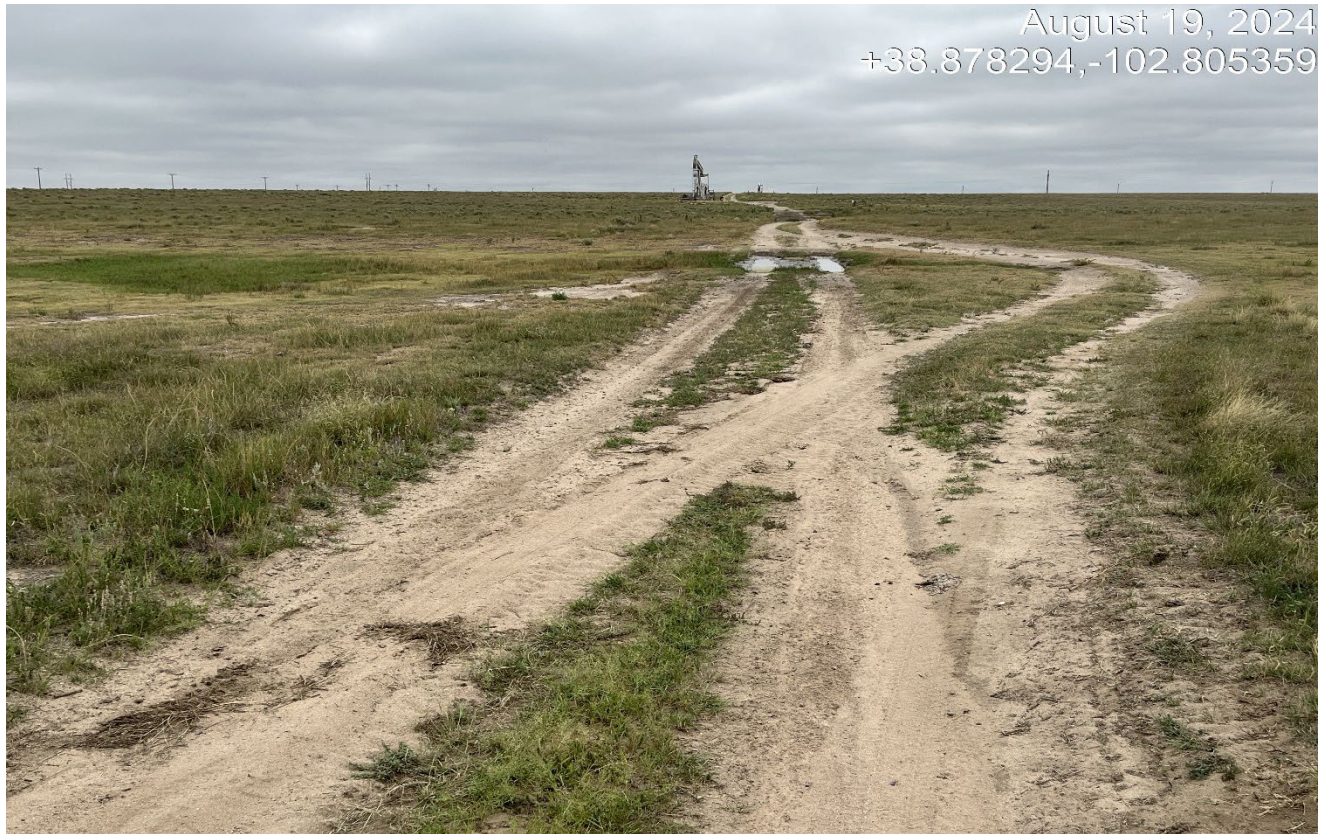
**Photo 1.** Facing east along the access road. Vehicles are causing unnecessary disturbance driving outside of the access road due to stormwater pooling on the road. The access road must be maintained and shall not drive outside of the access road boundary.

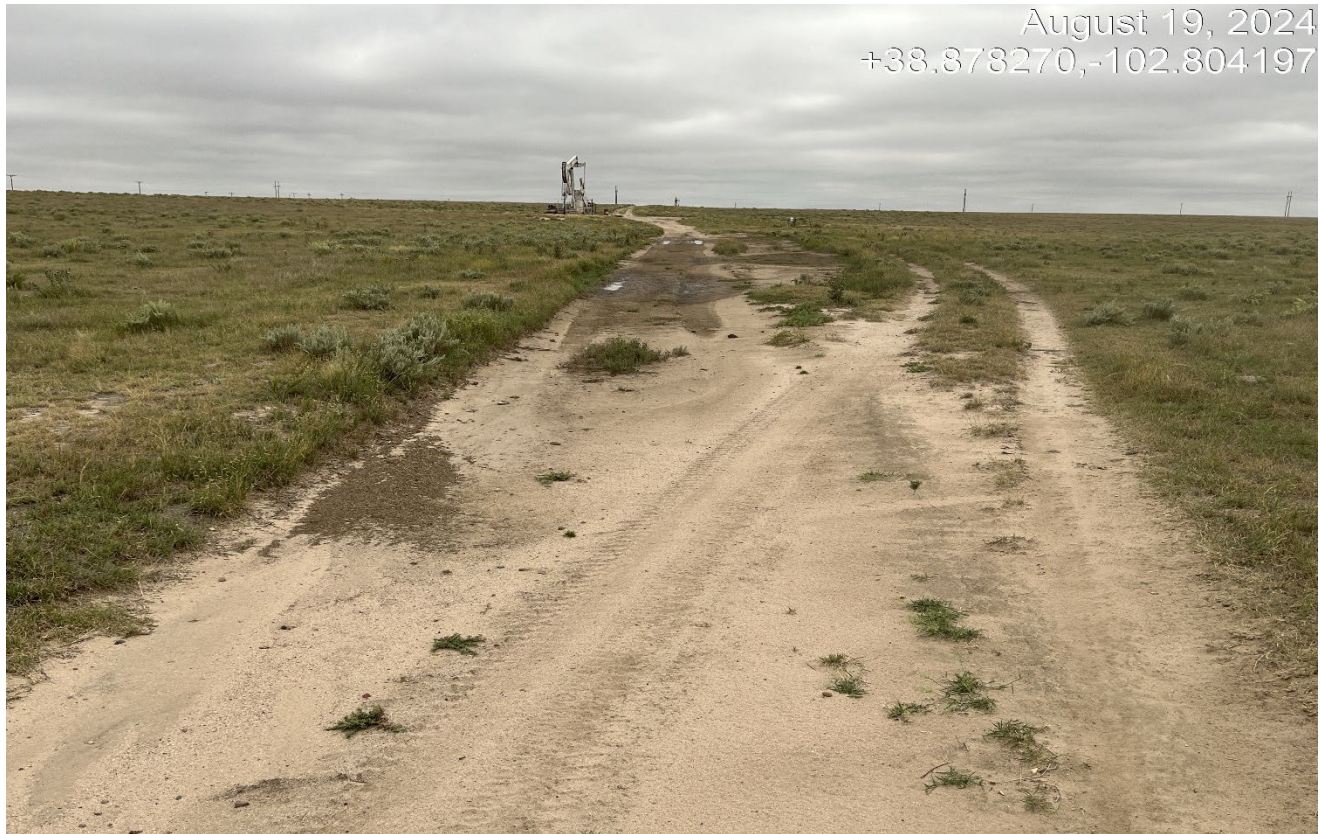
**Photo 2.** Facing east along the access road. Vehicles are causing unnecessary disturbance driving outside of the access road due to stormwater pooling on the road. The access road must be maintained and shall not drive outside of the access road boundary.

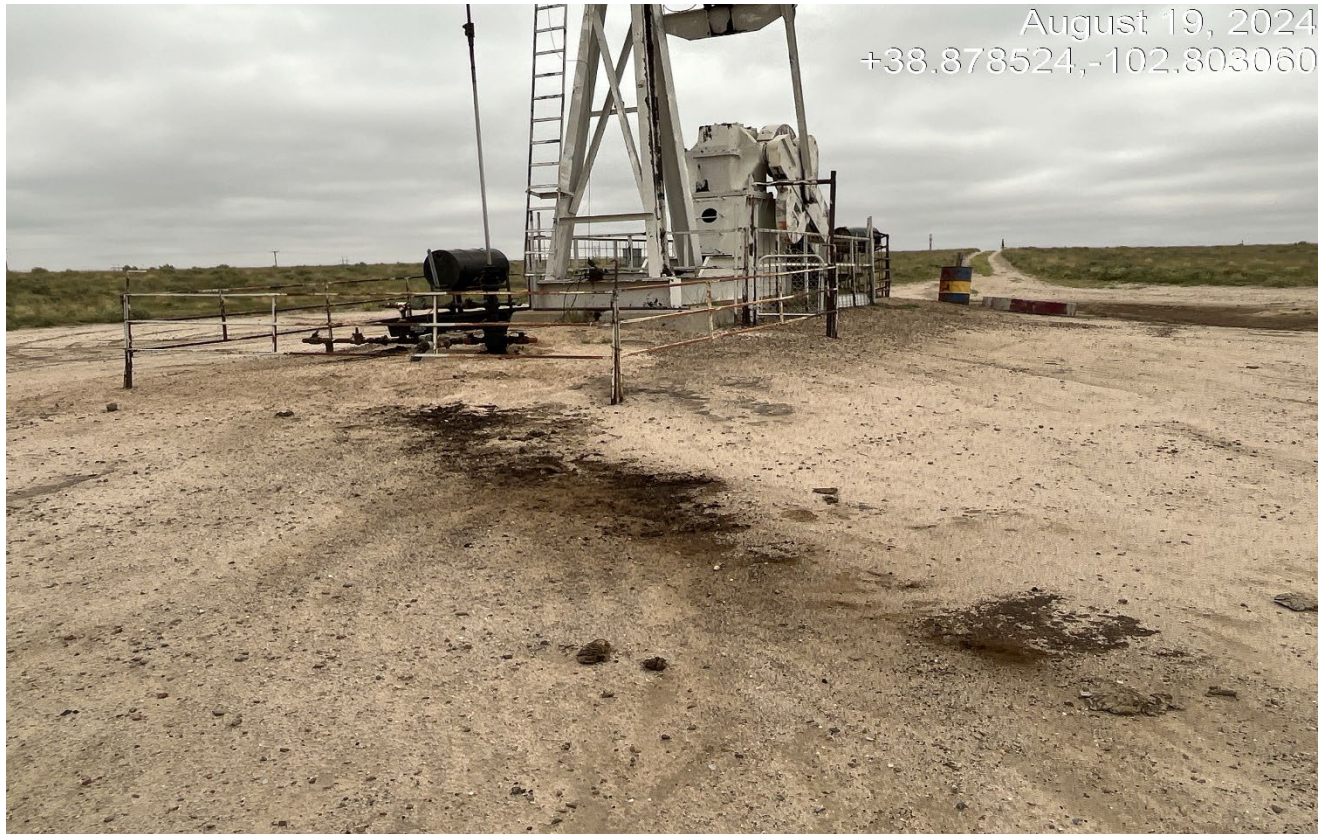
**Photo 3.** Facing northeast toward the wellsite. There is impacted soils from the previous spill that were not cleaned up.

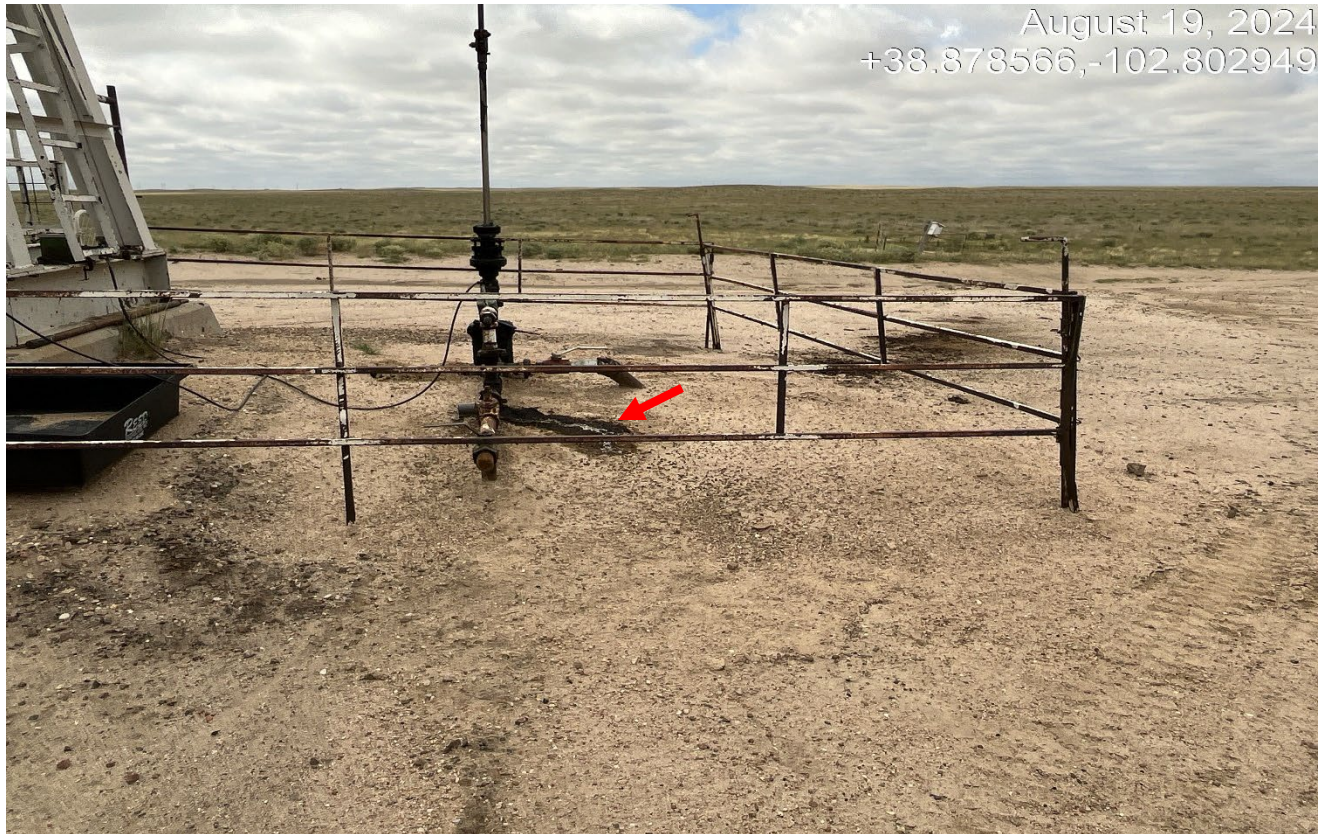
**Photo 4.** It appears there was sand spread on top of the spill which was not cleaned up per the rules. There is a new leak at the wellhead shown at red arrow.

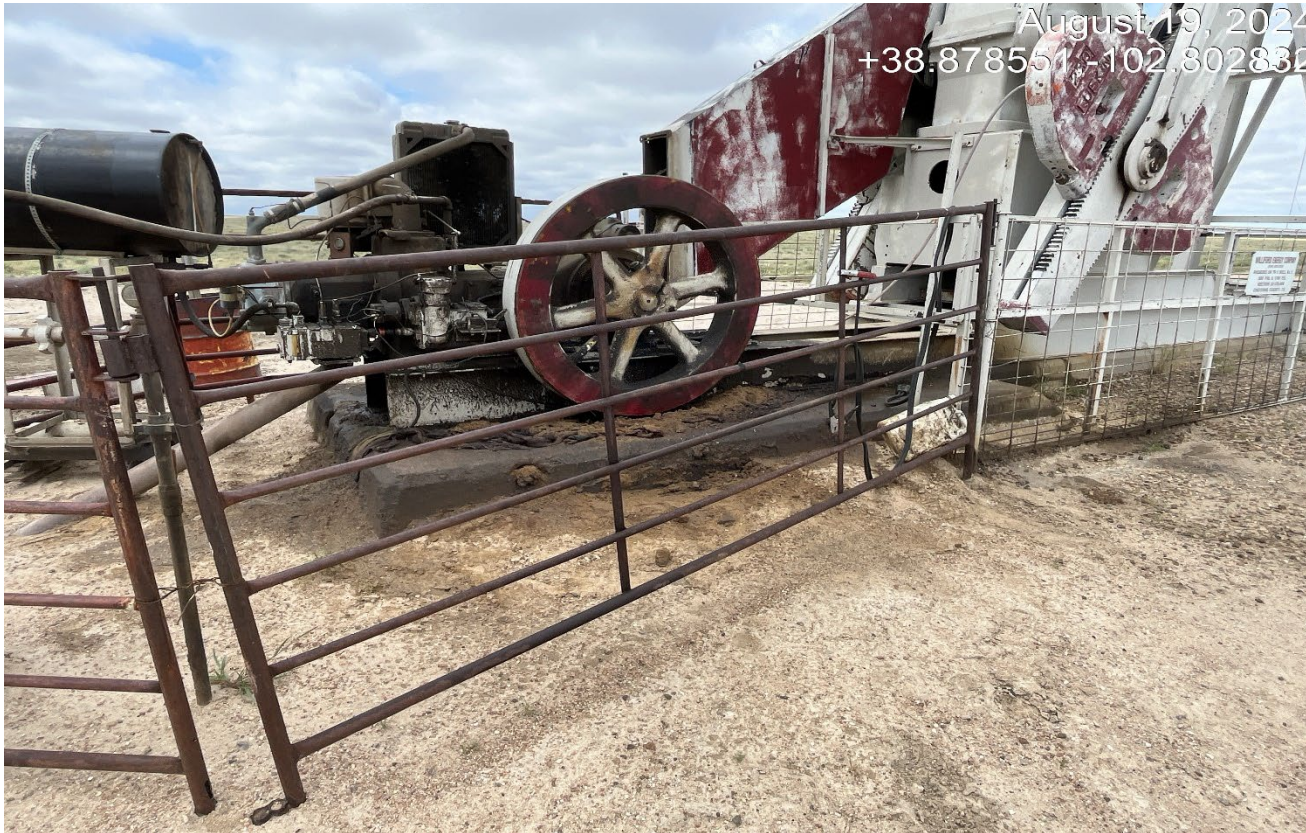
**Photo 5.** The pumpjack engine is still leaking oil and there is stained soils around the base.

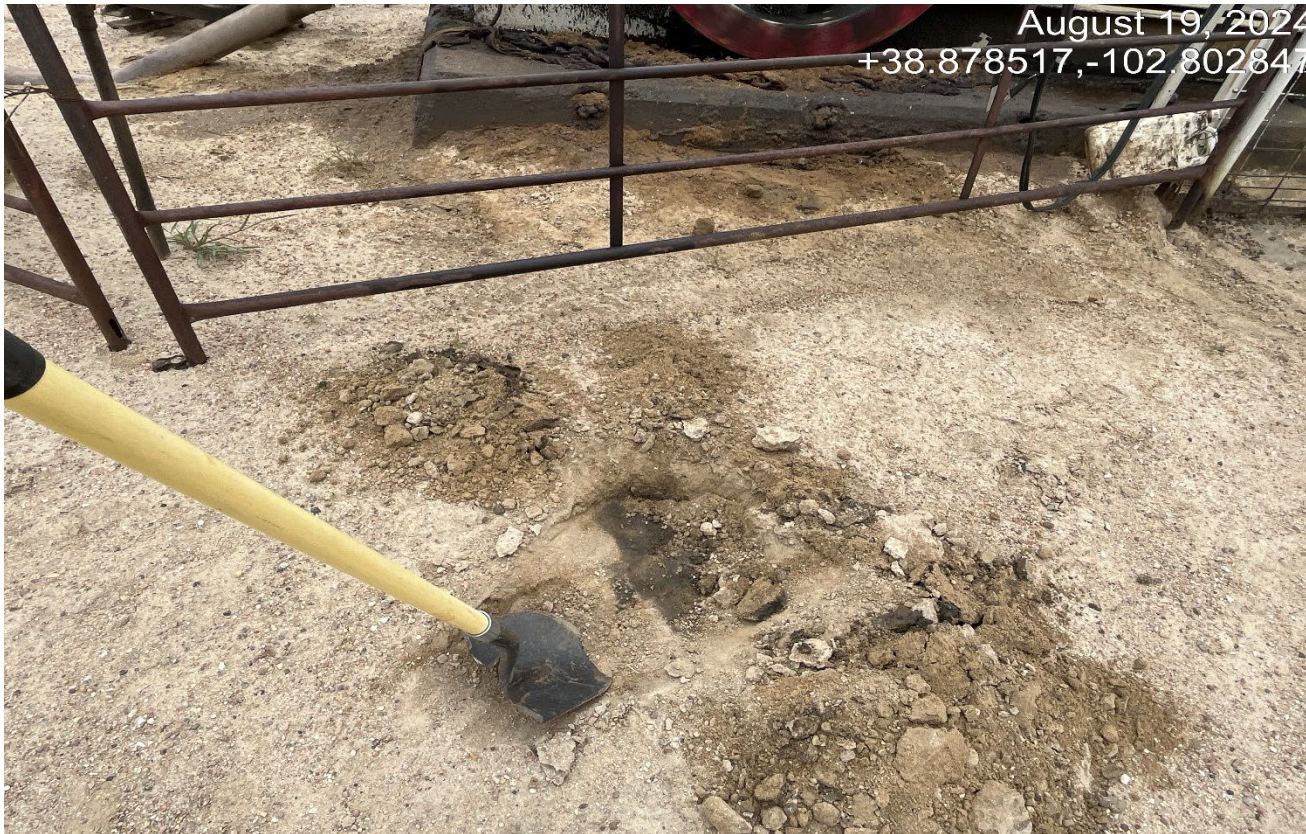
**Photo 6.** It appears there was sand spread on top of the spill which was not cleaned up per the rules. There is still oily soils that remain underneath the sand that was placed over the stained soils.

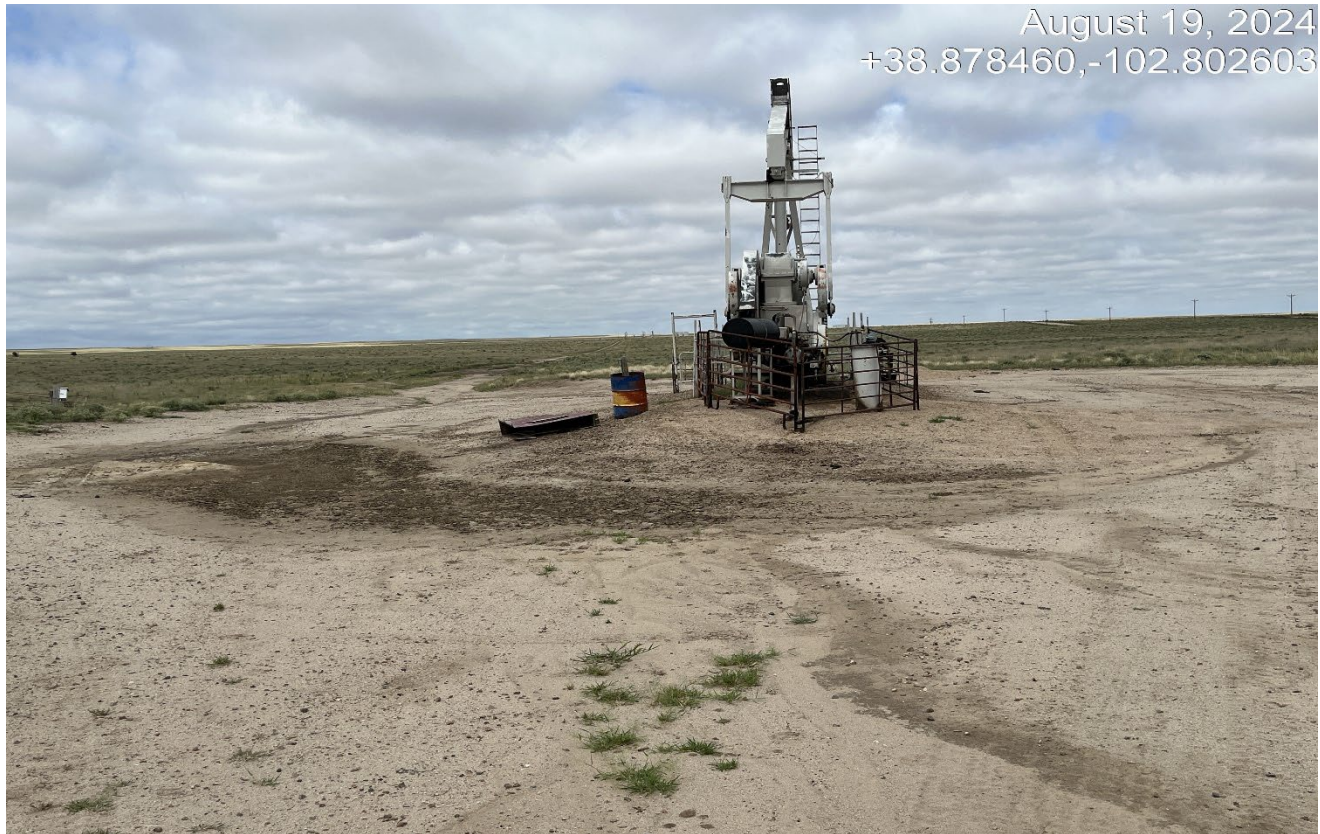
**Photo 7.** Facing west toward the location. There is evidence of water pooling at the east side of the pumpjack with no proper drainage. There is a piece of the pumpjack laying on the ground.
